# **BASELINE DATA REPORT**

## **Section 8.0**

### **Surface Water**

Roca Honda Resources, LLC  
4001 Office Court, Suite 102, Santa Fe, NM 87507

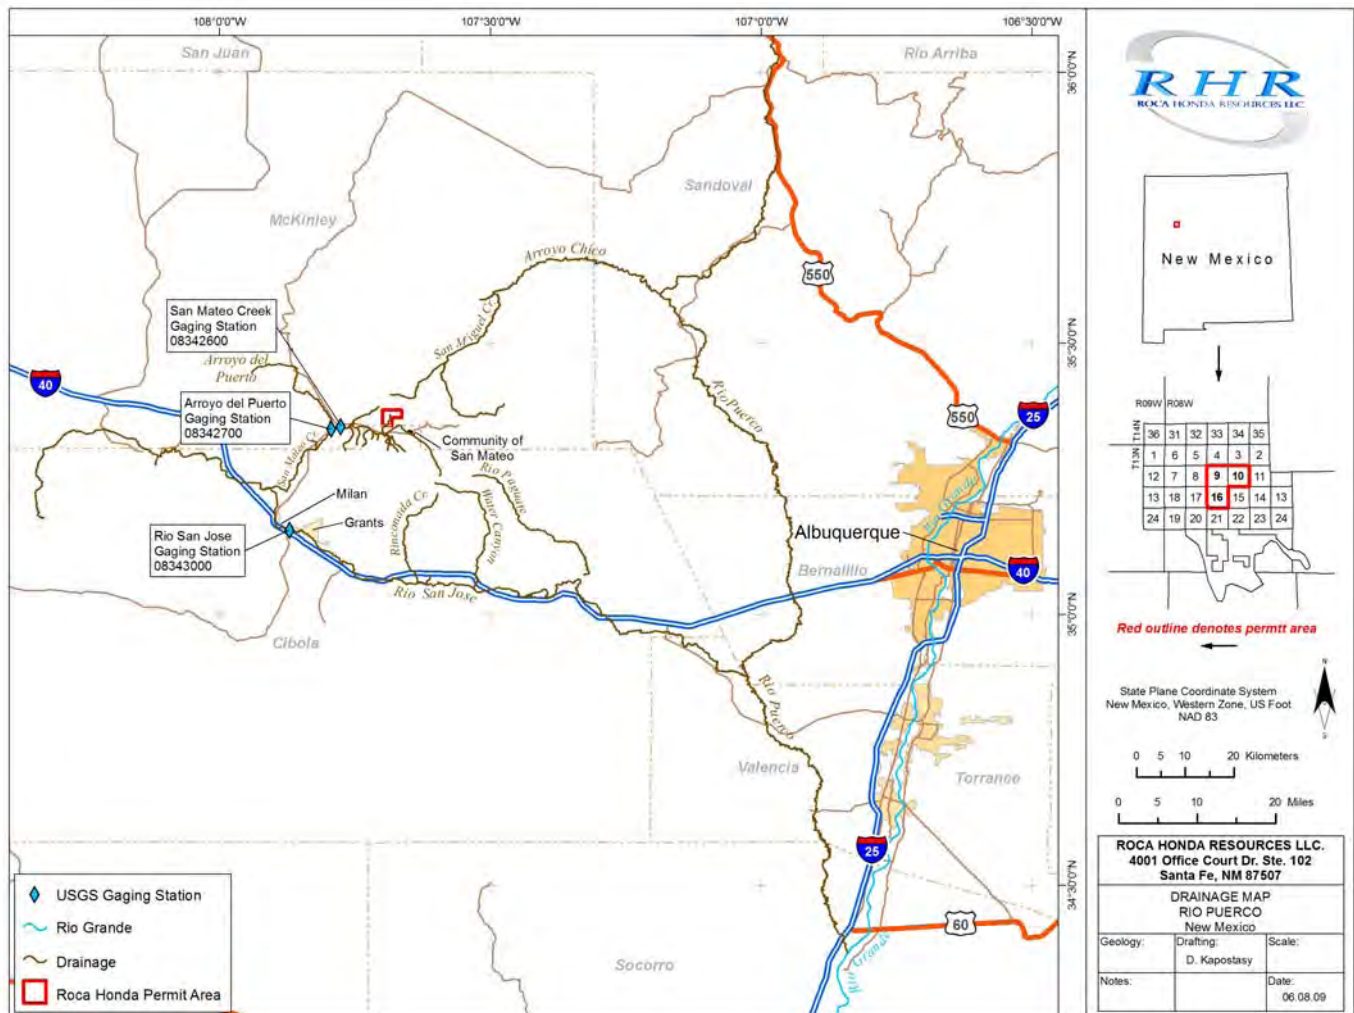
Figure 8-1. RHR Project Location within the Rio Puerco Drainage

The RHR permit area lies within the middle portion of the watershed of San Mateo Creek, a small stream system that is tributary to the Rio San Jose, the Rio Puerco, and ultimately the Rio Grande (Figure 8-1). Because the stream is perennial only in its headwaters, and that flow is completely diverted for irrigation purposes, no permanent gaging station exists on the creek. The limited historical water quality and water quantity data for San Mateo Creek were collected either for the purpose of establishing baseline hydrologic conditions prior to development of the Gulf Mt. Taylor mine, or in response to subsequent mining and dewatering activities. These data include measurements from a stream flow gaging station that measured mine water discharge to San Mateo Creek above its confluence with Arroyo del Puerto (USGS gaging station 08342600), a short period of measurements for Arroyo del Puerto (USGS gaging station 08342700), water quality and quantity data collected in the middle and upper San Mateo Creek watershed by the New Mexico Environmental Institute (NMEI) in 1974, and streamflow gaging records for the Rio San Jose (USGS gaging station 08343000) just below its confluence with San Mateo Creek.

The permit area lies within the middle portion of the San Mateo Creek Watershed. Figure 8-1 and Figure 8-2 identify the location of surface watercourses in and adjacent to the permit area and designate the location and size of the watersheds in and adjacent to the permit area.

del Puerto (which drains Ambrosia Lake Valley). The gaging stations, designated as San Mateo Creek near San Mateo, NM (Station 08342600) and Arroyo del Puerto near San Mateo, NM (Station 08342700), are approximately 1 mile apart. These locations are shown in Figure 8–1 on page 8-2. The San Mateo gaging station was located about 8 miles west of the community of San Mateo. It recorded daily flow of the creek from a watershed drainage area of 75.6 square miles from May 23, 1977 to October 7, 1982. Mean daily streamflow data for the 5-year operational period are shown on Figure 8-3. Mean monthly flow of San Mateo Creek is shown on Figure 8-4 for the same period. Elevated stream flows, which ranged from 2 to 12 cfs (900 to 5,400 gpm) prior to March 1978, reflect mine dewatering discharge during prior mining activities including the Johnny M mine and discharge during excavation of the Mt. Taylor mine shafts. Sporadic high flows of the creek after that period generally reflect high rainfall episodes during the summer/early fall and spring snowmelt runoff periods.
