**QUESTA TAILINGS PIPELINE REMOVAL  
MMD/NMED WORK PLAN  
CHEVRON ENVIRONMENTAL MANAGEMENT COMPANY  
QUESTA MINE**

**May 19, 2017**

**SUBMITTED BY:** Trihydro Corporation

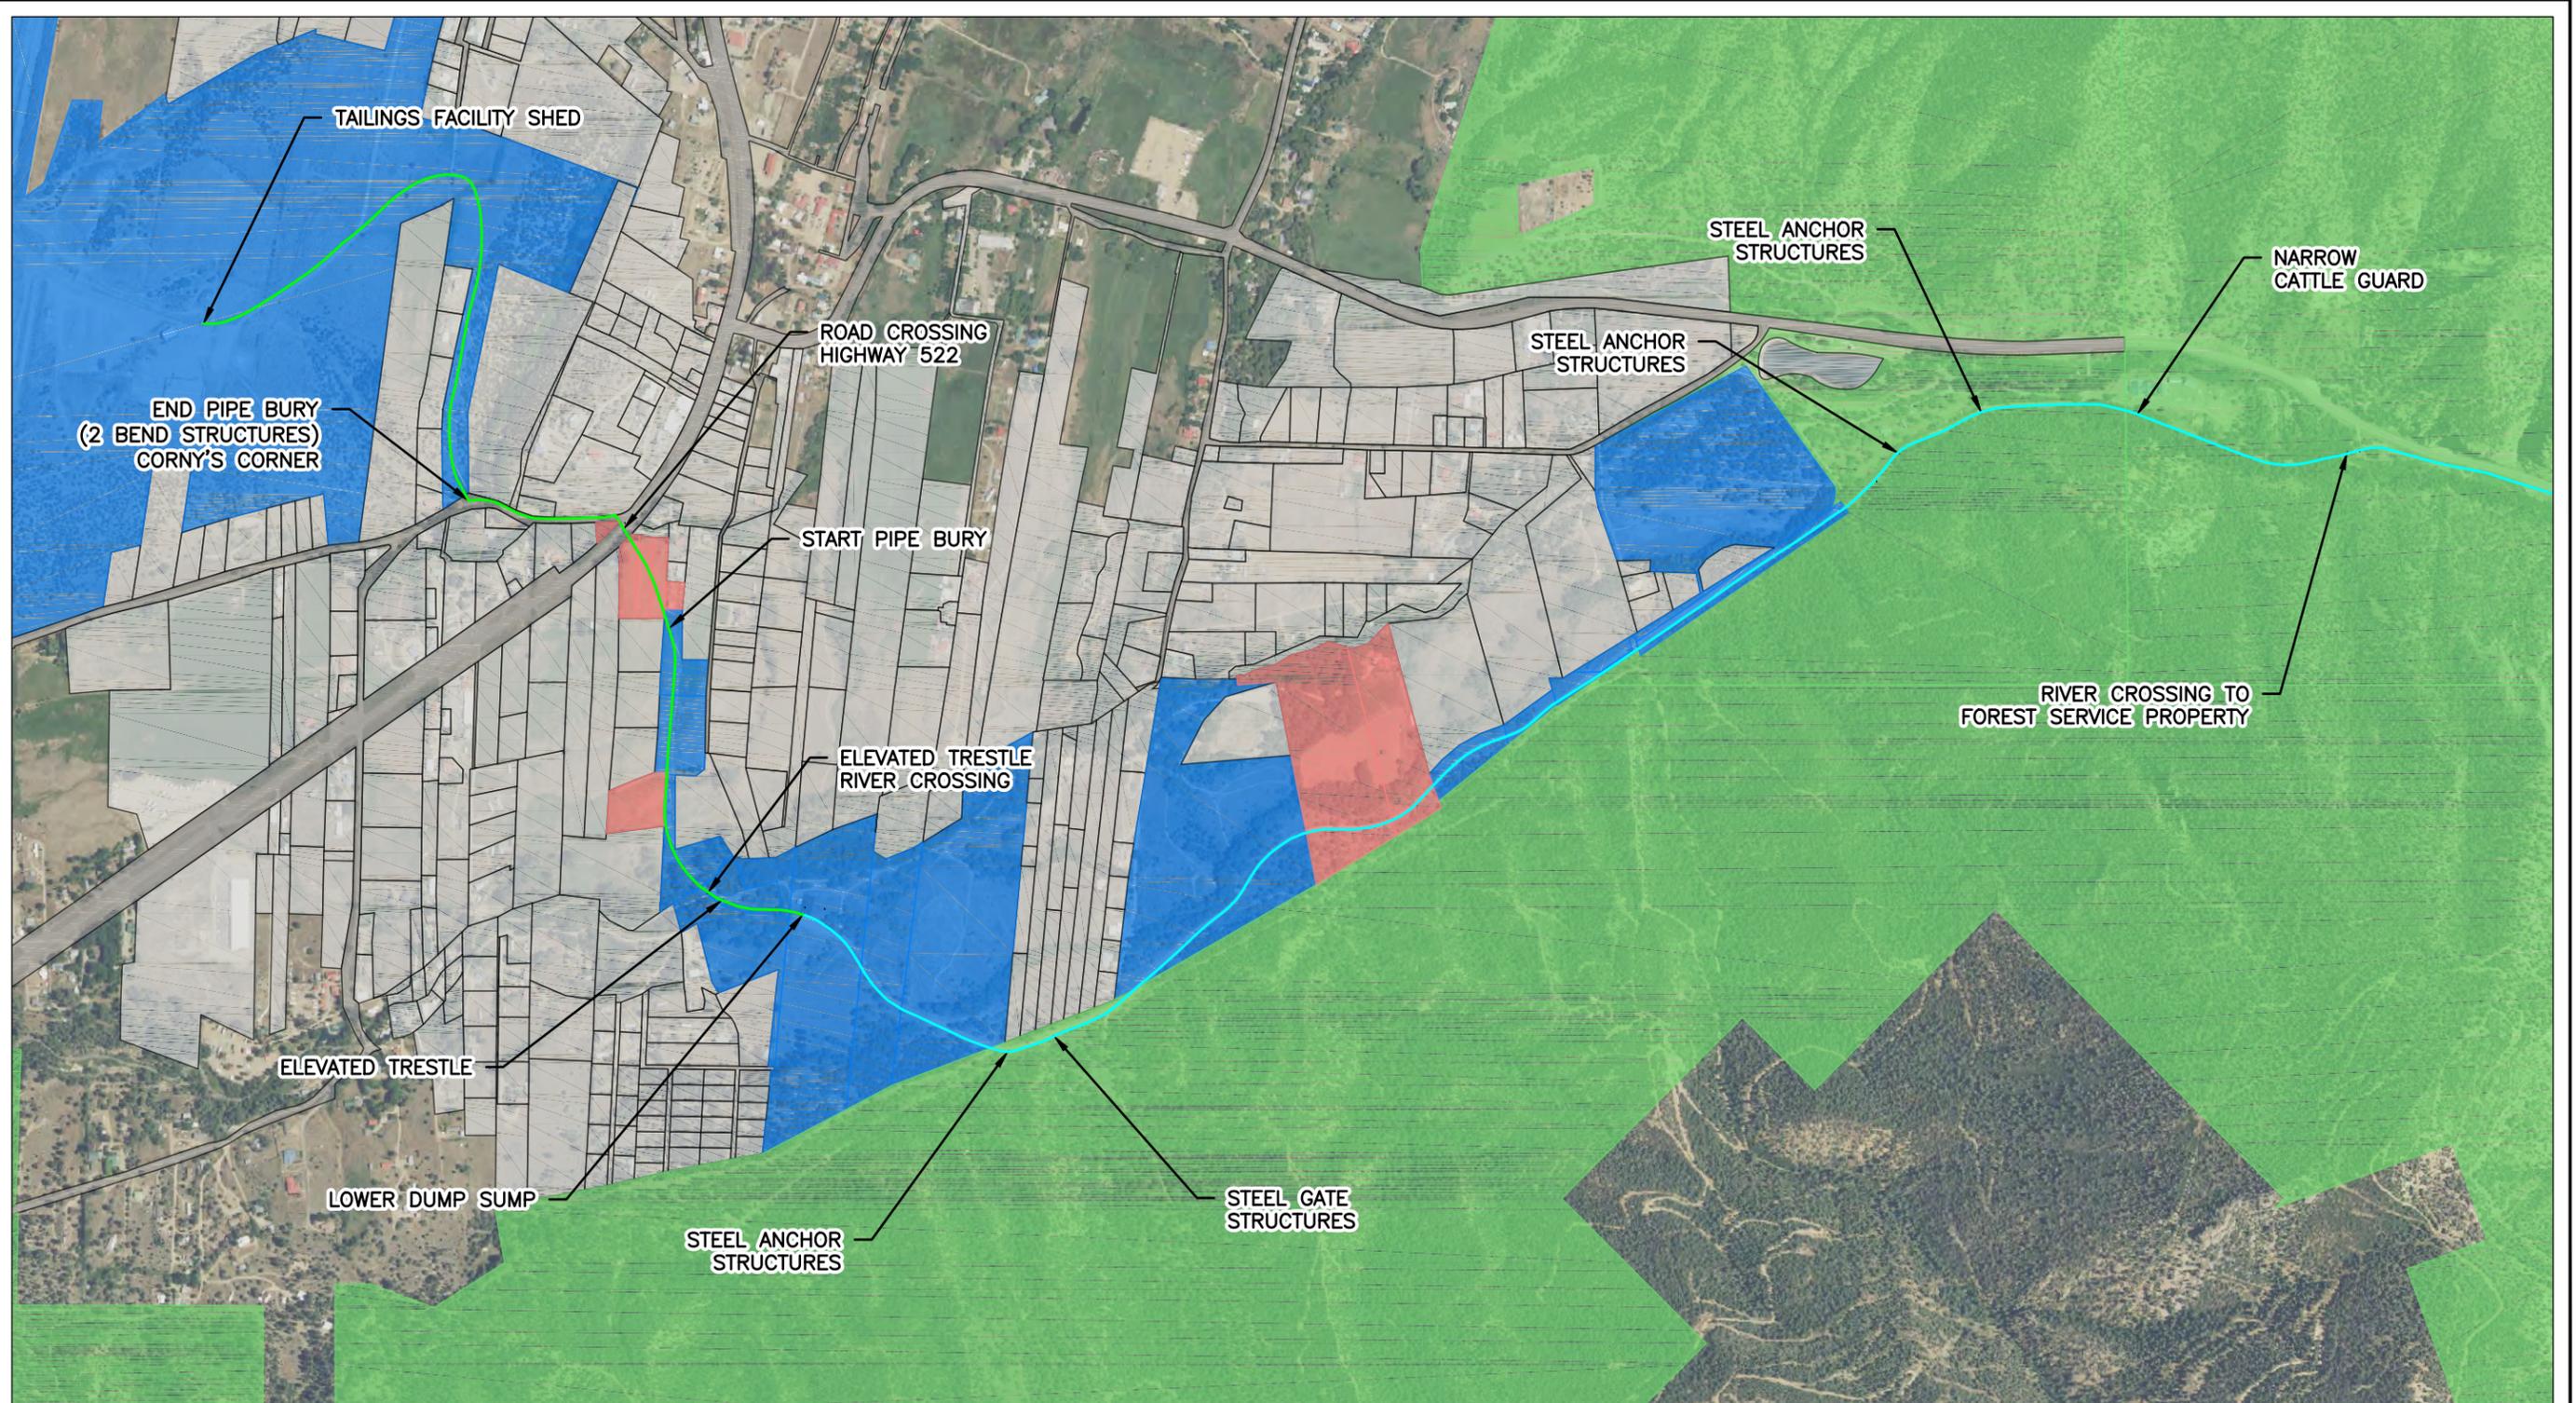
<b>FIGURE 1-2</b>			
<b>EXISTING SITE PLAN - WEST AREA DETAIL</b> <b>CMI TAILINGS PIPELINE</b>			
<b>CMI QUESTA</b> <b>QUESTA, NEW MEXICO</b>			
Drawn By: LH	Checked By: SH	Scale: 1" = 1000'	Date: 2/20/17 File: QUESTAPIPELINE_SP

Five pipe bend structures were observed on CMI property, but more bend structures may be buried and not visible. Two structures are located near Corny's Corner (Figure 1-2) at the west end of the site. Three bend structures are located near the entrance road to the Chevron Administration Building. Typical pipe bend structures are shown in Photo #9 of Appendix A.

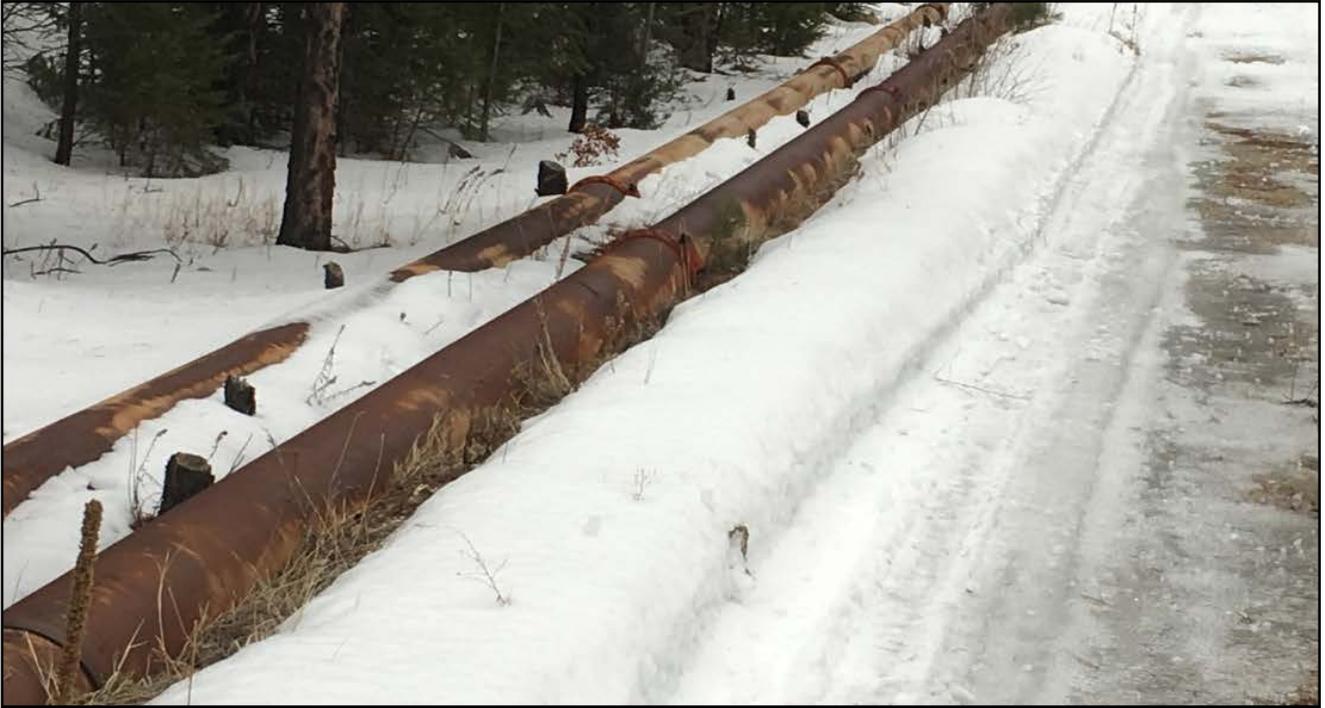
Photo #1  
14" Ø Rubber-lined Painted Steel Pipe – Typical

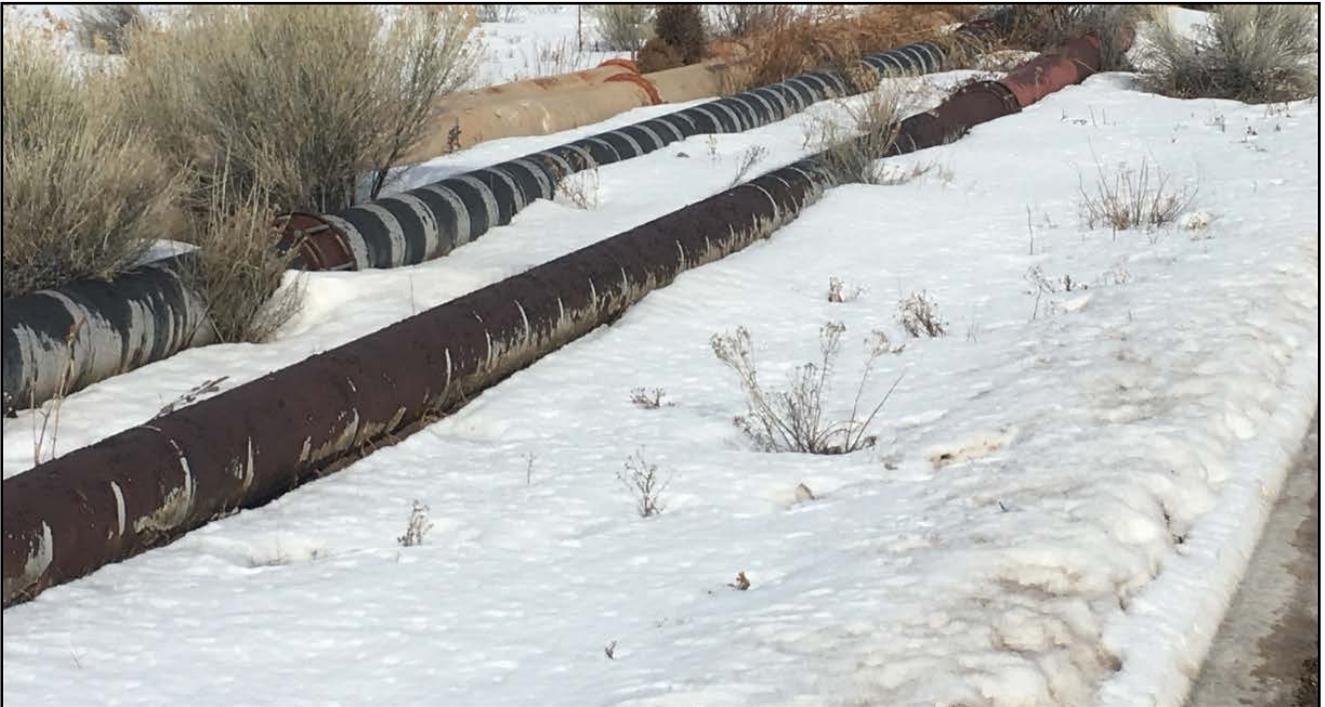
Photo #2  
14" Ø Wrapped Steel Pipe – Typical

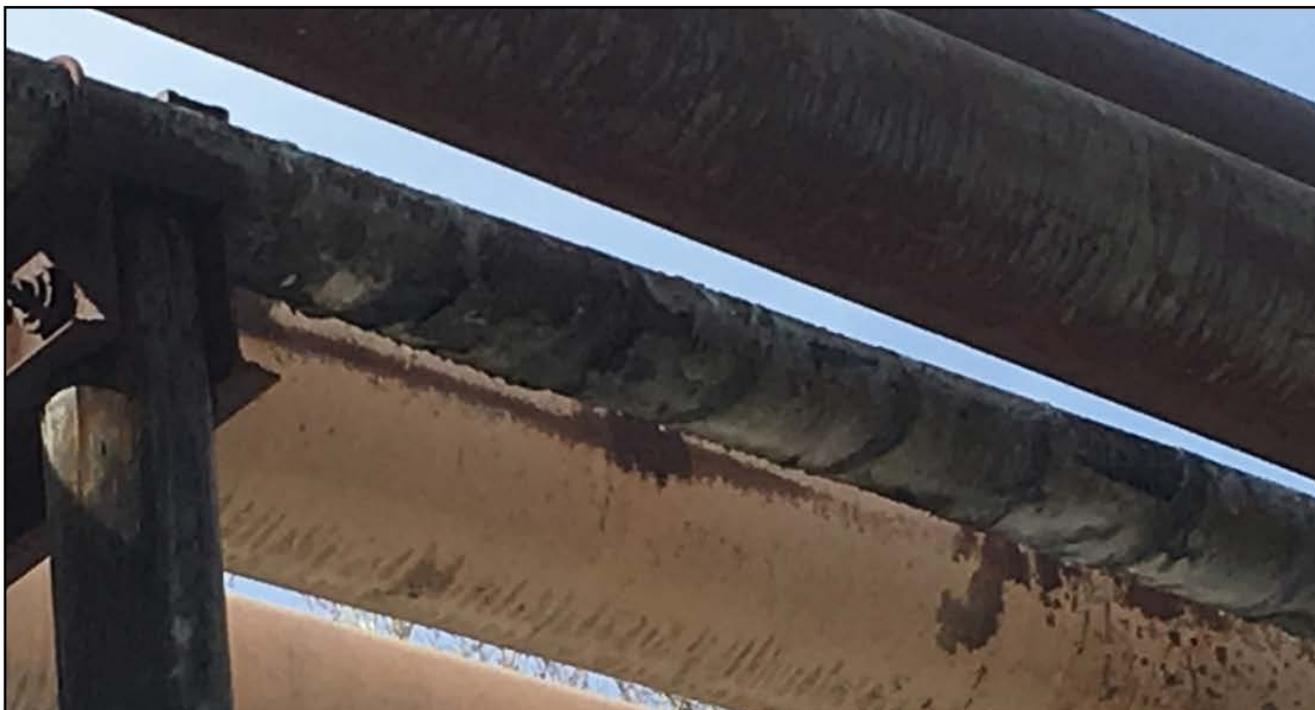
Photo #3  
8" Ø Wrapped Steel Pipe (middle pipe) – Typical

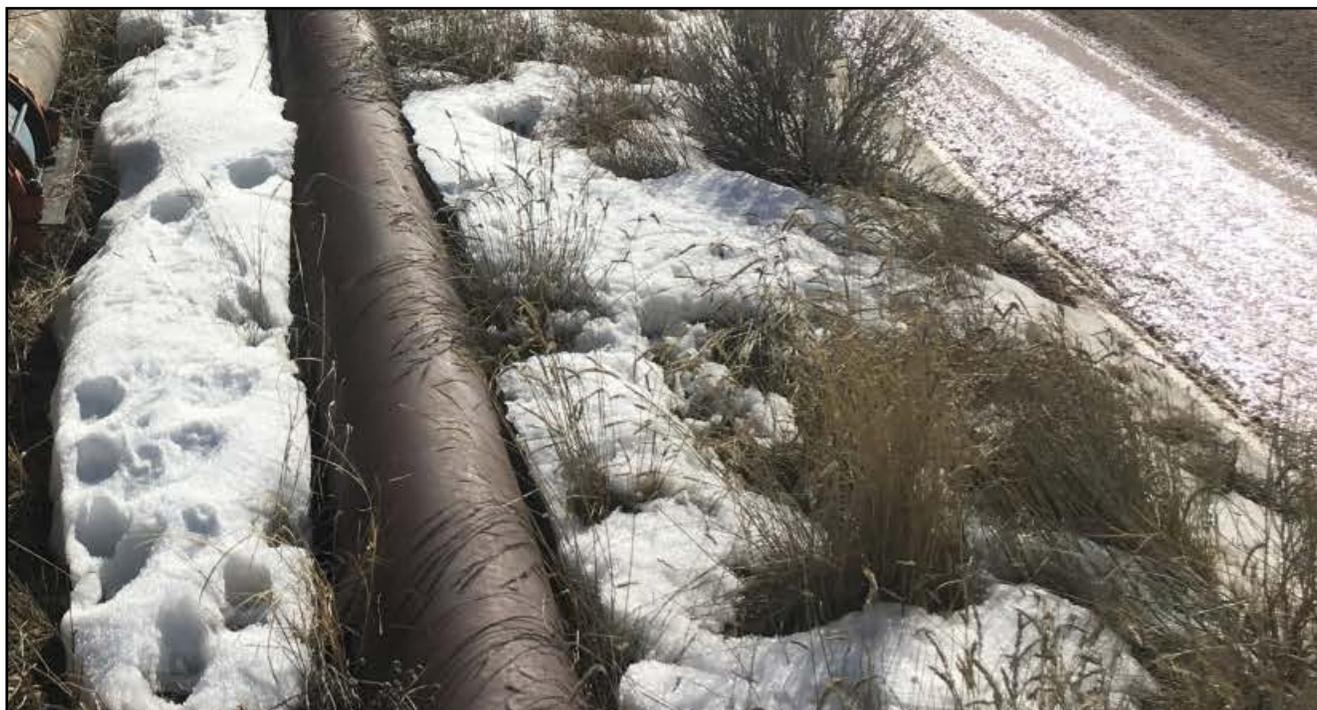
Photo #4  
14" Ø Unpainted Steel Pipe – Typical

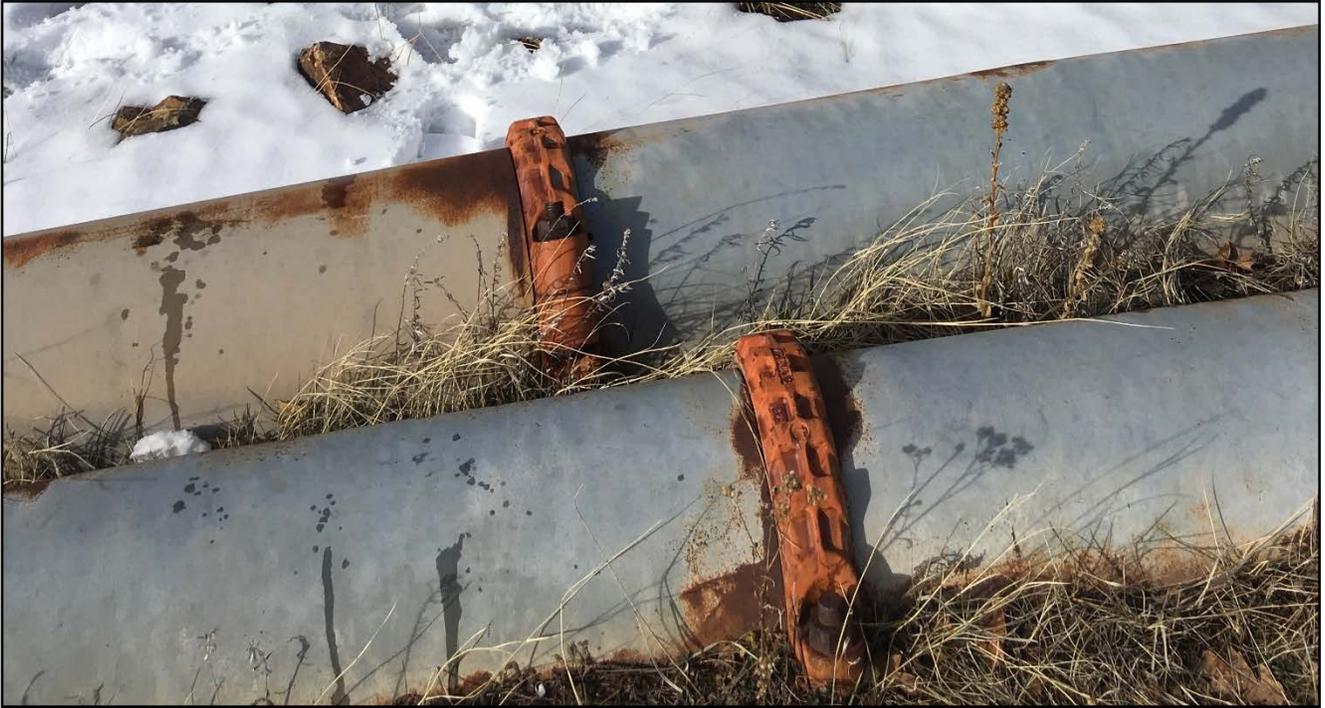
Photo #5  
Victaulic® Compression Fittings – Typical

Based on an estimated coupling spacing of 35 feet, there are approximately 1,695 couplings on CMI property (Photos #5 and #6 of Appendix A). Steel anchor structures were observed east of the Lower Dump Sump. A typical steel anchor structure is shown in Photos #7 and #8 of Appendix A.

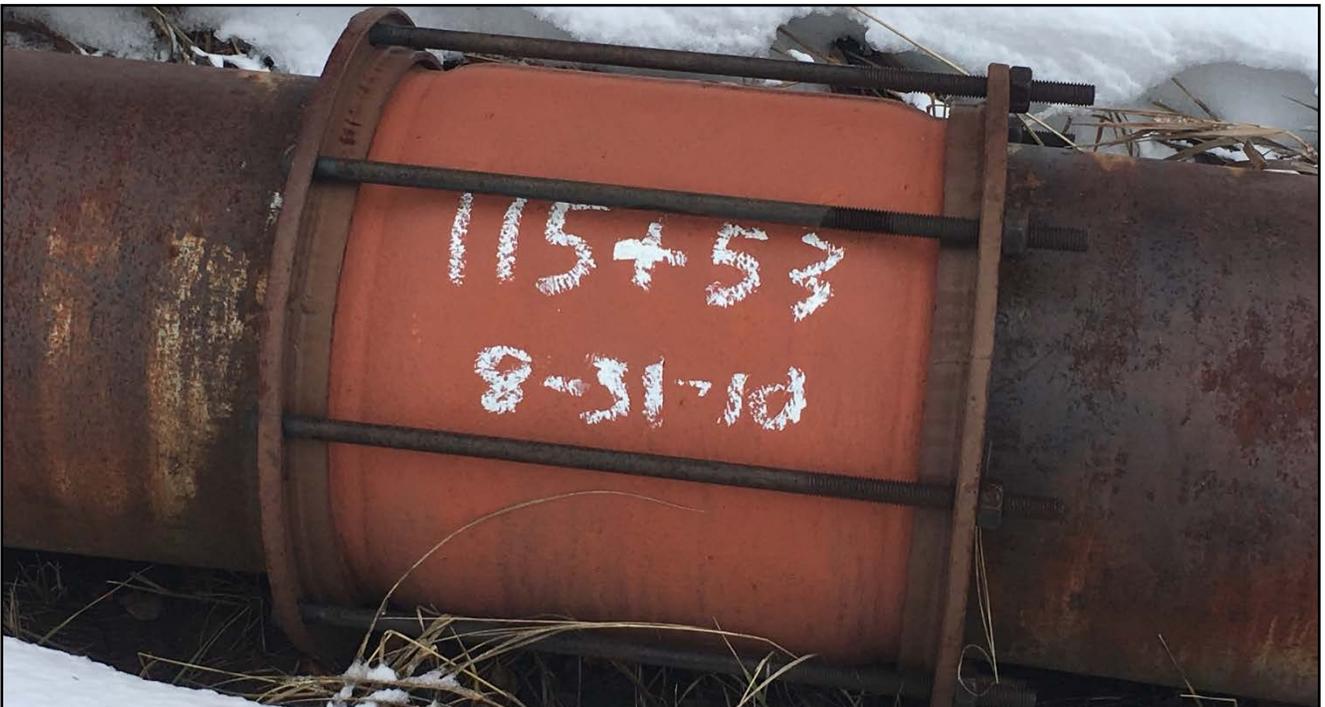
Photo #6  
Dresser® Fitting – Typical

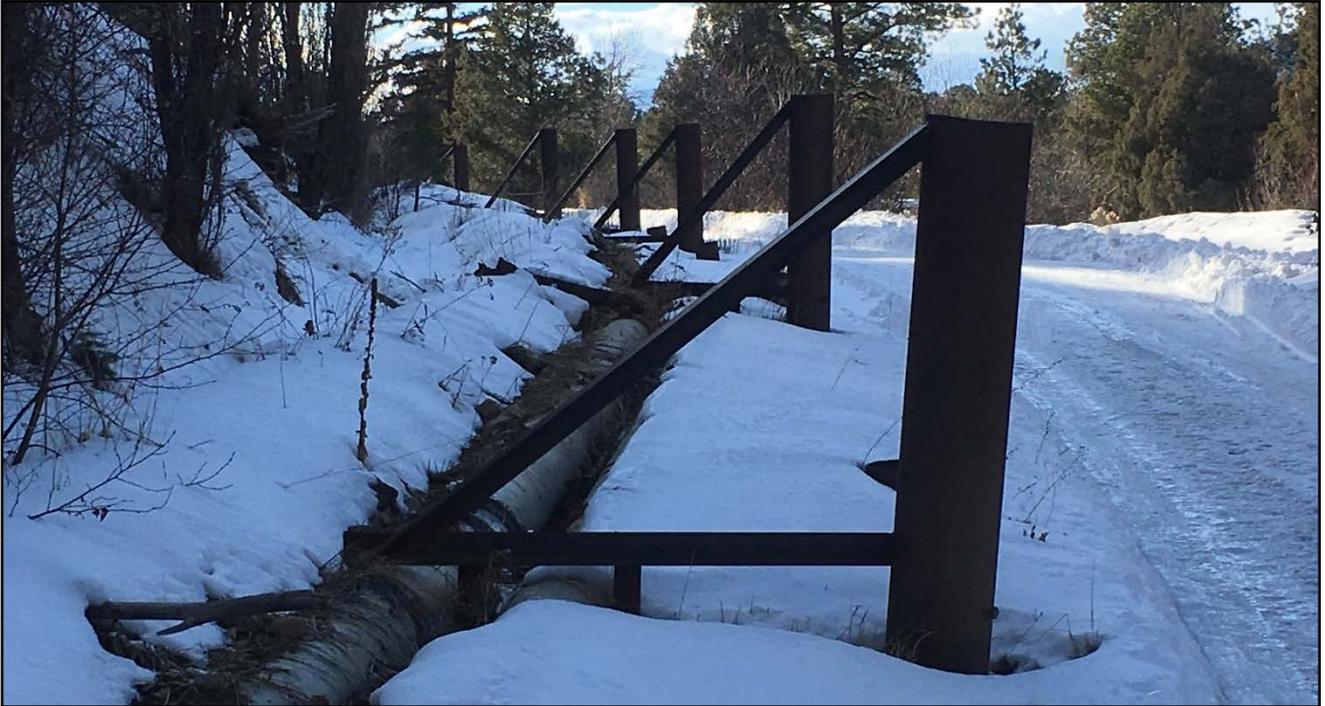
Photo #7  
Steel Anchor Structures - Typical

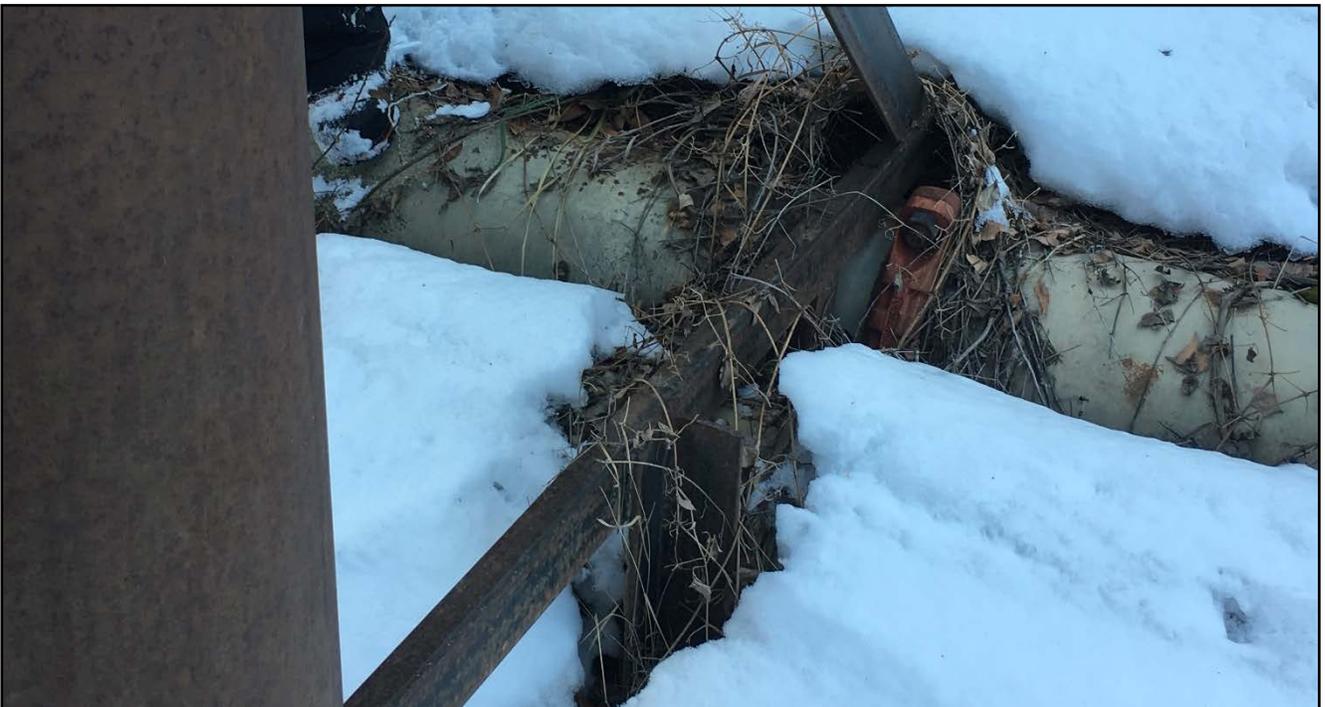
Photo #8  
Steel Anchor and Protection Structures – Ground Detail - Typical

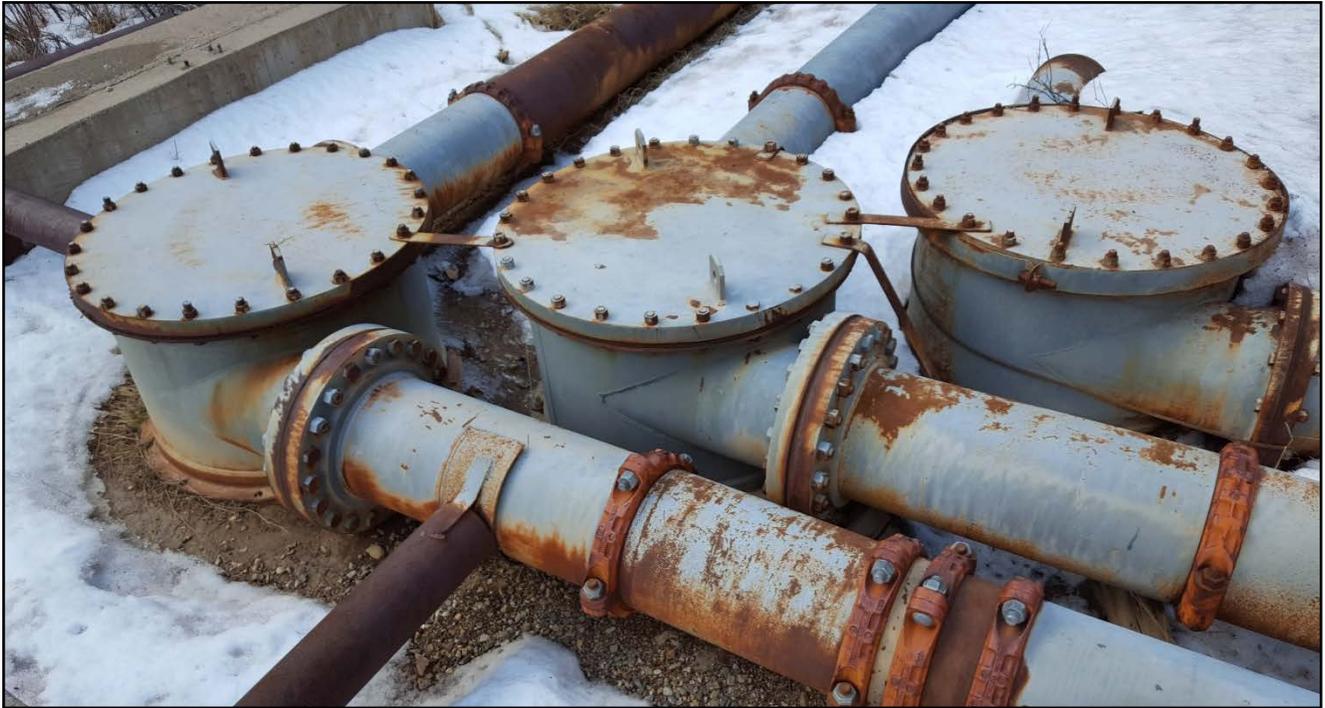
Photo #9  
Steel Pipe Bend Structures - Typical

Steel bend structures are present at abrupt changes in direction of the pipeline. They are located typically before and after road crossings (see Photo #9 of Appendix A).

Steel bend structures were observed at abrupt changes in direction of the pipeline. They are located typically before and after road crossings (see Photo #9 of Appendix A). These structures will be demolished and the refuse hauled to the staging area after the pipe has been removed. The steel will be recycled through Chevron Third Party Waste Stewardship approved recycling facility.

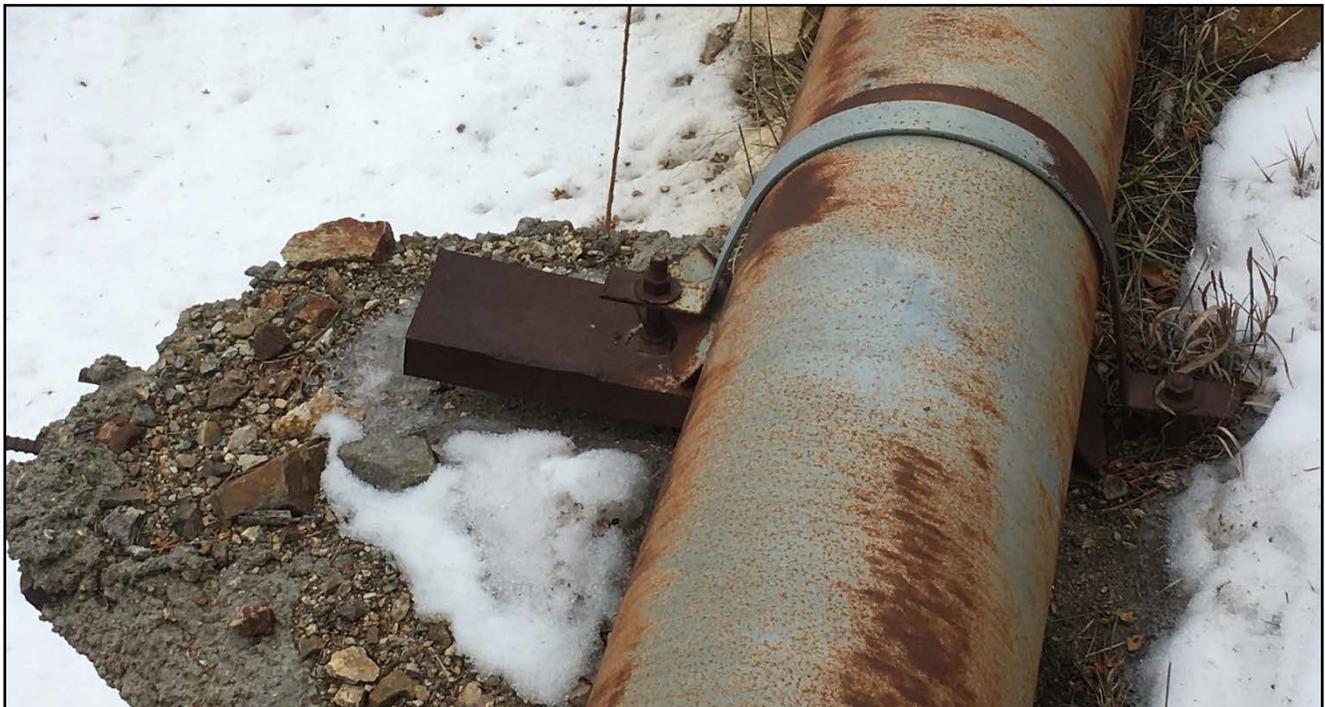
Photo #10  
Concrete Thrust Block –Typical

The quantity of thrust blocks was not determined due to snow cover, but if they are present along a majority of the pipeline, especially at changes in the pipeline alignment (Photo #10 of Appendix A).

The quantity of thrust blocks was not determined due to snow cover, but it is assumed they are along a majority of the pipeline, especially at points of intersection (Photo #10 of Appendix A).

The quantity of thrust blocks was not determined due to snow cover, but it is assumed they are along a majority of the pipeline, especially at changes in the pipeline alignment (Photo #10 of Appendix A).

The quantity of thrust blocks was not determined due to snow cover, but it is assumed they exist along a majority of the pipeline, especially at bends in the pipeline alignment (Photo #10 of Appendix A).

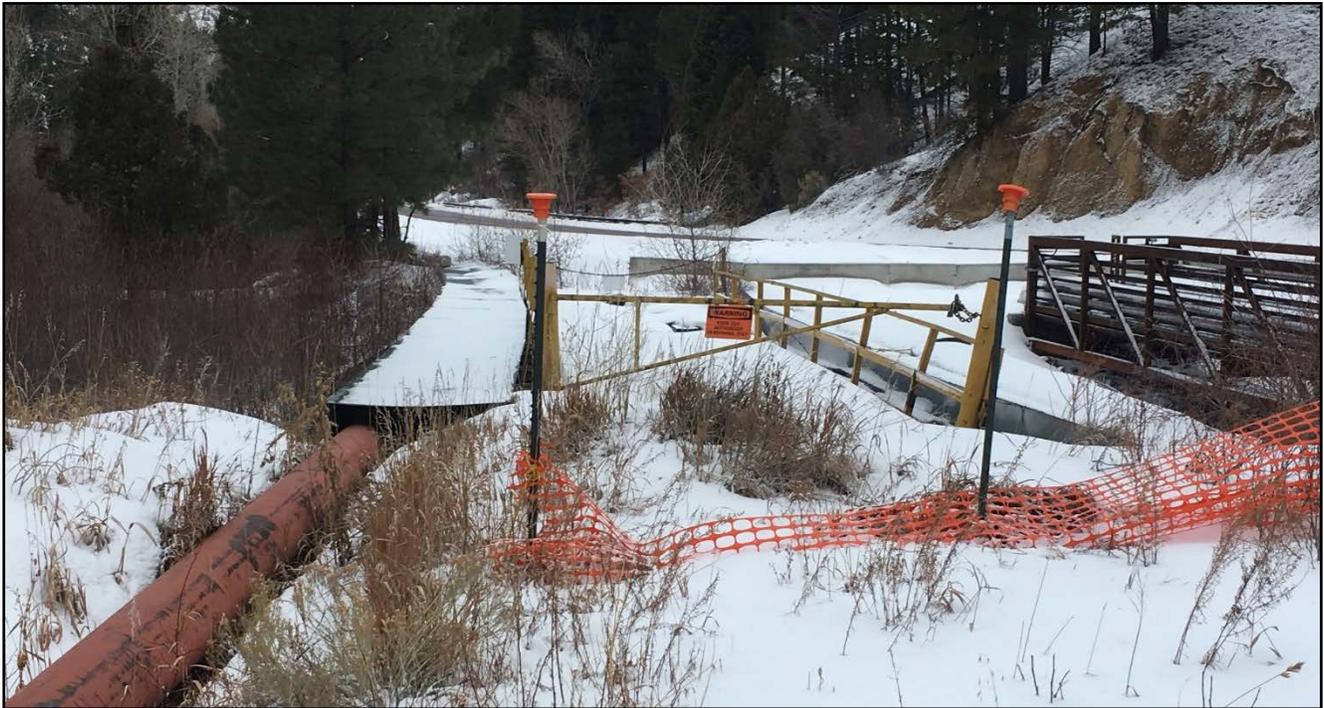
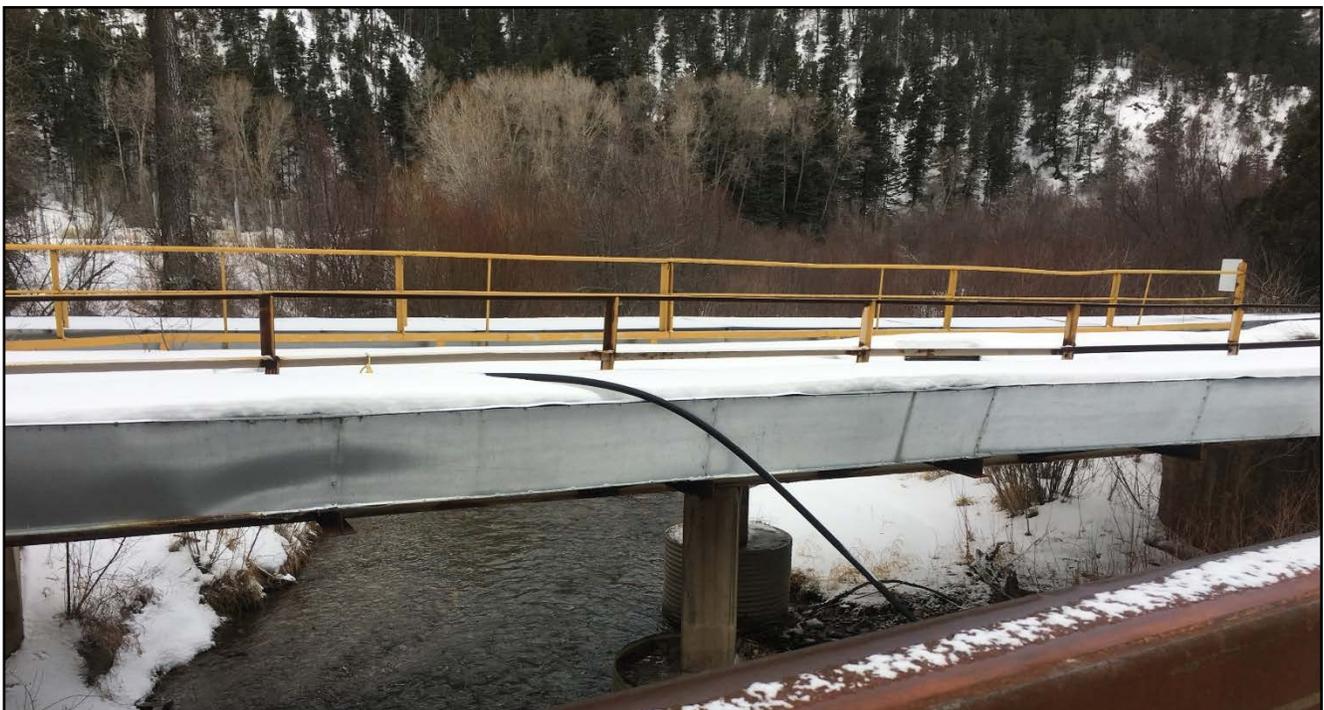
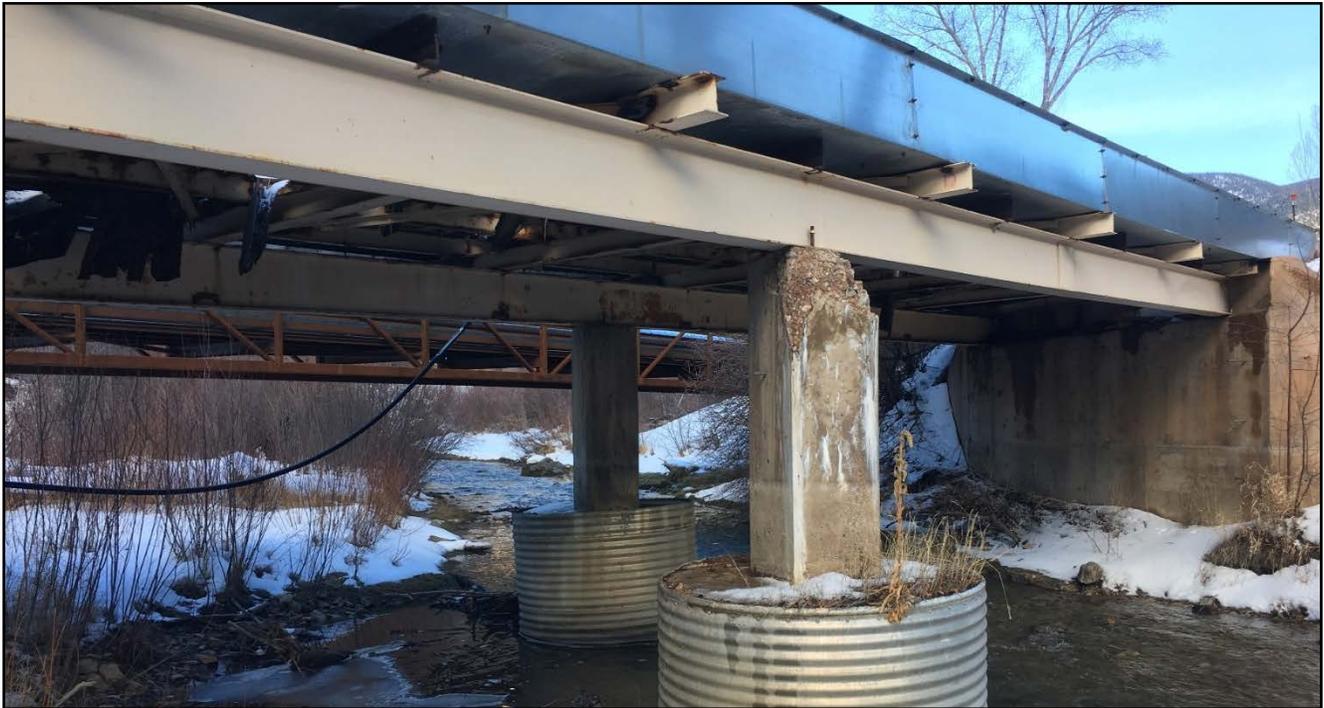
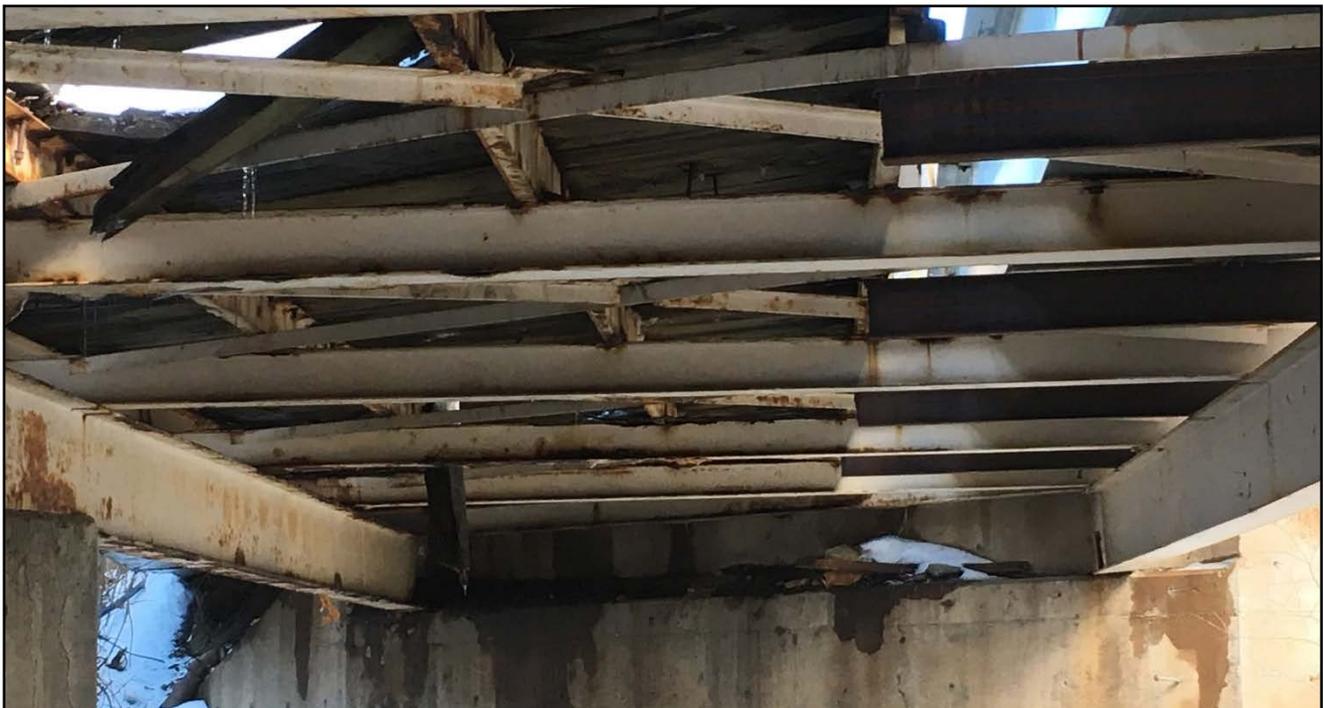
Photo #11  
Thunder Bridge – Top View  
Looking West

Photo #12  
Thunder Bridge and Electrical Cable – Top View  
Looking South

Photo #13  
Thunder Bridge – Stream View  
Looking Northeast

Photo #14  
Thunder Bridge – Underneath

The tailings pipeline crosses Red River at "Thunder Bridge" on CMI property. The bridge that carries the pipeline across the river includes concrete abutments, concrete piers, painted steel girders, deteriorated wood decking, and galvanized metal containment for the pipe (Photos #11 through #14 of Appendix A). This entire structure will be removed. In previous discussions about this bridge, the State Historic Preservation Office (SHPO) has expressed an interest in documenting some of the structures associated with the bridge.

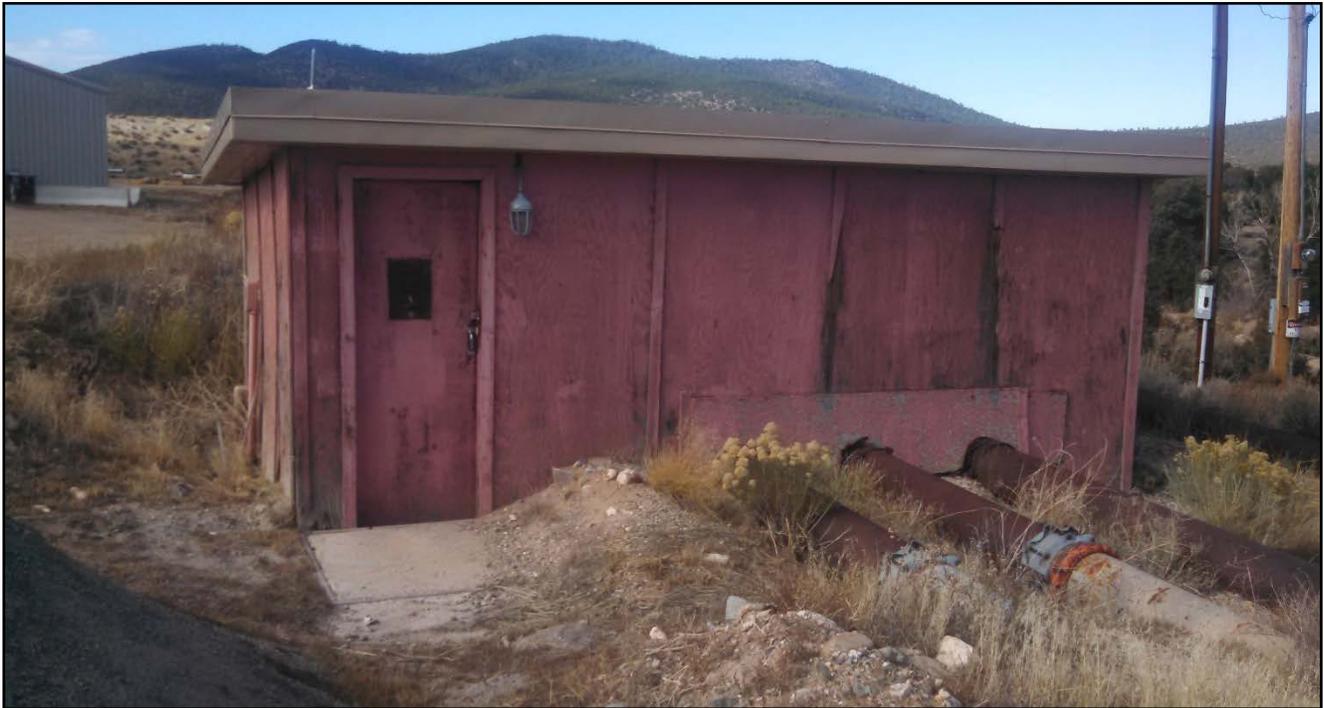
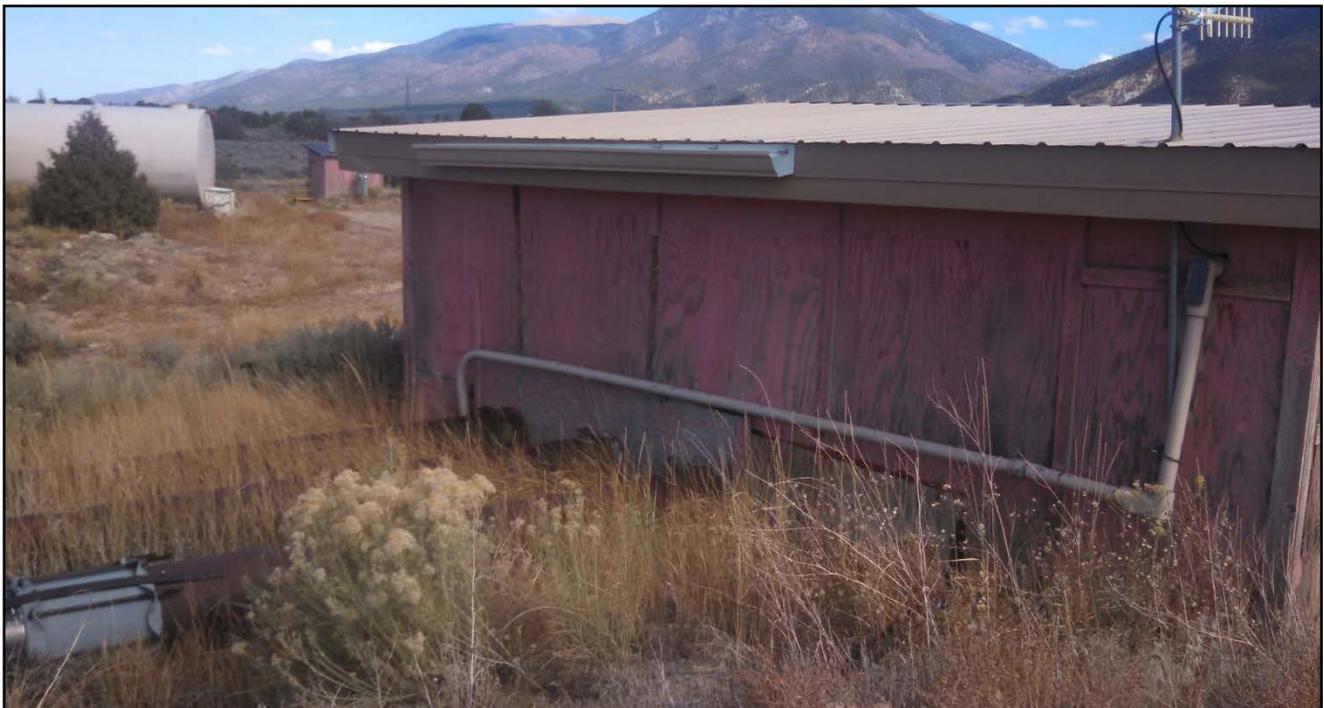
Photo #15  
Tailings Facility Flow Monitoring Building  
Looking West

Photo #16  
Tailings Facility Flow Monitoring Building  
Looking Northeast

The Tailings Facility Flow Monitoring Building is located near where the pipe undergoes a flanged transition from steel to HDPE. The building is built of plywood, has a concrete pad near the entrance, and a concrete floor. (Photos #15 and #16 of Appendix A).

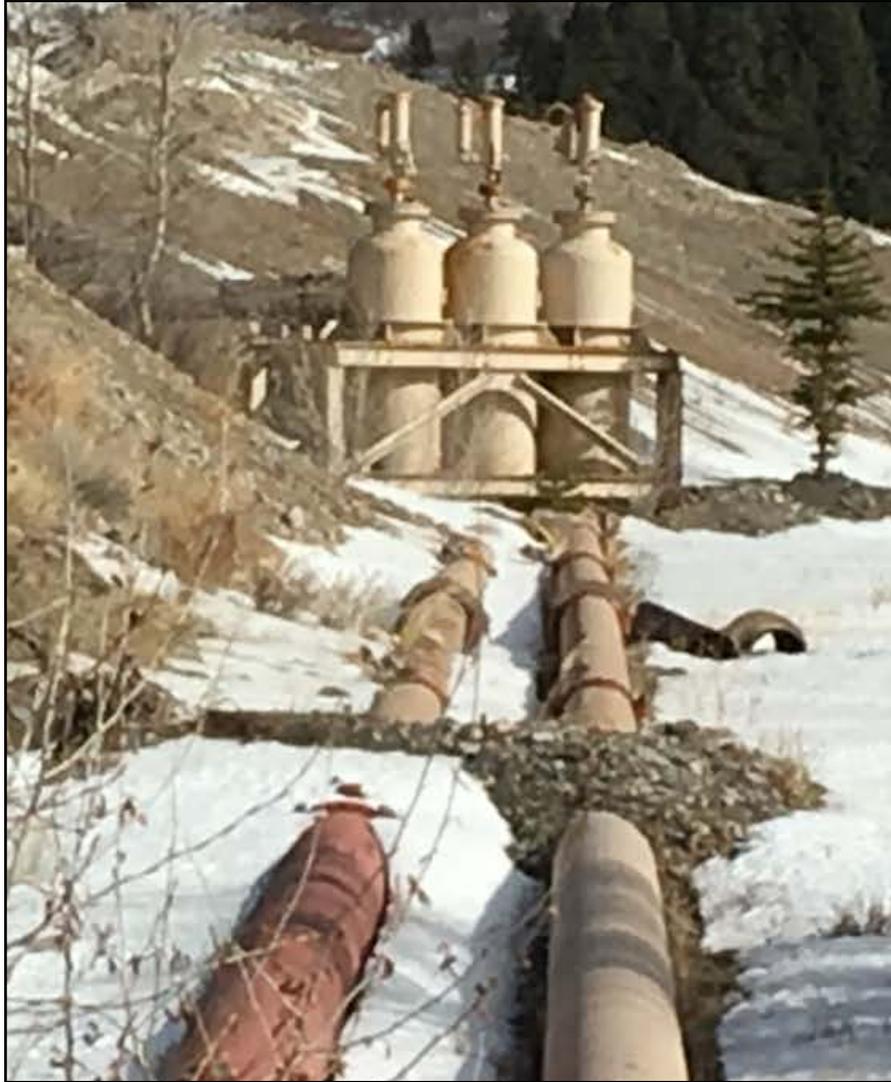
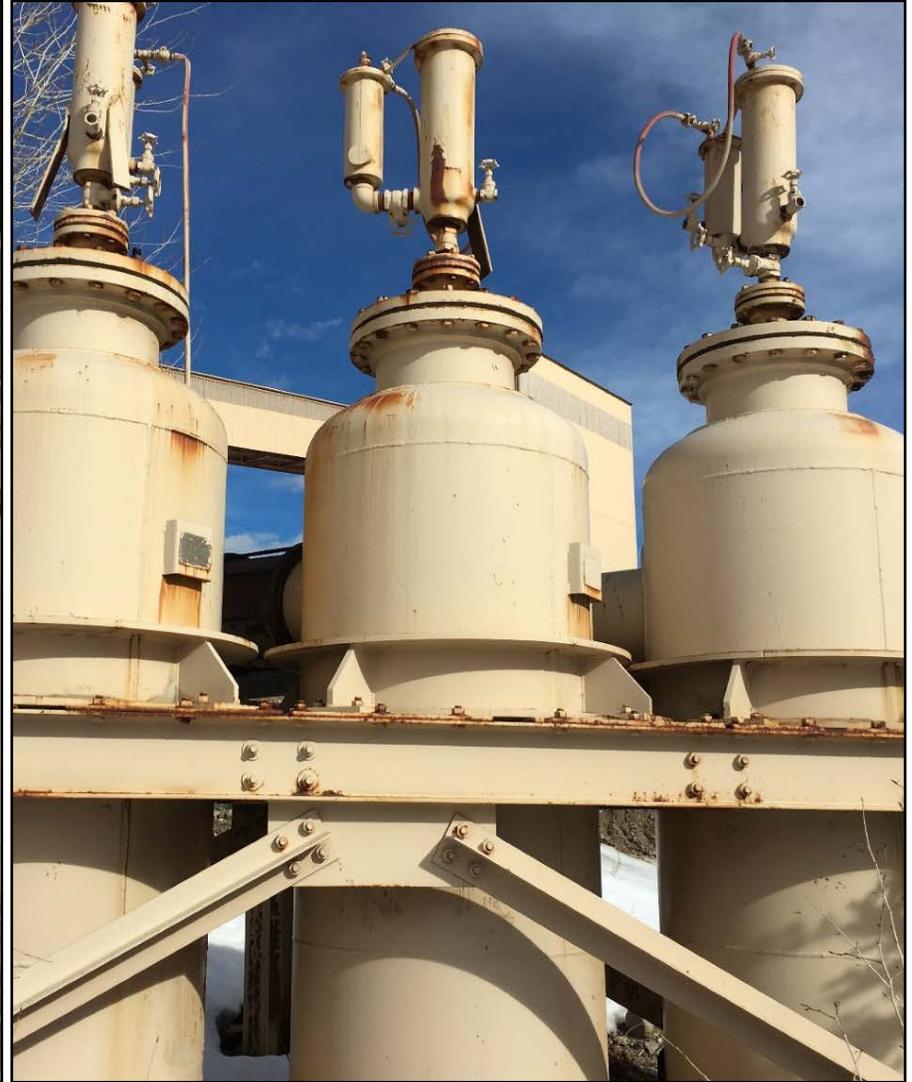
Photo #17  
Pressure Vessels  
Looking East

Photo #18  
Pressure Vessels  
Looking Northeast

Three pressure vessels exist on the east end of the pipeline within fenced and secured CMI property. They are made of steel and include additional valves and couplings (Photo #17 and #18 of Appendix A).
