**QUESTA TAILINGS PIPELINE REMOVAL  
MMD/NMED WORK PLAN  
CHEVRON ENVIRONMENTAL MANAGEMENT COMPANY  
QUESTA MINE**

**May 19, 2017**

**SUBMITTED BY:** Trihydro Corporation

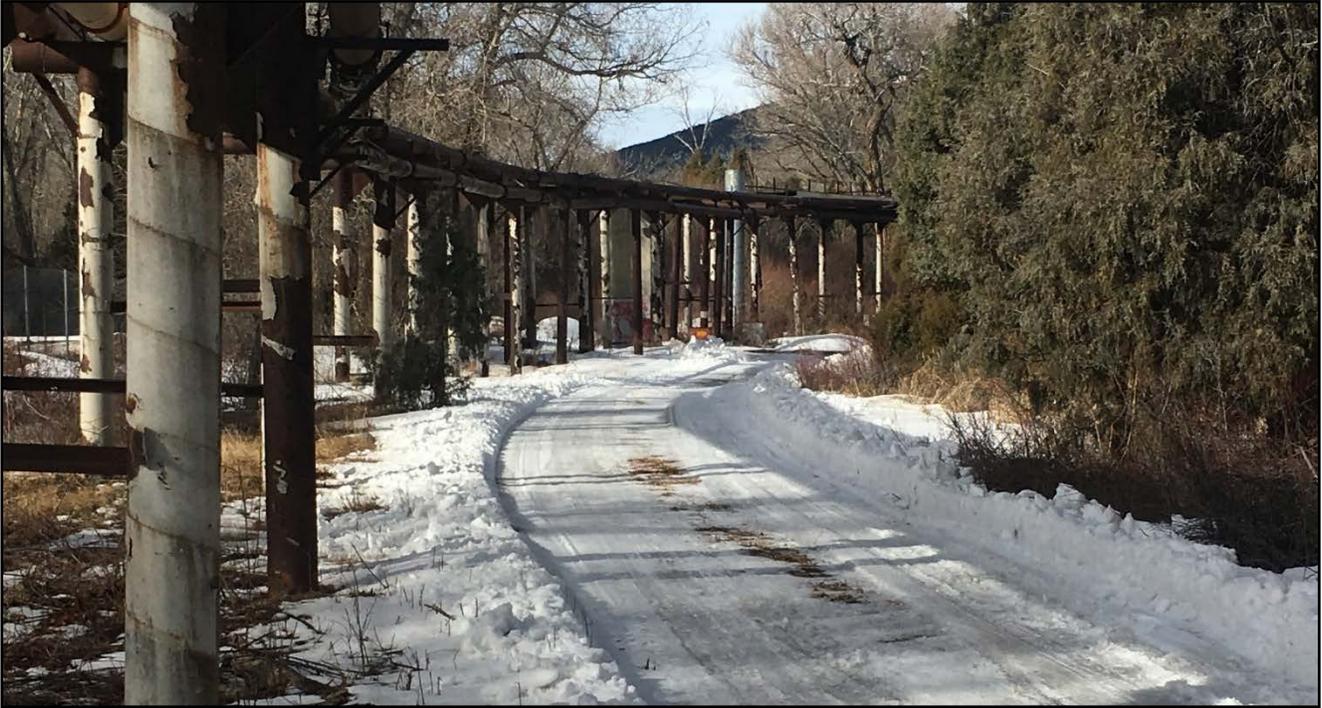
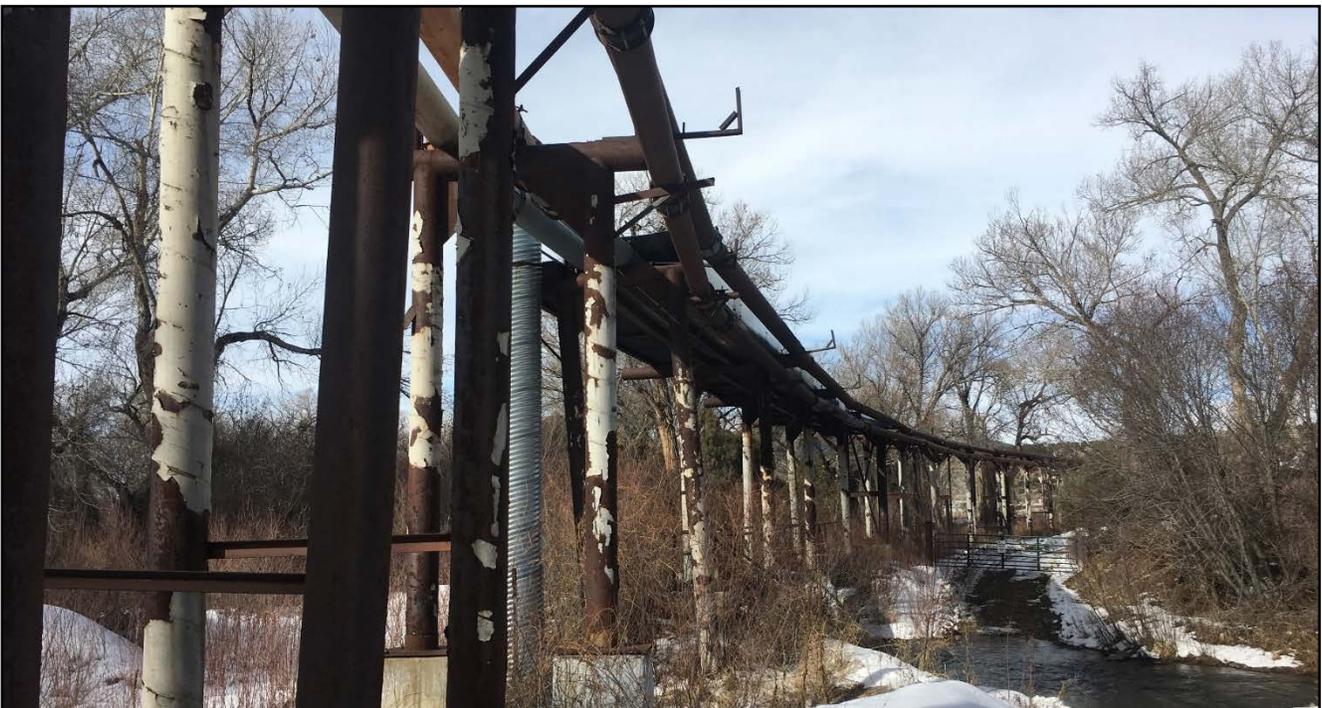
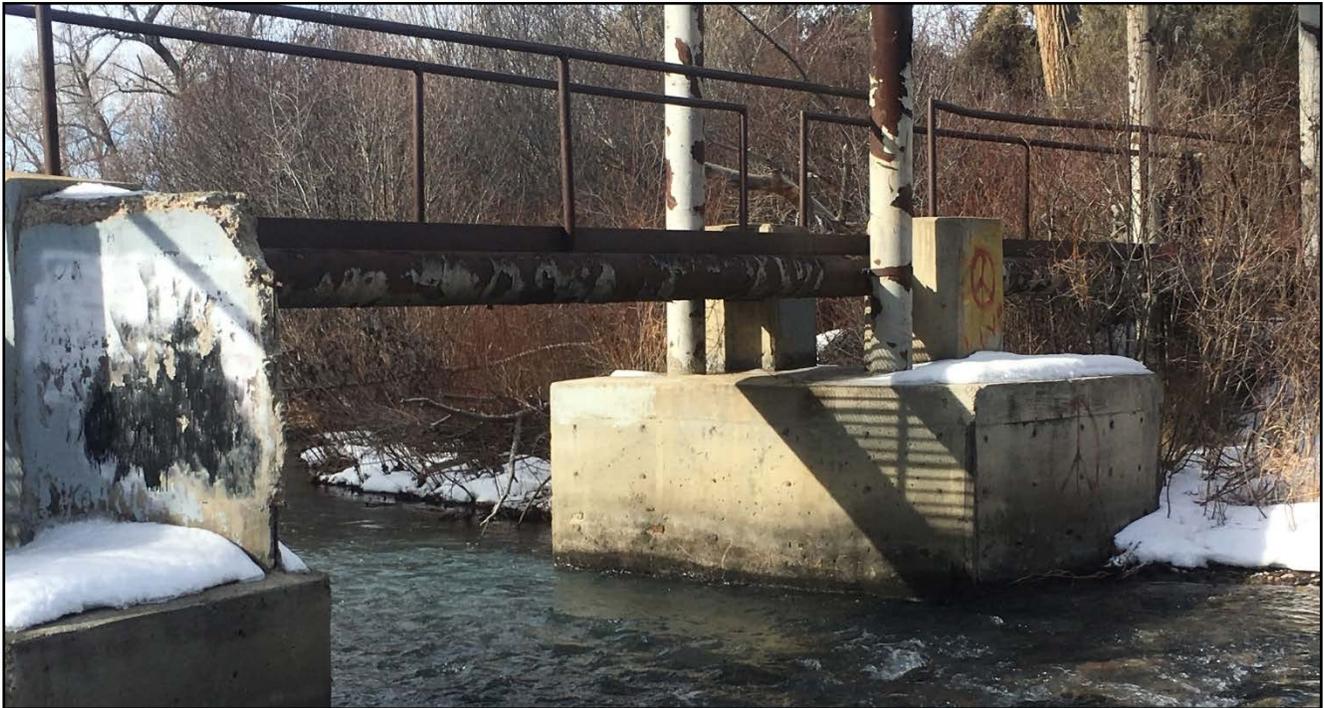
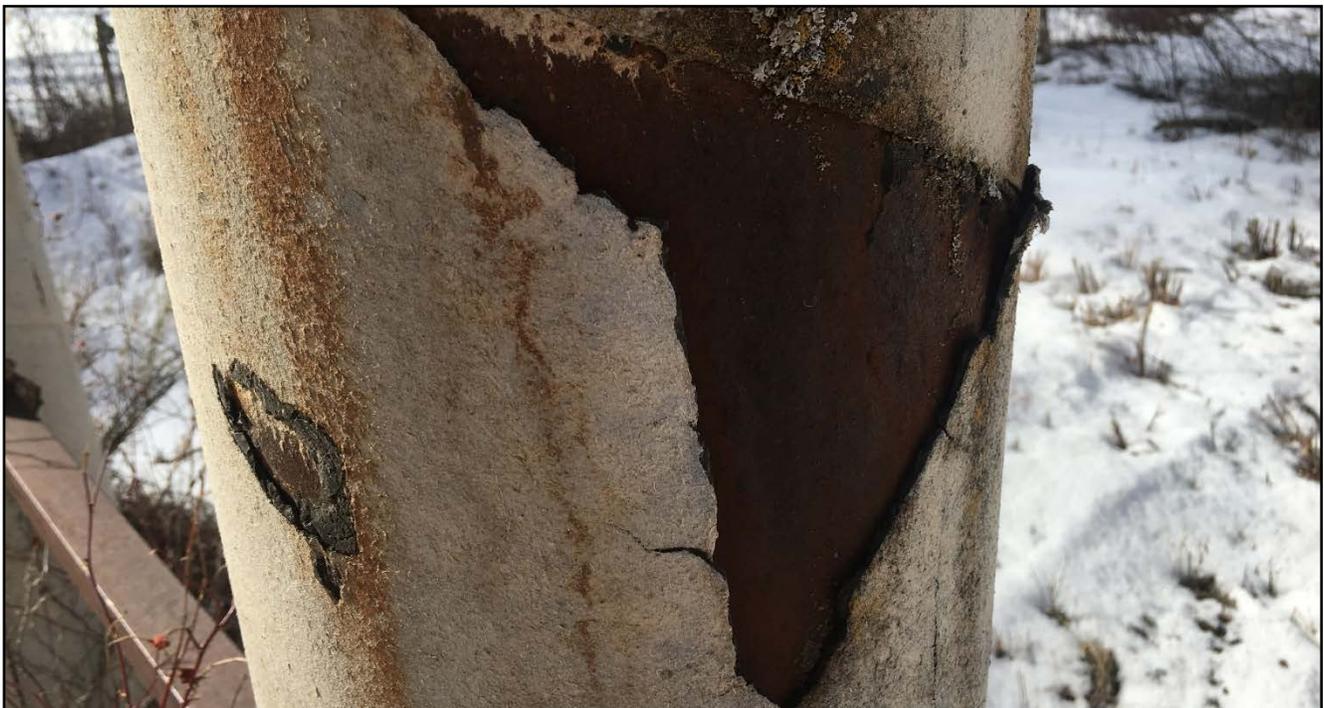
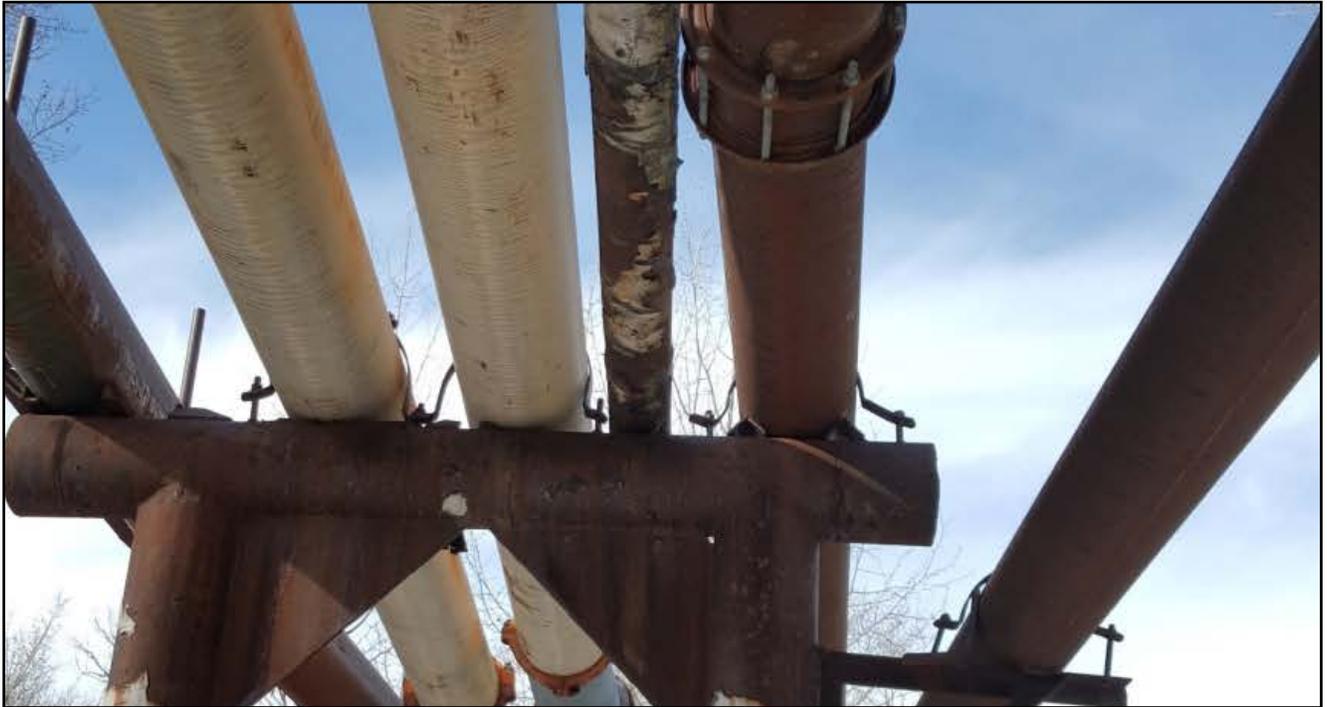
Photo #19  
Elevated Trestle – West of Lower Dump Sump  
Looking West

Photo #20  
Elevated Trestle – River Crossing  
Looking West

Photo #21  
Elevated Trestle – Concrete Abutments and Walkway  
Looking West

Photo #22  
Elevated Trestle – Pipe Wrapping (possible ACM)

Photo #23  
Elevated Trestle – Pipes Elevated By Supports

An elevated trestle was constructed for a river crossing west of the Lower Dump Sump (Photos #19 through #23). The trestle suspends 5 pipelines above a public roadway, as well as across Red River. The trestle is constructed with the following materials:

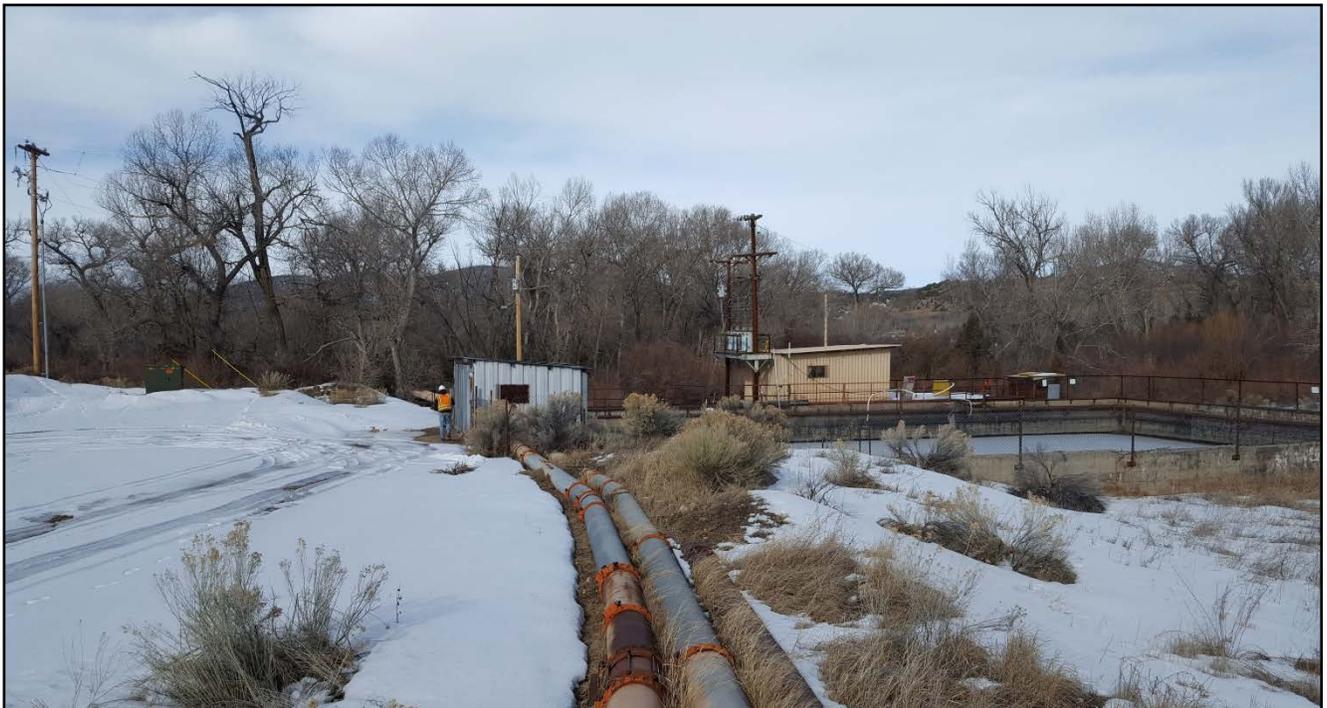
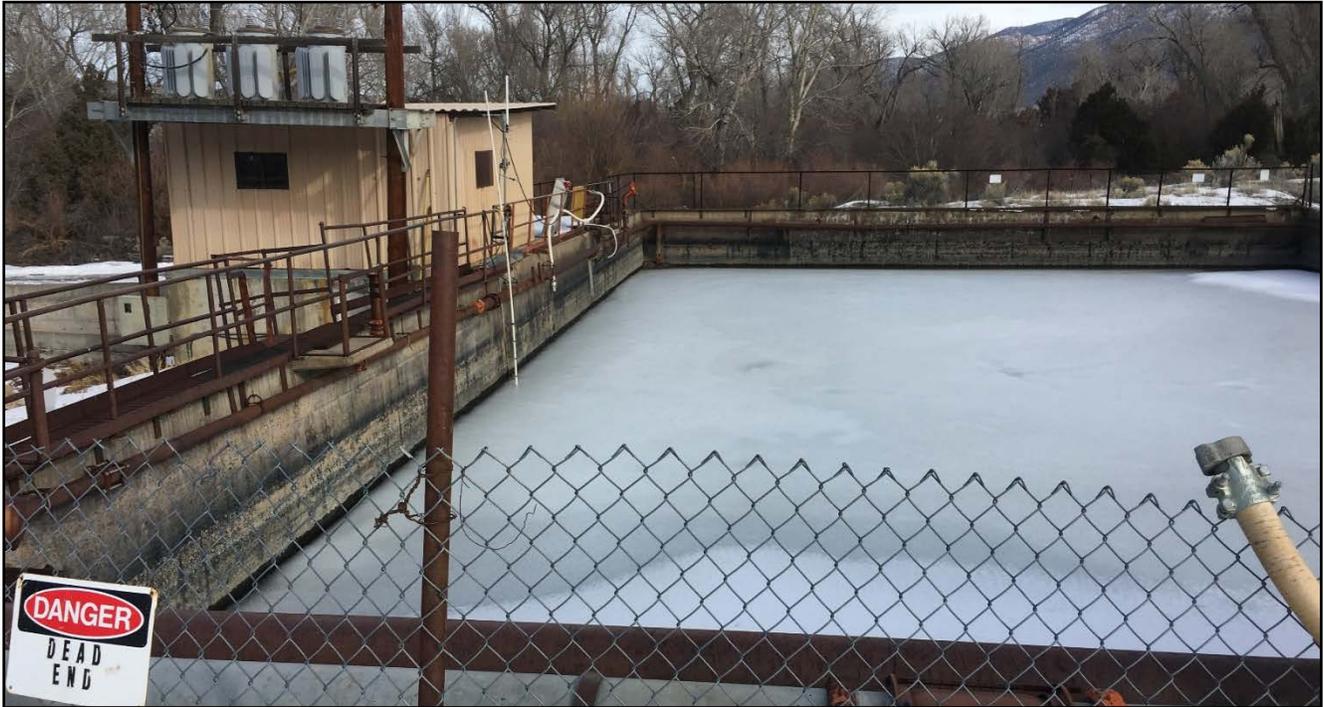
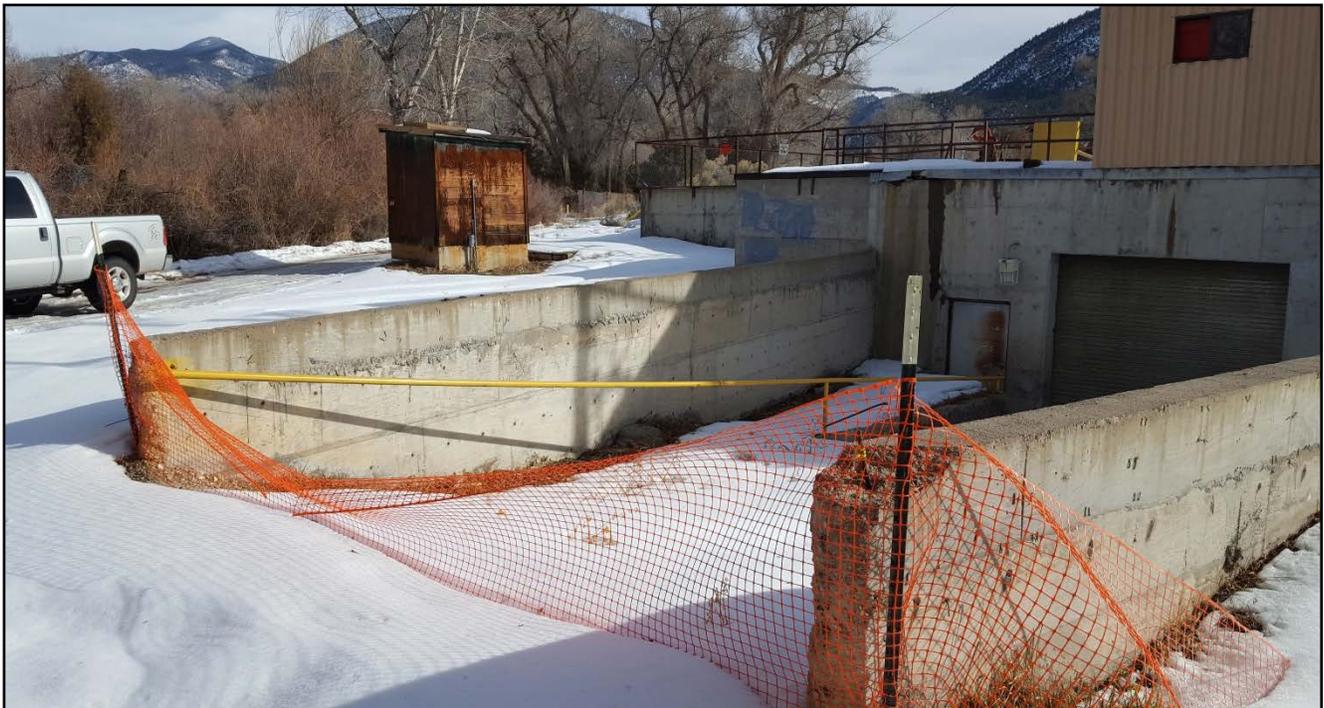
Photo #24  
Lower Dump Sump  
Looking West

Photo #25  
Lower Dump Sump Basin  
Looking North

Photo #26  
Lower Dump Sump  
Looking Northeast

The Lower Dump Sump consists of a rectangular basin constructed of concrete and protected by a steel barricade and chain link fence. The basin contains stormwater that will be pumped out and trucked to the Tailing Facility for disposal prior to demolishing the facility. The basin measures approximately 70 feet by 110 feet by 5 to 8 feet deep (Photos #24 through #26).

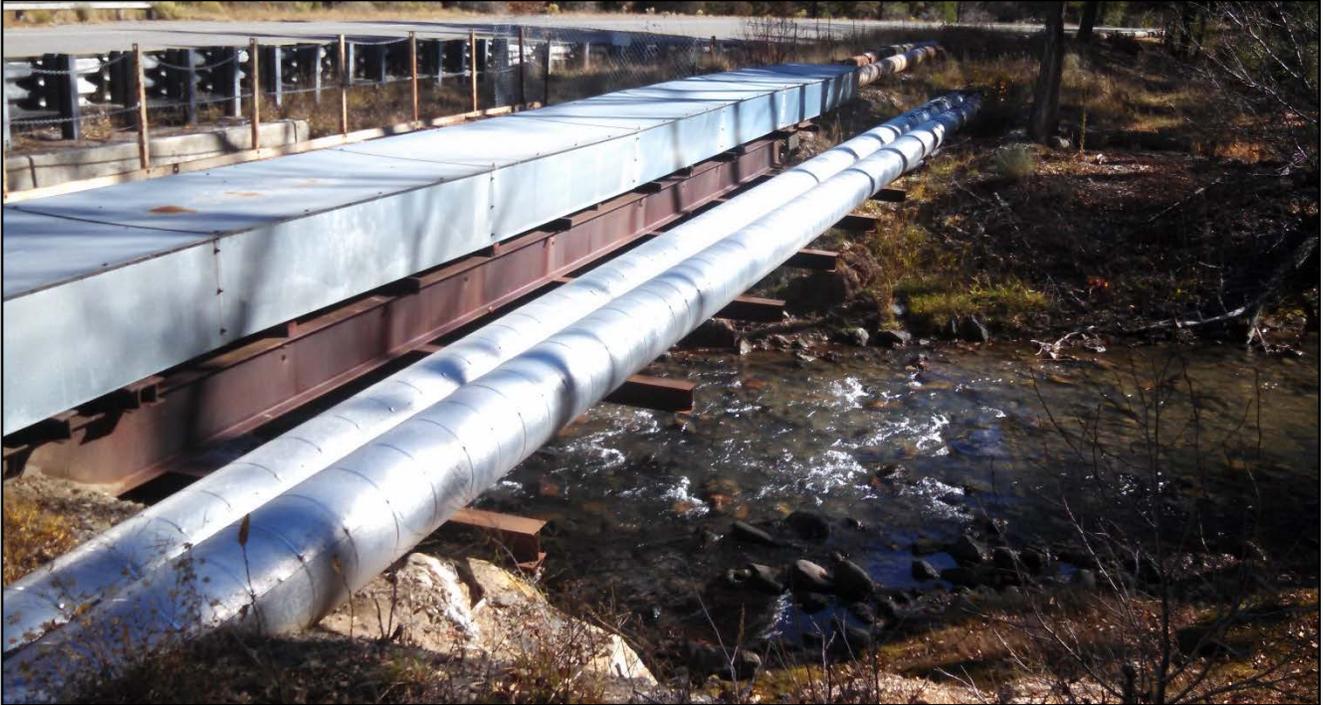
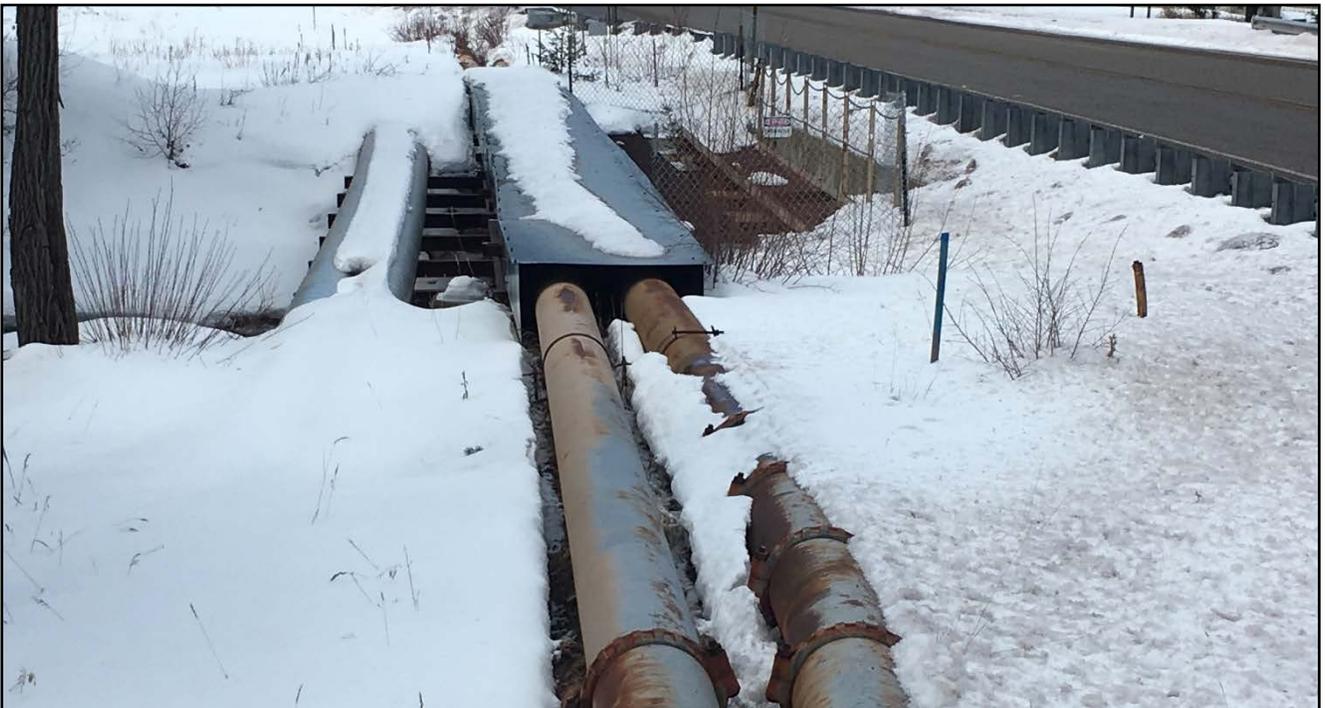
Photo #27  
River Crossing Near Columbine Curve  
Looking East

Photo #28  
River Crossing Near Columbine Curve  
Looking West

The tailings pipeline crosses the Red River near Columbine Park which is on USFS property and within the NMDOT ROW. The bridge that carries the pipeline across the river includes concrete abutments, concrete piers, steel girders, steel decking, and galvanized metal spill prevention boxes for the pipe. Additional utilities including some active CMI piping is located on this bridge therefore this bridge will be left in place. All piping and structures specifically associated with the tailing pipeline will be removed (Photos #27 and #28 of Appendix A).

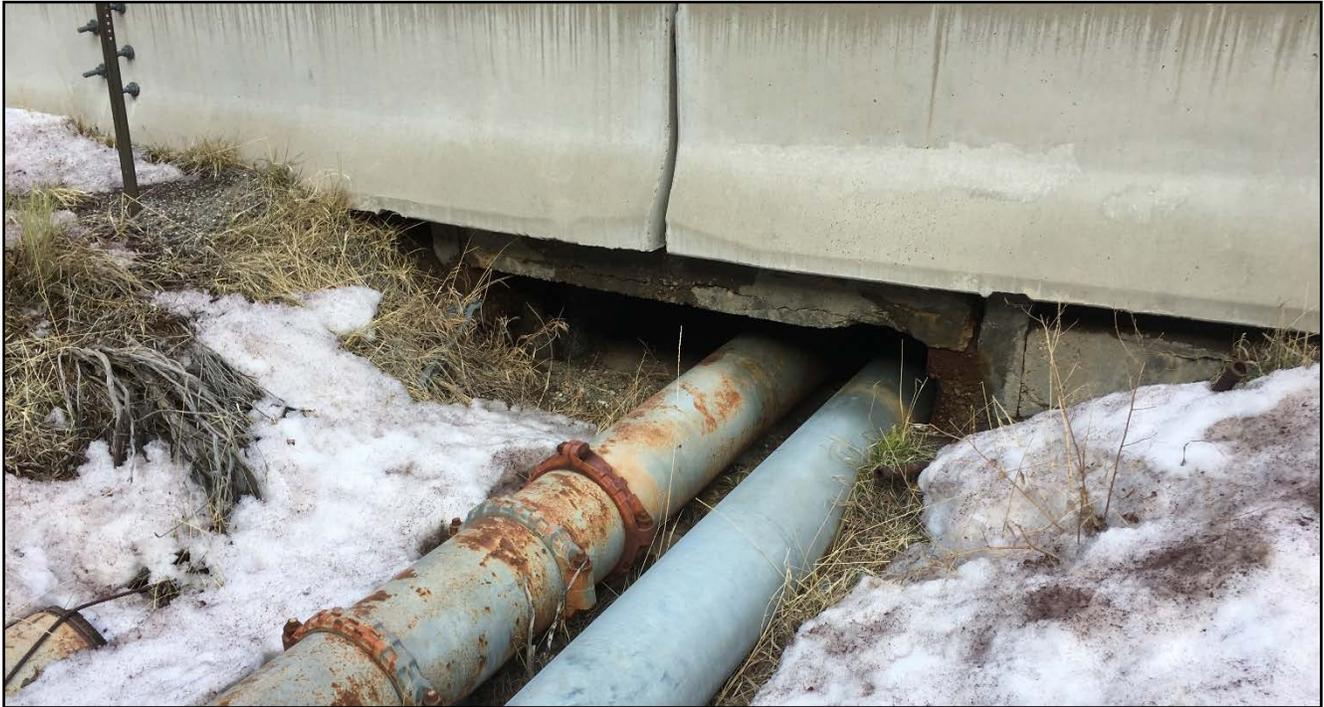
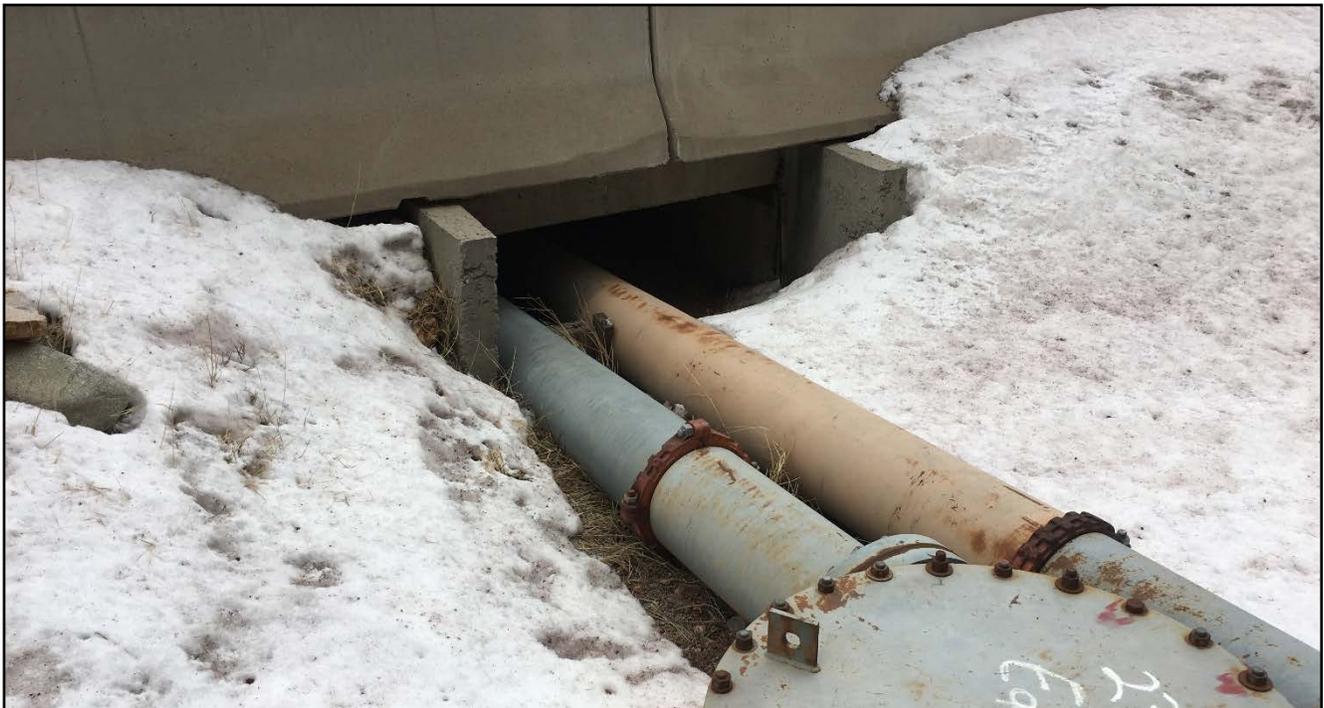
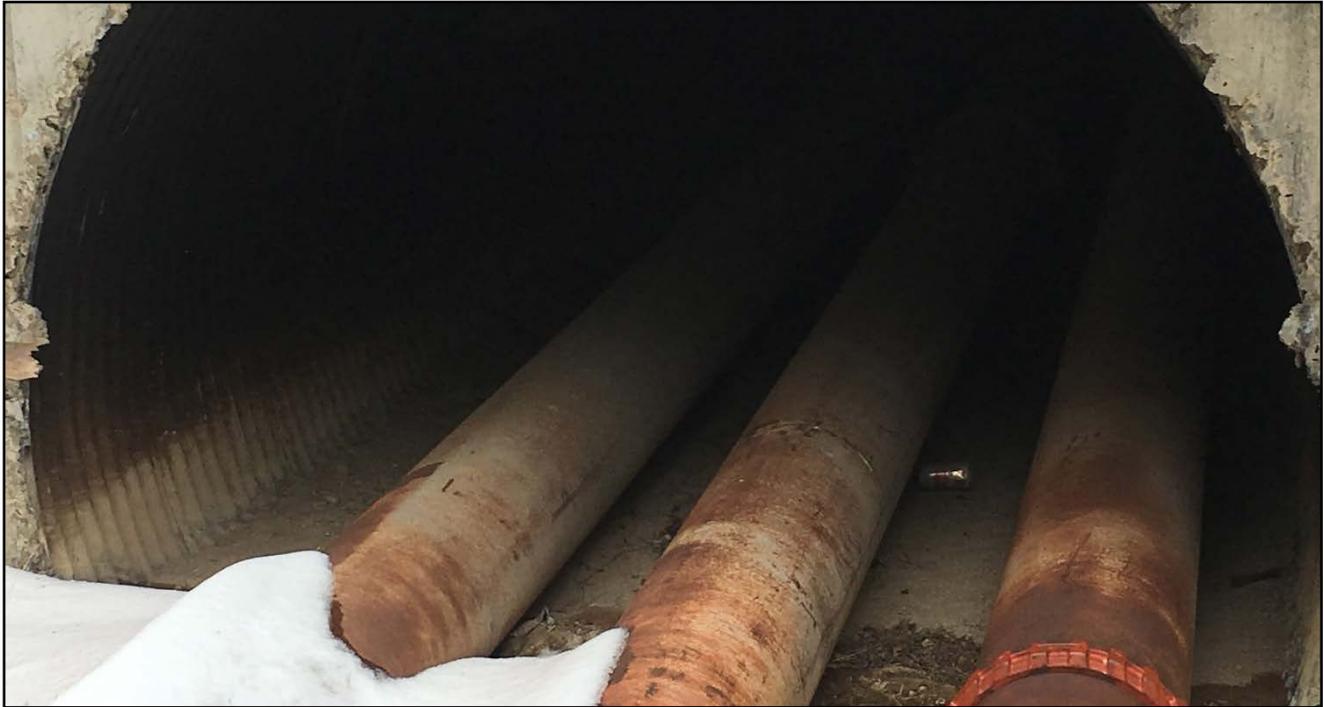
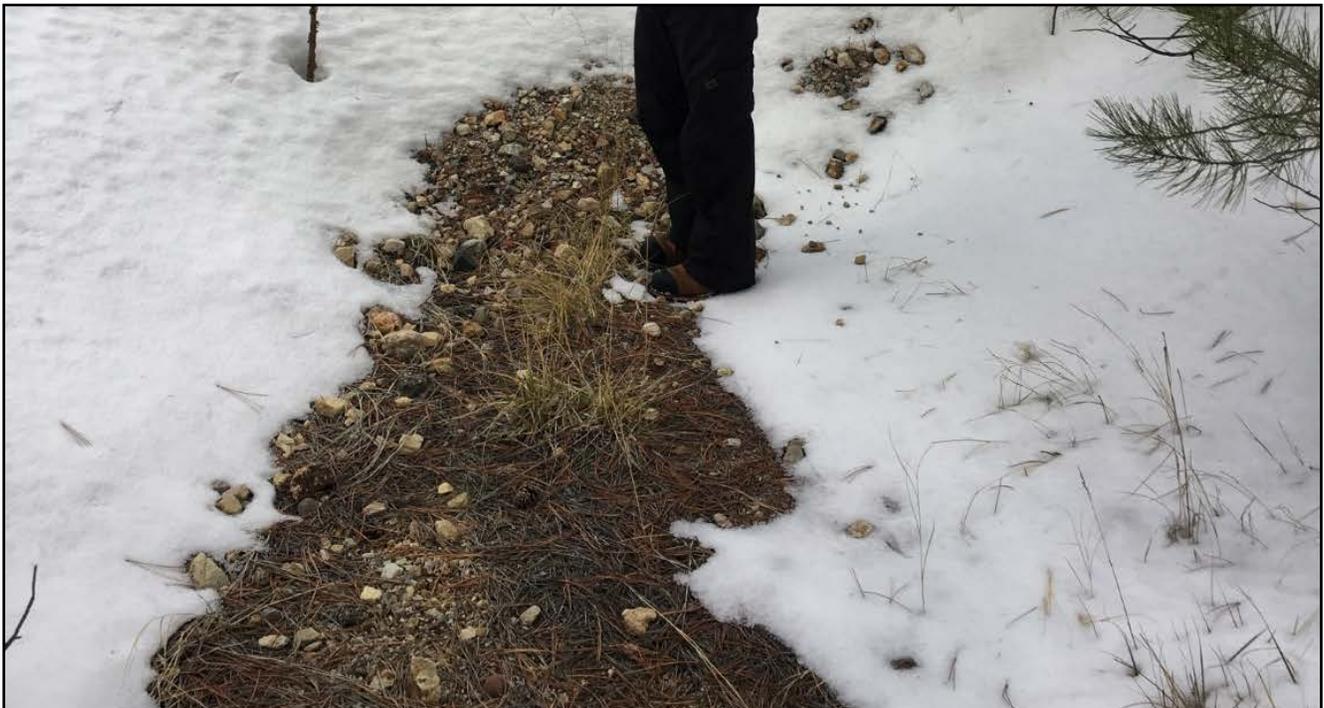
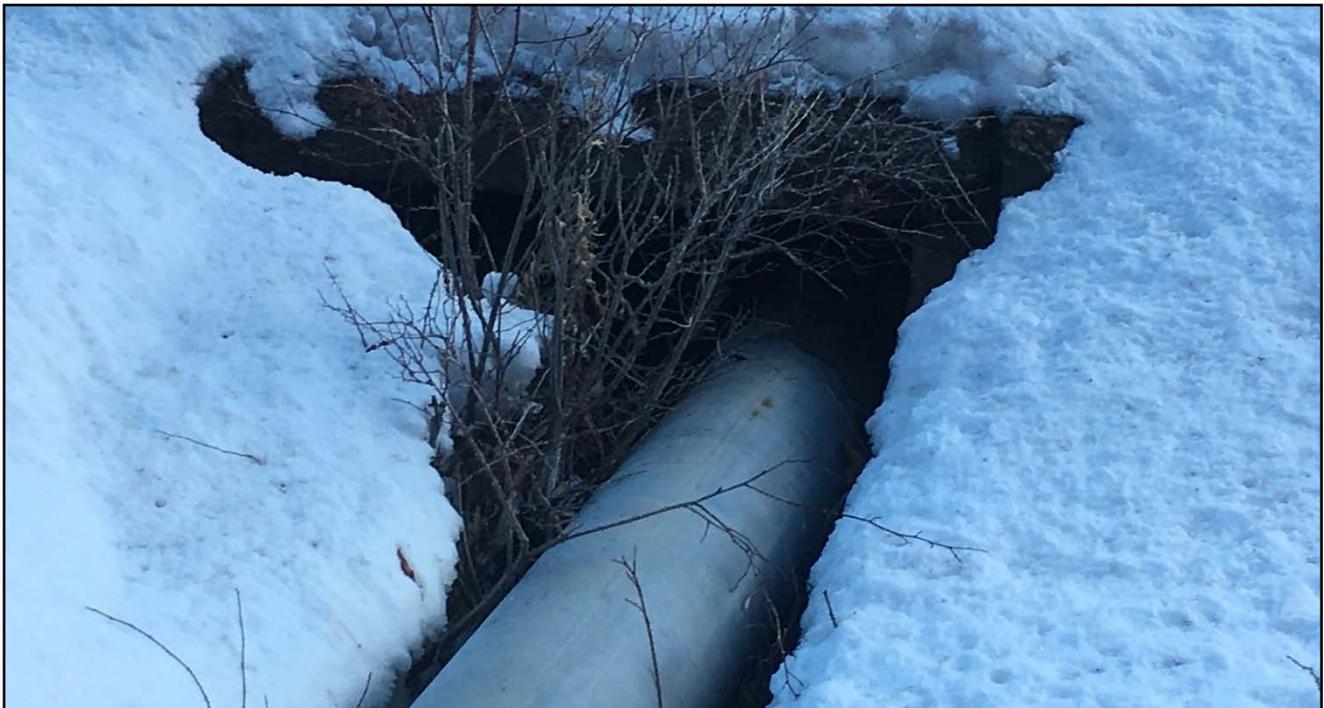
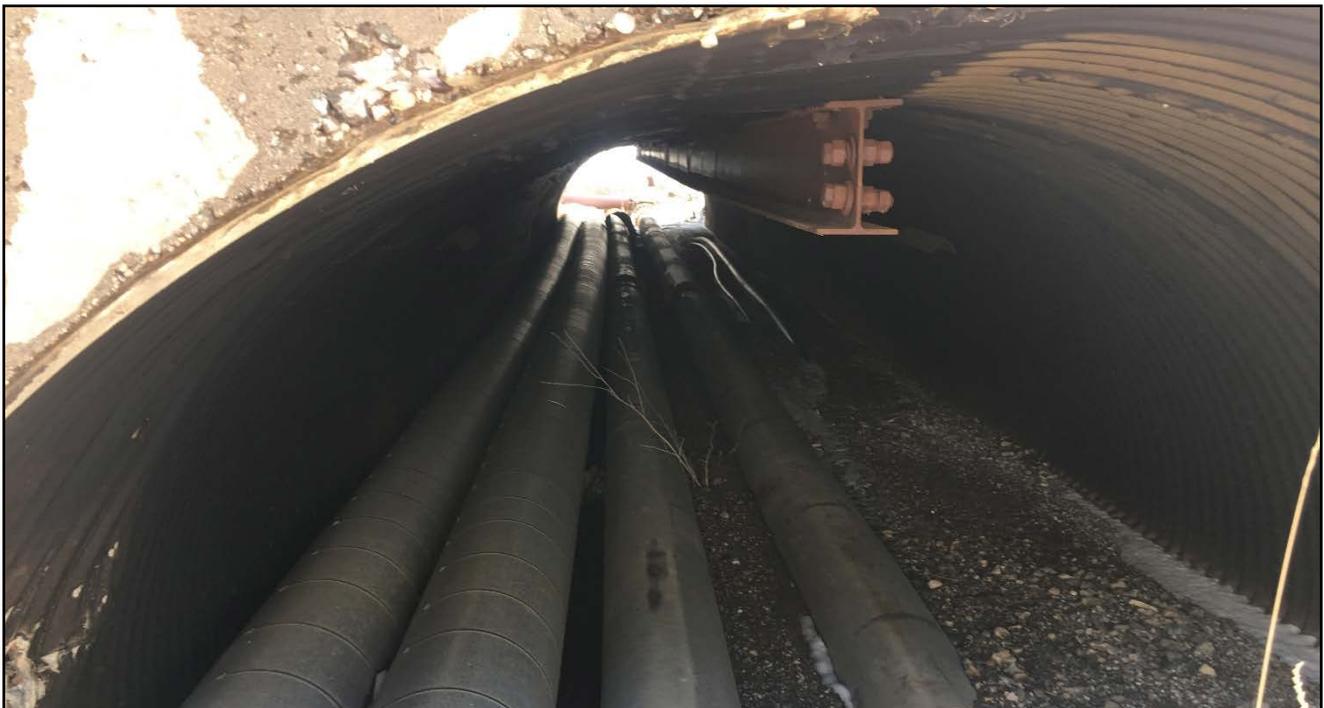
Photo #29  
Road Crossing Near Bear Cut  
South Side of Road

Photo #30  
Road Crossing Near Bear Cut  
North Side of Road

Photo #31  
CEMC Admin Road Crossing  
North Side

Photo #32  
CEMC Admin Road Crossing  
South Side

Photo #33  
Road Crossing Near Thunder Bridge  
North Side of the Road

Photo #34  
Road Crossing Near Columbine Curve  
North Side of the Road Looking South

There are four crossings within an NMDOT right-of-way. Three road crossings of Highway 38 are within casing pipes or structures and are approximately 90 feet in length. One road crossing of Highway 522 is buried, but it is uncertain the depth or length of the crossing. (Photos #29 through #34 of Appendix A).

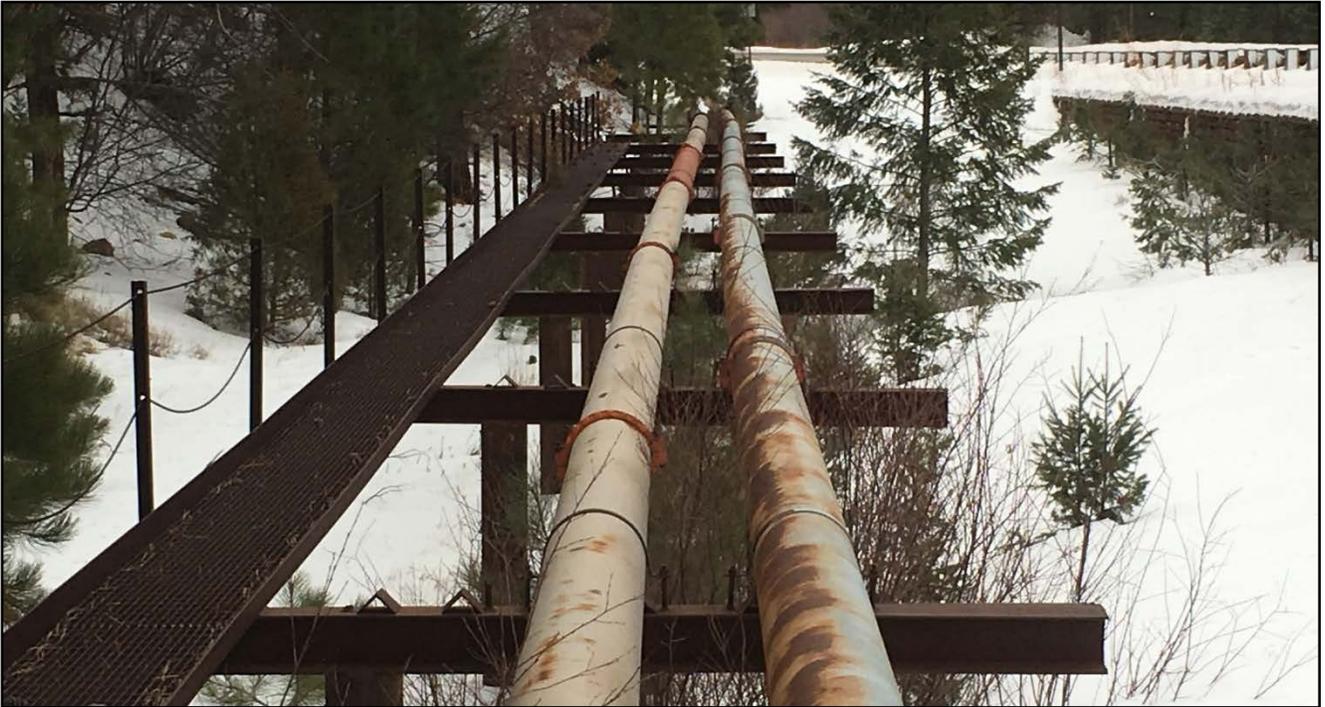
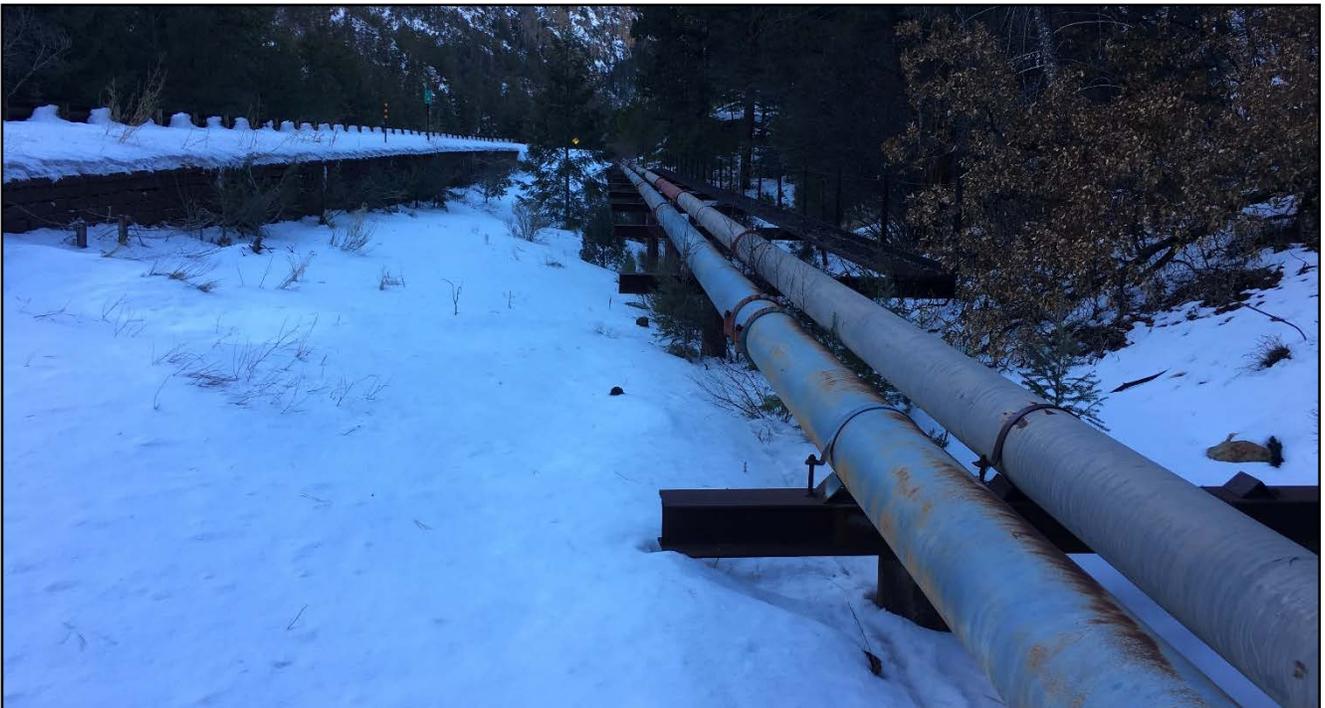
Photo #35  
Elevated Trestle Near Thunder Bridge  
Looking East

Photo #36  
Elevated Trestle Near Thunder Bridge  
Looking West
