Re: Chevron Questa Mine Superfund Site CERCLA Docket No. 06-13-12 Early Removal Actions: Final Addendum to Historic Tailing Spills Removal Action Work Plan and Stage 8 Pipeline Removal Work Plan and response to Comments.

• Final Addendum to Historic Tailing Spills Removal Action Work Plan and Stage 8 Pipeline Removal Work Plan and response to EPA and NMED/MMD comments.

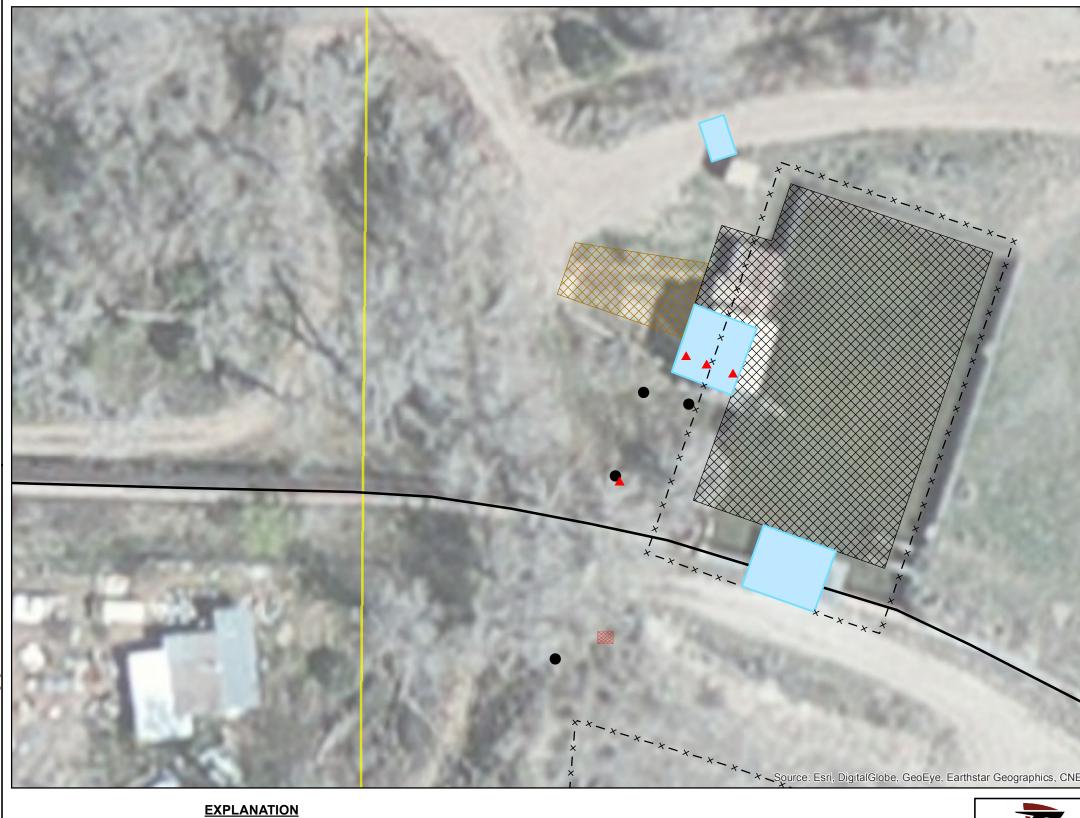
- ELECTRICAL BOX POWER POLE
- TRANSFORMER AND SOIL SAMPLE LOCATIONS
- $\times \times \times$ FENCE

A total of five electrical transformers are located within the Lower Dump Sump removal boundary (Photo 1, Appendix A). Four of the electrical transformers are located on a platform located adjacent to and south of one of the steel support buildings (Photo 2, Appendix A). The fifth transformer is located individually on a power pole on the south side of the site (Figure 3-2 and Photo 1, Appendix A).

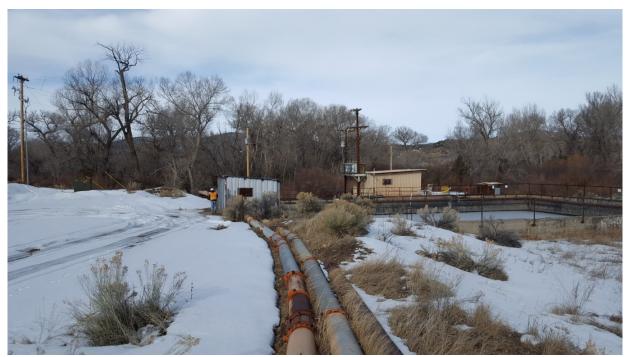
Photo 1. Lower Dump Sump, Viewed from East, Within Stage 8 Boundary

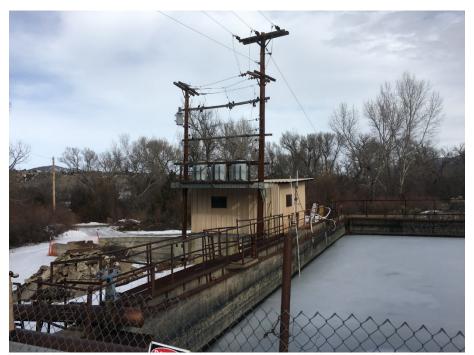
Photo 2. Southwest Support Building and Electrical Transformers, Viewed from South of Sump, Within Site Boundary

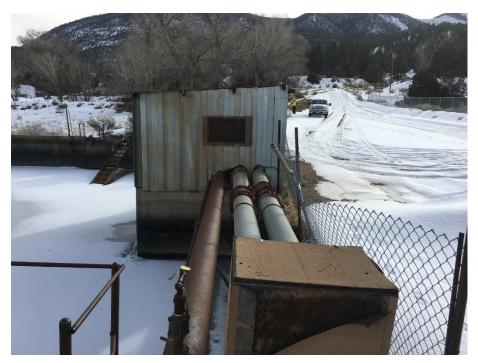
Photo 3. Southern Support Building, Viewed from West, Within Site Boundary

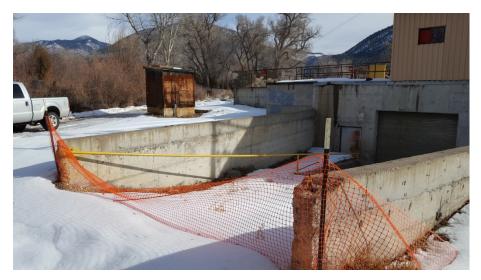
Photo 4. Ramped Access, Viewed from West, Within Site Boundary

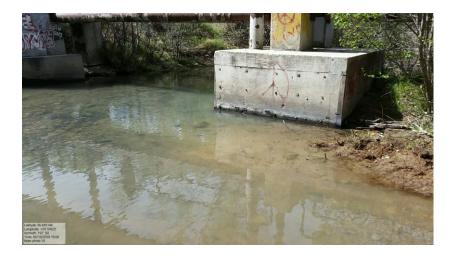
Photo 10. 4th Red River Crossing

The tailings pipeline crosses the Red River, on an elevated trestle, from 36°41'41.97"N, 105°35'45.20"W to 36°41'45.07"N, 105°35'48.90"W. From the east, this is the 4th crossing of the Red River as shown in Figure 3. The pipeline is suspended above the river by an elevated steel trestle (Photo 9 and Photo 10 of Appendix B). The river is approximately 26 feet wide at the crossing. Pipeline removal would involve removal of concrete supports located at the east and west bank of the river, within the river channel. NWI data indicates that a small amount of PFO wetland occurs approximately 20 feet to the south of the pipeline on both the east and west side of the river.

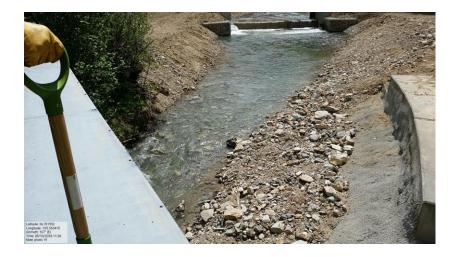
Photo 20a. 3rd Red River Crossing

The tailings pipeline crosses the Red River at approximately 36°42'6.96"N, 105°34'47.96"W east of the ranger station. From the east, this is the 3rd crossing of the Red River as shown in Figure 5. The pipeline is suspended above the river by a steel bridge (Photo 20a and 20b of Appendix B). The river is approximately 21 feet wide at the crossing. Pipeline removal would involve removal of concrete supports located at the east and west bank of the river, outside of the river channel.

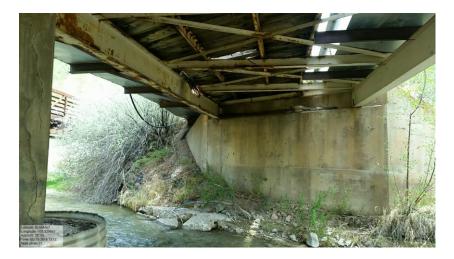
Photo 20b. 3rd Red River Crossing

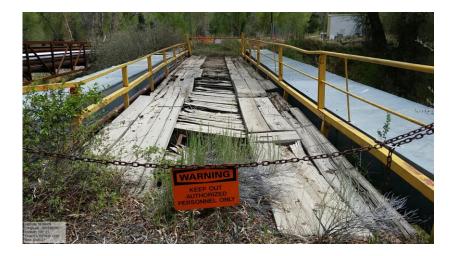
Photo 21. 2nd Red River Crossing (Thunder Bridge)

The tailings pipeline crosses the Red River at approximately 36°41'4.29"N, 105°31'47.83"W. From the east, this is the 2nd crossing of the Red River as shown in Figure 7. This is known at the Thunder Bridge crossing. The river is approximately 25 feet wide at the crossing. The pipeline is suspended above the river by a wide steel bridge with wooden planks on top (Photo 21, 21a, and 21b of Appendix B). Pipeline removal would involve removal of the concrete supports located at the east and west bank of the river.

Bridge crossings were checked for potential bat roost sites. With the exception of Thunder Bridge (2nd Red River Crossing) no suitable roosting habitat was observed at the bridges. The Thunder Bridge has a number of microhabitat features which could be used by bats; however, no signs of bat use were observed. An acoustic bat monitor was used during the day to check for ultrasonic vocalizations beneath the bridge. No bat vocalizations were recorded. A bat night roost was observed inside a large concrete culvert adjacent to the tailings pipeline (Photo 26 of Appendix B). This culvert crosses below Highway 38. Bat droppings were prevalent in the culvert indicating this is a commonly used roost site during the summer months. Suitable day roost or hibernacula habitat was not observed at this site. The culvert will not be removed during pipeline removal.

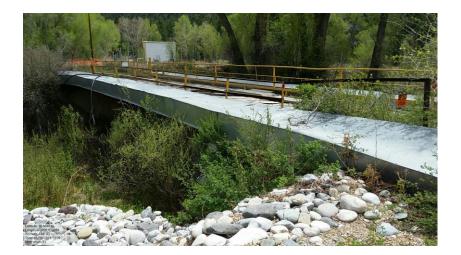
Photo 21a. 2nd Red River Crossing (Thunder Bridge)

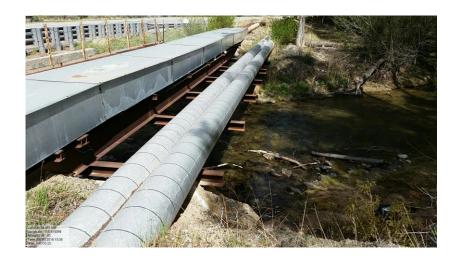
Photo 21b. 2nd Red River Crossing (Thunder Bridge)

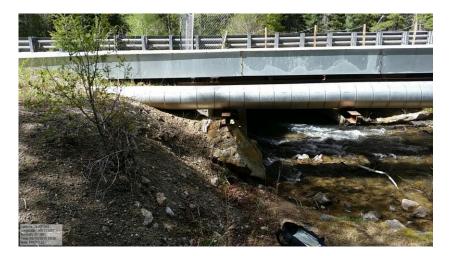
Photo 22a. 1st Red River Crossing

The tailings pipeline crosses the Red River at approximately 36°40'53.33"N, 105°30'53.97"W by Columbine Park. From the east, this is the 1st crossing of the Red River as shown in Figure 7. The pipeline is suspended above the river by a steel bridge (Photo 22a and 22b of Appendix B). The river is approximately 26 feet wide at the crossing. Pipeline removal would involve removal of concrete supports located at the east and west bank of the river. NWI data indicates that no wetlands occur on either side of the riverine area. Two determination points were assessed at this location including Q-6a placed 5 feet and Q-6b placed approximately 15 feet from the edge of the ordinary high water mark (OHWM) of the river. Hydrophytic vegetation was present at both locations; however, hydric soil indicators were lacking at both locations. Therefore, NWI was correct in that no wetland is present, adjacent to the Red River, at this crossing. The exact location of the riverine area was found to be inaccurate by approximately 75 feet. The actual boundary of the riverine area was delineated and is shown on Figure 7. Narrowleaf cottonwood is the dominant woody species along the riparian area with sparse shrubs, grasses, and forbs in the understory. Sphagnum moss was observed in an area within 5 or 6 feet of the riverine area.

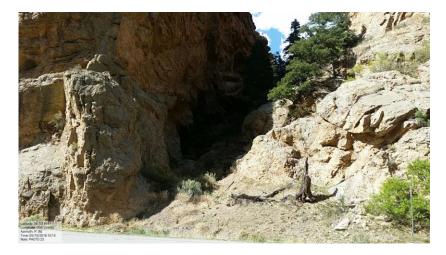
Photo 22b. 1st Red River Crossing

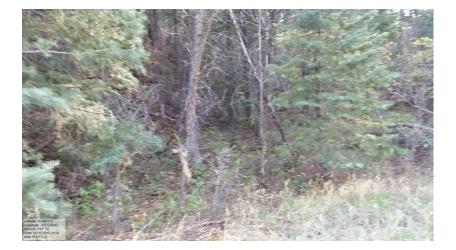
Photo 26. Culvert Crossing – Bat Roost

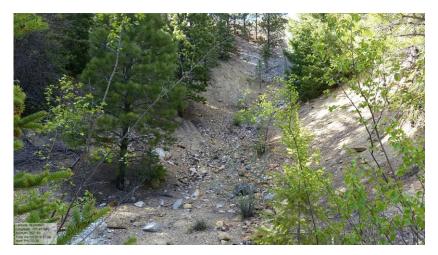
Photo 28a. Culverts Under Road

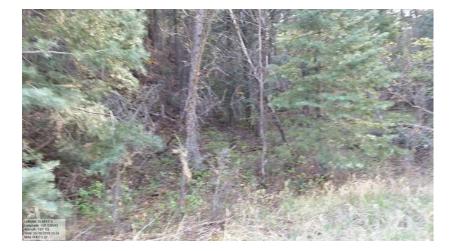
Photo 26. Culvert Crossing – Bat Roost

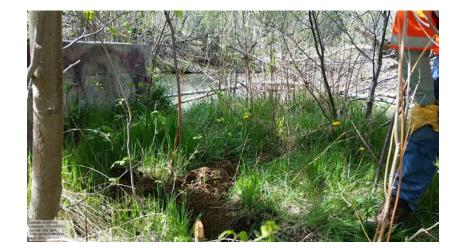
Photo Q-3a. Non-hydric Soil

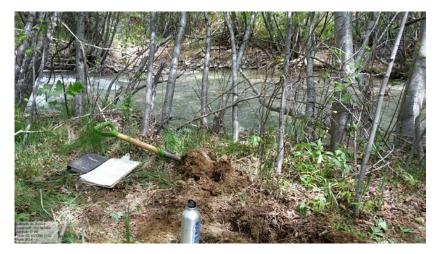
Photo Q-4. Non-hydric Soil (Chroma greater than 2)

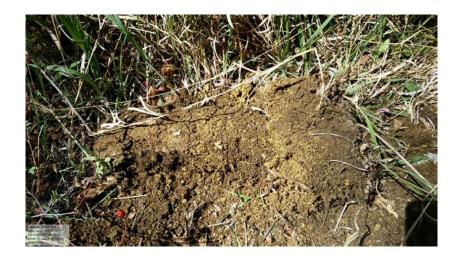
Photo Q-5a. PSS Wetland

All three wetland indicators were observed at point Q-5a, on the west side of the river. Hydric soil indicators observed include 30 percent redox concentrations in pore linings in a depleted matrix (10YR 4/2). In addition, hydrology indicators were observed including saturation (6" below ground surface), algal mat, iron deposits, water-stained leaves, and drainages patterns. All dominant plant species were FAC, FACW, or OBL species with water birch and willows dominating the shrub stratum. The boundary the PSS wetland as indicated by NWI data was found to be slightly inaccurate and was delineated in the field (Figure 7), within the 50-foot pipeline buffer. The NWI data was correct in classifying the wetland to the west of the river crossing as a PSS wetland.

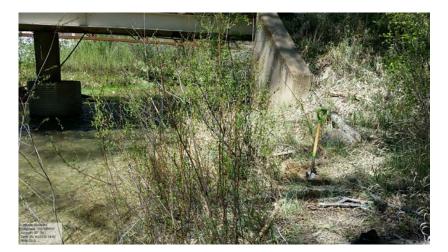
Photo Q-5b. Non-hydric Coil (High Chroma)

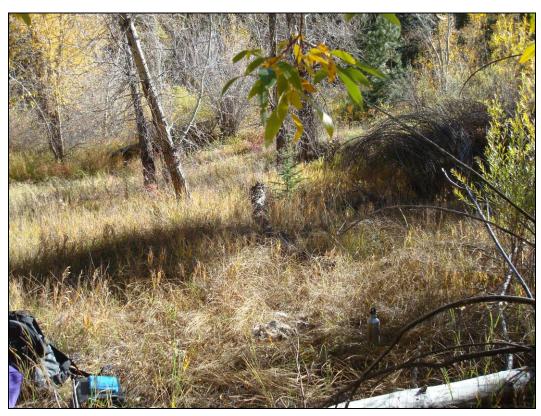
Photograph 1. To Southwest. View of feature HTS-1. This area did not meet the three substantive criteria for wetlands.

A second area within Tailing Deposit 1 that supports hydrophytic vegetation was also investigated as a wetland; however, it was determined that this feature did not meet the USACE wetland criteria for hydric soils and lacked evidence of hydrology. The soil pit for this feature (HTS-1) is included on Appendix A, Figure 2 and described in an Individual Wetland Data Form included in Appendix C.

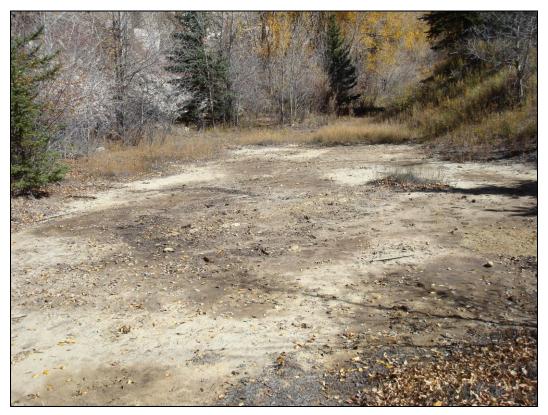
Photograph 2. To East. View of wetland HTS-2.

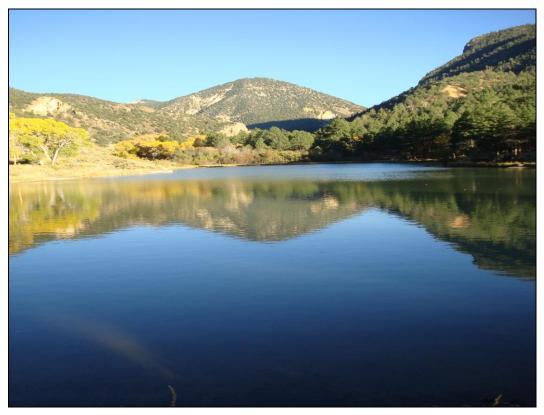
Photograph 3. To East. View of Eagle Rock Lake (OW-ERL1).

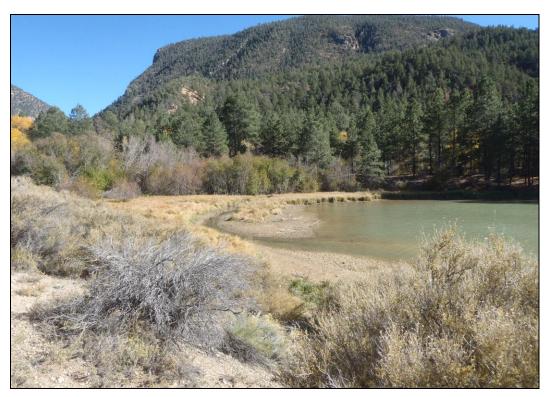
Photograph 4. To Southeast. View of wetland ERL-PEM at the mouth of the diversion ditch (OW-ERL3). Wetland ERL-PFO can be seen behind the feature. Eagle Rock Lake (OW-ERL1) in foreground.

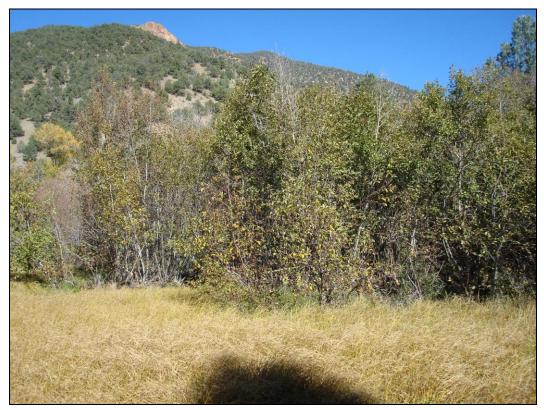
Photograph 6. To Northeast. View of wetland ERL-PFO. Wetland ERL-PEM occurs in photograph foreground.

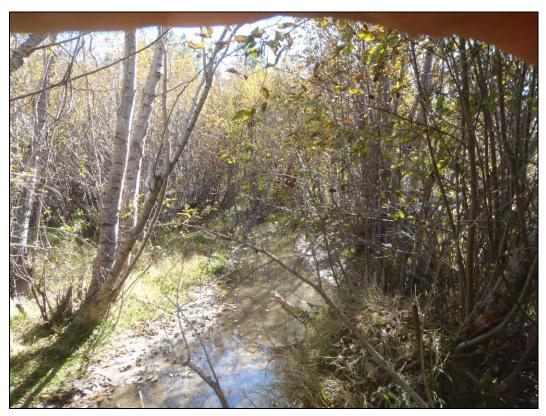
Photograph 7. To West. View of wetland ERL-PFO and Eagle Rock Lake diversion channel (OW-ERL3) near Eagle Rock Lake.

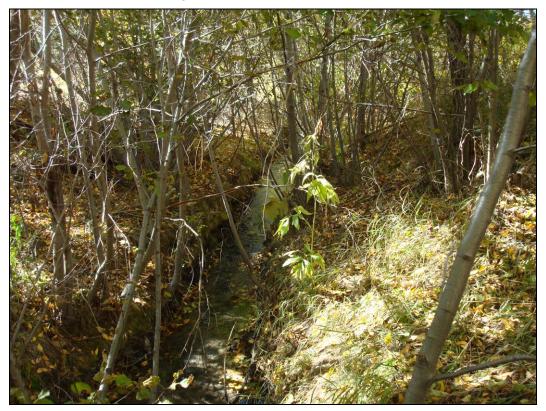
Photograph 8. To West. View of diversion channel OW-ERL3 upstream of wetland ERL-PFO.

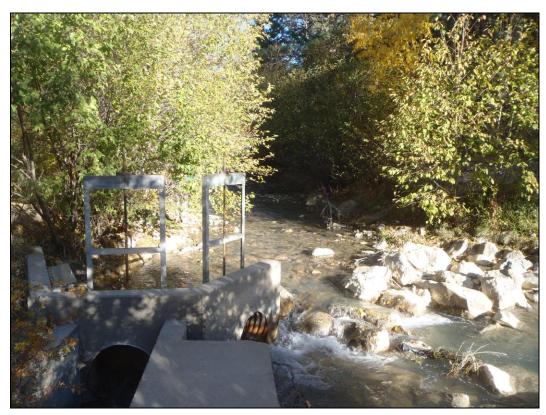
Photograph 9. To East. View upstream of Red River (OW-ERL2) at the headgate of the diversion channel (OW-ERL3).

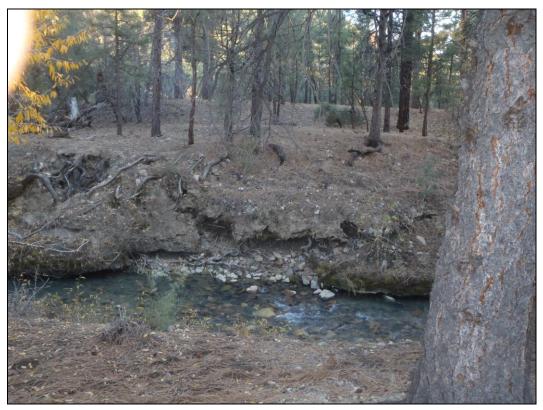
Photograph 10. To South. View of a reach of the Red River (OW-ERL2) adjacent to Eagle Rock Lake (OW-ERL1).

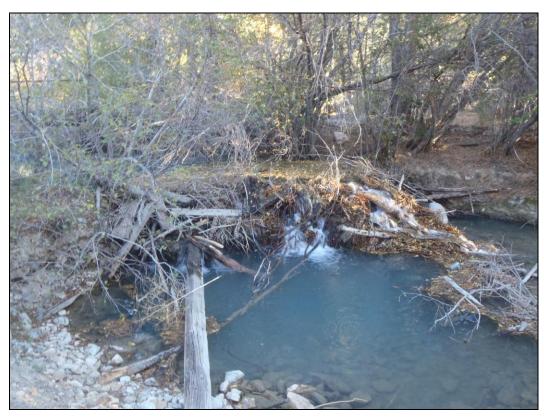
Photograph 11. To South. View of beaver dam within Red River (OW-ERL2) at the western end of the Eagle Rock Lake remediation area.

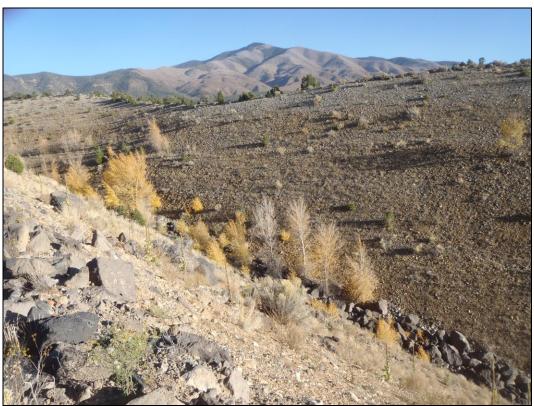
Photograph 17. To North. View of feature EDC-6 within the Eastern Diversion Channel. This area did not meet the three substantive criteria for wetlands.

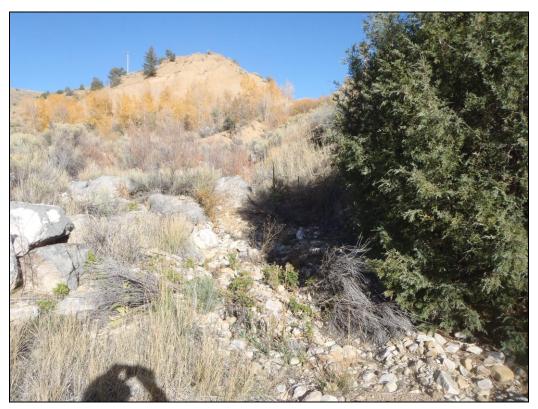
Photograph 22. To Northeast. View of the upland near EDC-3. A portion of the Eastern Diversion lower channel appears in the photograph center.

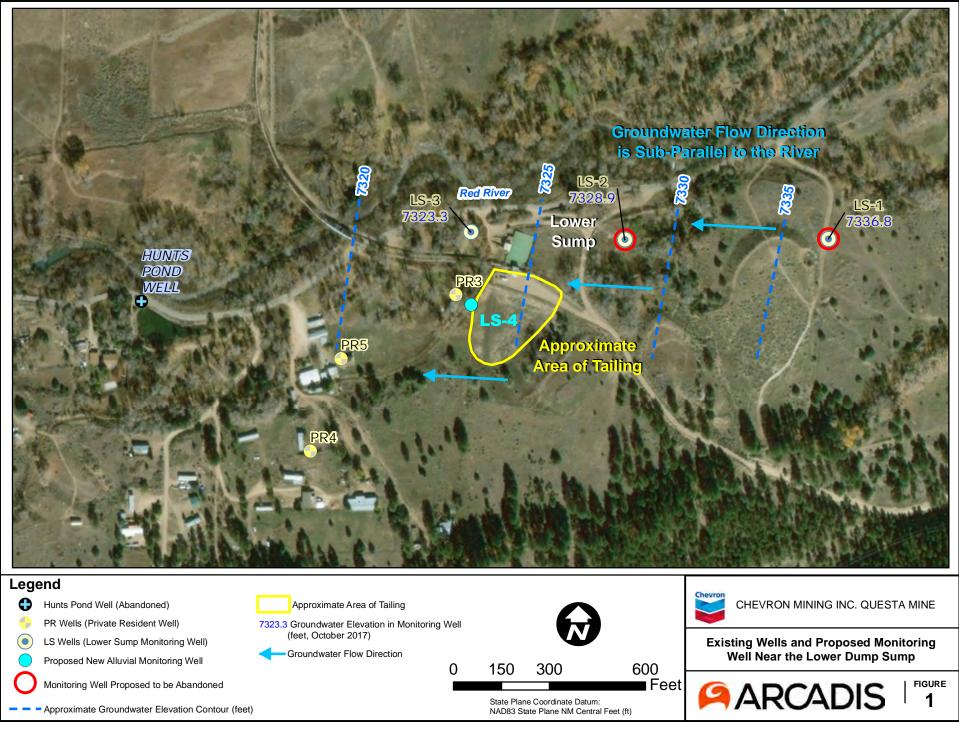
Figure 1 Existing Wells and Proposed Monitoring Well Near the Lower Dump Sump
