ENGINEER'S ESTIMATE

Rev. A, 10/07/2019

SECTION 12 MINE RECLAMATION - CONSTRUCTION SERVICES

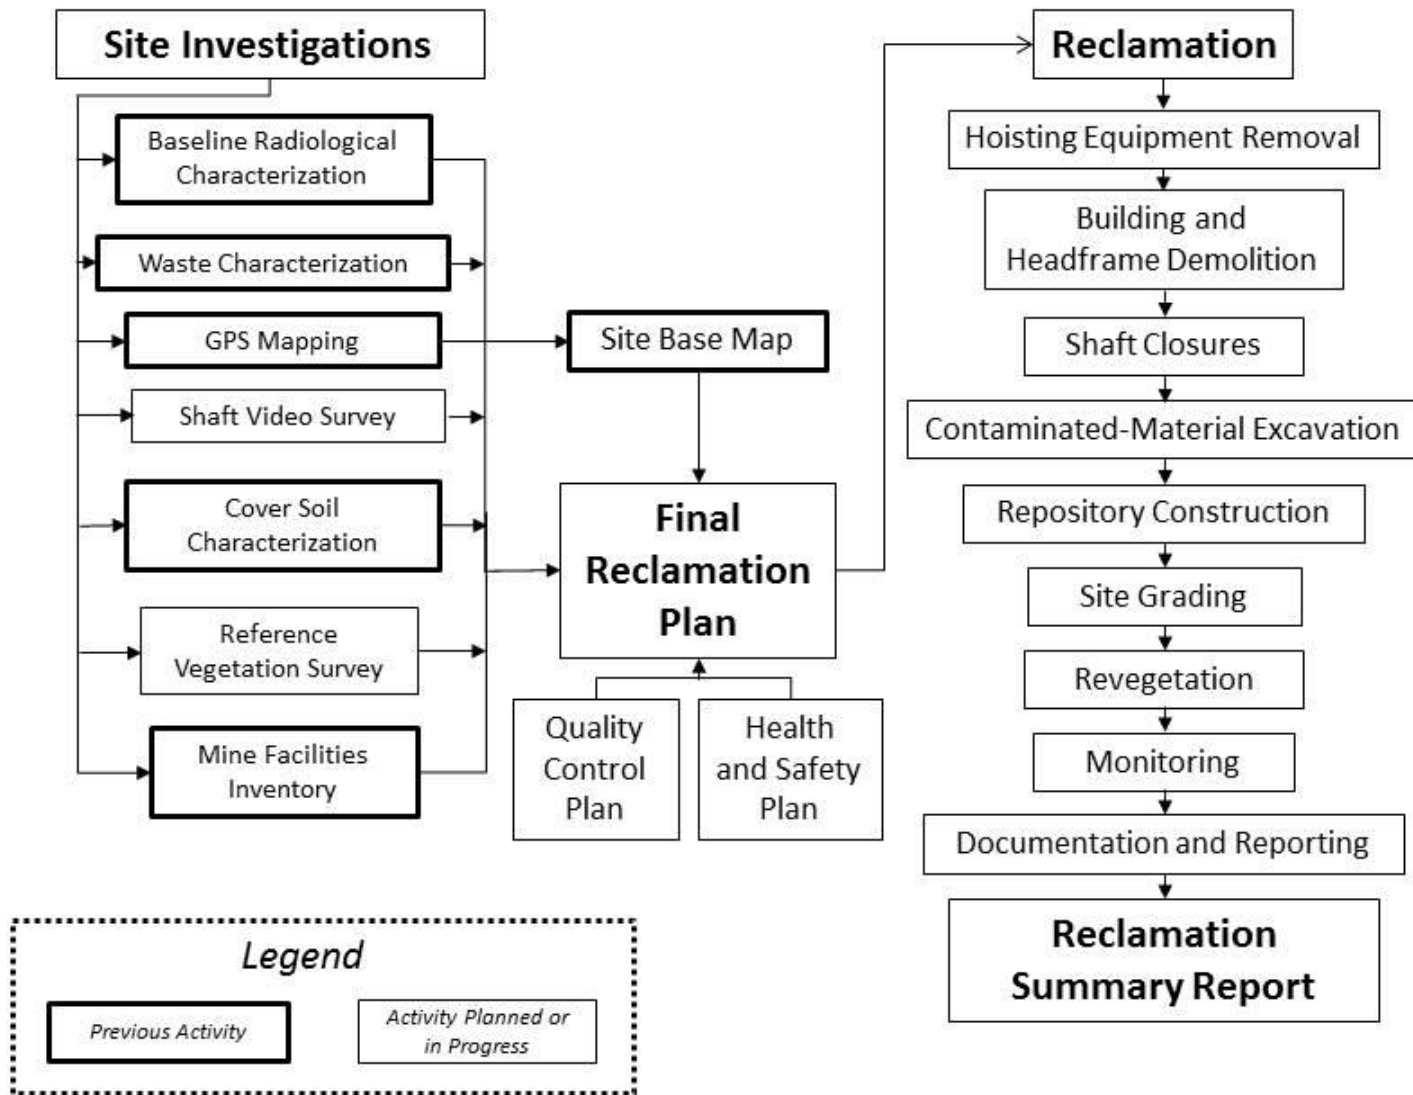
Figure 1. Reclamation Plan - Sequence of Activities

The sequence of activities in the Work Plan is illustrated in Figure 1. The estimated schedule of these activities is shown in Table 1, along with the primary responsibility and potentially impacting factors for each activity.

Previous activities identified as “ongoing” will be continued to completion in 2019 and early 2020. In addition to completing these activities, the following tasks will be performed during the remainder of 2019 and in 2020. The sequence of the Work Plan activities is illustrated in Figure 1.
