QUESTA TAILINGS PIPELINE REMOVAL STAGE 6 WORK PLAN CHEVRON ENVIRONMENTAL MANAGEMENT COMPANY QUESTA MINE

Project #: 476-027-002

SUBMITTED BY: Trihydro Corporation

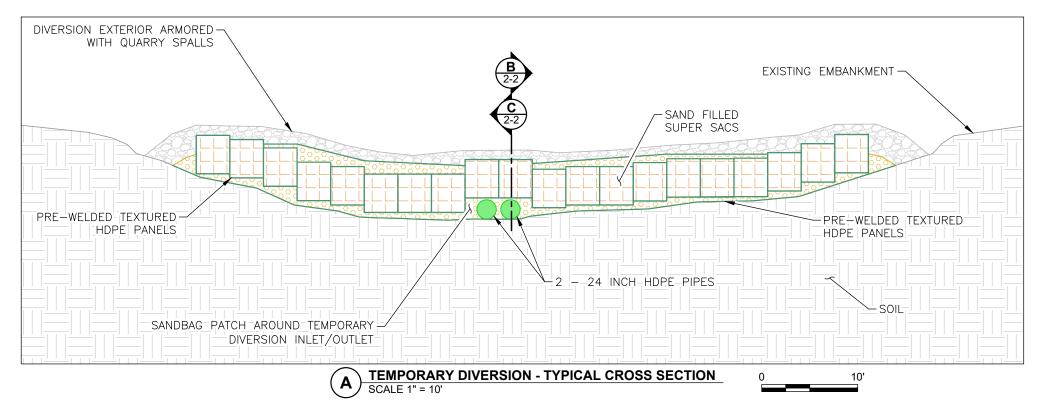
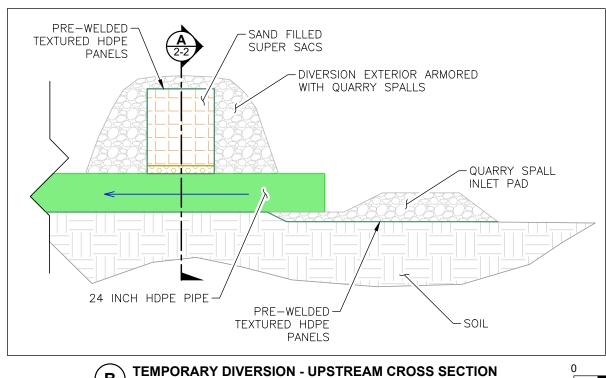
FIGURE 2-2

-PRE-WELDED SAND FILLED -TEXTURED HDPE SUPER SACS PANELS DIVERSION EXTERIOR ARMORED -WITH QUARRY SPALLS QUARRY SPALL -OUTLET PAD SOIL PRE-WELDED --24 INCH HDPE PIPE TEXTURED HDPE PANELS **TEMPORARY DIVERSION - DOWNSTREAM CROSS SECTION**

QUARRY SPALL STREAM FLOWPATH PRE-WELDED TEXTURED HDPE PANELS

- 2-1. Red River Temporary Diversion, Thunder Bridge
- 2-2. Red River Temporary Diversion Dam Cross Section
- 3-1. Stage 6 Pipeline Removal Locations
- 3-2. First River Crossing (AKA Columbine Bridge)
- 3-3. Second River Crossing (AKA Thunder Bridge)
- 3-4. Third River Crossing (AKA USFS Bridge)
- 3-5. Stage 6 Pipeline Removal Location, Rael Property
- 4-1. Pipeline Sampling Locations, Existing Site Plan-West Area Detail, CMI Tailings Pipeline
- 4-2. Pipeline Sampling Locations, Existing Site Plan-East Area Detail, CMI Tailings Pipeline

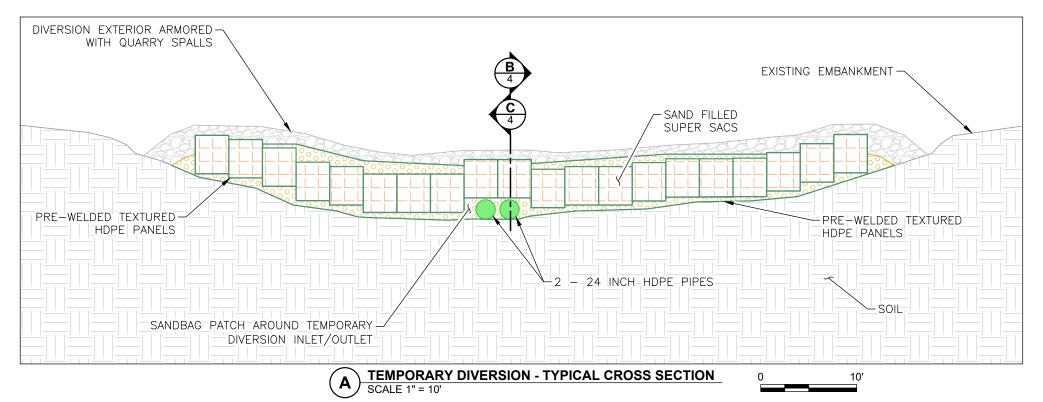
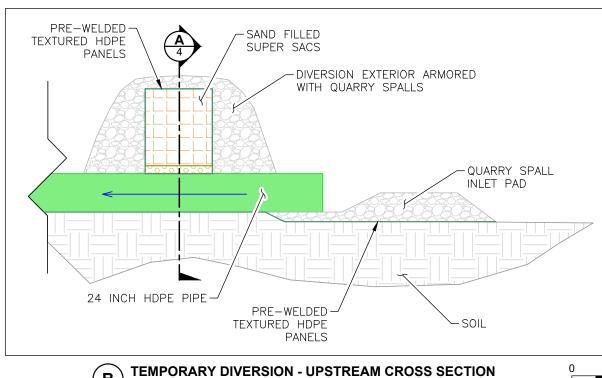
FIGURE 4

-PRE-WELDED SAND FILLED -TEXTURED HDPE SUPER SACS PANELS DIVERSION EXTERIOR ARMORED -WITH QUARRY SPALLS QUARRY SPALL -OUTLET PAD SOIL PRE-WELDED --24 INCH HDPE PIPE TEXTURED HDPE PANELS **TEMPORARY DIVERSION - DOWNSTREAM CROSS SECTION**

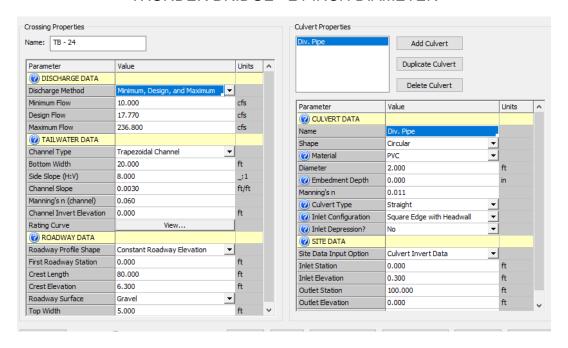
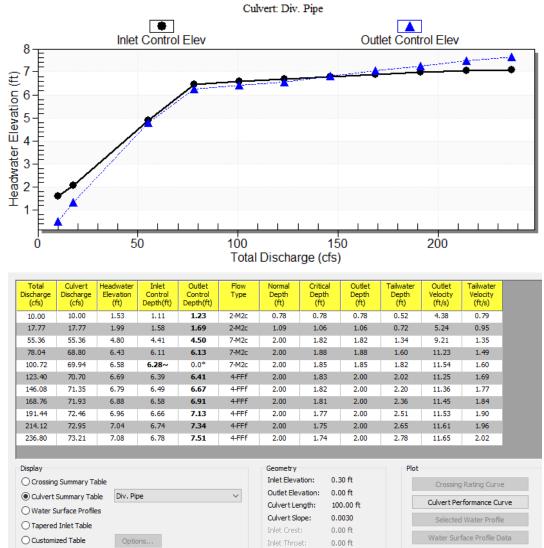
THUNDER BRIDGE - 24-INCH DIAMETER

* Full Flow Headwater elevation is below inlet invert.
~ Inlet control is shown, but flow profile is substantially FF.

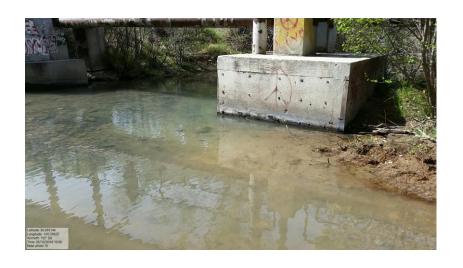
Photo 10. 4th Red River Crossing

The tailings pipeline crosses the Red River, on an elevated trestle, from 36°41'41.97"N, 105°35'45.20"W to 36°41'45.07"N, 105°35'48.90"W. From the east, this is the 4th crossing of the Red River as shown in Figure 3. The pipeline is suspended above the river by an elevated steel trestle (Photo 9 and Photo 10 of Appendix B). The river is approximately 26 feet wide at the crossing. In order to perform the pipeline removal, the project will involve the installation of two temporary diversion structures and two 24-inch diversion pipelines. Pipeline removal would consist of removing two 14-inch steel pipes, removal of one 14" wrapped pipe, and removal of concrete supports located at the east and west bank of the river, within the river channel. NWI data indicates that a small amount of PFO wetland occurs approximately 20 feet to the south of the pipeline on both the east and west side of the river.

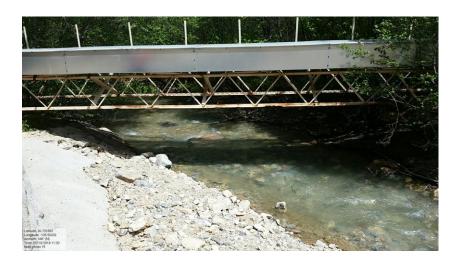
Photo 20a. 3rd Red River Crossing

The tailings pipeline crosses the Red River at approximately 36°42′6.96″N, 105°34′47.96″W east of the ranger station. From the east, this is the 3rd crossing of the Red River as shown in Figure 5. The pipeline is suspended above the river by a steel bridge (Photo 20a and 20b of Appendix B). The river is approximately 21 feet wide at the crossing. Pipeline removal would involve removal of two 14-inch steel pipes from the bridge structure. The bridge structure shall remain in place. Based on the delineation and proposed construction footprint, no impacts to WOUS or wetlands will occur at this location. The two sections of 14-inch steel pipe will be pulled outised of the WOUS.

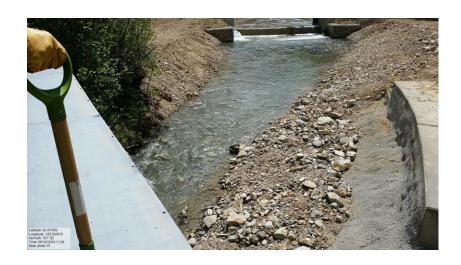
Photo 20b. 3rd Red River Crossing

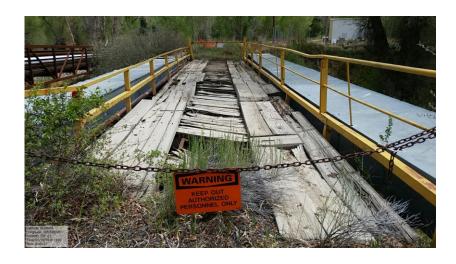
Photo 21a. 2nd Red River Crossing (Thunder Bridge)

The tailings pipeline crosses the Red River at approximately 36°41'4.29"N, 105°31'47.83"W. From the east, this is the 2nd crossing of the Red River as shown in Figure 7. This is known at the Thunder Bridge crossing. The river is approximately 25 feet wide at the crossing. The pipeline is suspended above the river by a wide steel bridge with wooden planks on top (Photo 21, 21a, and 21b of Appendix B). In order to perform the pipeline removal, the project will involve the installation of two temporary diversion structures and two 24-inch diversion pipelines. Pipeline removal would consist of removing two 14-inch steel pipes, and removal of the concrete supports and abutments located at the east and west bank of the river.

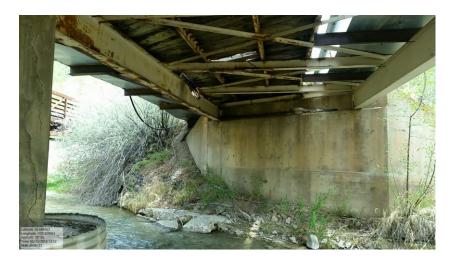
Photo 21. 2nd Red River Crossing (Thunder Bridge)

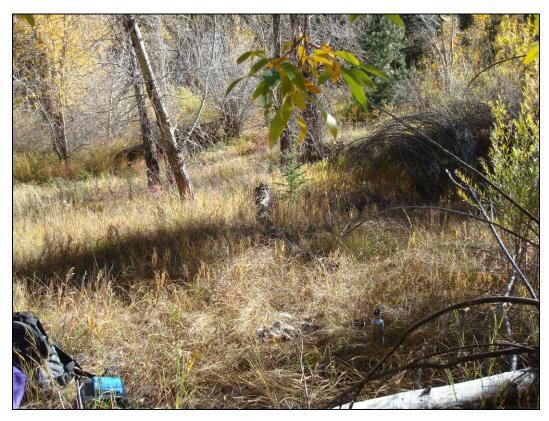
Photograph 1. To Southwest. View of feature HTS-1. This area did not meet the three substantive criteria for wetlands.

A second area within Tailing Deposit 1 that supports hydrophytic vegetation was also investigated as a wetland; however, it was determined that this feature did not meet the USACE wetland criteria for hydric soils and lacked evidence of hydrology. The soil pit for this feature (HTS-1) is included on Appendix A, Figure 2 and described in an Individual Wetland Data Form included in Appendix C.

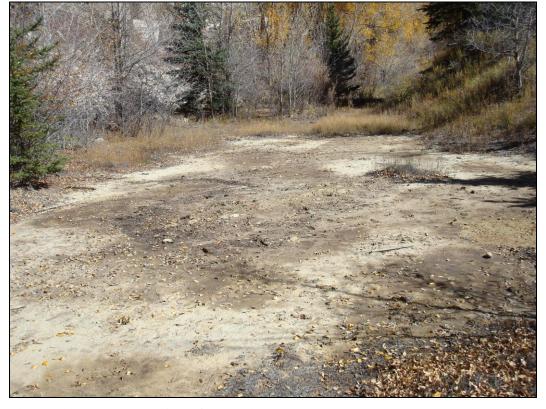
Photograph 2. To East. View of wetland HTS-2.

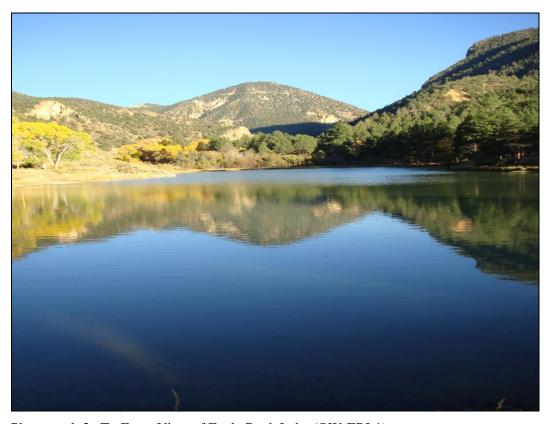
Photograph 3. To East. View of Eagle Rock Lake (OW-ERL1).

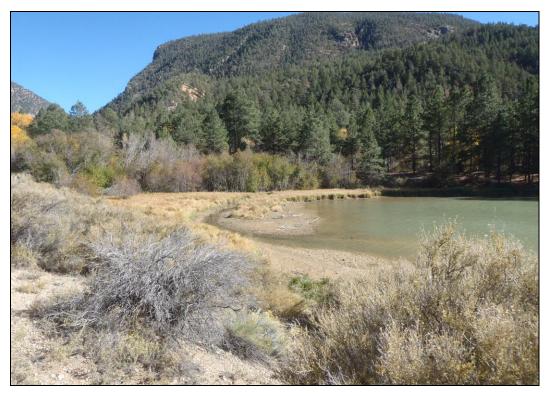
Photograph 4. To Southeast. View of wetland ERL-PEM at the mouth of the diversion ditch (OW-ERL3). Wetland ERL-PFO can be seen behind the feature. Eagle Rock Lake (OW-ERL1) in foreground.

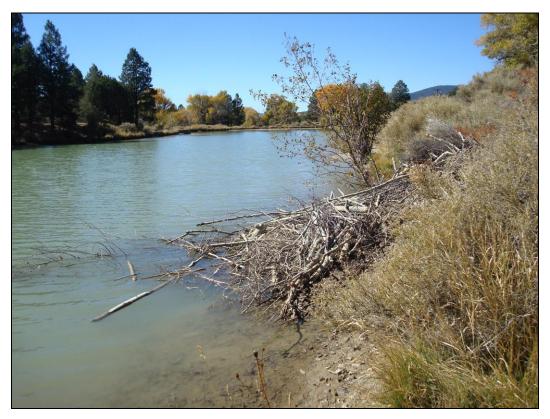
Photograph 5. To West. Beaver lodge on the north shore of Eagle Rock Lake (OW-ERL1).

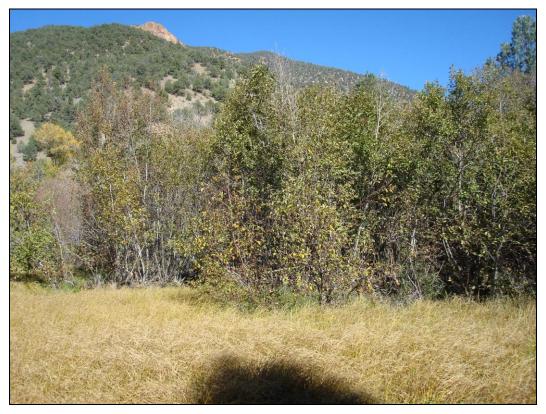
Photograph 6. To Northeast. View of wetland ERL-PFO. Wetland ERL-PEM occurs in photograph foreground.

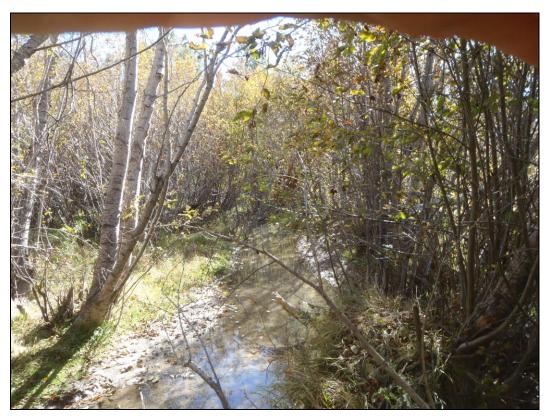
Photograph 7. To West. View of wetland ERL-PFO and Eagle Rock Lake diversion channel (OW-ERL3) near Eagle Rock Lake.

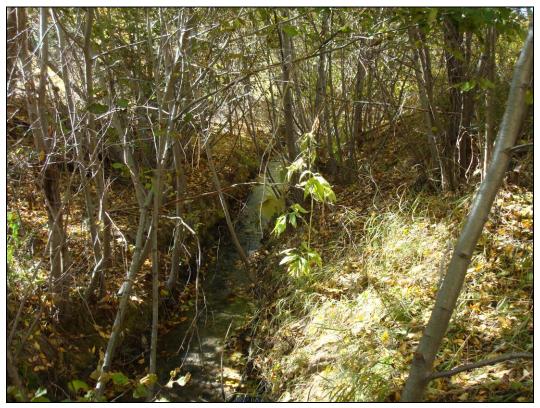
Photograph 8. To West. View of diversion channel OW-ERL3 upstream of wetland ERL-PFO.

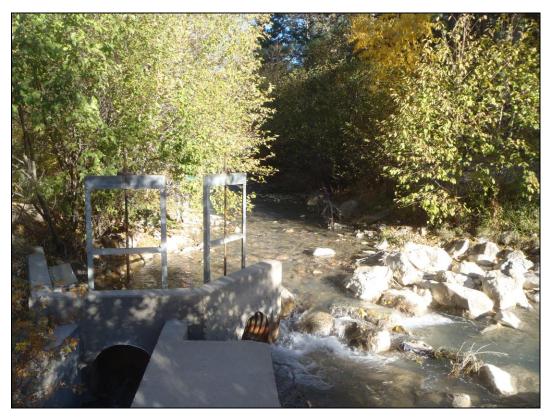
Photograph 9. To East. View upstream of Red River (OW-ERL2) at the headgate of the diversion channel (OW-ERL3).

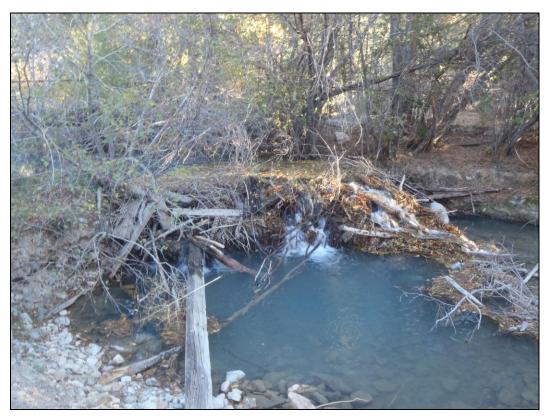
Photograph 11. To South. View of beaver dam within Red River (OW-ERL2) at the western end of the Eagle Rock Lake remediation area.

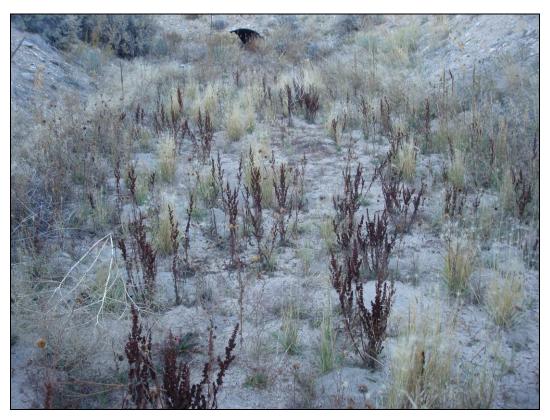
Photograph 17. To North. View of feature EDC-6 within the Eastern Diversion Channel. This area did not meet the three substantive criteria for wetlands.

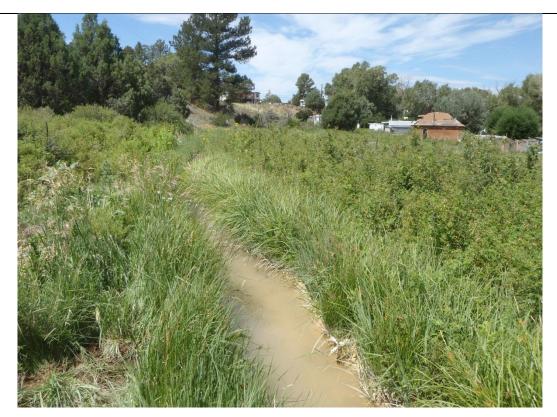
Photo 1. WL-1, looking west along Gallegos Ditch. Shrub on right is Wood's rose.

The potential herbaceous wetland area is identified as WL-1 in the data sheets and is shown in Photos 1 and 2 in Attachment B. This was an area about 75 feet long and about 2 to 3 feet wide on each side of the Gallegos Ditch in the central part of the study area. The area of potential wetland was bounded by the open water of the ditch and by raised berms of soil and sediment excavated from the ditch, which are visible on the aerial photo. The vegetation was dominated by hydrophytic sedges and grasses, with all 3 dominant species having wetland indicators, Nebraska sedge, Kentucky bluegrass and timothy. Three soil pits were dug and no hydric soil indicators were found. No water or saturation was found in the soil pits, and no evidence of hydrology was found in vegetated areas immediately adjacent to Gallegos Ditch. The irrigation channel was flowing at the time of the survey, but did not provide wetland hydrology to adjoining soils.

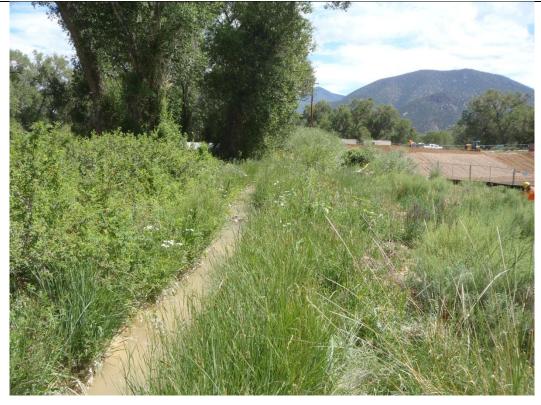
Photo 2. WL-1, looking east along Gallegos Ditch.

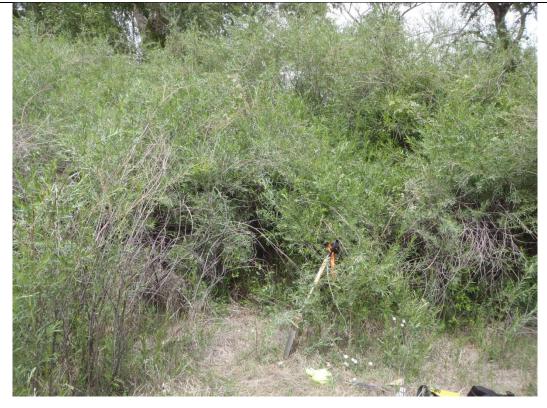
Photo 4. WL-2, looking west.

The potential scrub-shrub wetland area (WL-2 in the data sheets) consisted of a dense thicket of narrow-leaf willow located on a slope the east side of Gallegos Ditch and extending to the terrace below the ditch (Attachment B Photos 4 and 5). The vegetation was hydrophytic, with 3 of 4 species having wetland indicators, including narrow-leaf willow, deciduous traveller's joy (Clematis ligusticifolia), and Kentucky bluegrass. One soil pit was dug, located at the bottom of the slope about 5 feet vertically below Gallegos Ditch. No soil or hydrology indicators were observed. There was no observed evidence of overflow, leaks, or seepage from the ditch.

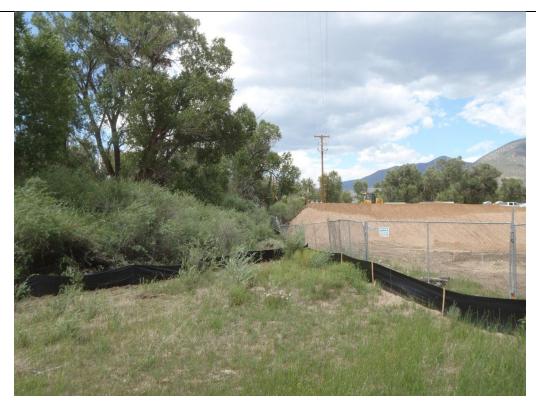
Photo 5. WL-2 (on left), looking north. LDS excavation is on right.

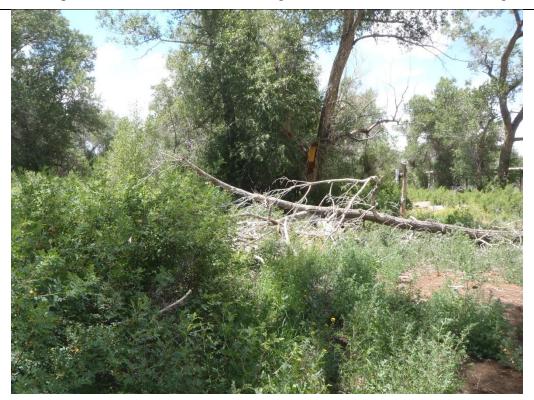
Photo 8. Riparian woodland east of former Reddell residence, looking northwest. Elevated tailing pipeline is in right background.

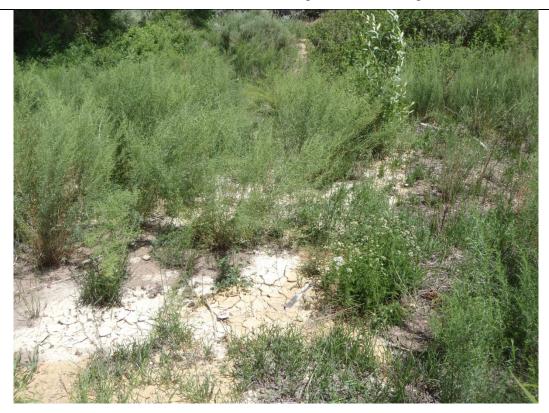
Photo 10. Recent sediment deposits in meadow.

Thin deposits of yellow sediment were found on vegetation and surface soils along the ditch and in the meadow north of the ditch (Attachment B, Photo 10. The sediment deposits appear to have resulted from a recent storm event that sent excess water down the ditch from the Red River and overtopped the edges of the ditch. There was no apparent relationship between areas of sediment deposition and presence of wetland plant species. The sediment deposits and presumed overtopping were interpreted as an uncommon event that does not result in wetland hydrology.
