**QUESTA TAILINGS PIPELINE REMOVAL
STAGE 7 WORK PLAN
CHEVRON ENVIRONMENTAL MANAGEMENT COMPANY
QUESTA MINE**

May 21, 2019

SUBMITTED BY: Trihydro Corporation

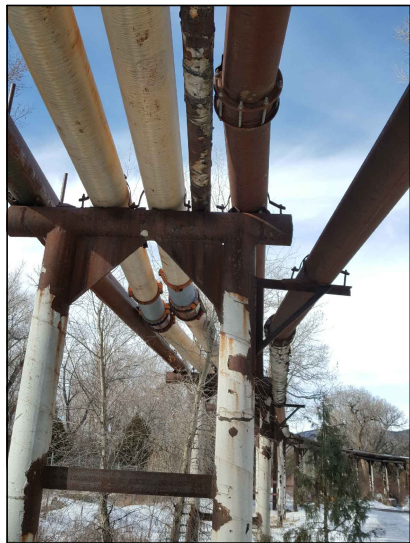
B ELEVATED PIPES AT STA. 374+14

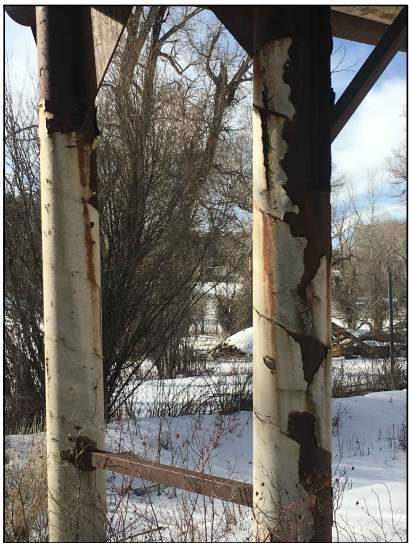
A TRESTLE PIPES, PIPE WRAP CONDITION

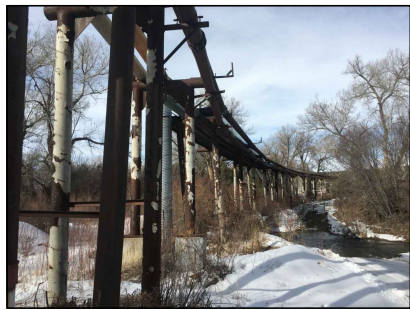
D CROSSING AT RED RIVER, LOOKING WEST

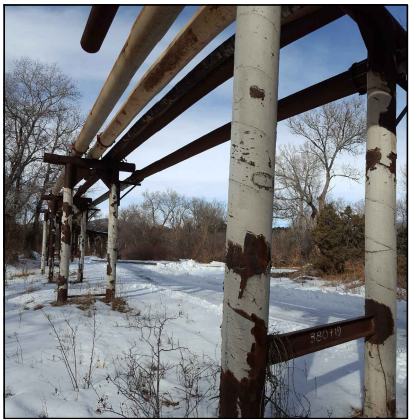
C ELEVATED PIPES AT STA. 374+14

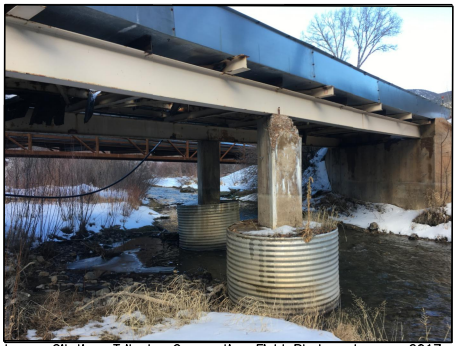
A **CONDITION OF THUNDER BRIDGE**

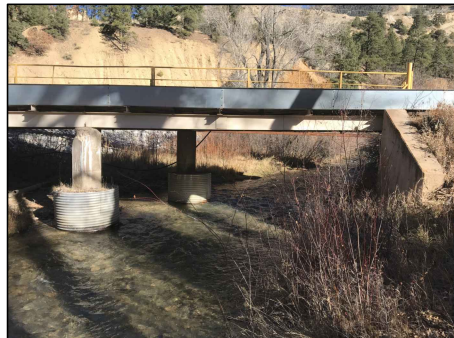
B **CONDITION OF THUNDER BRIDGE**

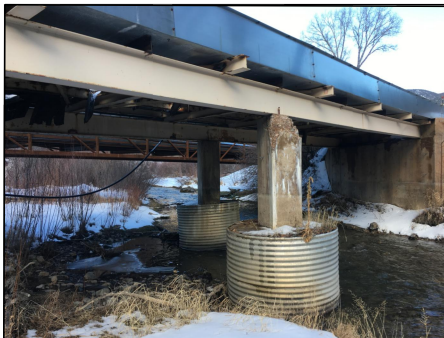
A **CONDITION OF THUNDER BRIDGE**

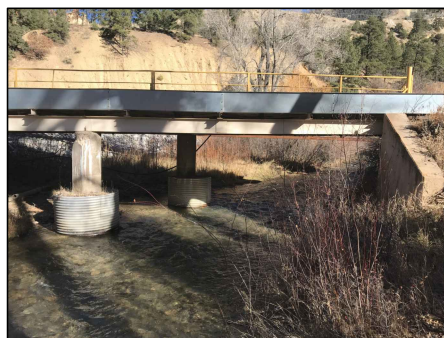
B **CONDITION OF THUNDER BRIDGE**

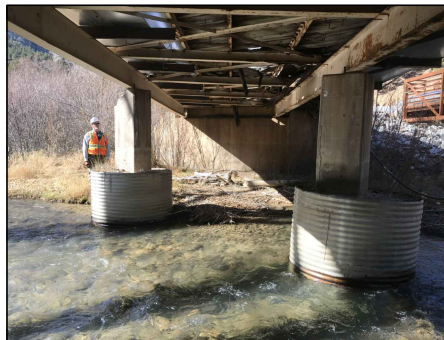
C **CONDITION OF THUNDER BRIDGE**

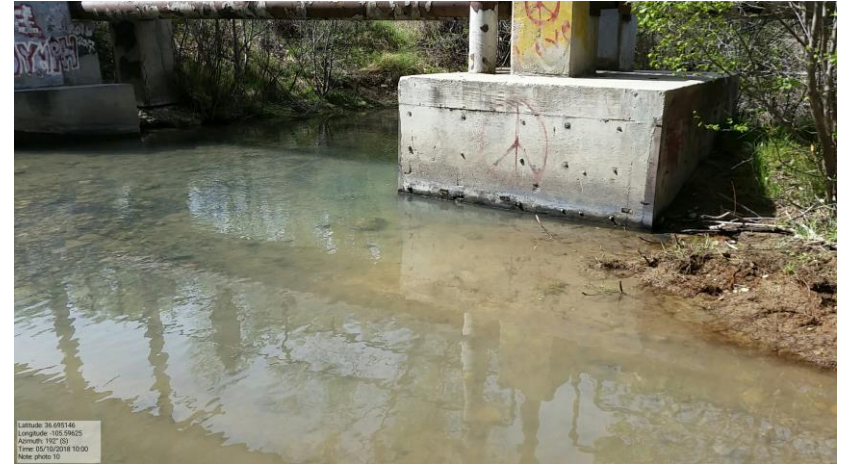
Photo 10. 4th Red River Crossing

The tailings pipeline crosses the Red River, on an elevated trestle, from 36°41'41.97"N, 105°35'45.20"W to 36°41'45.07"N, 105°35'48.90"W. From the east, this is the 4th crossing of the Red River as shown in Figure 3. The pipeline is suspended above the river by an elevated steel trestle (Photo 9 and Photo 10 of Appendix B). The river is approximately 26 feet wide at the crossing. In order to perform the pipeline removal, the project will involve the installation of two temporary diversion structures and two 24-inch diversion pipelines. Pipeline removal would consist of removing two 14-inch steel pipes, removal of one 14" wrapped pipe, and removal of concrete supports located at the east and west bank of the river, within the river channel. NWI data indicates that a small amount of PFO wetland occurs approximately 20 feet to the south of the pipeline on both the east and west side of the river.

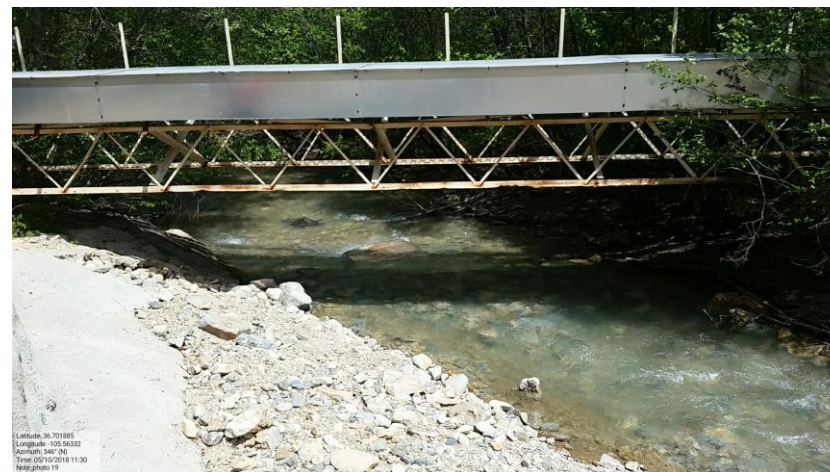
Photo 20a. 3rd Red River Crossing

The tailings pipeline crosses the Red River at approximately 36°42'6.96"N, 105°34'47.96"W east of the ranger station. From the east, this is the 3rd crossing of the Red River as shown in Figure 5. The pipeline is suspended above the river by a steel bridge (Photo 20a and 20b of Appendix B). The river is approximately 21 feet wide at the crossing. Pipeline removal would involve removal of two 14-inch steel pipes from the bridge structure. The bridge structure shall remain in place. . Based on the delineation and proposed construction footprint, no impacts to WOUS or wetlands will occur at this location. The two sections of 14-inch steel pipe will be pulled out of the WOUS.

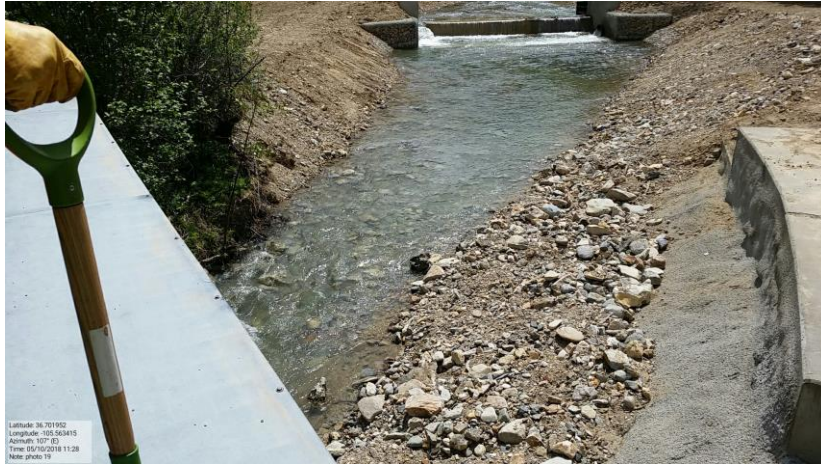
Photo 20b. 3rd Red River Crossing

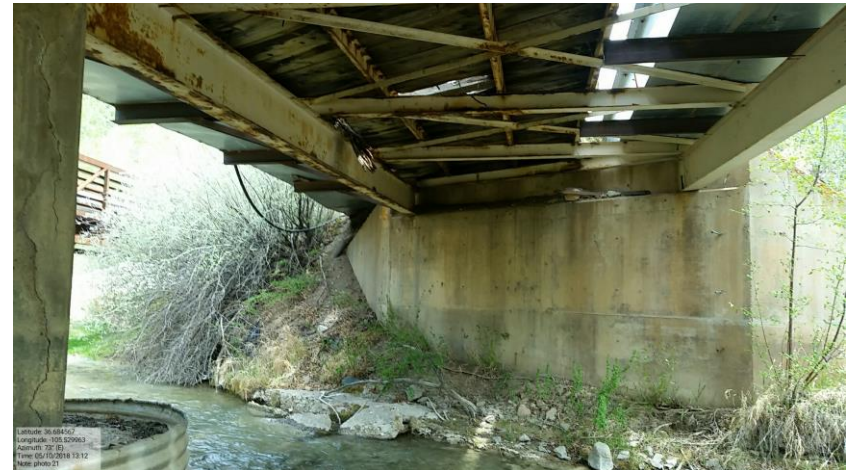
Photo 21. 2nd Red River Crossing (Thunder Bridge)

The tailings pipeline crosses the Red River at approximately 36°41'4.29"N, 105°31'47.83"W. From the east, this is the 2nd crossing of the Red River as shown in Figure 7. This is known as the Thunder Bridge crossing. The river is approximately 25 feet wide at the crossing. The pipeline is suspended above the river by a wide steel bridge with wooden planks on top (Photo 21, 21a, and 21b of Appendix B). In order to perform the pipeline removal, the project will involve the installation of two temporary diversion structures and two 24-inch diversion pipelines. Pipeline removal would consist of removing two 14-inch steel pipes, and removal of the concrete supports and abutments located at the east and west bank of the river.

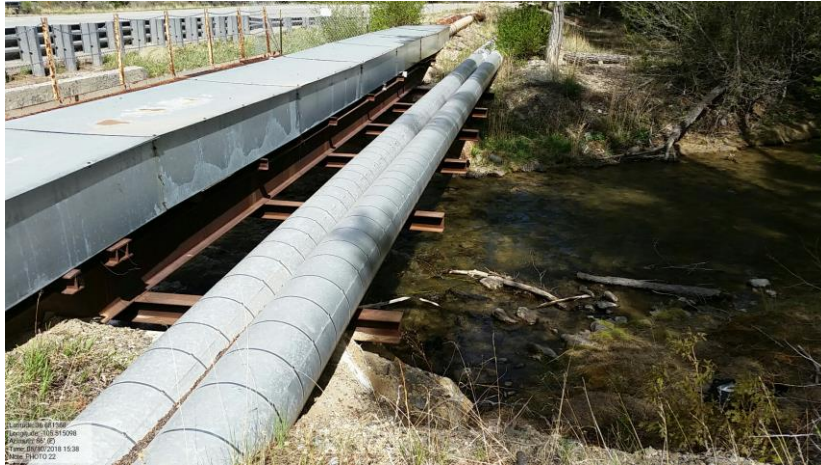
Photo 22a. 1st Red River Crossing

The tailings pipeline crosses the Red River at approximately 36°40'53.33"N, 105°30'53.97"W by Columbine Park. From the east, this is the 1st crossing of the Red River as shown in Figure 7. The pipeline is suspended above the river by a steel bridge (Photo 22a and 22b of Appendix B). The river is approximately 26 feet wide at the crossing. Pipeline removal would involve removal of two 14-inch steel pipes, the bridge cantilever, and the GWW liner. NWI data indicates that no wetlands occur on either side of the riverine area. Two determination points were assessed at this location including Q-6a placed 5 feet and Q-6b placed approximately 15 feet from the edge of the OHWM of the river. Hydrophytic vegetation was present at both locations; however, hydric soil indicators were lacking at both locations.

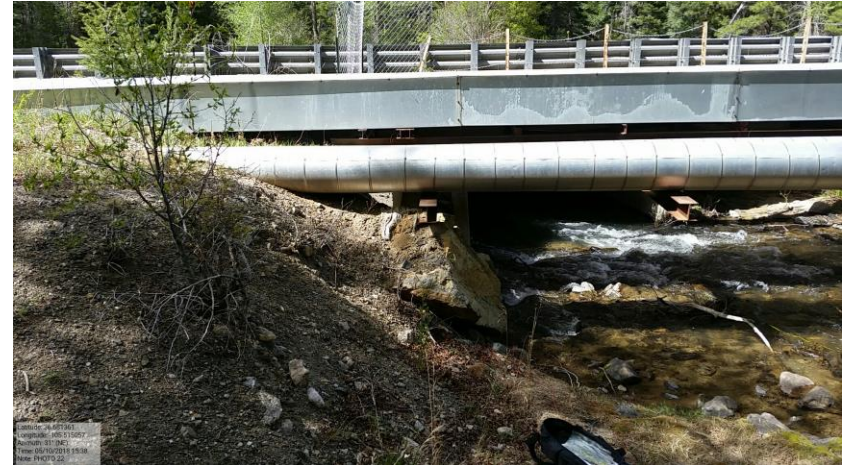
Photo 22b. 1st Red River Crossing

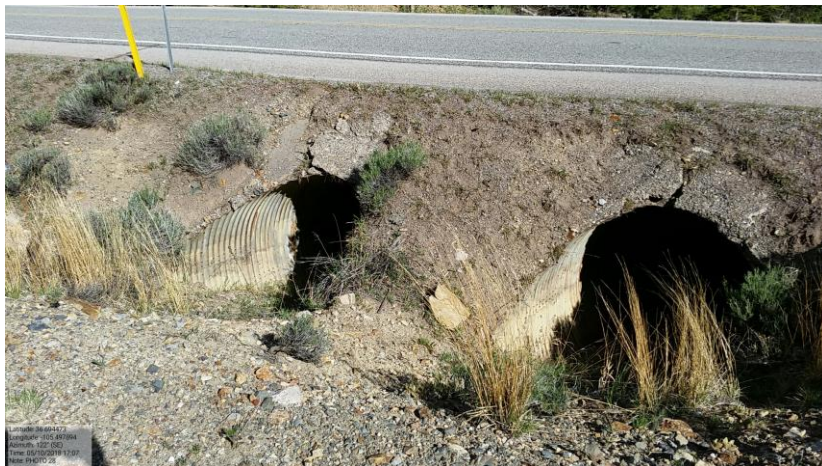
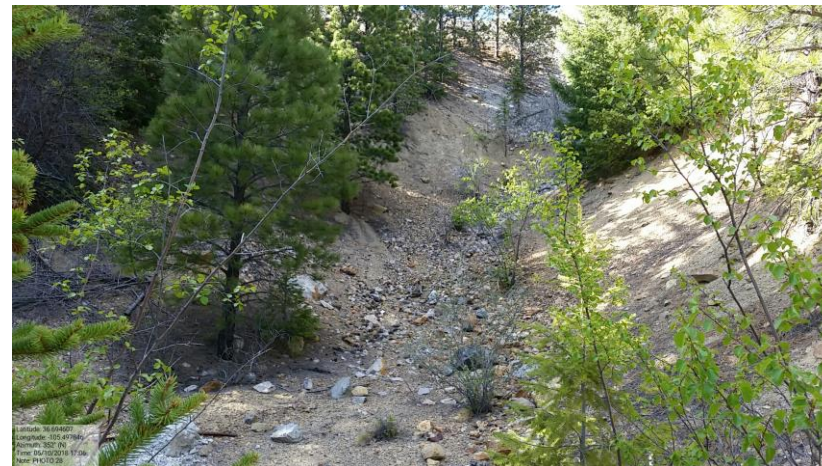
Photo 28a. Culverts Under Road

Photo 28b.

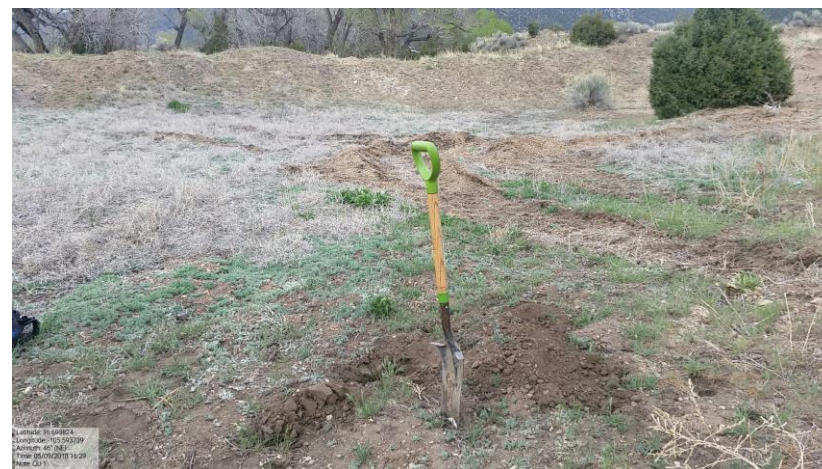
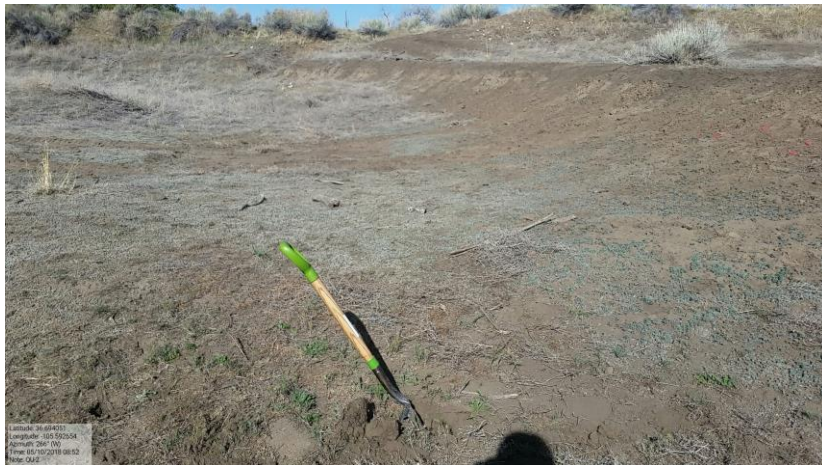
Photo Q-1.

Photo Q-2

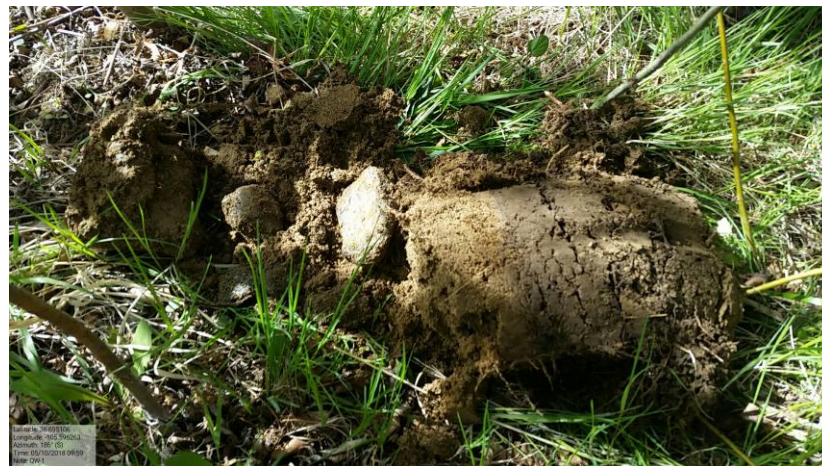
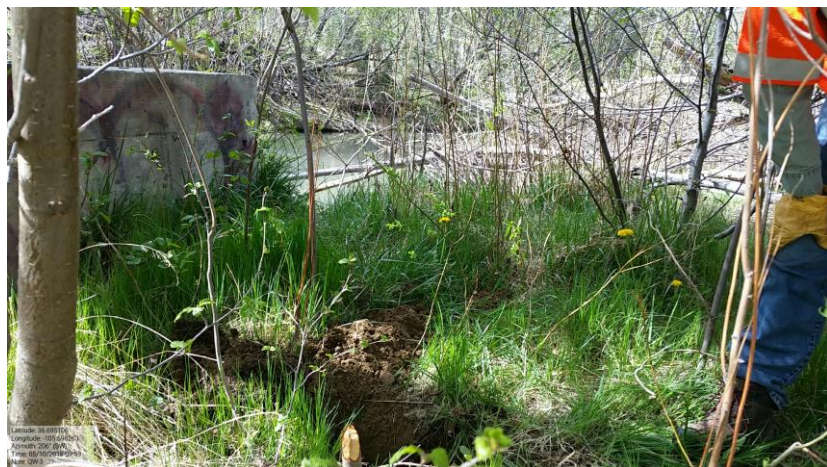
Photo Q-3a. Non-hydric Soil

Photo Q-3a.

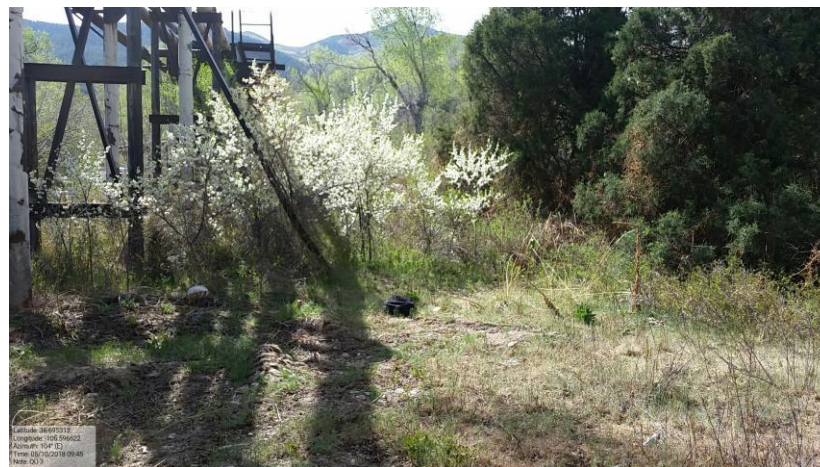
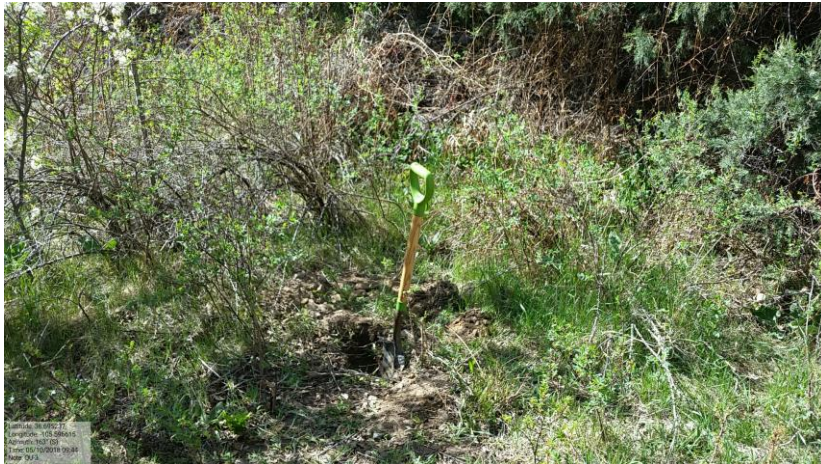
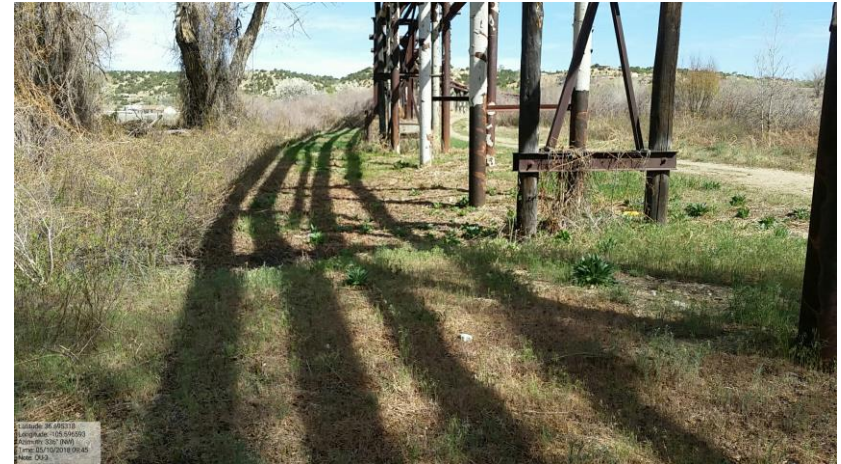
Photo Q-3b. General Area

Photo Q-3b. Toward River

Photo Q-3b Under Trestle – Away From River

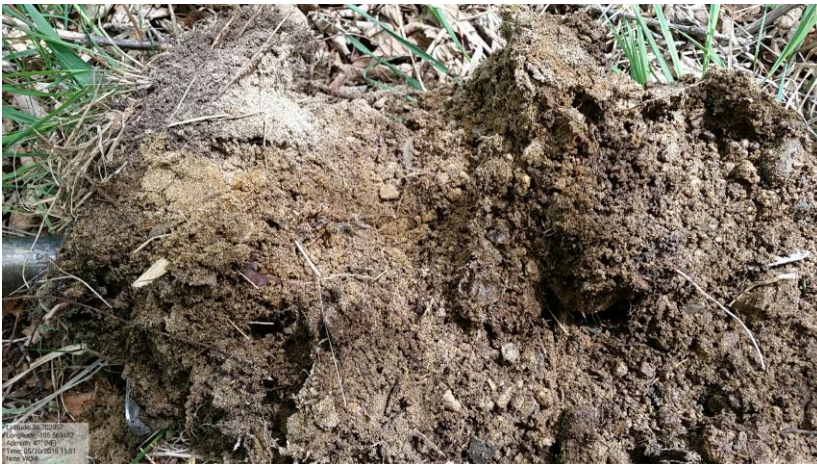
Photo Q-4. Non-hydric Soil (Chroma greater than 2)

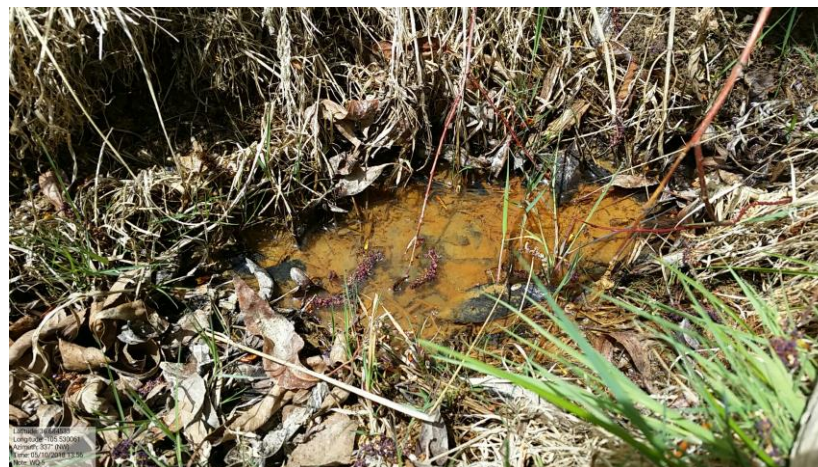
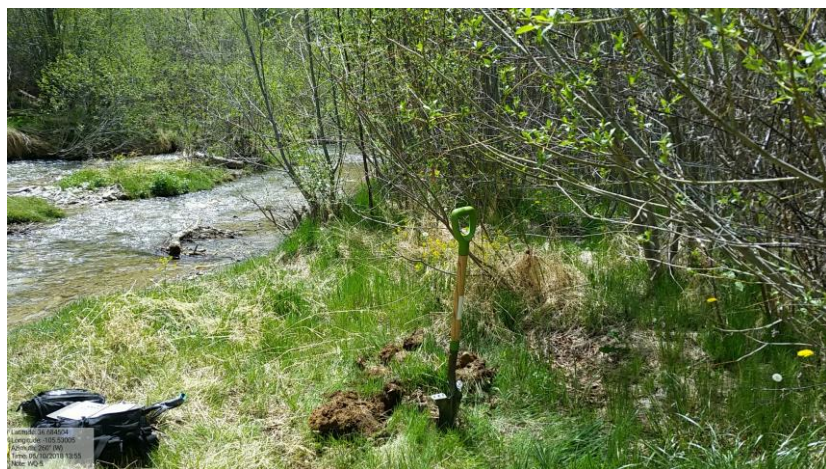
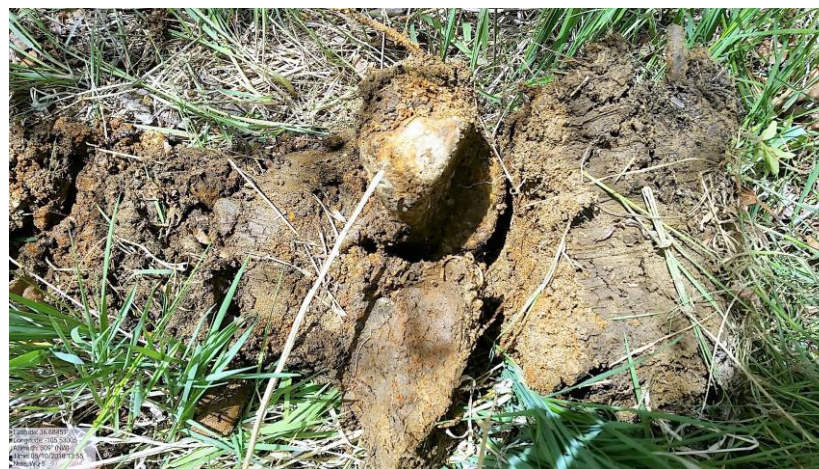
Photo Q-5a. Iron Deposits

Photo Q-5a. PSS Wetland

Photo Q-5a

All three wetland indicators were observed at point Q-5a, on the west side of the river. Hydric soil indicators observed include 30 percent redox concentrations in pore linings in a depleted matrix (10YR 4/2). In addition, hydrology indicators were observed including saturation (6" below ground surface), algal mat, iron deposits, water-stained leaves, and drainages patterns. All dominant plant species were FAC, FACW, or OBL species with water birch and willows dominating the shrub stratum. The boundary the PSS wetland as indicated by NWI data was found to be slightly inaccurate and was delineated in the field (Figure 7), within the 50-foot pipeline buffer. The NWI data was correct in classifying the wetland to the west of the river crossing as a PSS wetland.

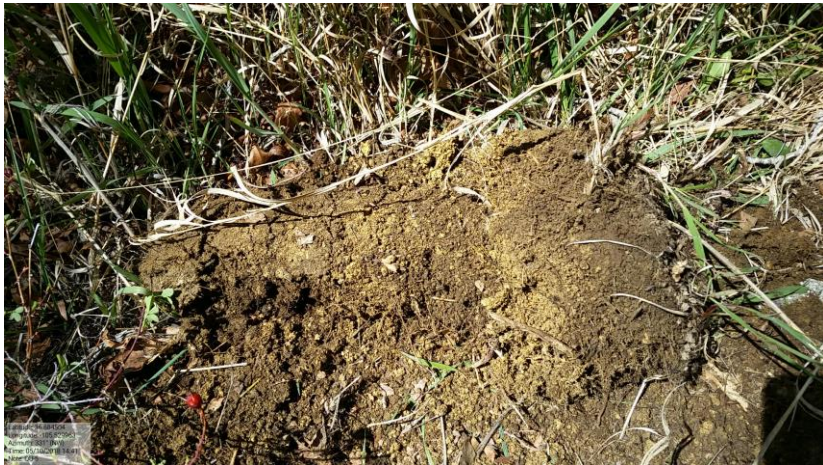
Photo Q-5b. Non-hydric Soil (High Chroma)

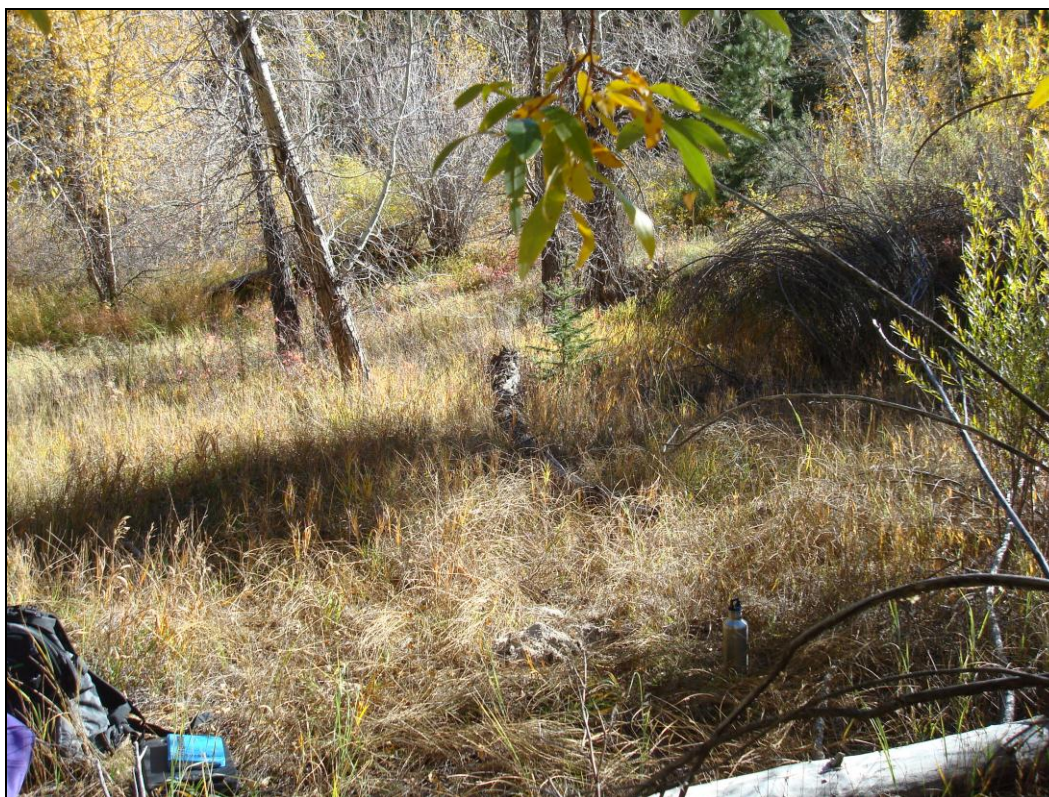
Photograph 1. To Southwest. View of feature HTS-1. This area did not meet the three substantive criteria for wetlands.

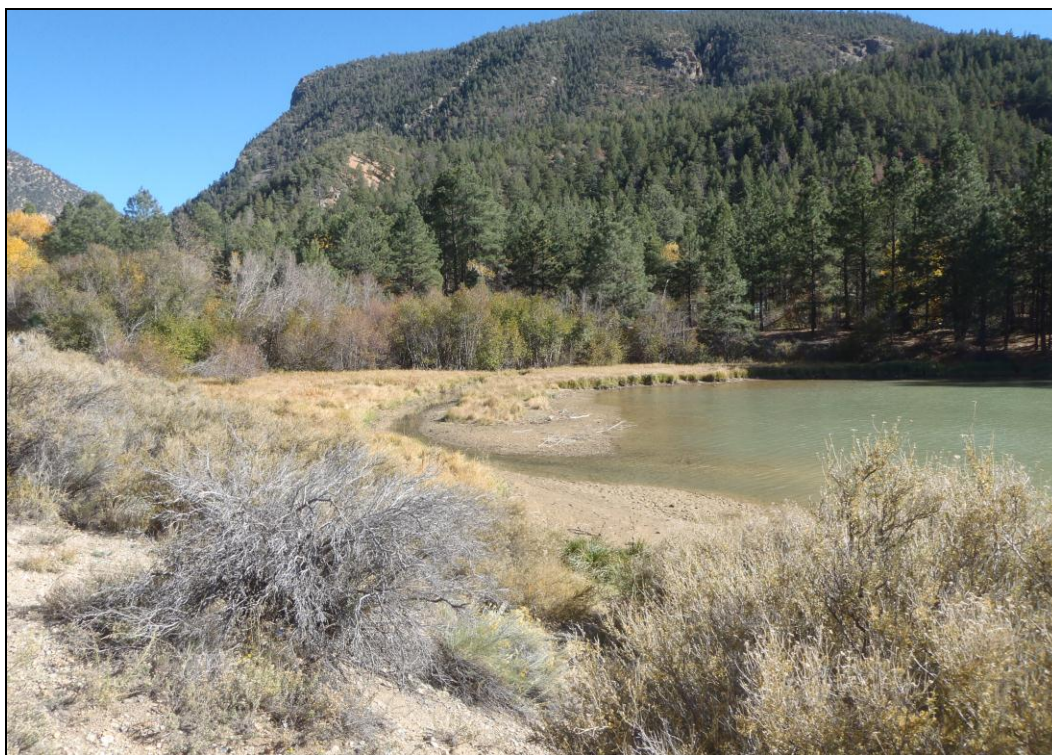
Photograph 4. To Southeast. View of wetland ERL-PEM at the mouth of the diversion ditch (OW-ERL3). Wetland ERL-PFO can be seen behind the feature. Eagle Rock Lake (OW-ERL1) in foreground.

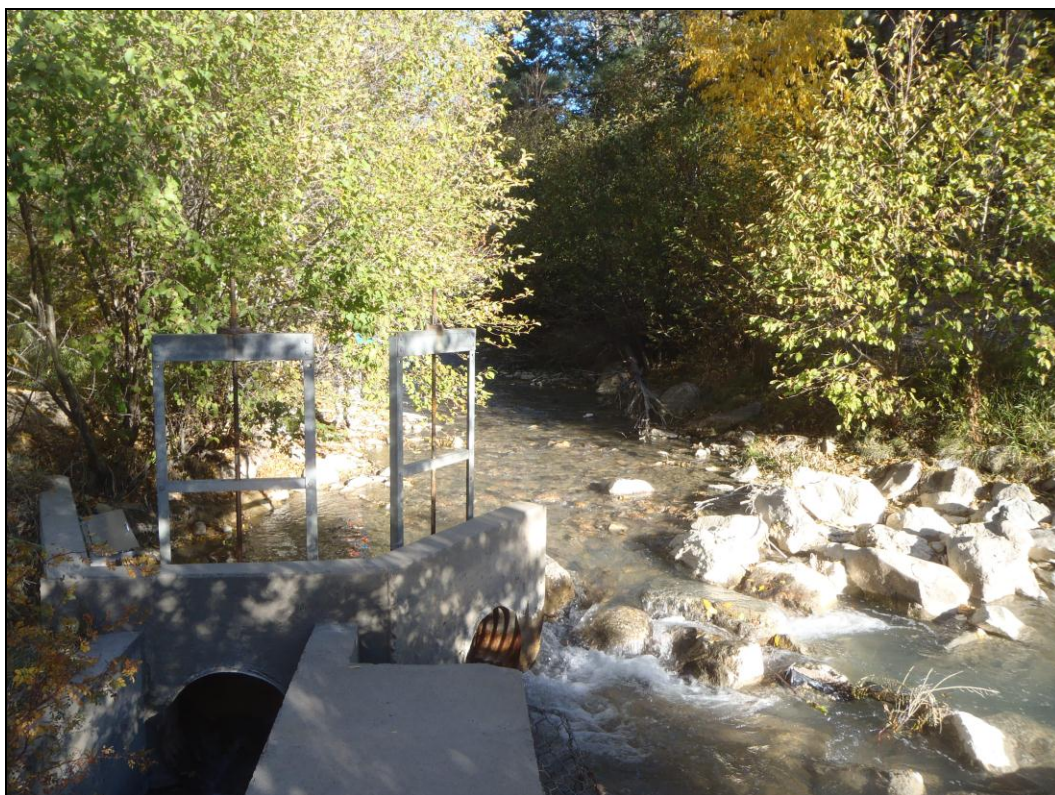
Photograph 9. To East. View upstream of Red River (OW-ERL2) at the headgate of the diversion channel (OW-ERL3).

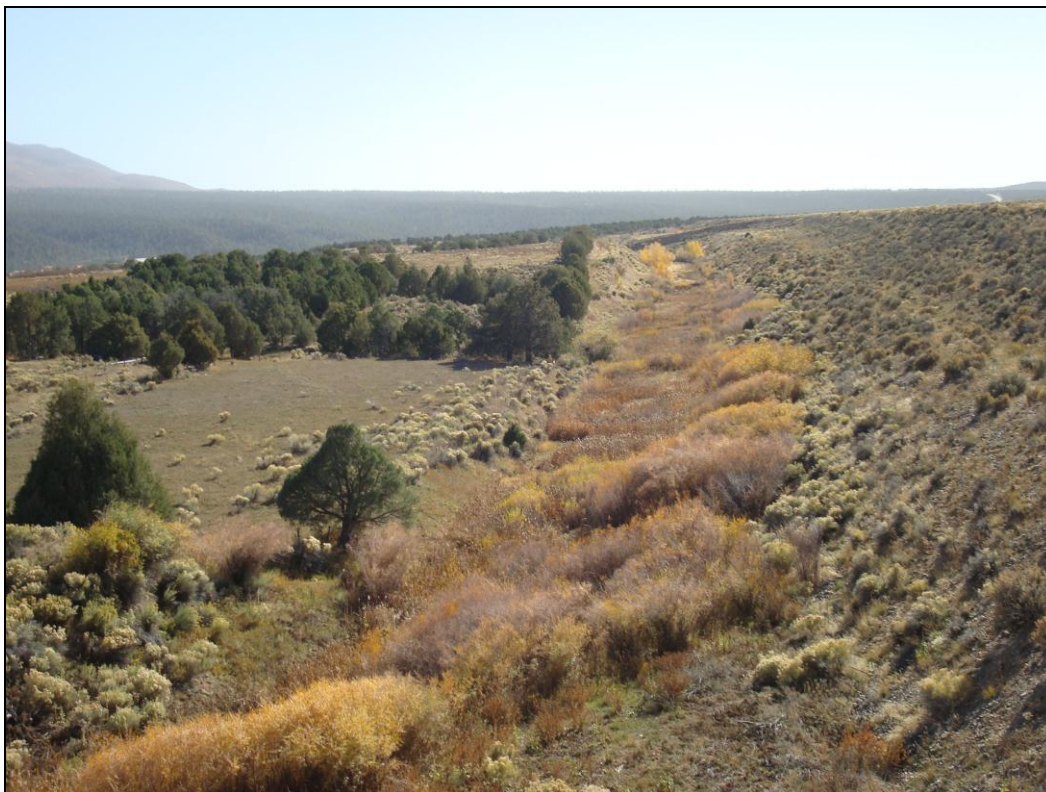
Photograph 13. To South. Overview of wetland EDC-1/EDC-2 within the Eastern Diversion Channel remediation area.

The area immediately down-channel from EDC-1 and EDC-2 was investigated for wetland characteristics. This area is physically separated by a mine road and culverts, which are perched on the upslope side and partially filled with sediment. Although hydrology was observed in two of the five years for which aerial photography is available, this area did not meet the criteria to be delineated as a wetland. The soil pit for this feature (EDC-6) is included on Appendix A, Figure 5 and described in an Individual Wetland Data Form included in Appendix C.

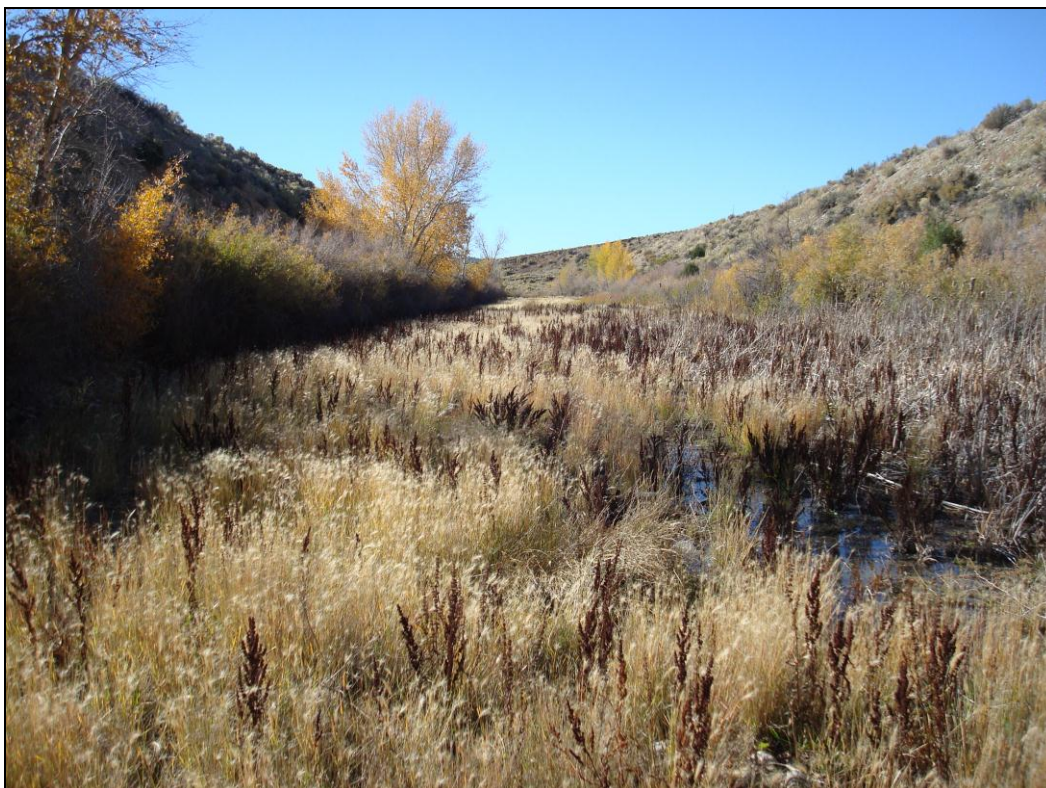
Photograph 14. To North. View of wetland EDC-1 within the Eastern Diversion Channel.

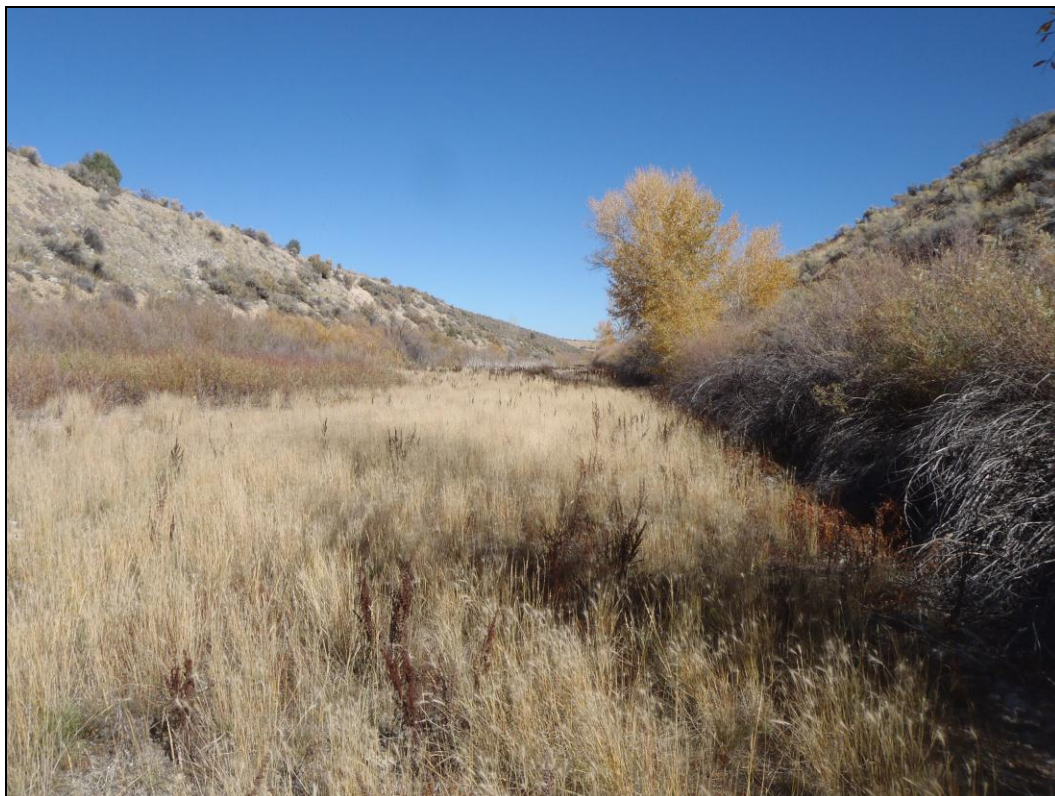
Photograph 15. To North. View of EDC-2.

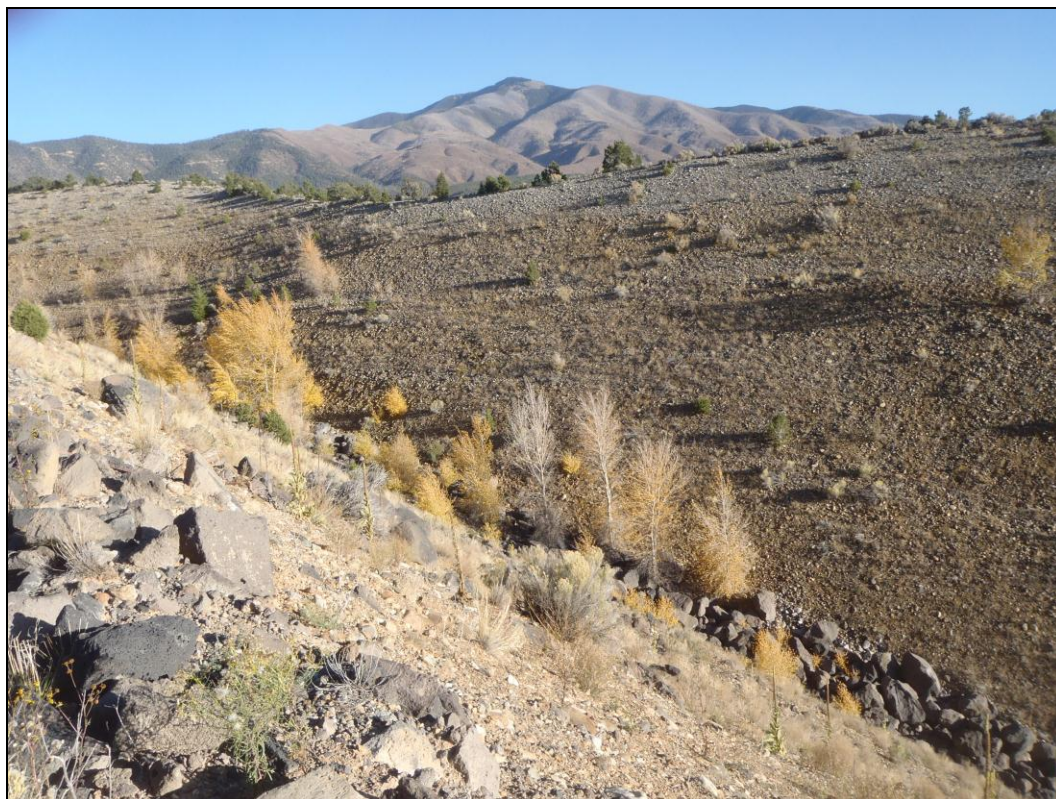
Photograph 18. To East. Overview of the Eastern Diversion Channel and surrounding upland south of feature EDC-6.

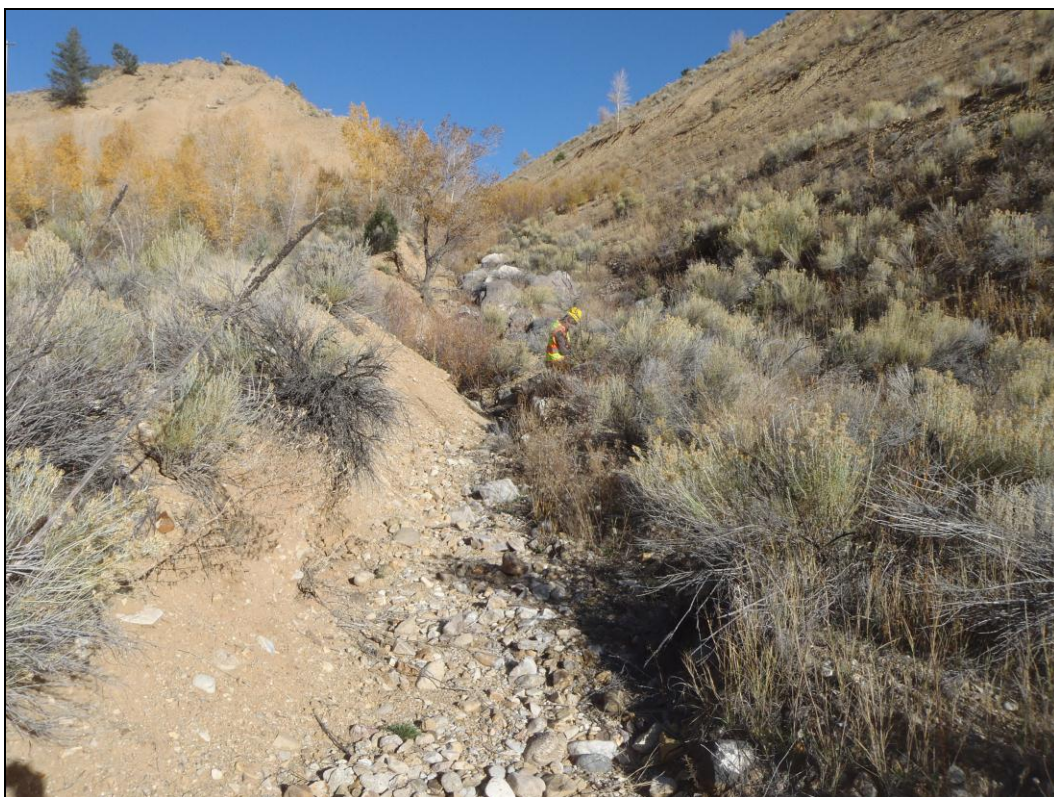
Photograph 20. To Northeast. View of Eastern Diversion Channel along the channel's lower reach.

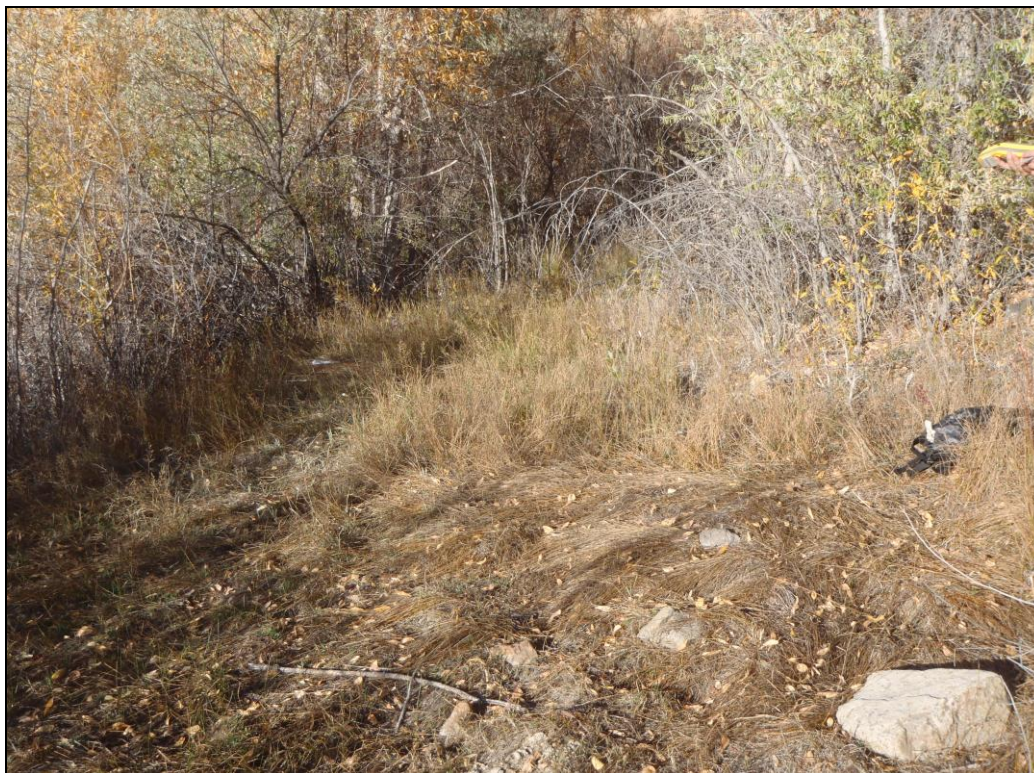
Photograph 21. To North. View of wetland EDC-3.

A PEM/PSS wetland (EDC-3) totaling less than 0.01 acre was delineated near the southern end of the Eastern Diversion Channel, on a slope above the lower part the steep portion of the channel. EDC-3 is supported by a small spring that outflows to the Eastern Diversion Channel and wets a small portion of the channel bottom. The channel does not have an ordinary high water mark and the wetland is isolated. Two additional spring-supported wetlands were also observed along the slope of this area outside of the Study Area (Appendix A, Figure 6). The three spring-supported wetlands are located within a grove of cottonwoods and other woody plants.

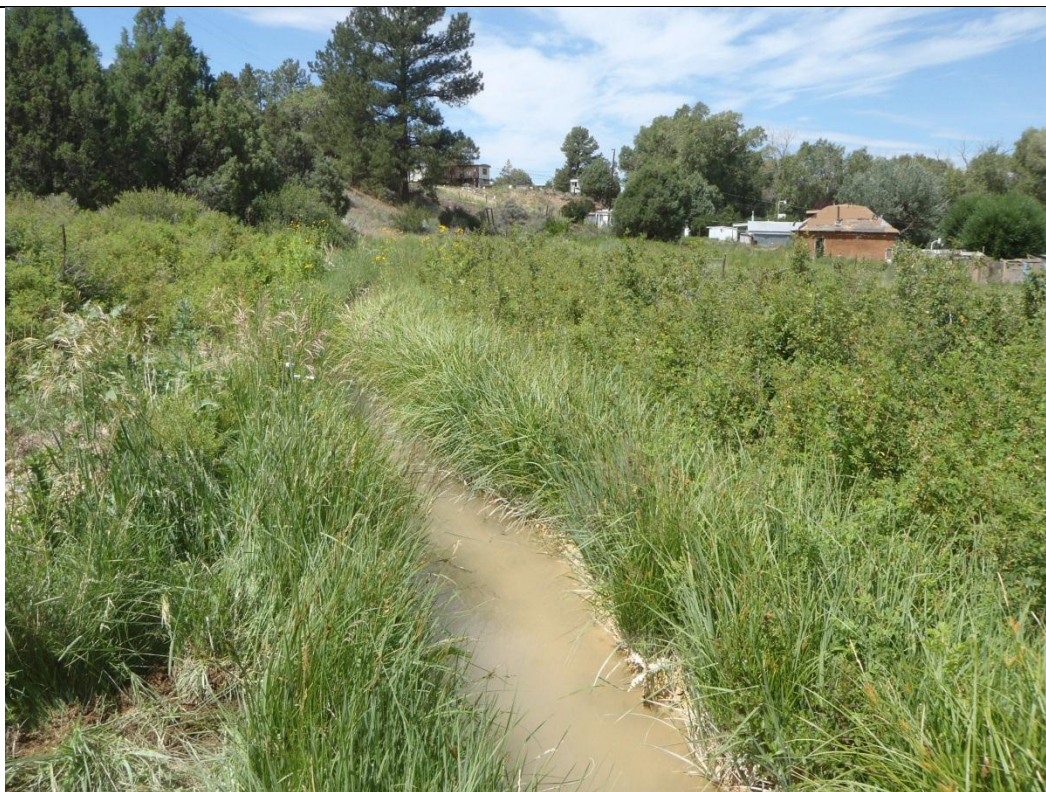
Photo 1. WL-1, looking west along Gallegos Ditch. Shrub on right is Wood's rose.

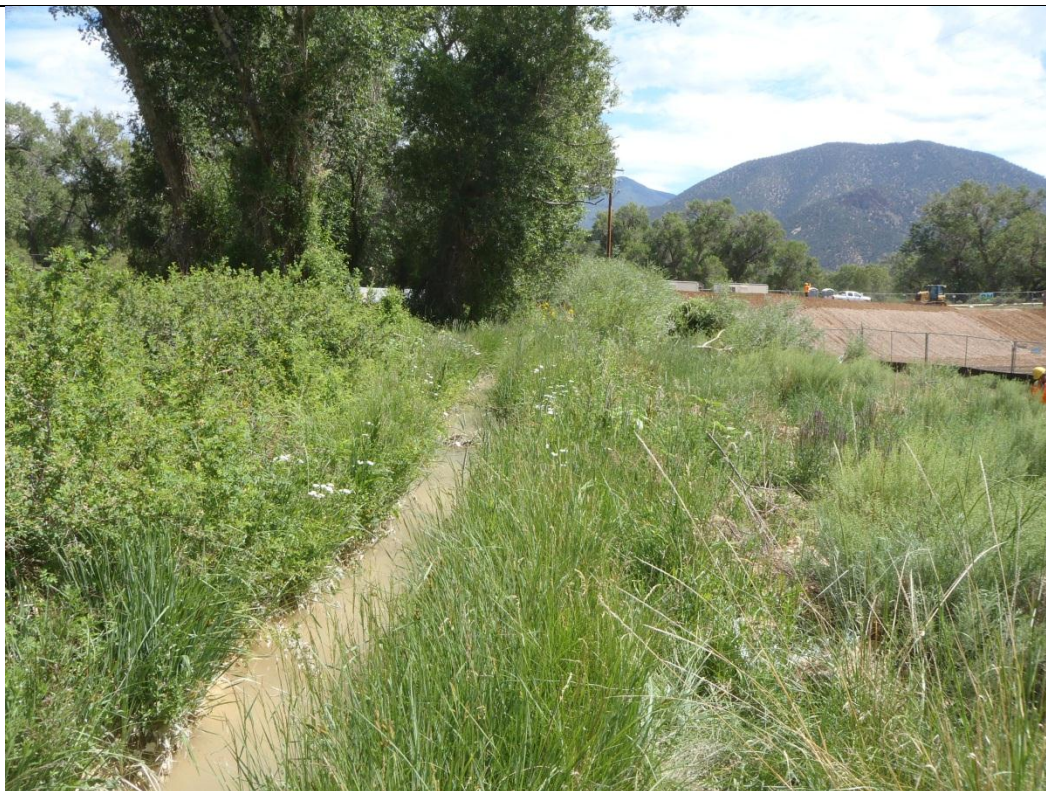
Photo 2. WL-1, looking east along Gallegos Ditch.

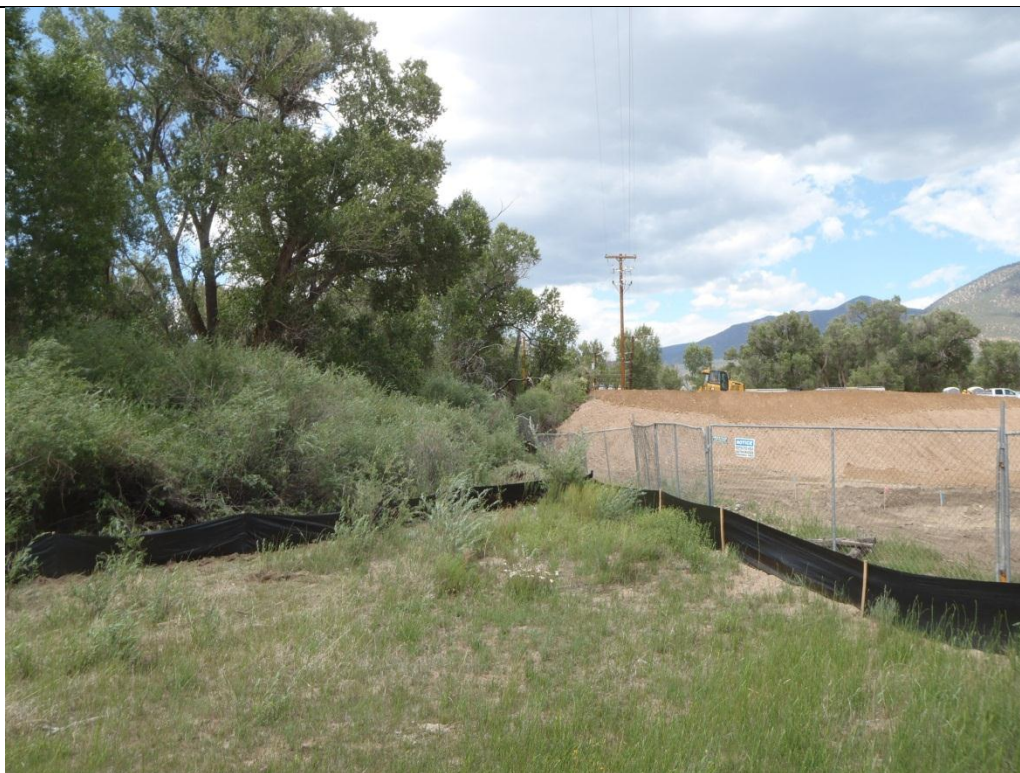
Photo 5. WL-2 (on left), looking north. LDS excavation is on right.

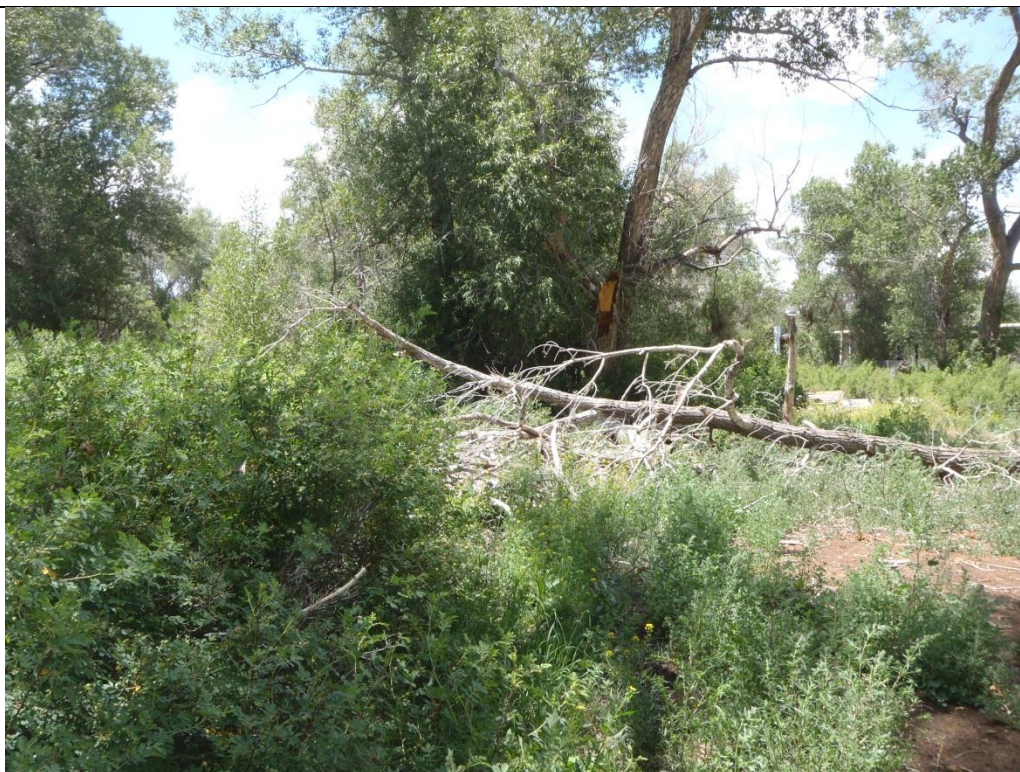
Photo 8. Riparian woodland east of former Reddell residence, looking northwest. Elevated tailing pipeline is in right background.

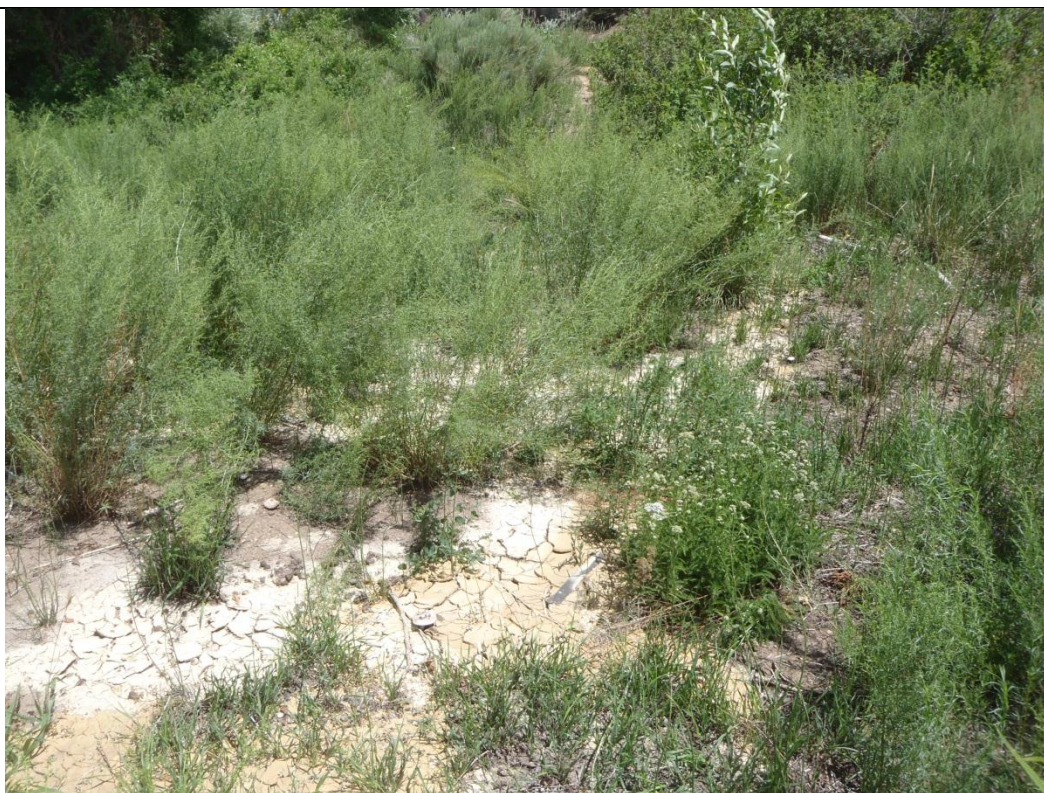
Photo 10. Recent sediment deposits in meadow.

Thin deposits of yellow sediment were found on vegetation and surface soils along the ditch and in the meadow north of the ditch (Attachment B, Photo 10). The sediment deposits appear to have resulted from a recent storm event that sent excess water down the ditch from the Red River and overtopped the edges of the ditch. There was no apparent relationship between areas of sediment deposition and presence of wetland plant species. The sediment deposits and presumed overtopping were interpreted as an uncommon event that does not result in wetland hydrology.
