LAC MINERALS (USA) LLC  
CUNNINGHAM HILL MINE RECLAMATION PROJECT  
582 COUNTY ROAD #55  
CERRILLOS, NM 87010  
TELEPHONE: 505.471.0434  
FAX: 505.474.8582

**RE: Revised CCP update for MMD Permit No. SF002RE, LAC Minerals (USA) LLC  
Cunningham Hill Mine**

JULY 2020  
Revised OCTOBER 2020

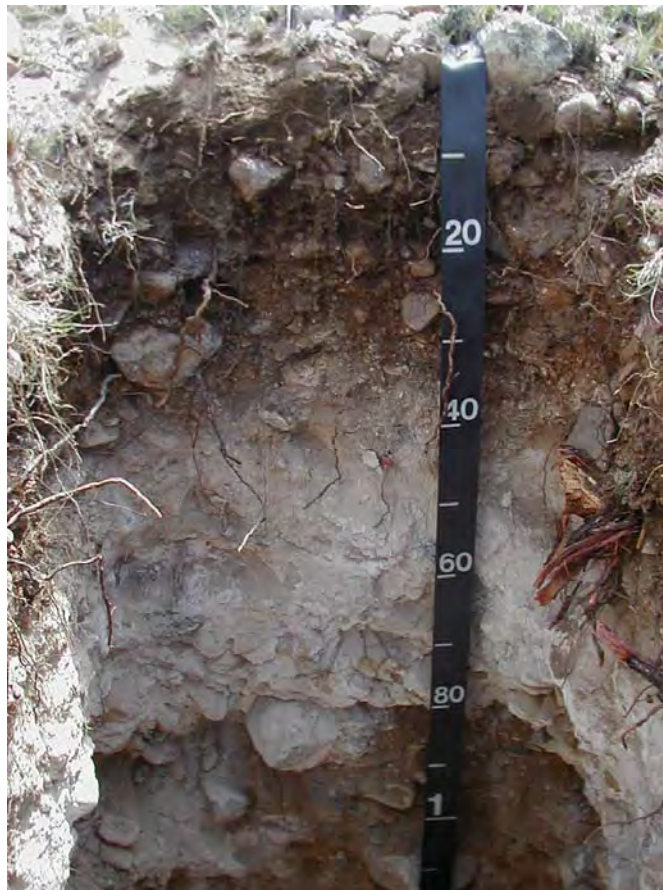
**Figure 69.—**Typical profile of Pedregal very cobbly loam, 8 to 15 percent slopes, with the dark surface, red subsoil, and white substratum. A well developed petrocalcic horizon, cemented by calcium carbonate, exists in this soil in the upper part of the white area. There are many rock fragments throughout this soil.

Oi—0 to 1 inch; slightly decomposed plant material (fig. 69)

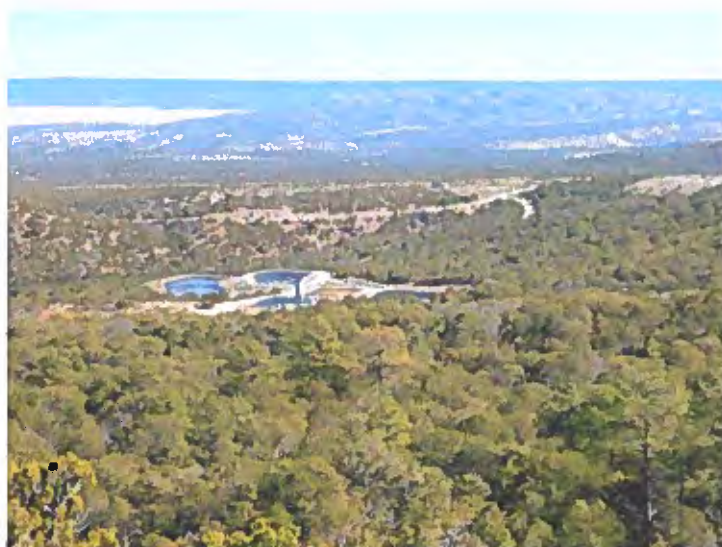
**Figure 6: View of evaporation ponds near Dolores Ranch with dense piñon-juniper of Area 2 in the foreground.**

This area consists mostly of piñon-juniper woodland with 2-4% ponderosa pine as shown in the table above. The stand density in this area is the highest on the property. The area is the watershed above and around the Dolores Ranch, the pump house, evaporation ponds, etc.

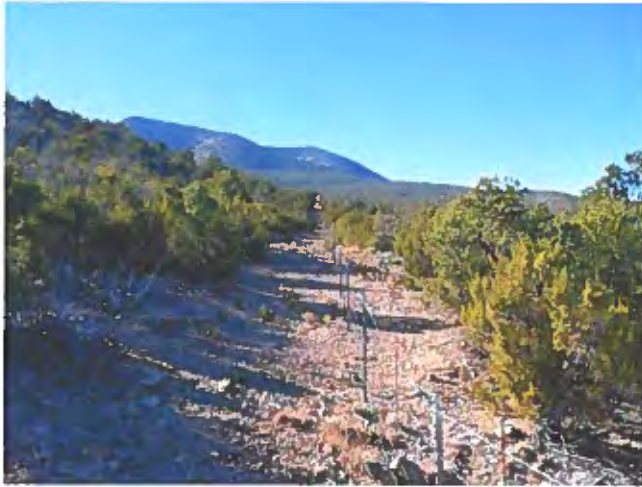
-Widen the narrow cleared area along the northern fence line by homes as much as possible as time and expenses allow. Ideally a 300+ foot wide fuelbreak would be installed.

**Figure 7: Northern boundary fence line.**

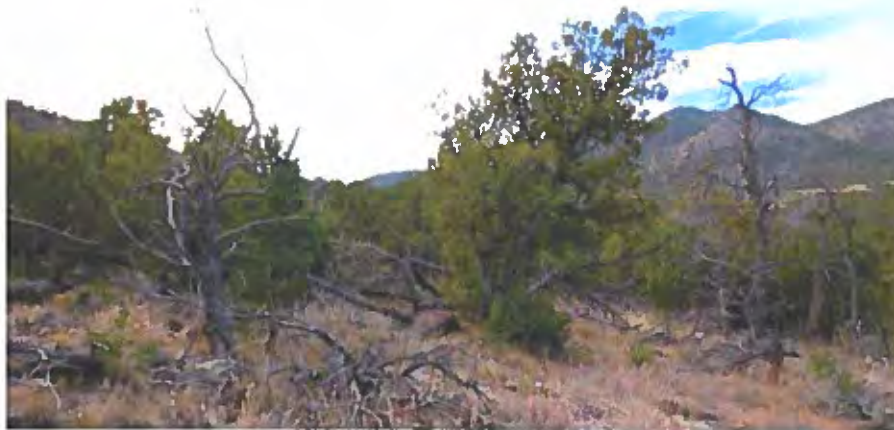
Figure 8: Dead and live trees in Area 5A.

Dead trees in this area make up 26 to 29% of the stand. As the table below shows there are more dead piñon pine trees than live. The mortality is likely due to trees being stressed by the recent drought that ended in 2014. Portions of this area have a high

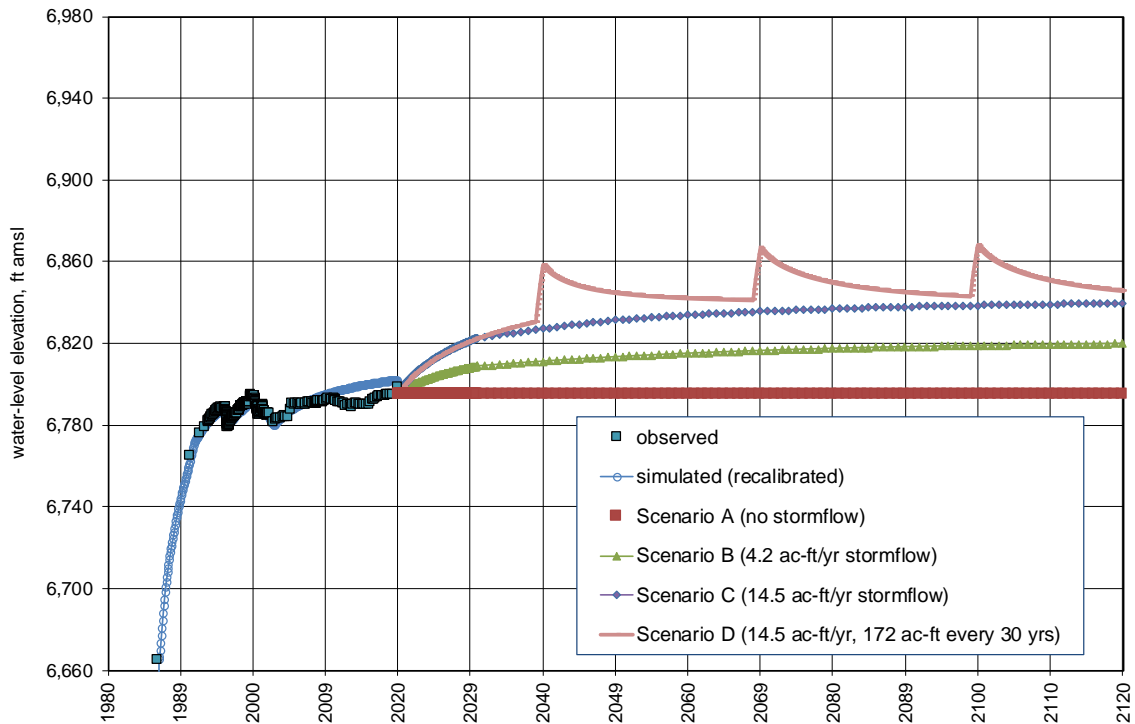
Figure 5. Graph of observed open pit water levels, model-calibrated water levels and model-simulated pit filling scenarios.

The updated and recalibrated groundwater flow model (JSAI, 2011a) was used to evaluate open pit filling resulting from the storm-water runoff Scenarios A through C (Fig. 5). Current open pit water level elevation is 6,798.5 feet above mean sea level (ft amsl). Steady state model-predicted open pit water levels range from 6,800 to 6,840 ft amsl. Regardless of the scenario, near steady-state open pit water levels are observed today. The maximum expected open pit water level is 6,840 ft amsl (Fig. 5), which would require an average open pit water level rise of 0.6 ft/yr over the next 60 to 70 years. The observed rise in open pit water levels over the last 4 years has been at an average rate of 2.0 ft/yr (Fig. 6).

The expected steady-state open pit water levels are to range from 6,795 to 6,840 ft amsl (Fig. 5). The observed rise in open pit water levels over the last 10 years has been at an average rate of 0.8 ft/yr (Fig. 6).

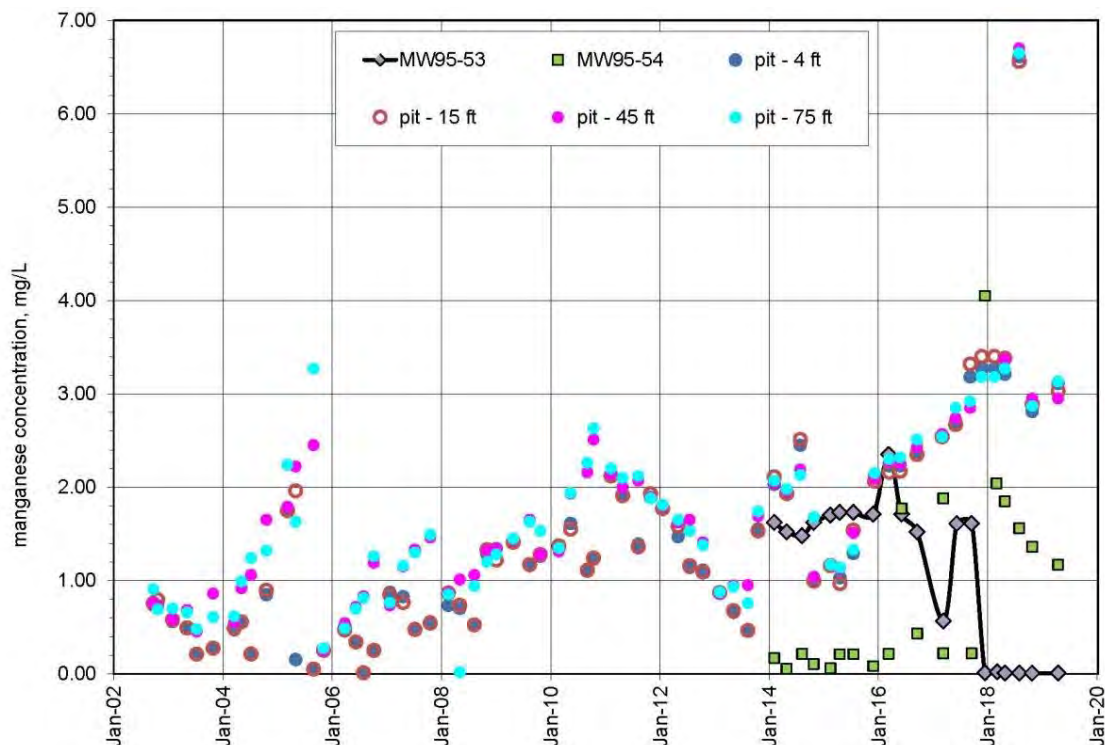
Figure 7. Graph showing manganese concentrations at the open pit and nearby monitoring wells, from 2002 through 2019.

Open pit manganese concentrations have recently spiked above the AP-27 groundwater discharge standard of 4 mg/L (Fig. 7). Down gradient monitoring well MW95-54 has been below AP-27 sulfate, TDS, and manganese standards for discharge to groundwater. Monitoring well MW95-53 is near or below the AP-27 sulfate, TDS, and manganese standards for discharge to groundwater (Figs. 7 and 8).

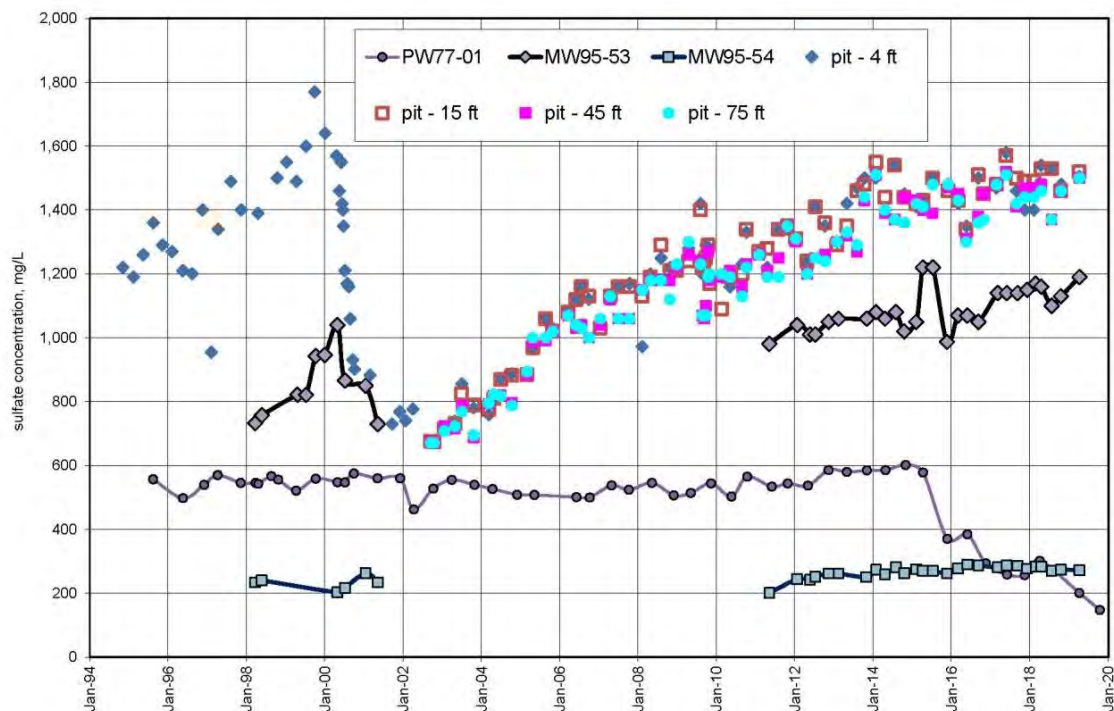
Figure 8. Graph showing sulfate concentrations at the open pit and nearby monitoring wells, from 1994 through 2019.

The current open pit water quality does not meet the AP-27 groundwater discharge standards for sulfate and TDS (Table 3). Open pit sulfate loading occurred after RO treatment (2002) and prior to implementation of source controls in 2014 (Fig. 8). Sulfate concentrations appear to have stabilized since implementation of source controls in 2014 (Fig. 8).
