RE: 2024 Erosion Mitigation Implementation Plan for JJ No.1 Mine, Permit N. Cl007RE, Cibola County, New Mexico

EROSION MITIGATION JJ NO.1 / L-BAR MINE

PREPARED FOR NEW MEXICO MINING AND MINERALS DIVISION

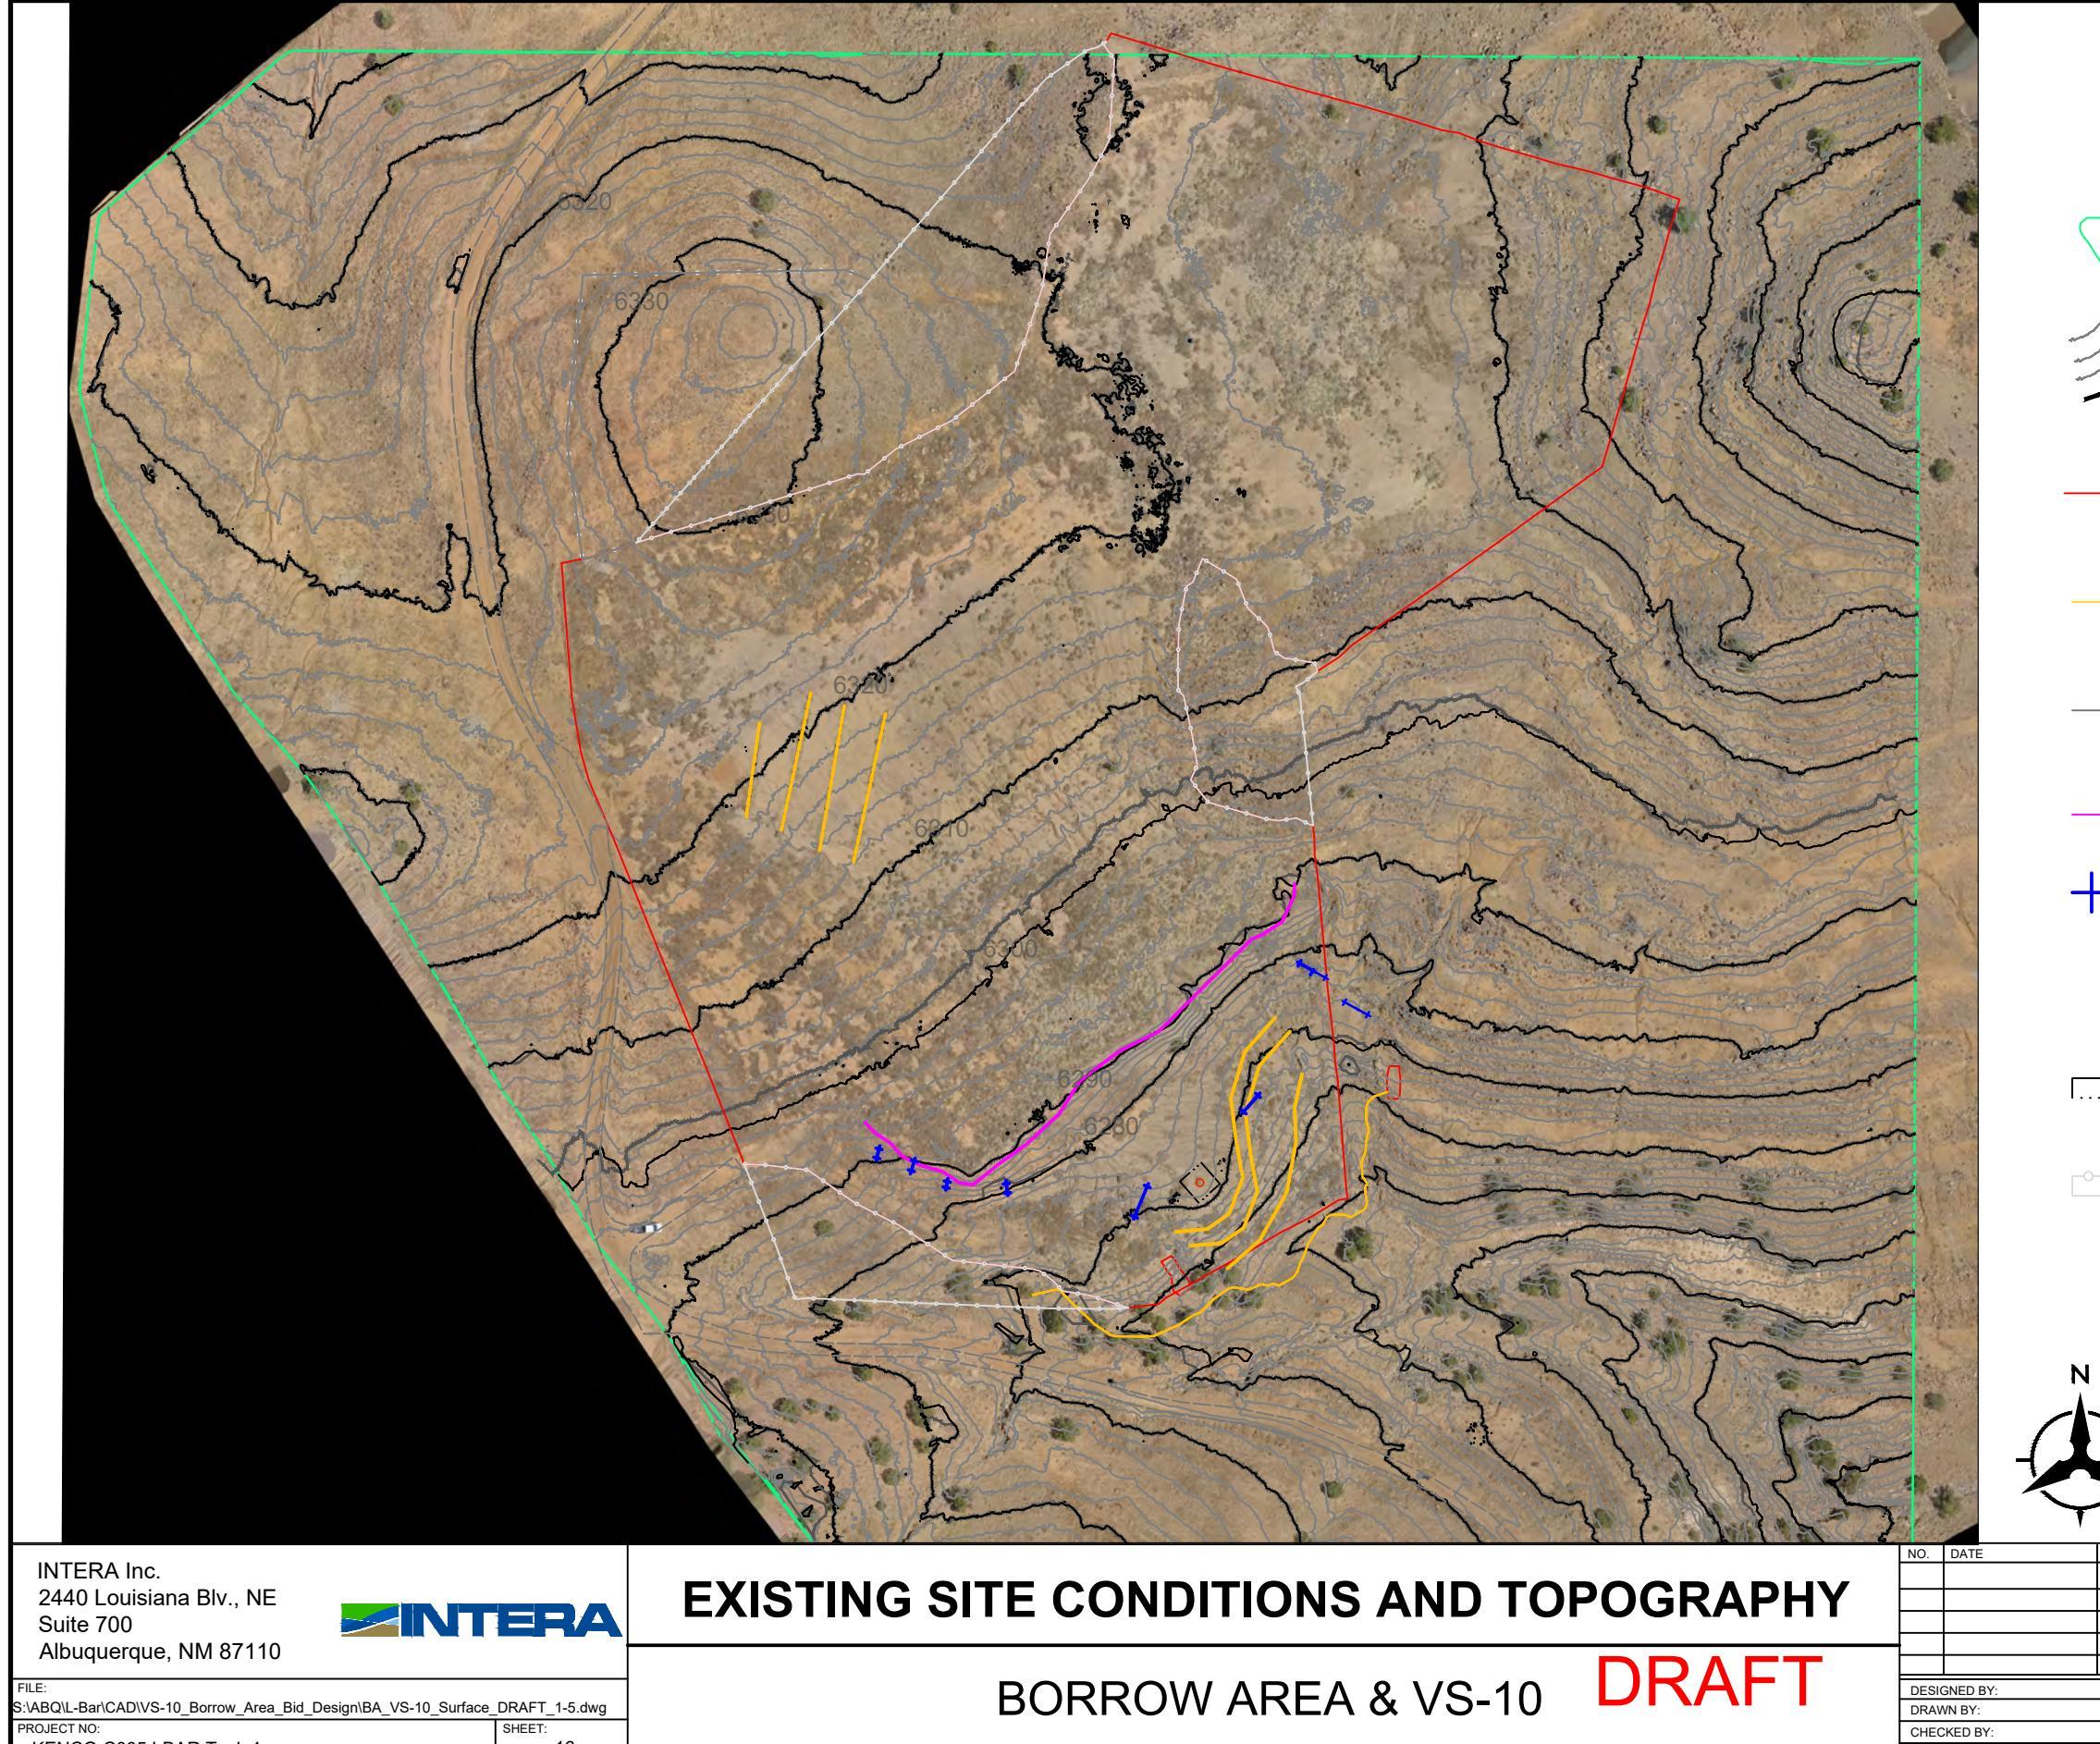
KENCO.C005.LBAR Task 4.a
 16

BORROW AREA & VS-10 DRAFT

Flow path lengths and slope values were determined using Civil3D, a subset of AutoCAD. The watershed area was drawn along with the flow paths, and those quantities were then used to calculate peak discharge and runoff using the TR-55 method. Three identified flow paths (See Sheet 16) were selected to represent runoff in different areas of VS-10 and the Borrow Area. A flow path following along the western perimeter of the reclamation area (west) has localized erosion (rilling, gully erosion, channel formation) that travels from the top of the of the fence line (approximately 6,320 ft NAVD88), around the constructed berm, down to the bottom of the fence line (approximately 6,228 ft NAVD88). The area was originally designed to act as a natural spillway for runoff. The second flow path located in the middle of VS-10 / Borrow Area (central) was selected to calculate runoff and peak discharge at the top of the constructed berm. The last flow path is located along the eastern perimeter of the reclamation area (east). The flow path was selected to determine runoff and peak discharge that is leaving the reclamation area, as there are several erosion features observed just outside of the fence line that are a result of runoff occurring inside the reclamation area.

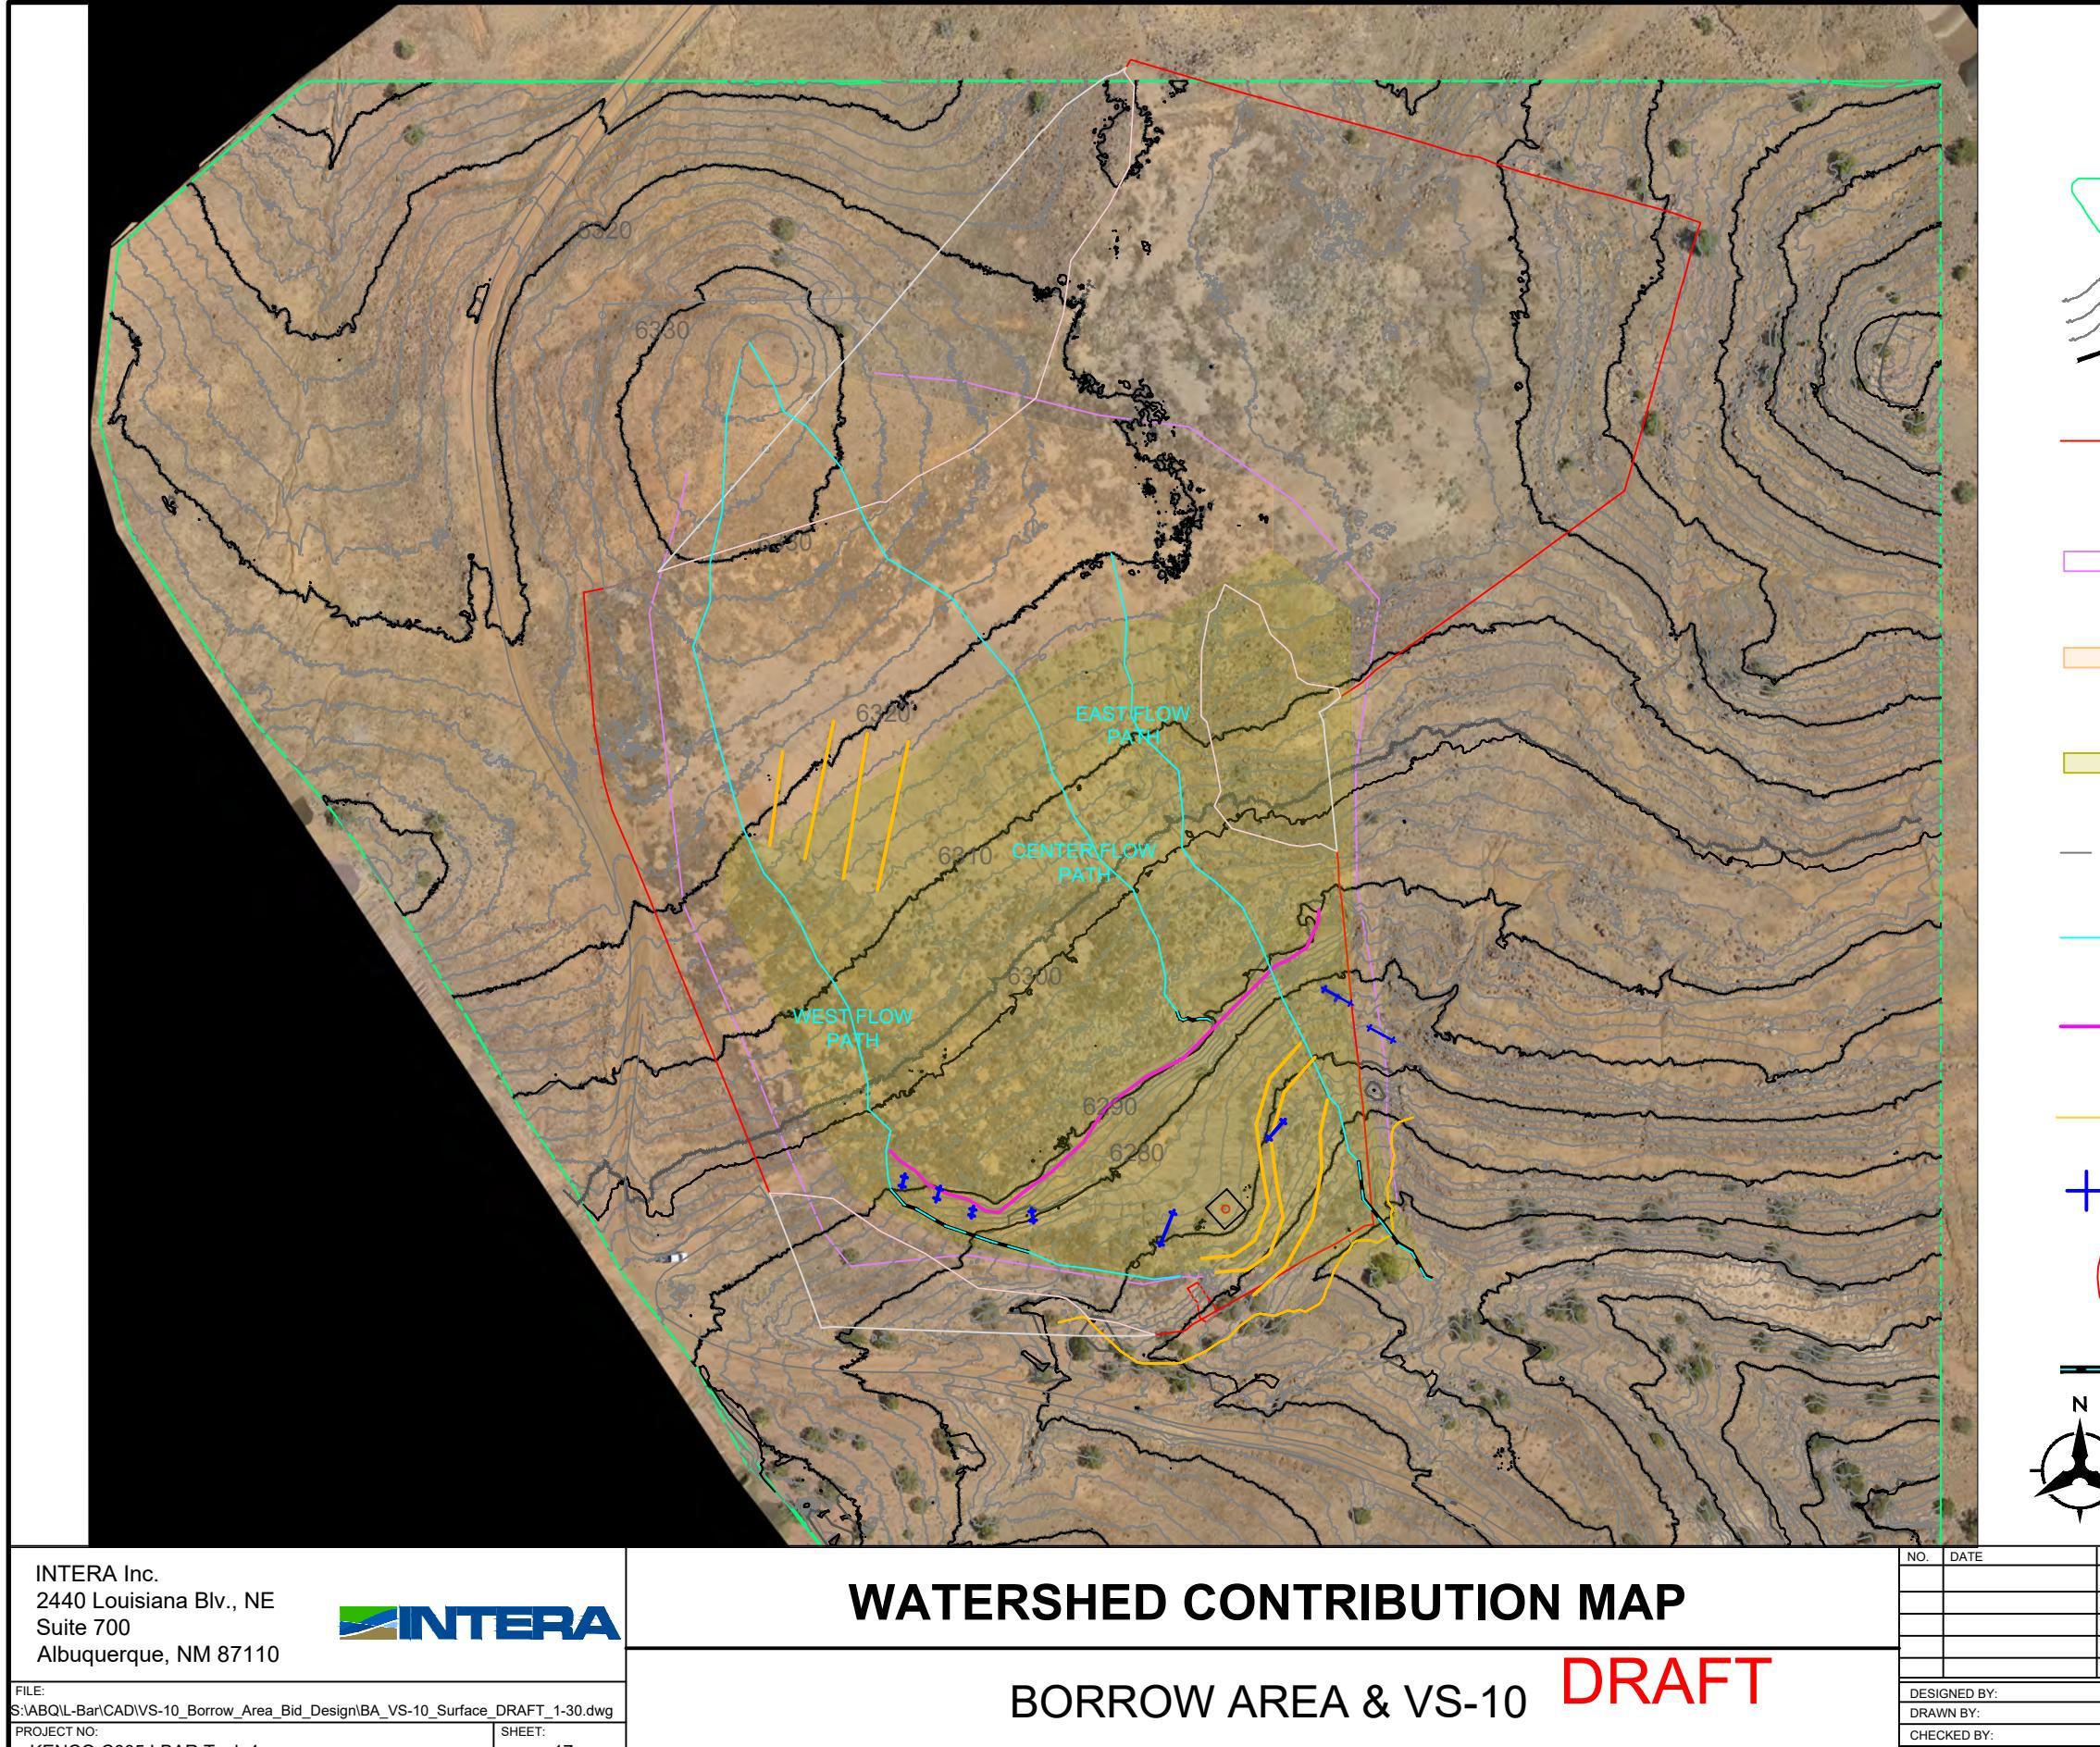
KENCO.C005.LBAR Task 4.a
 17

| | LIDAR BOUNDARY |
|---|--|
| | WATERSHED AREA |
| | PRIMARY FLOW PATHS |

Sources for the hydrologic calculations included the physical properties of the watershed areas, observations made in the field of existing flow paths, vegetation inspection reports, and aerial imagery obtained by INTERA of VS-10 / Borrow Area. The VS-10 / Borrow Area boundaries for the watershed areas were drawn based on field observations, topographical data, and aerial imagery (See Sheets 16 – 18). The fence line of the reclamation area served as a boundary, as the areas outside of the reclamation/reference areas were not included in the MMD Permitted areas.

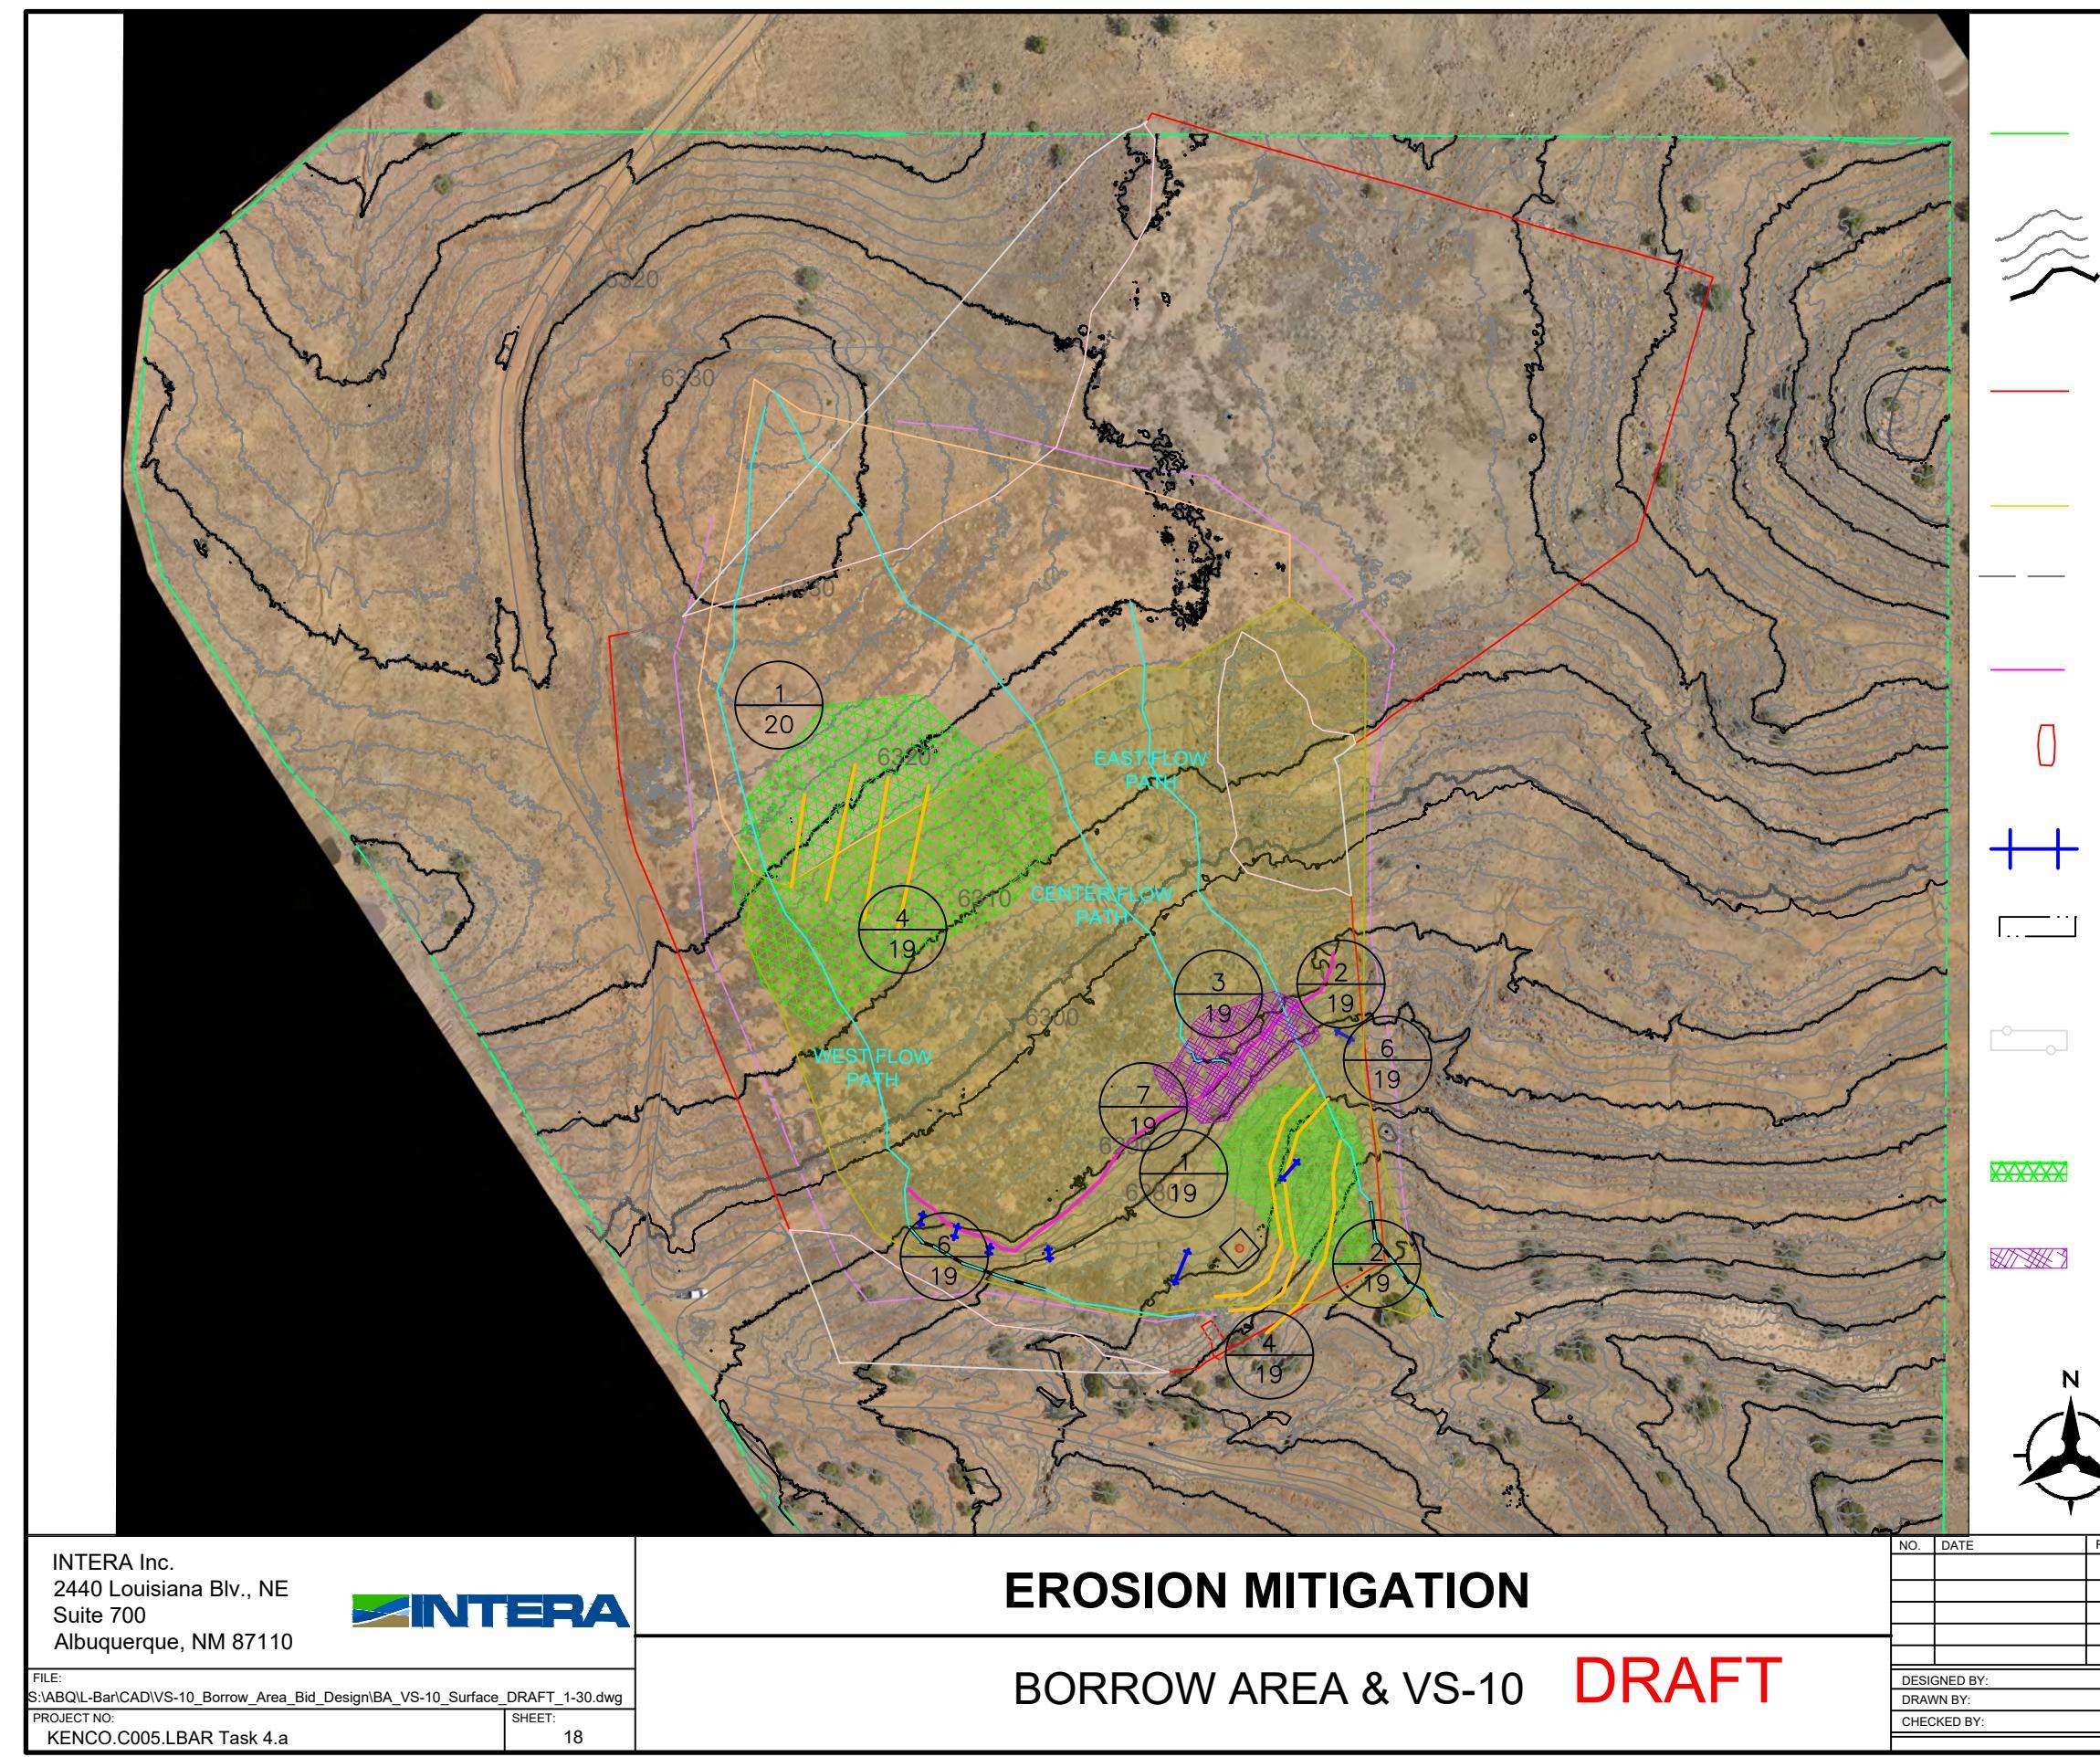
LIDAR BOUNDARY **FLOW PATHS** PROPOSED CONTOUR INTERVAL (2 FOOT) CHANNEL LENGTH FENCE LINE / RECLAMATION WATERSHED BOUNDARY AREA WATERSHED WATTLES **AREA -SHEET** ROAD FLOW BERM WATERSHED **AREA-SHALLOW RIP RAP** CONCENTRATED FLOW CHECK DAM **RECLAIMED VENT** SHAFT FENCED / UNFENCED **REFERENCE AREA** SEEDING CONCRETE EROSION CONTROL BLANKET SCALE 125 FEET 250 REVISIONS

- Phase II: In addition to the reseeding method and berm repairs outlined in Phase I, Phase II will include the installation of a concrete erosion control blanket, such as the Flexa-Mat[®] 10NW UV-T exposed aggregate product, on the slope of the berm where channel formation is present. The berm will be back sloped and re-graded for the installation of the concrete erosion control blanket. Designated channels will have rock armoring installed to prevent further erosion and slow down flow leaving the reclamation area.
