Re: Agency Review Comments and Request for Additional Information Modification 24-1 Permit No. LU047EM Little Mountain Exploration Project Luna County, New Mexico

Attachment A Repair of Overland Travel Paths and Stormwater Management BMPs

Re: Repair of Overland Travel Paths and Stormwater Management BMPs Little Mountain Project Permit No. LU047EM

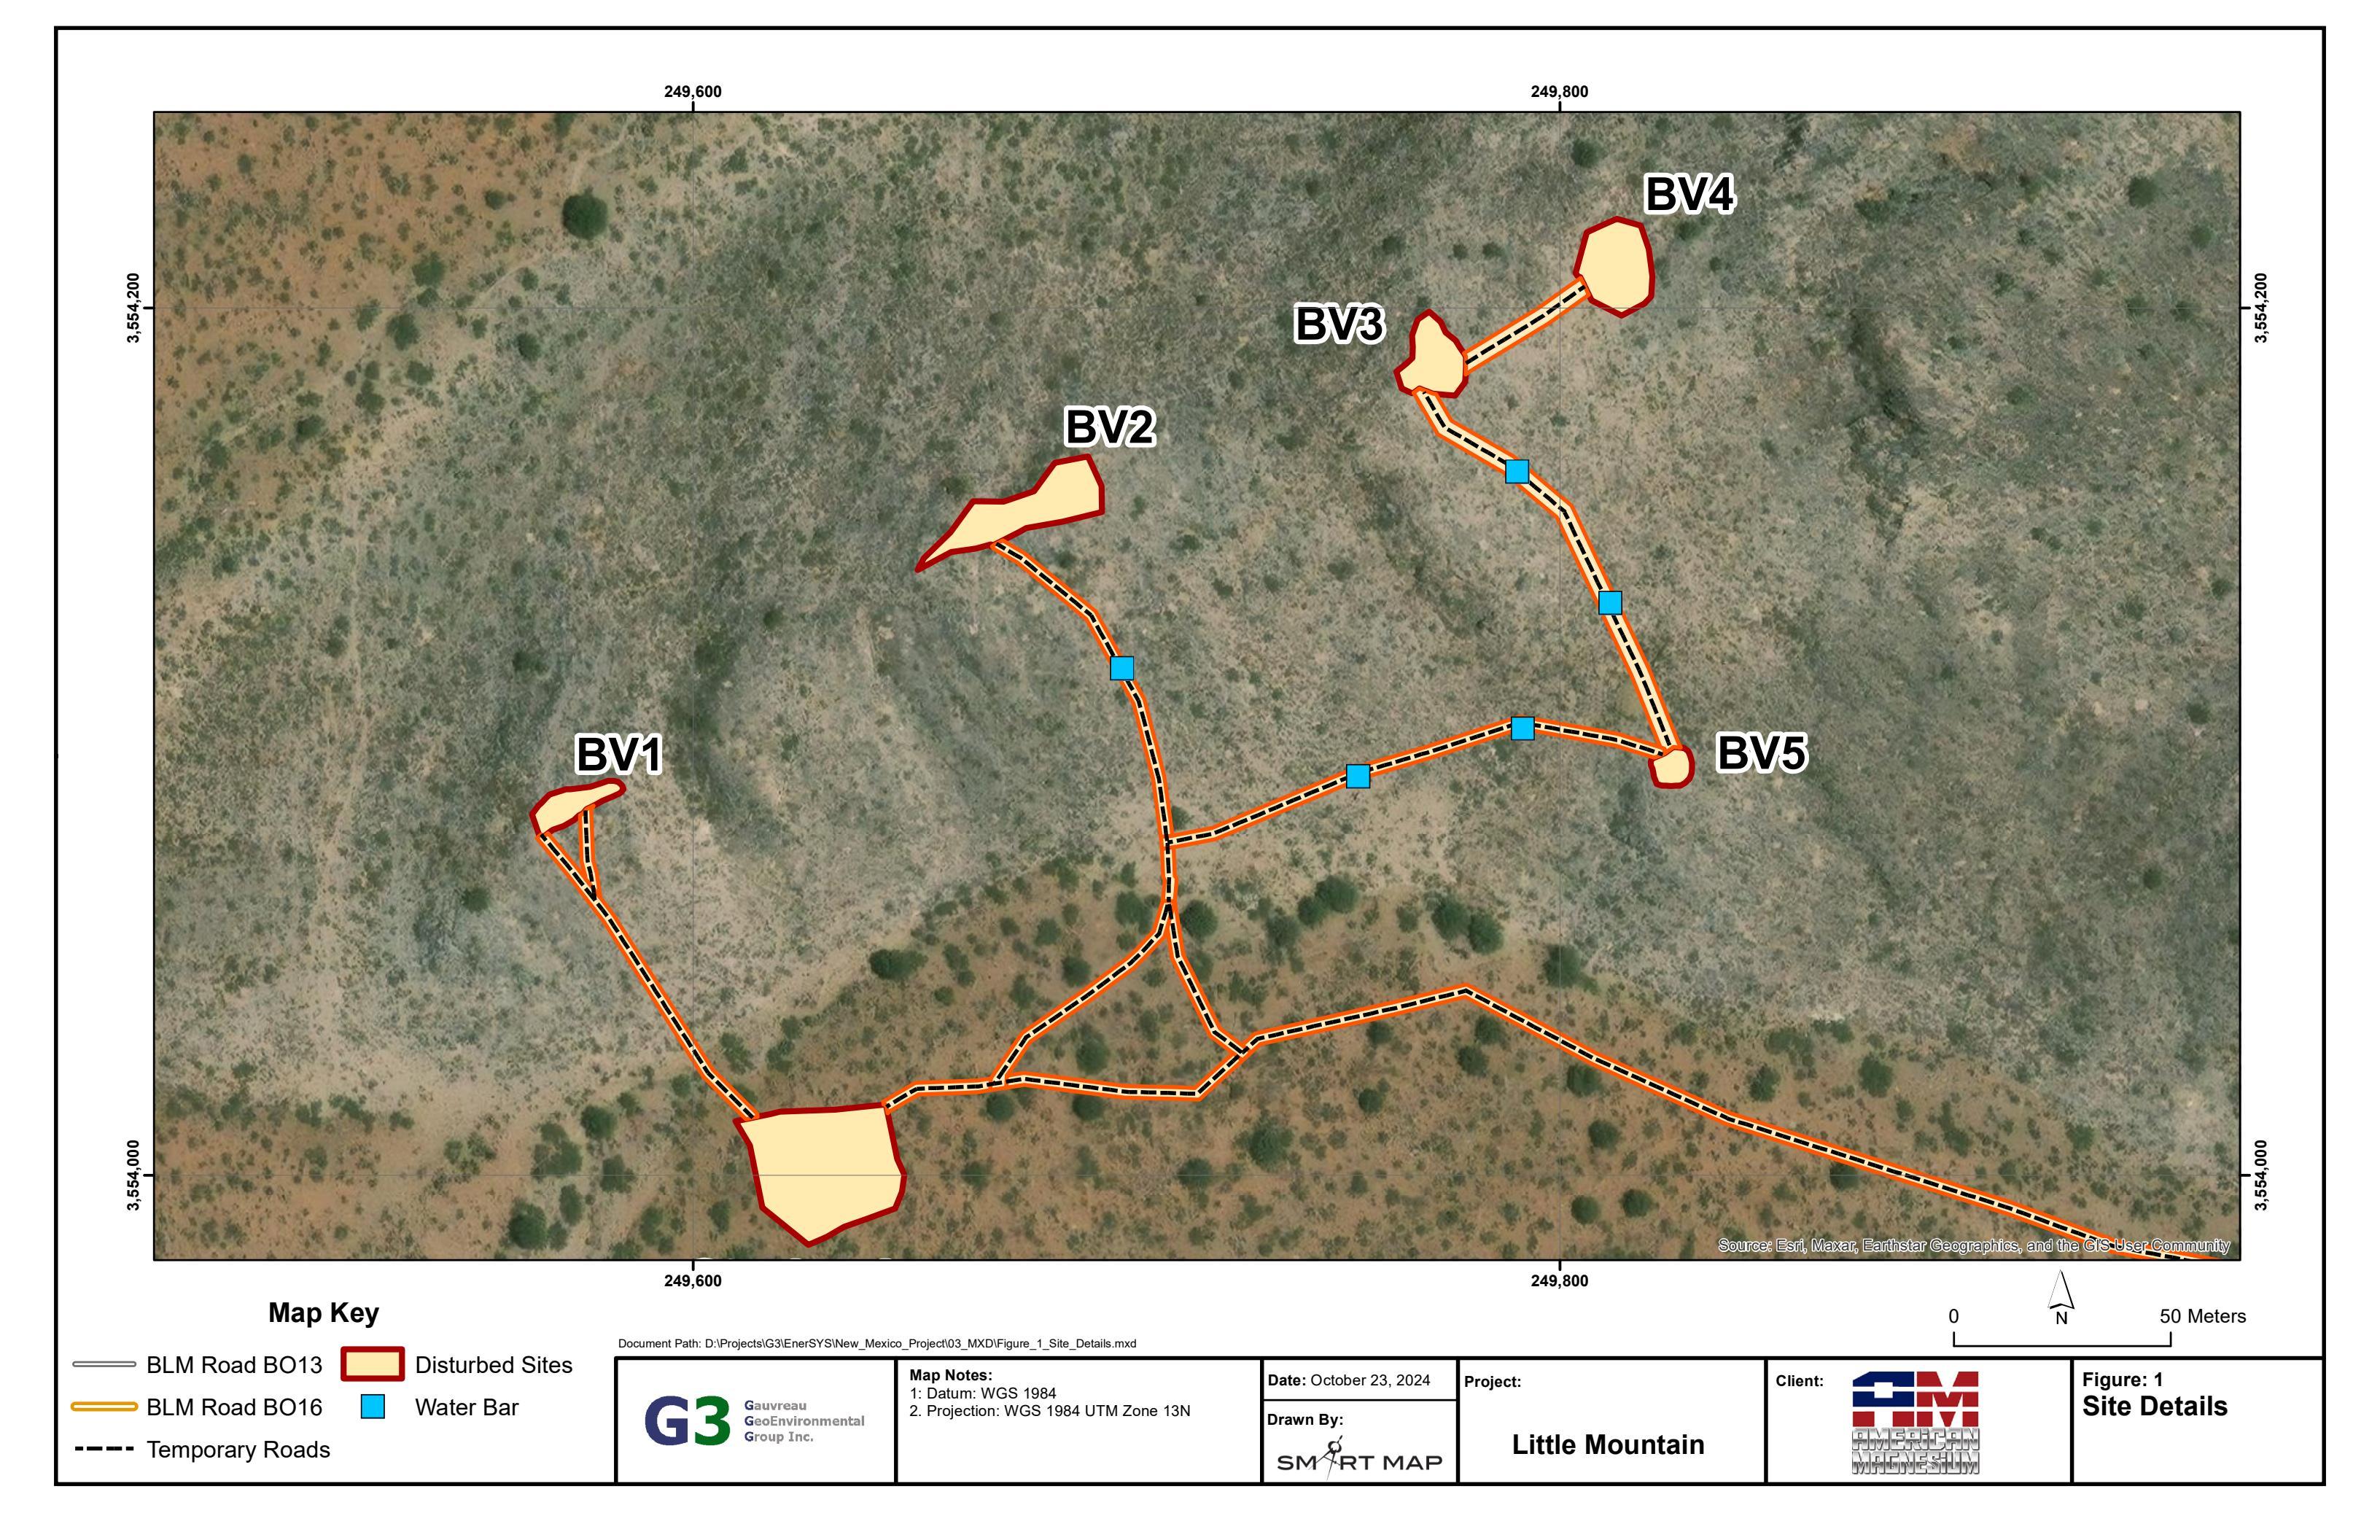
Figure 1 Figure 2

The second task is designed to utilize Best Management Practices (BMPs) to manage future stormwater runoff and maintain the integrity of the overland travel paths. This will involve the construction of water bars at appropriate locations across the overland travel paths. Approximate locations for the water bars are shown on the attached Figure 1. These water bars are intended to divert stormwater off the paths before it causes erosion of the granular materials. Details of the construction of the water bars is shown on the attached Figure 2. The water bars are to be built with the existing granular materials on the paths, and are sized to allow the drill rig and service vehicles to pass on the path without obstruction.

In addition to the water bars, berms should be constructed alongside the overland travel path to BV2, as well as the overland travel path to BV3-5. The berms should be a minimum of 1 foot in height and 2 feet in width and be constructed for existing granular materials on the paths. If insufficient granular materials are available withing the footprint of the currently disturbed areas for the construction of the water bars and berms, additional granular materials should be imported
