## PUBLIC INFORMATION MEETING

# Madrid Stormwater and Erosion Control Project

Thursday, January 25<sup>th</sup>, 2024 Madrid Firehouse – Madrid, NM

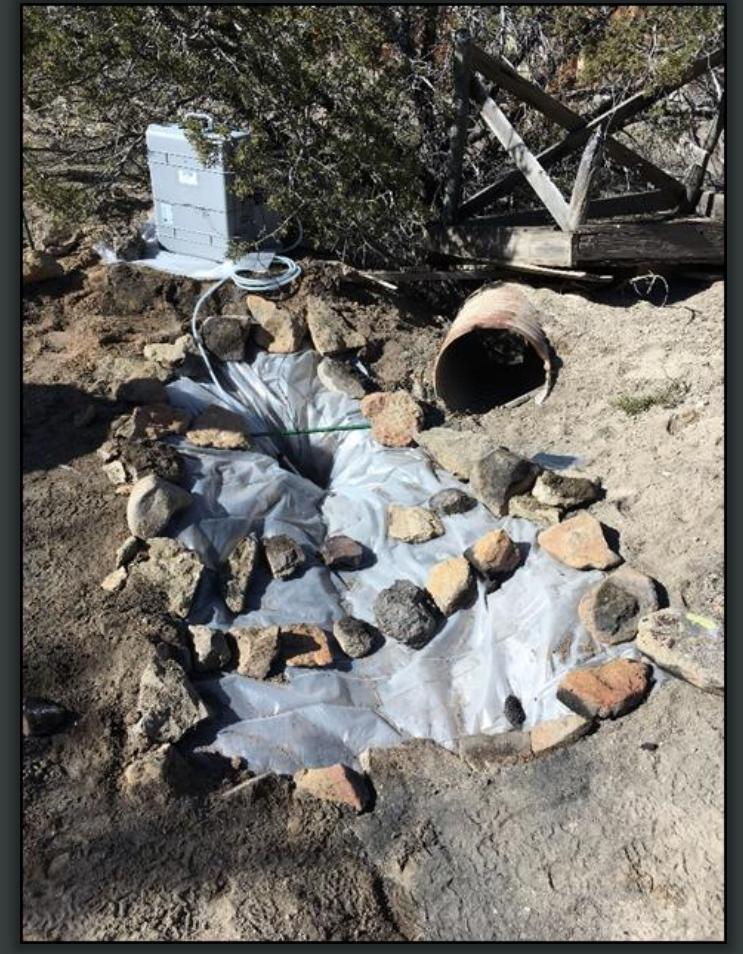
Water Quality Analysis – Photo Courtesy of Grouse Mountain

- 2 sites below gob piles
- 2 sites at discharge points
- 1 site away from mining effects (reference site)

- Total Dissolved Solids, dissolved manganese, dissolved aluminum above threshold
- Reference site and sample site below Zuni bowls all below thresholds

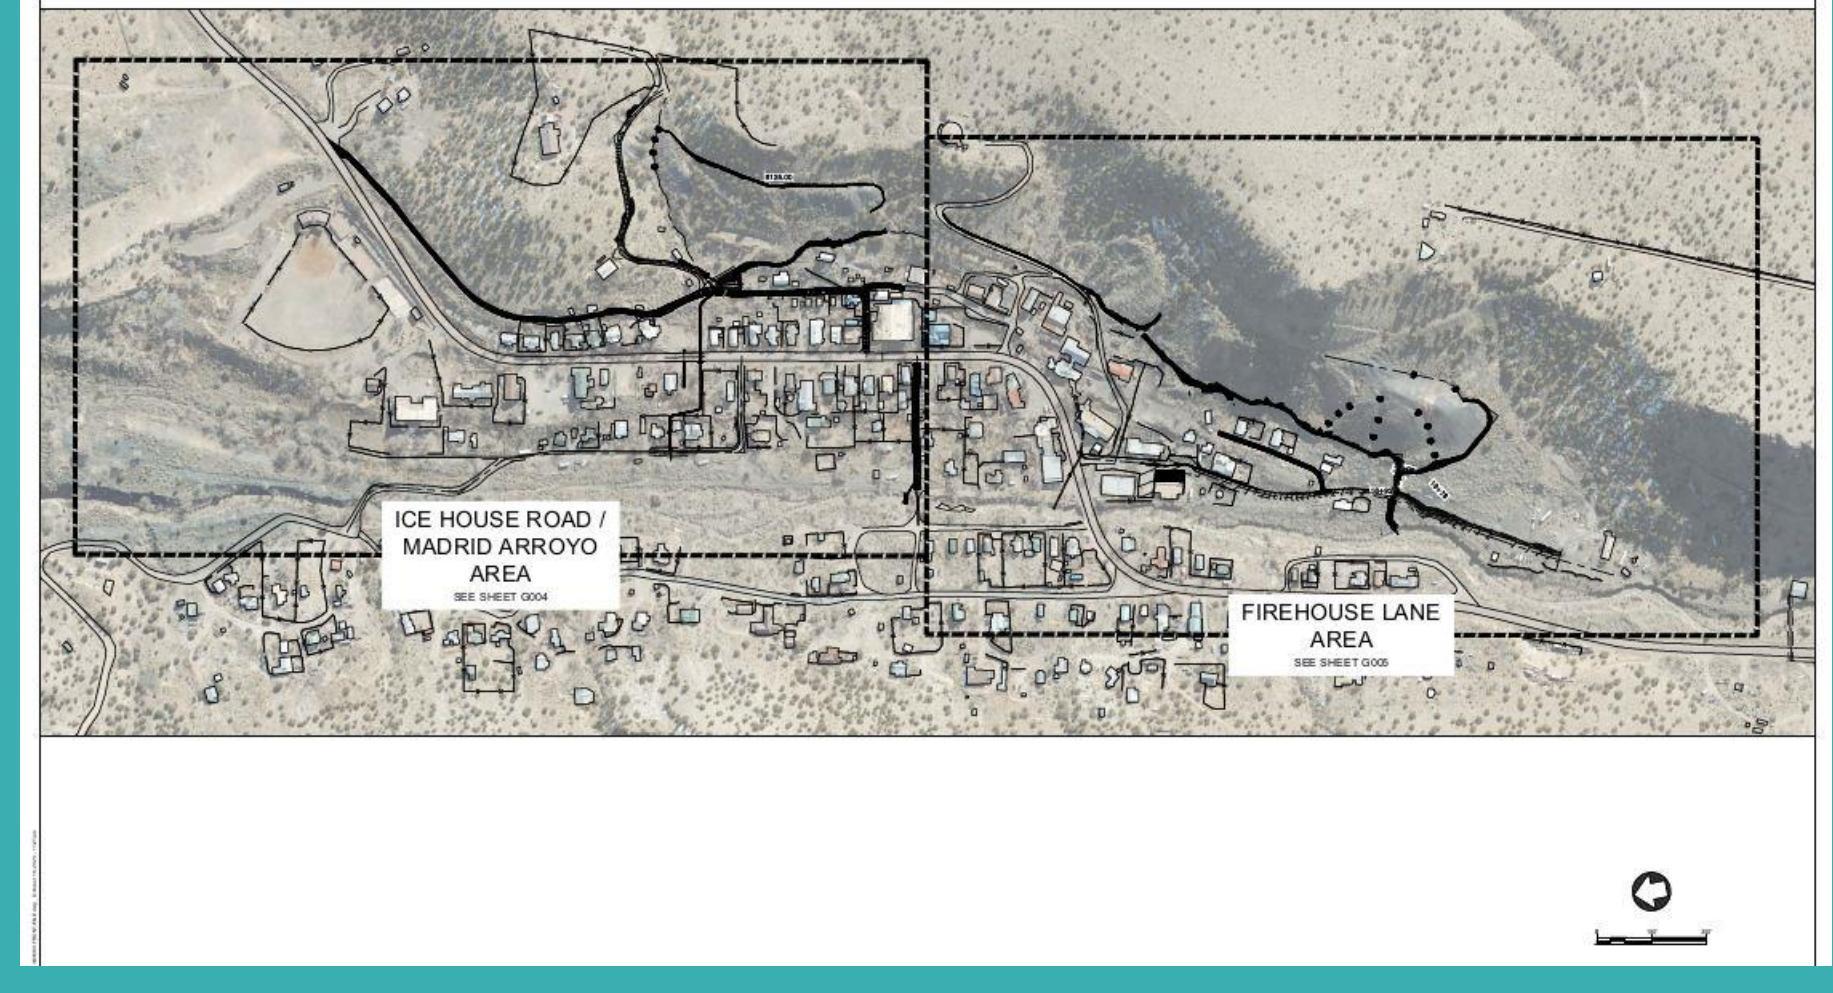
Proposed Action Overview - Photo Courtesy of Weston

- Close mine adit feature
- Water tank and fire suppression system
- Stormwater improvements

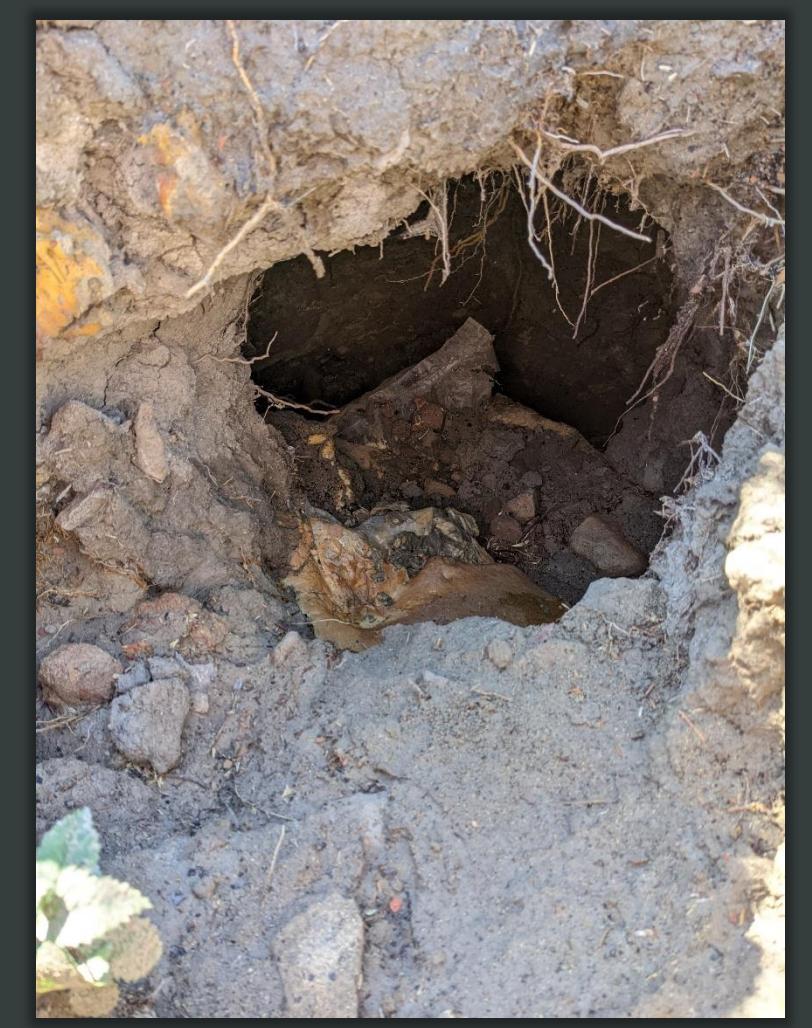
Open Mine Feature – Photo Courtesy of AML

Stormwater and erosion have opened a previously backfilled feature. Proposed Action would close by:

Manual or mechanical filling with soil and rock, waste material, and/or polyurethane foam

Structural barrier

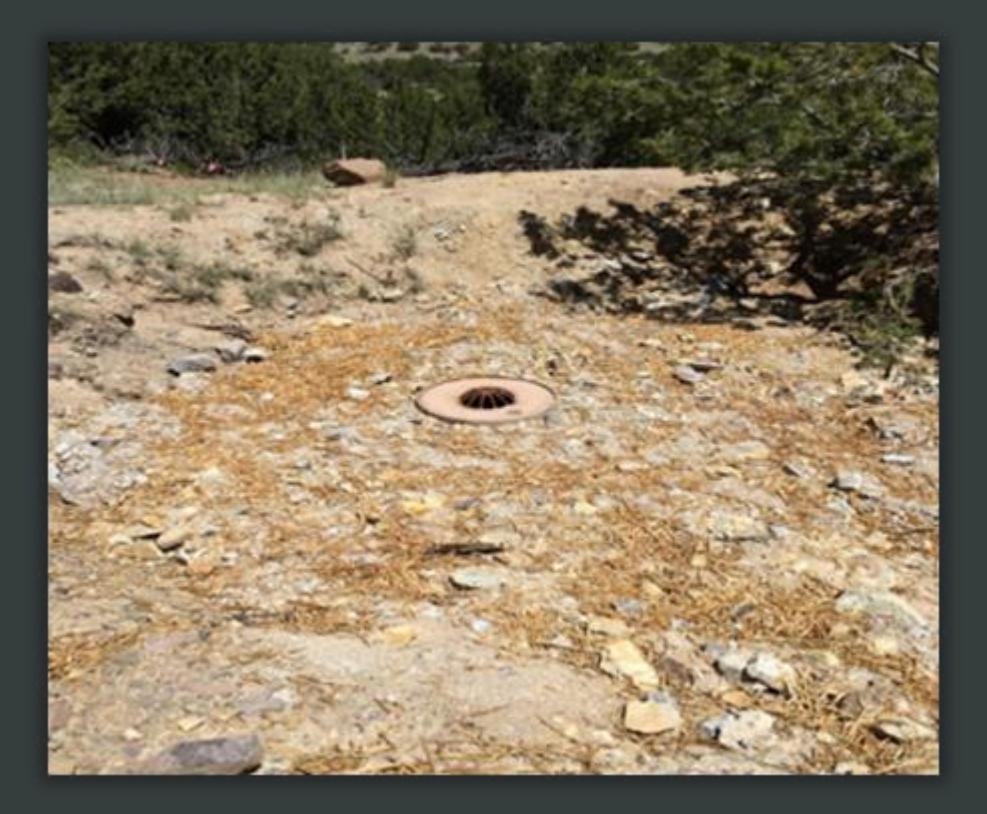
Polyurethane foam closure with drainage cap — Photo Courtesy of AML

Manual or mechanical filling with soil and rock, waste material, and/or polyurethane foam

Structural barrier

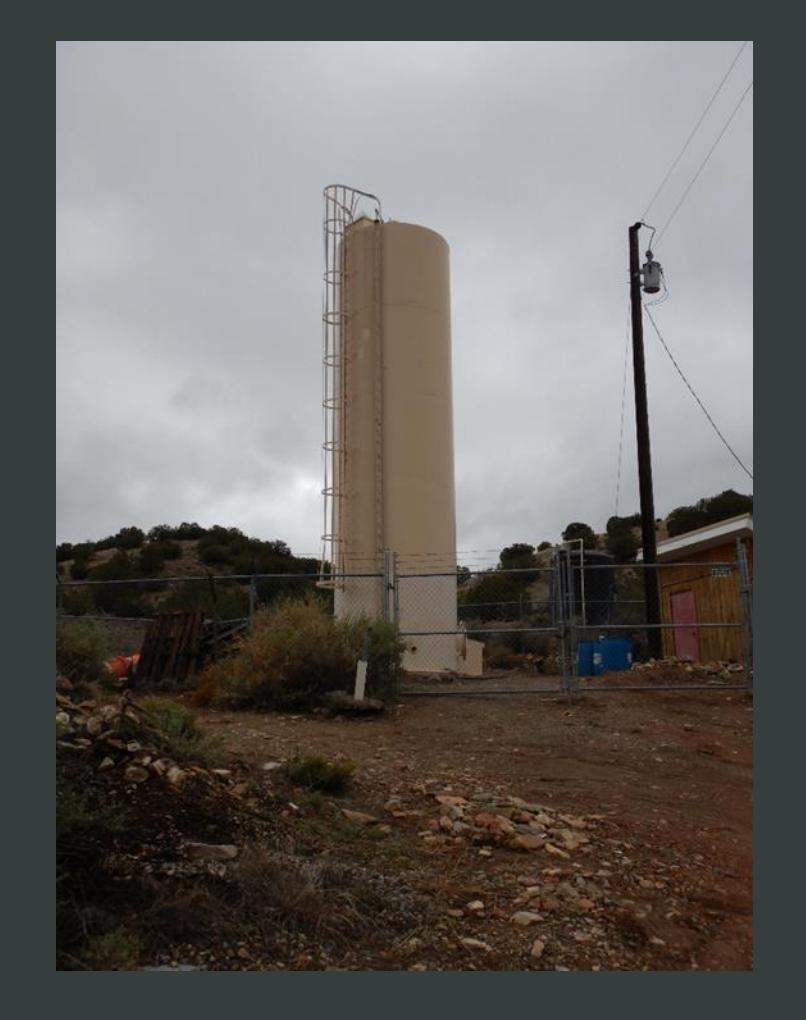
Current Water Tank – Photo Courtesy of AML

- Purpose: to meet Santa Fe County code requirements for fire suppression water volume and pressure
- New 125,000 gallon water tank
- Transmission pipeline- crosses south of Madrid and connects to existing pipeline near fire house
- Less disruptive
- Less potential for underground utility interference

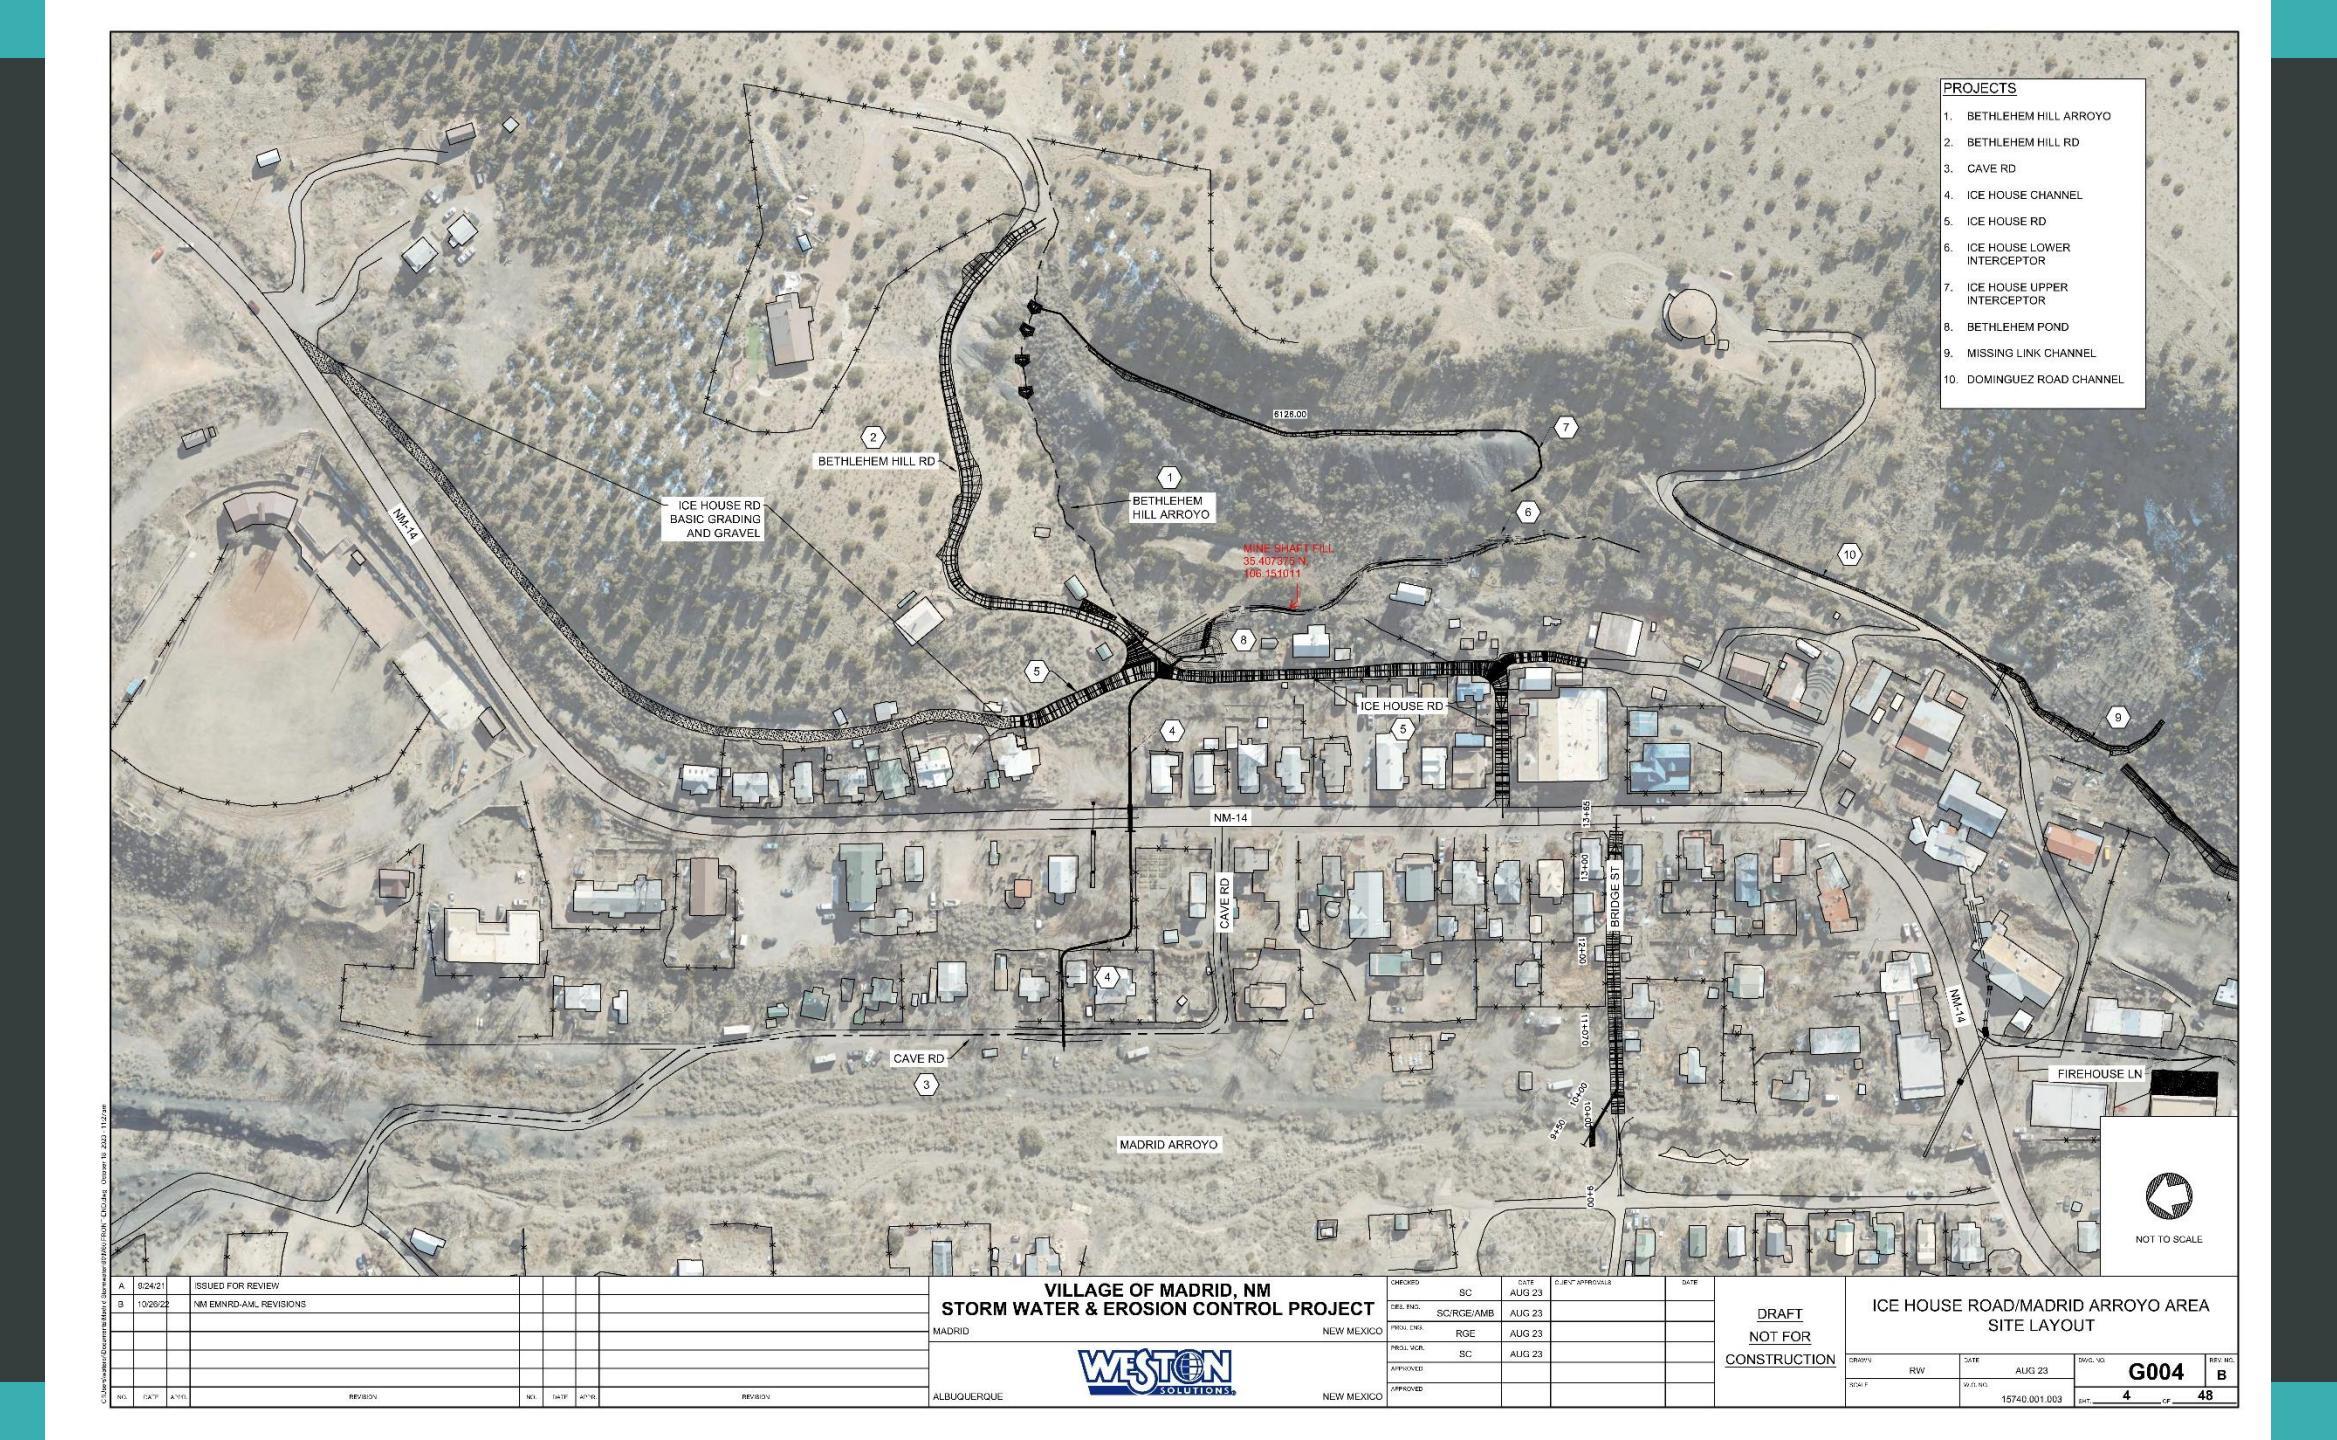
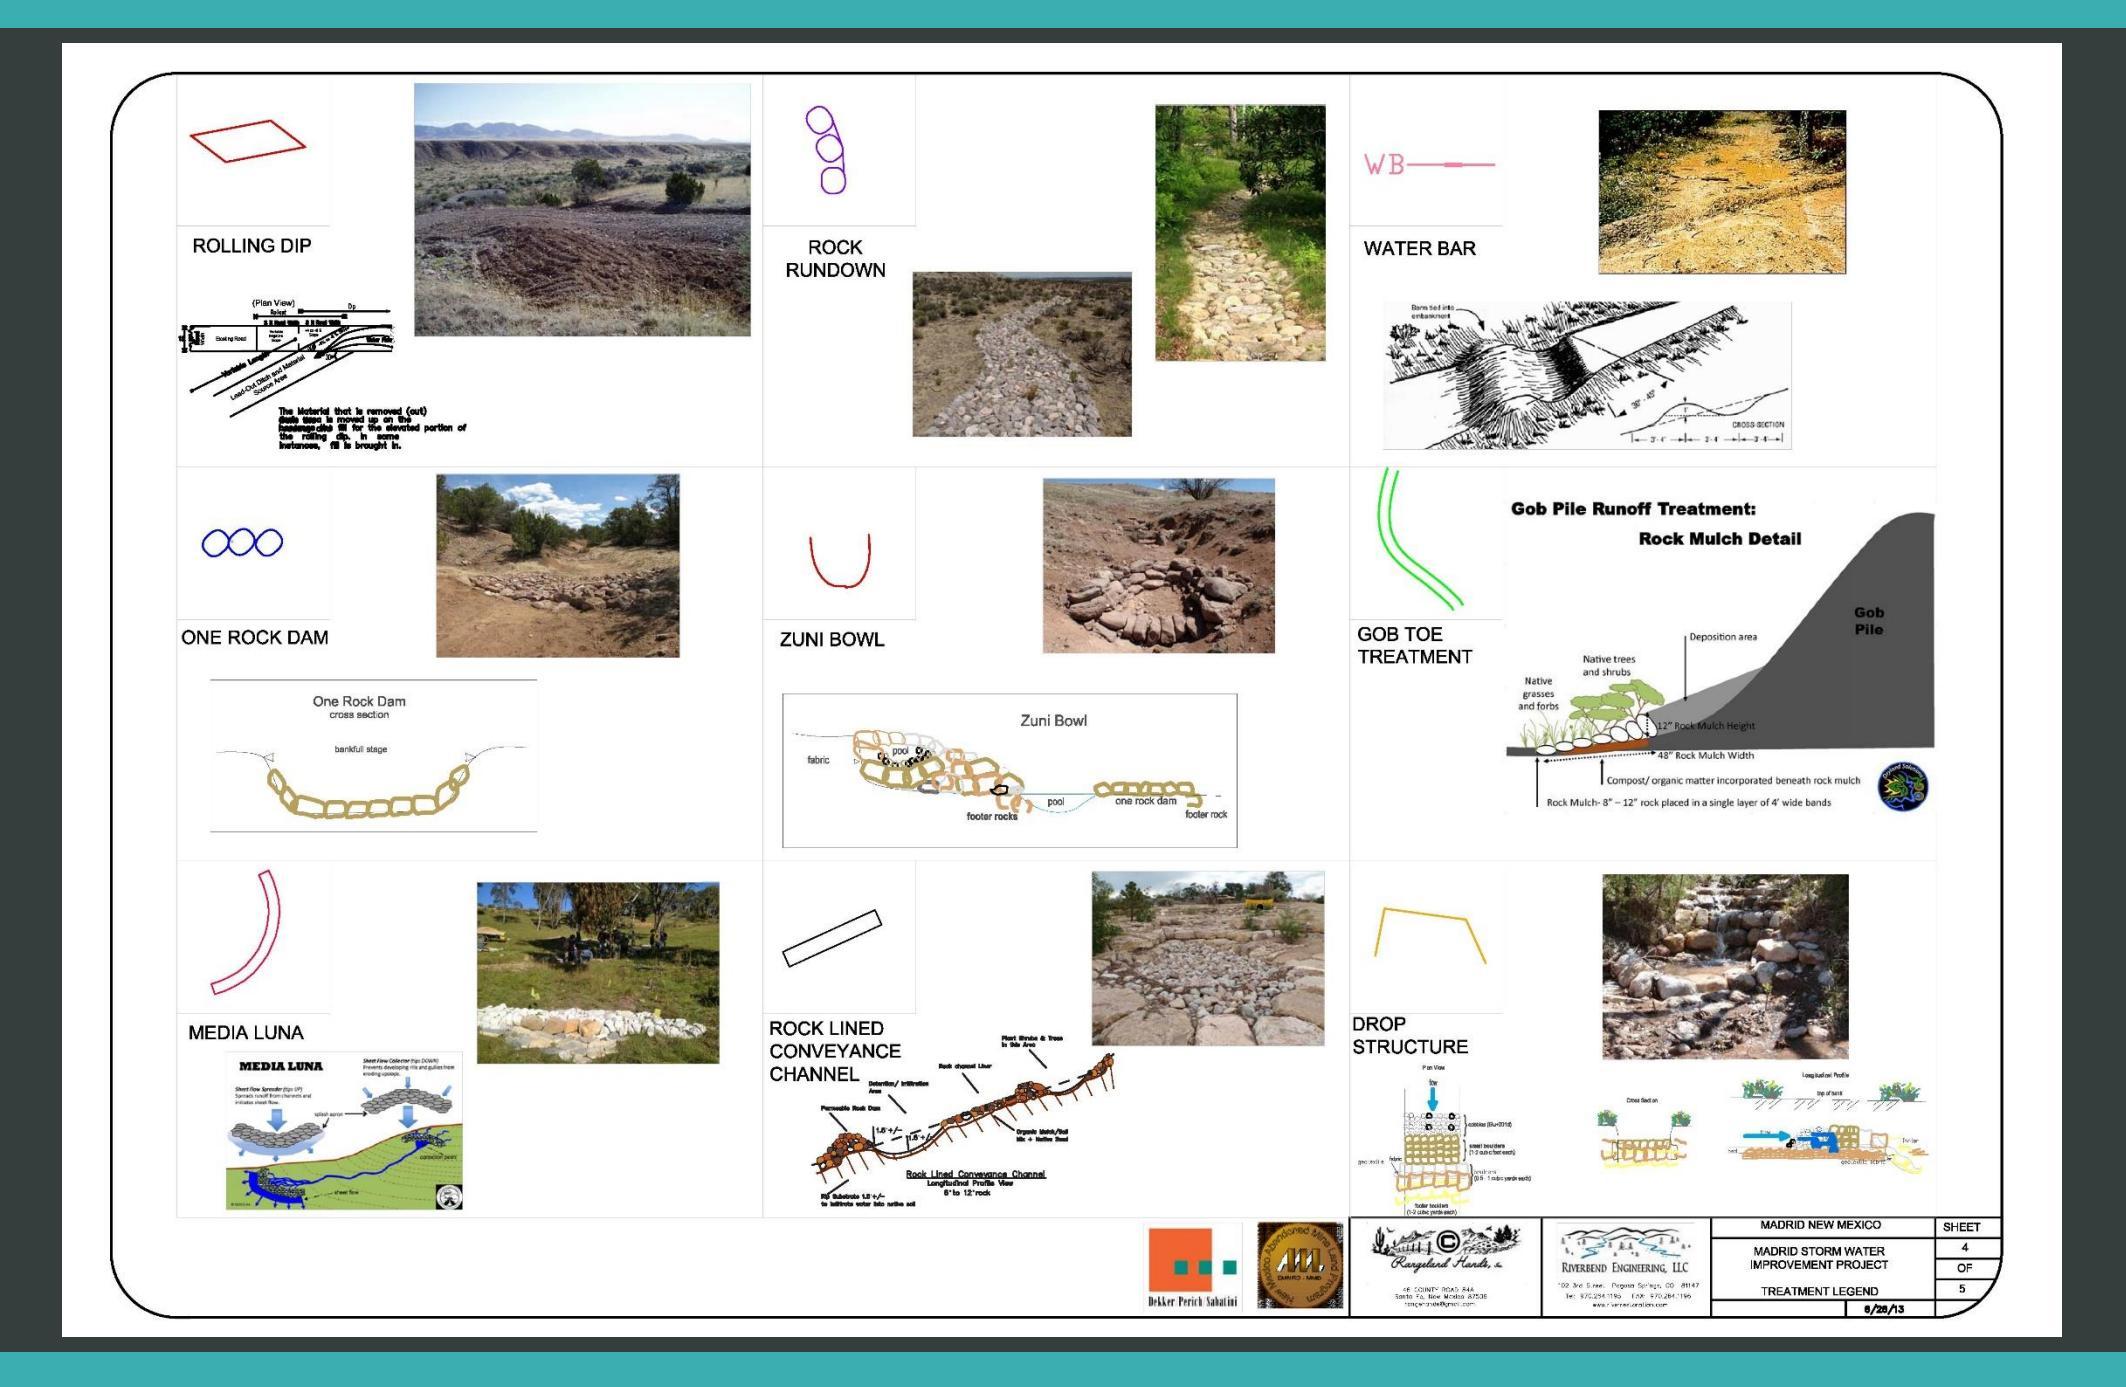
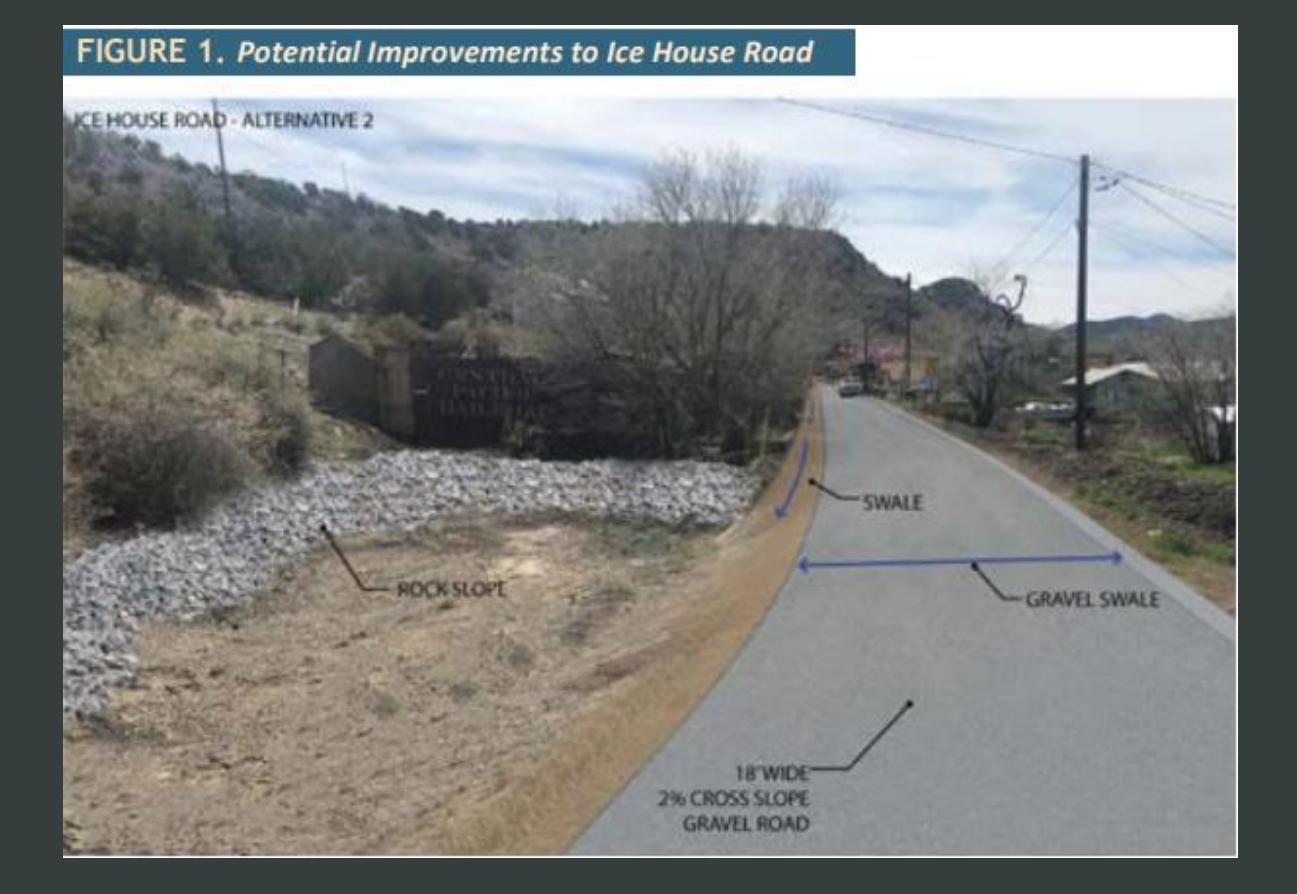
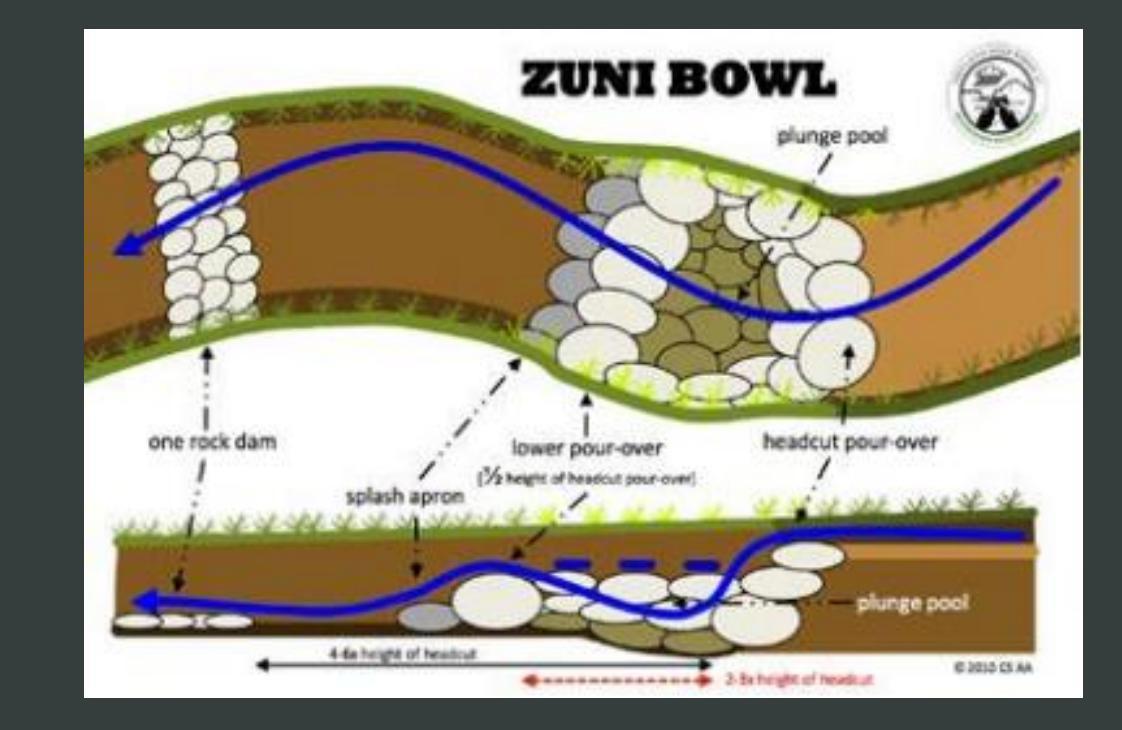
earthen rolling dips, cobble rock rundowns, cobble swales directing into a stormwater conveyance channel

• Zuni bowls, plunge pools, one-rock dams decrease erosion

- Re-graded with crowned gravel cross-section
- Sediment pond for stormwater
- Three channel intercepts with rock-lined channel to capture and directs stormwater away from private property (hidden from village view)

- Regrade gob piles, cover with excess material from Arroyo improvements, revegetate
- Add drainage and gob toe treatment

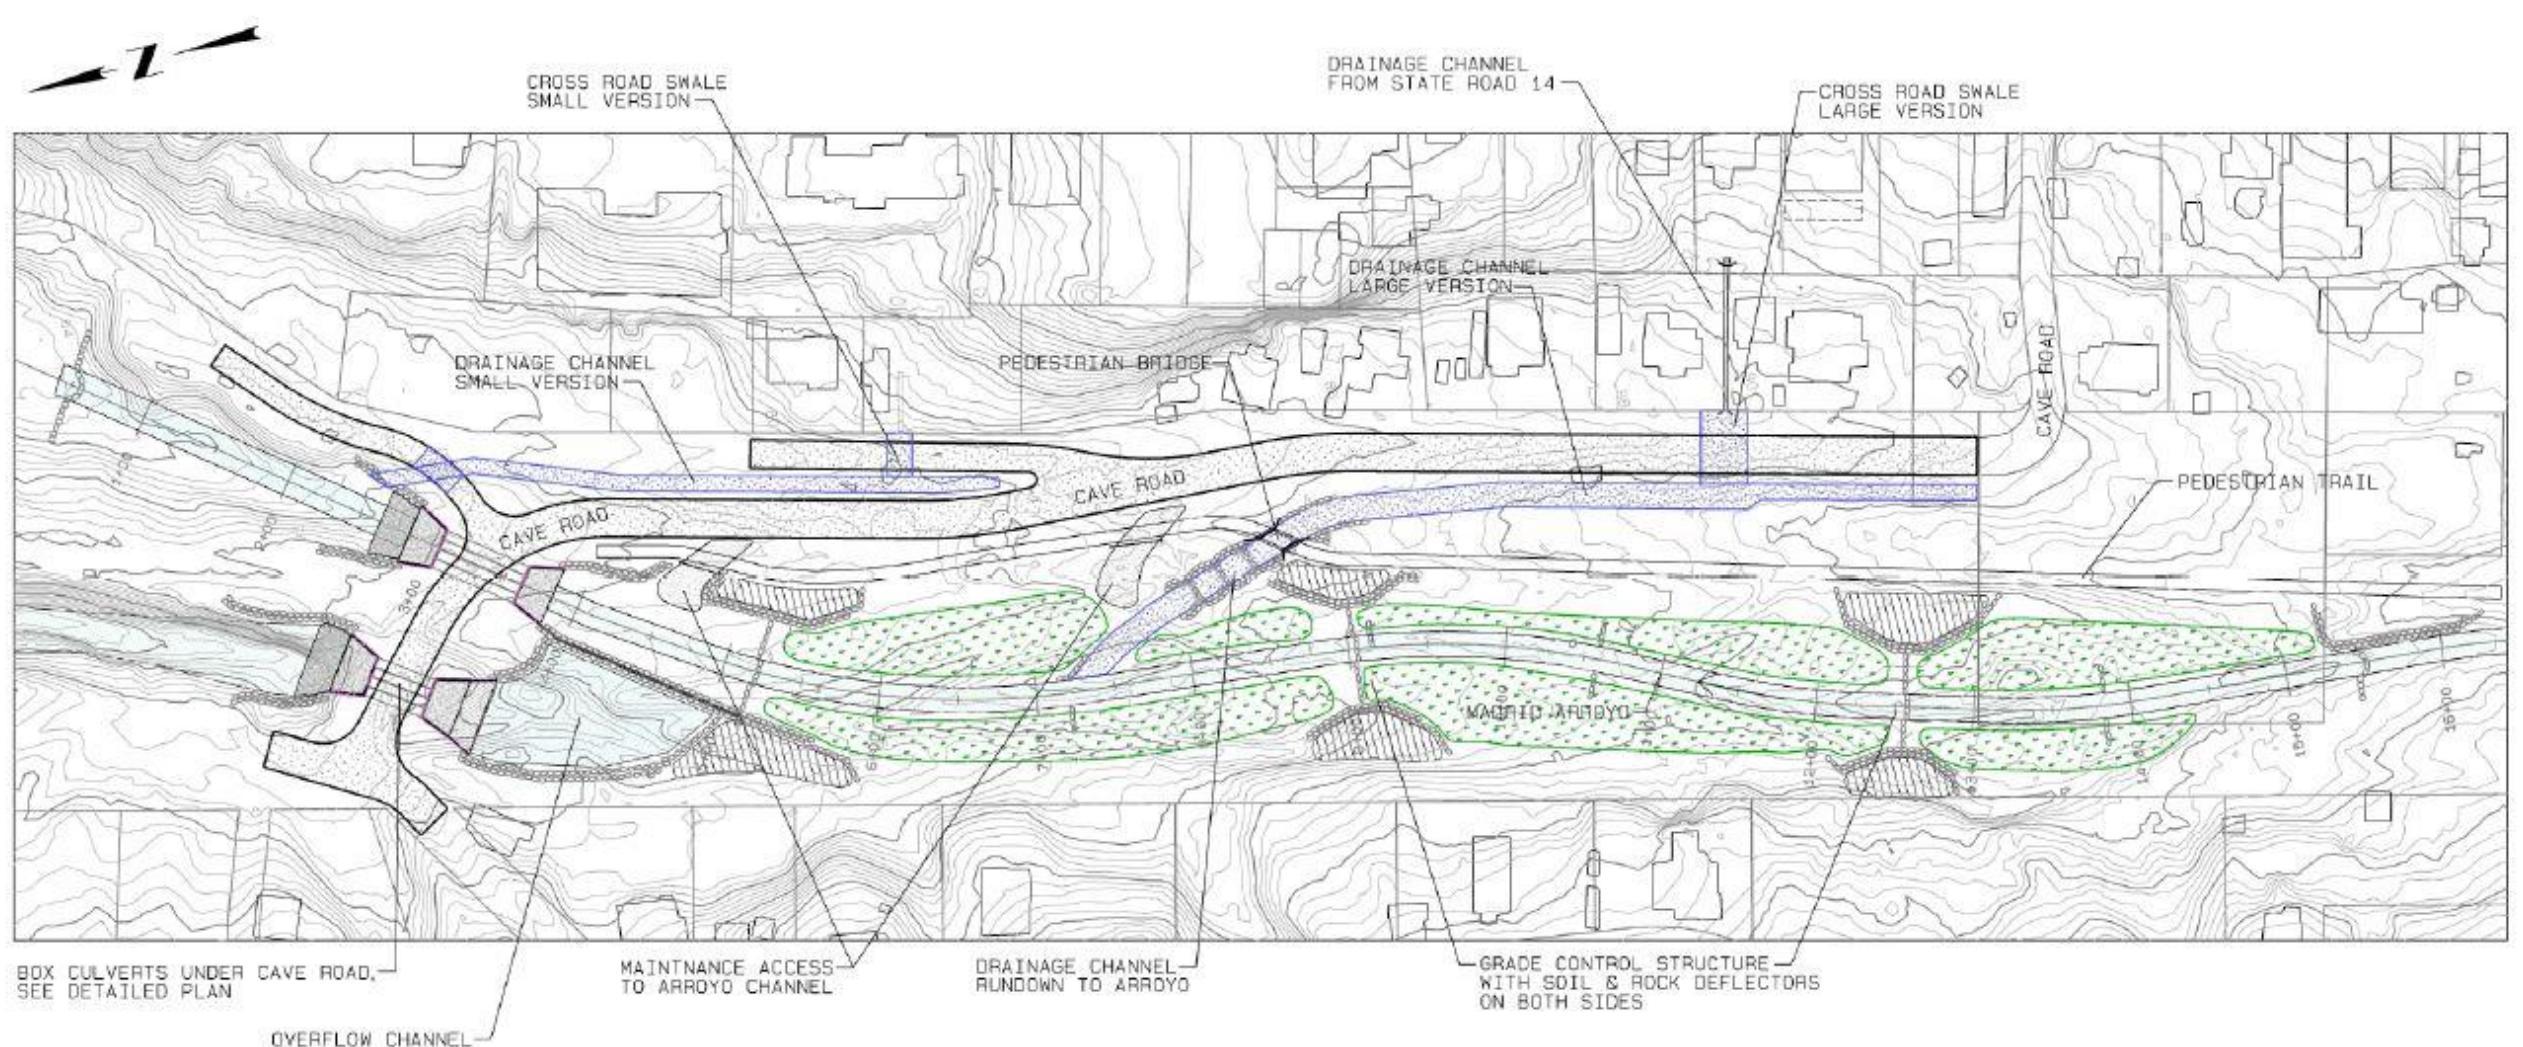
- re-grade with rock-lined swale and gravel roadway
- two bifurcated roadways (east and west) for local access and Arroyo crossing
- Excess fill from Arroyo added to old railroad grade between Cave Rd and Arroyo to prevent flooding
- Two channels with box culverts installed at Arroyo crossing

- re-graded with additional base coarse material
- install center valley gutter and drainage inlet drop structure into Madrid Arroyo

- main channel would be re-graded, with rock and soil deflectors installed within channel
- native seed mix and plantings to stabilize soils

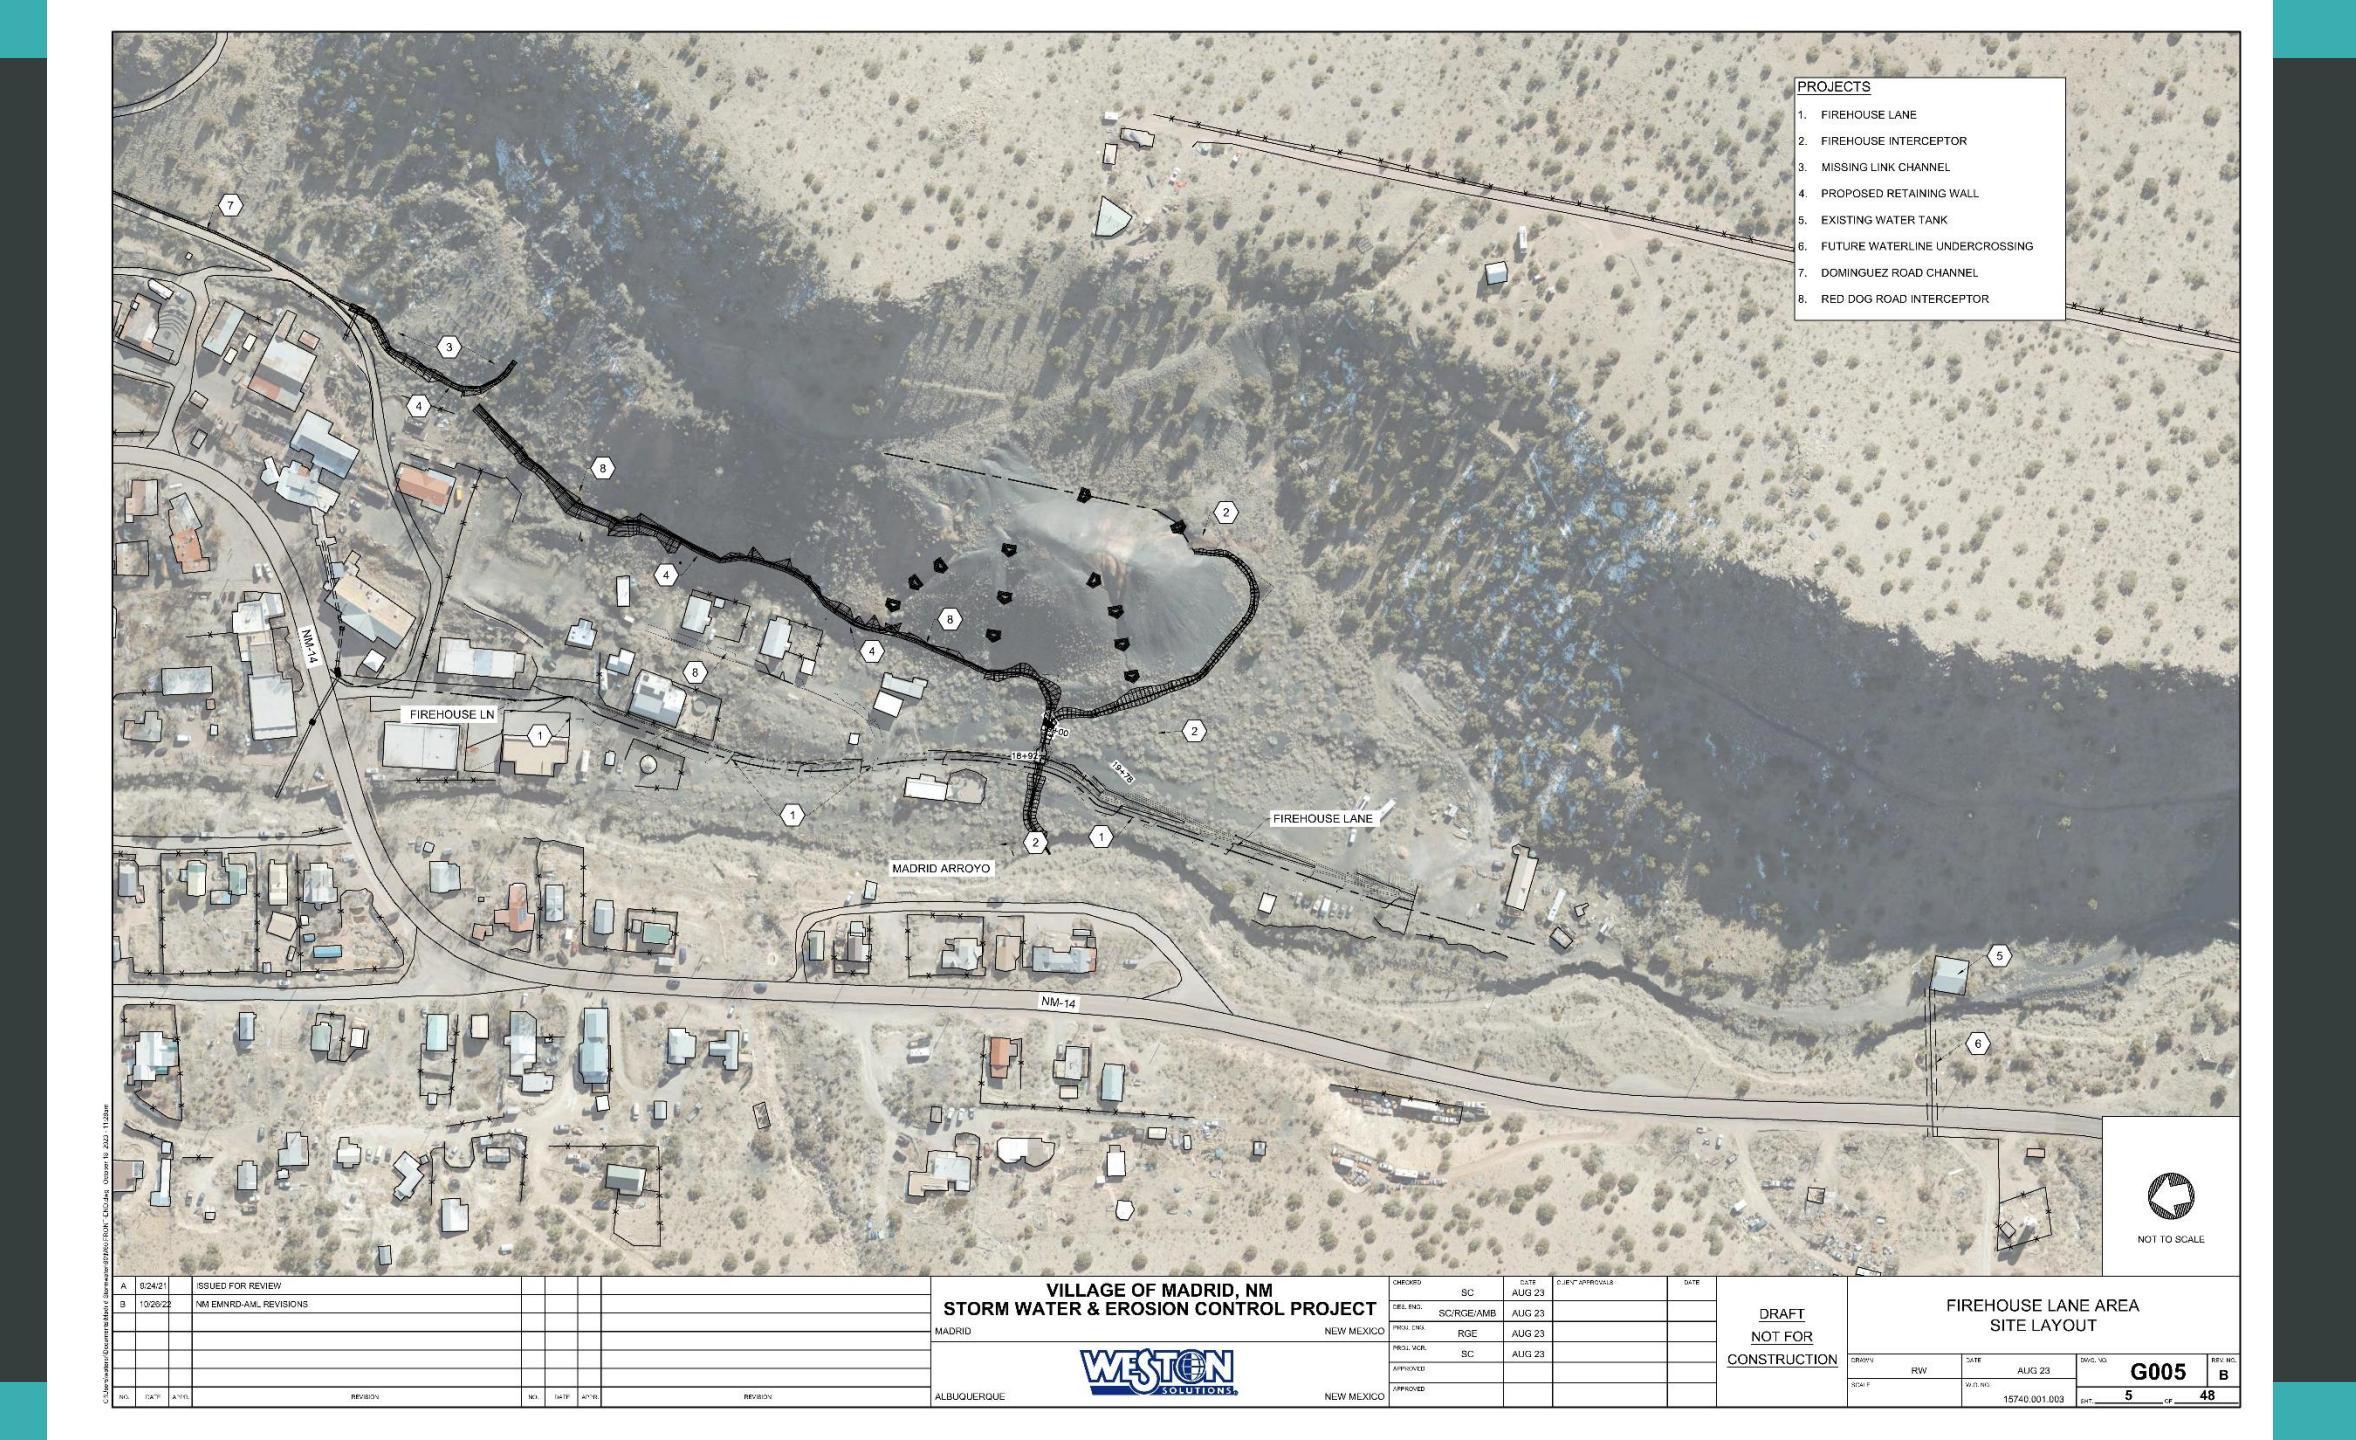
- Rock-lined gravel roadway channels water into Arroyo and existing drop inlet structure
- Add drainage structure midway
- North of drainage structure, re-grade to inverted crown gravel roadway

- Zuni bowls, plunge pools, one rock dams, and rock rundowns in higher elevations
- Trapezoidal channels at toes

- Re-graded with more base coarse material
- Rock-lined ditch above road to channel stormwater into existing culvert under Firehouse Ln
