### Memorandum

- From Cynthia Gulde, Ph.D., Chevron Energy Technology Company (CETC)
- Date January 20, 2011
- Re Questa Mine: Summary of Results from Cover Demonstration Project Pre-Construction Borrow Area Characterization

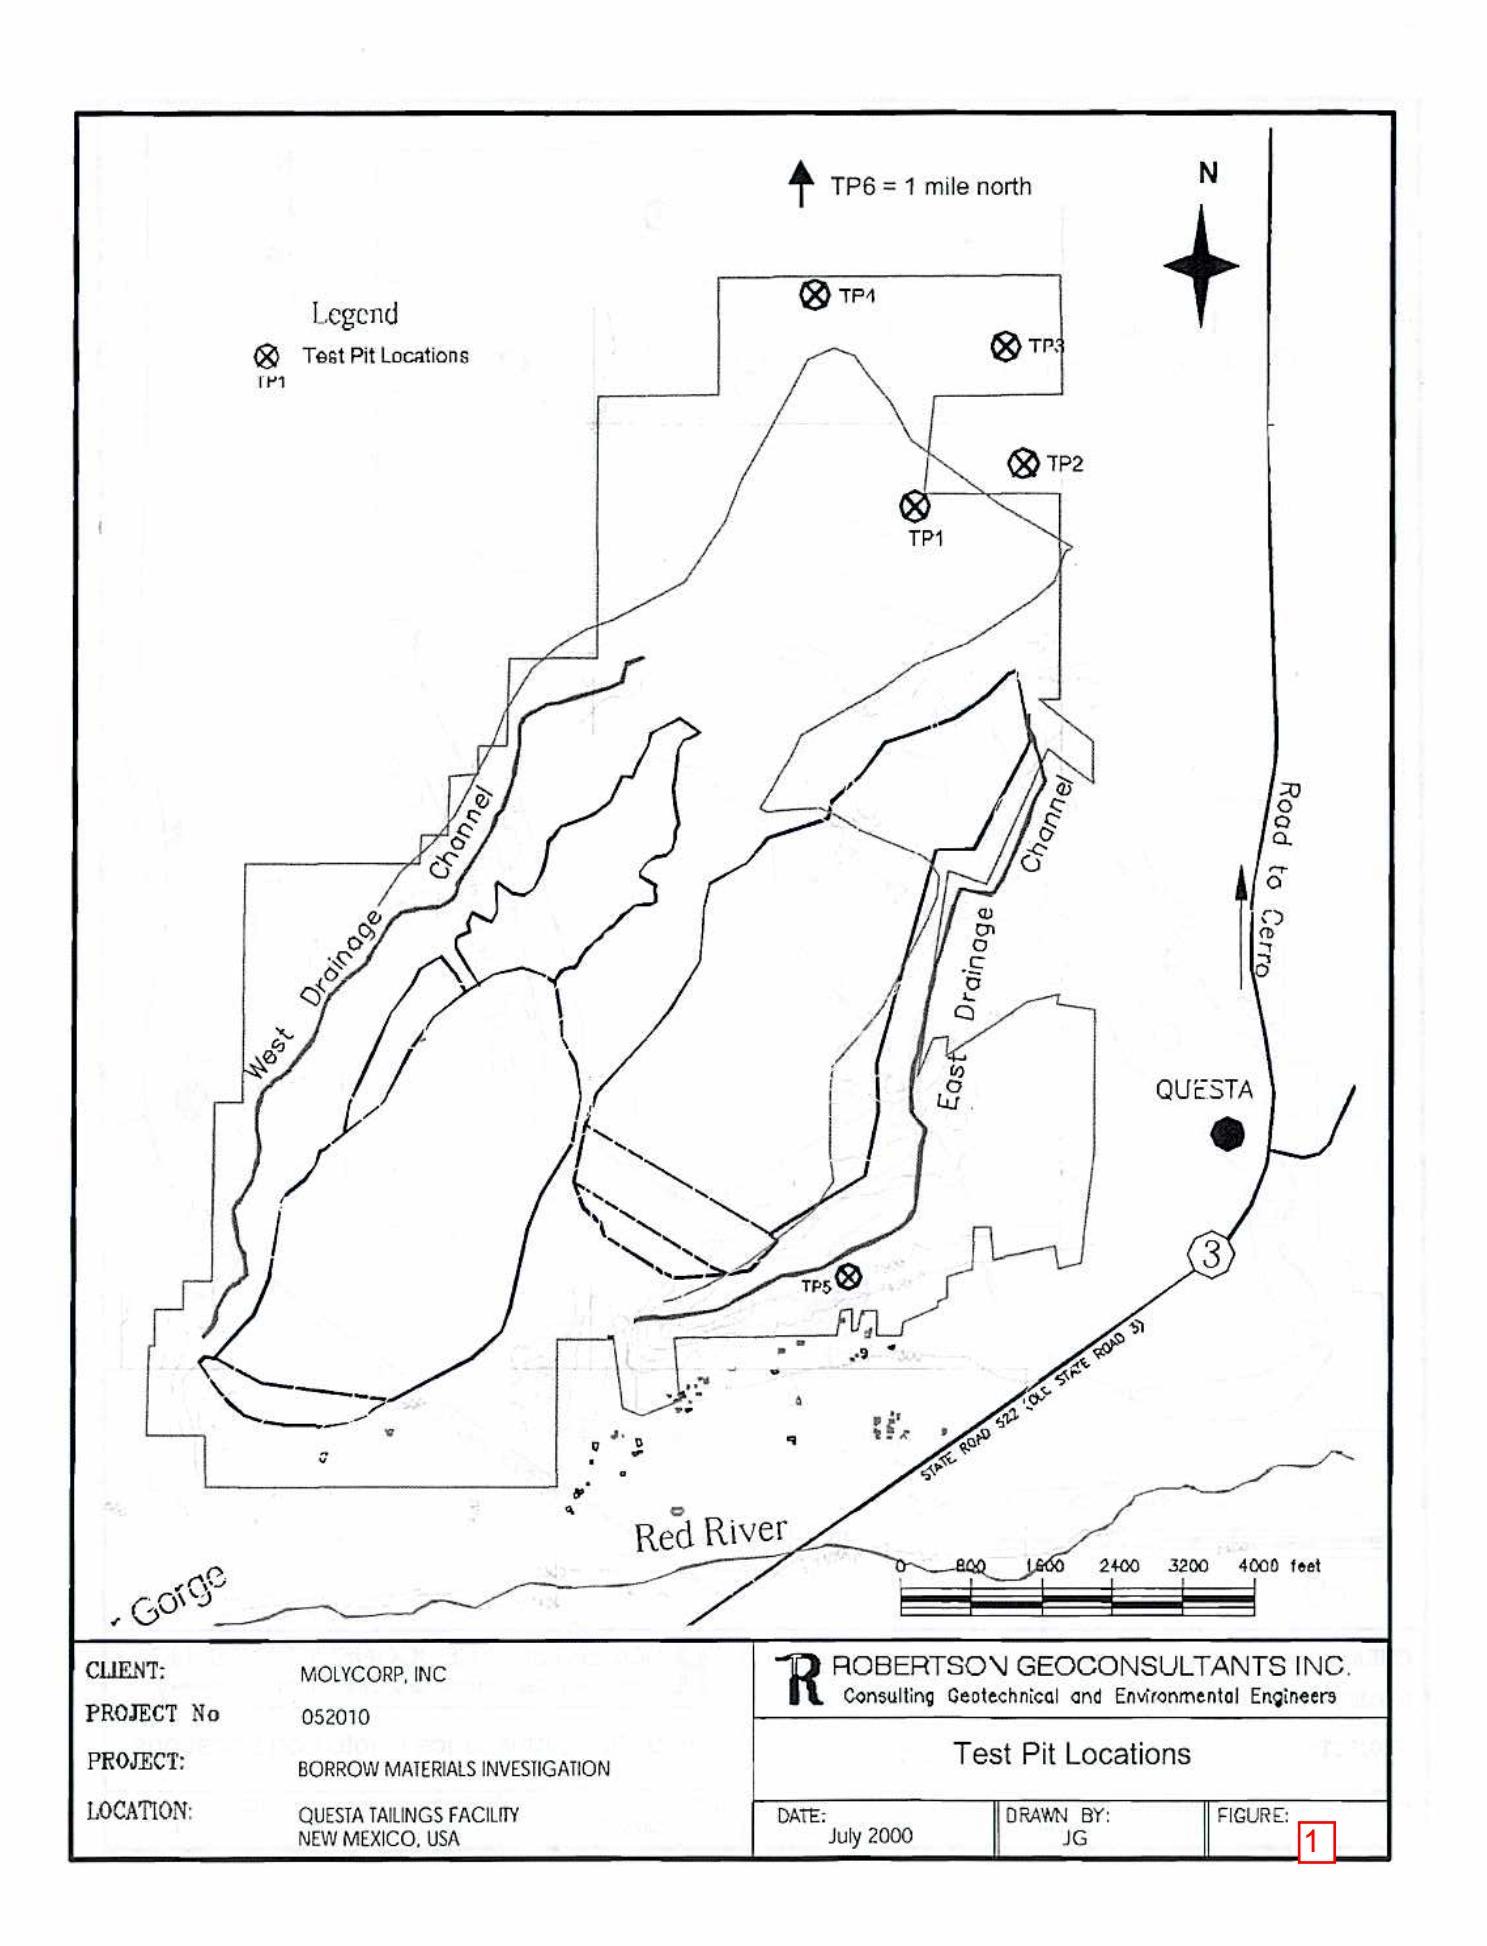
In 2000, six test pits (TP-1 to TP-6) were excavated to a depth of approximately 12 feet from the areas identified as \_TP-1 to TP-5 on Figure 1. Composite samples were collected from different depths within

This memorandum (the memo) summarizes the results of a borrow area characterization for the Cover Demonstration Project (the project) at Chevron's Questa Mine tailing facility (the tailing facility). As described in the November 2009 report "Demonstration Solar Facility and Alternative Cover Depth Project for Chevron Questa Mine" (termed "the Plan" in DP-933 Amendment Approval), tailing borrow materials were investigated in 2000 to document the physical and geochemical properties of the potential borrow material from five areas on or near the tailing facility (Figure 1). The results of these investigations are documented in the following reports:

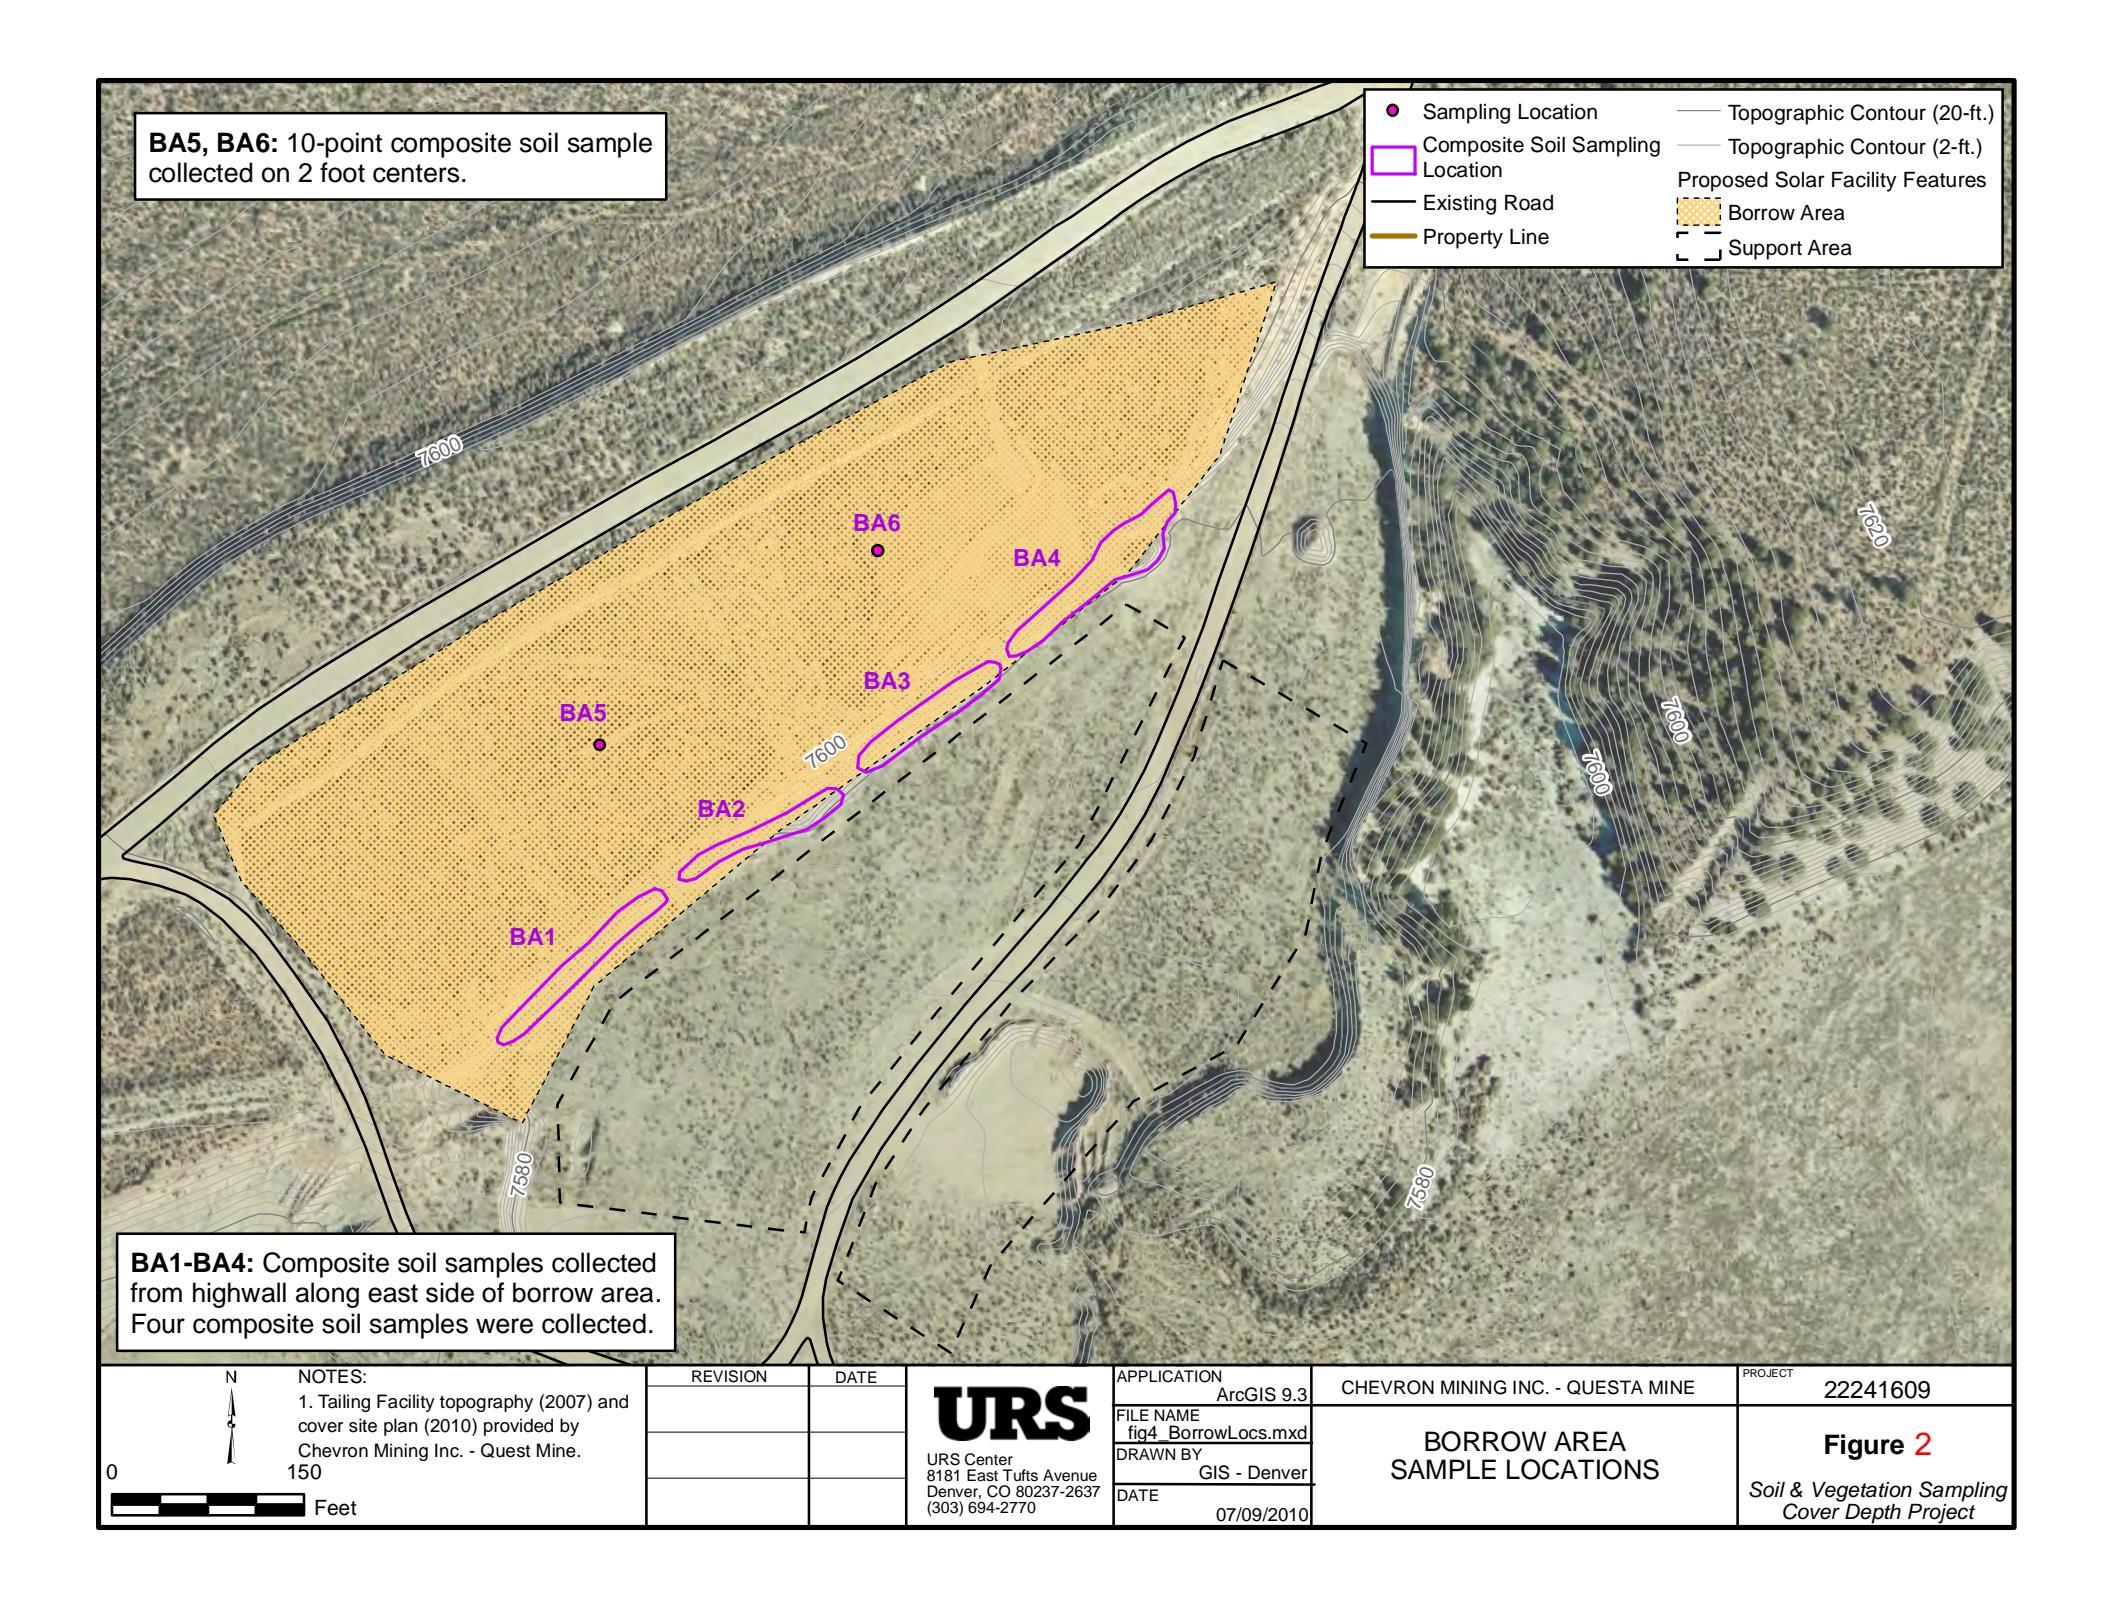
In 2010 following discussions with NMED and MMD, Chevron conducted a Borrow Area Characterization as part of the Cover Demonstration Pre-construction sampling to confirm that the borrow material used for the cover demonstration project was consistent with previous borrow material characterization. Two separate borrow material sampling events were conducted in spring 2010 (April and May) and were observed by Joe Vinson (MMD). During the April event (conducted by URS on April 28, 2010) four composite samples (BA1 through BA4) were collected from the exposed, vertical portion of the eastern side of the highwall of the identified borrow material source and two composite soil samples (BA5 and BA6) were collected from the soil surface of the borrow area. For samples BA1 through BA4, the east side of the borrow area highwall was sub-divided in four sections, which comprised the 4 composite

samples (Figure 2). At each location soil (i.e., borrow material) sub-samples were collected in clean 1gallon buckets, which were transferred into clean (new) 5-gallon plastic buckets. Soil sub-samples were collected directly into the 1-gallon bucket by scraping soil material from the highwall using a clean stainless steel trowel. The highwall was estimated to be between 20 and 30 feet in height. The exposed, vertical portion of the highwall was estimated to account for approximately 20 to 60 percent of the total height of the highwall (photograph 1).

Samples BA5 and BA6 (Figure 2) were collected from the surface of the borrow area, from soil surface to 6 inches below the surface, at 10 sub-sample locations spaced on 2-foot centers. Samples were placed into a clean stainless steel bowl. The composite samples were mixed using gloved (nitrile) hands or a clean stainless steel trowel.

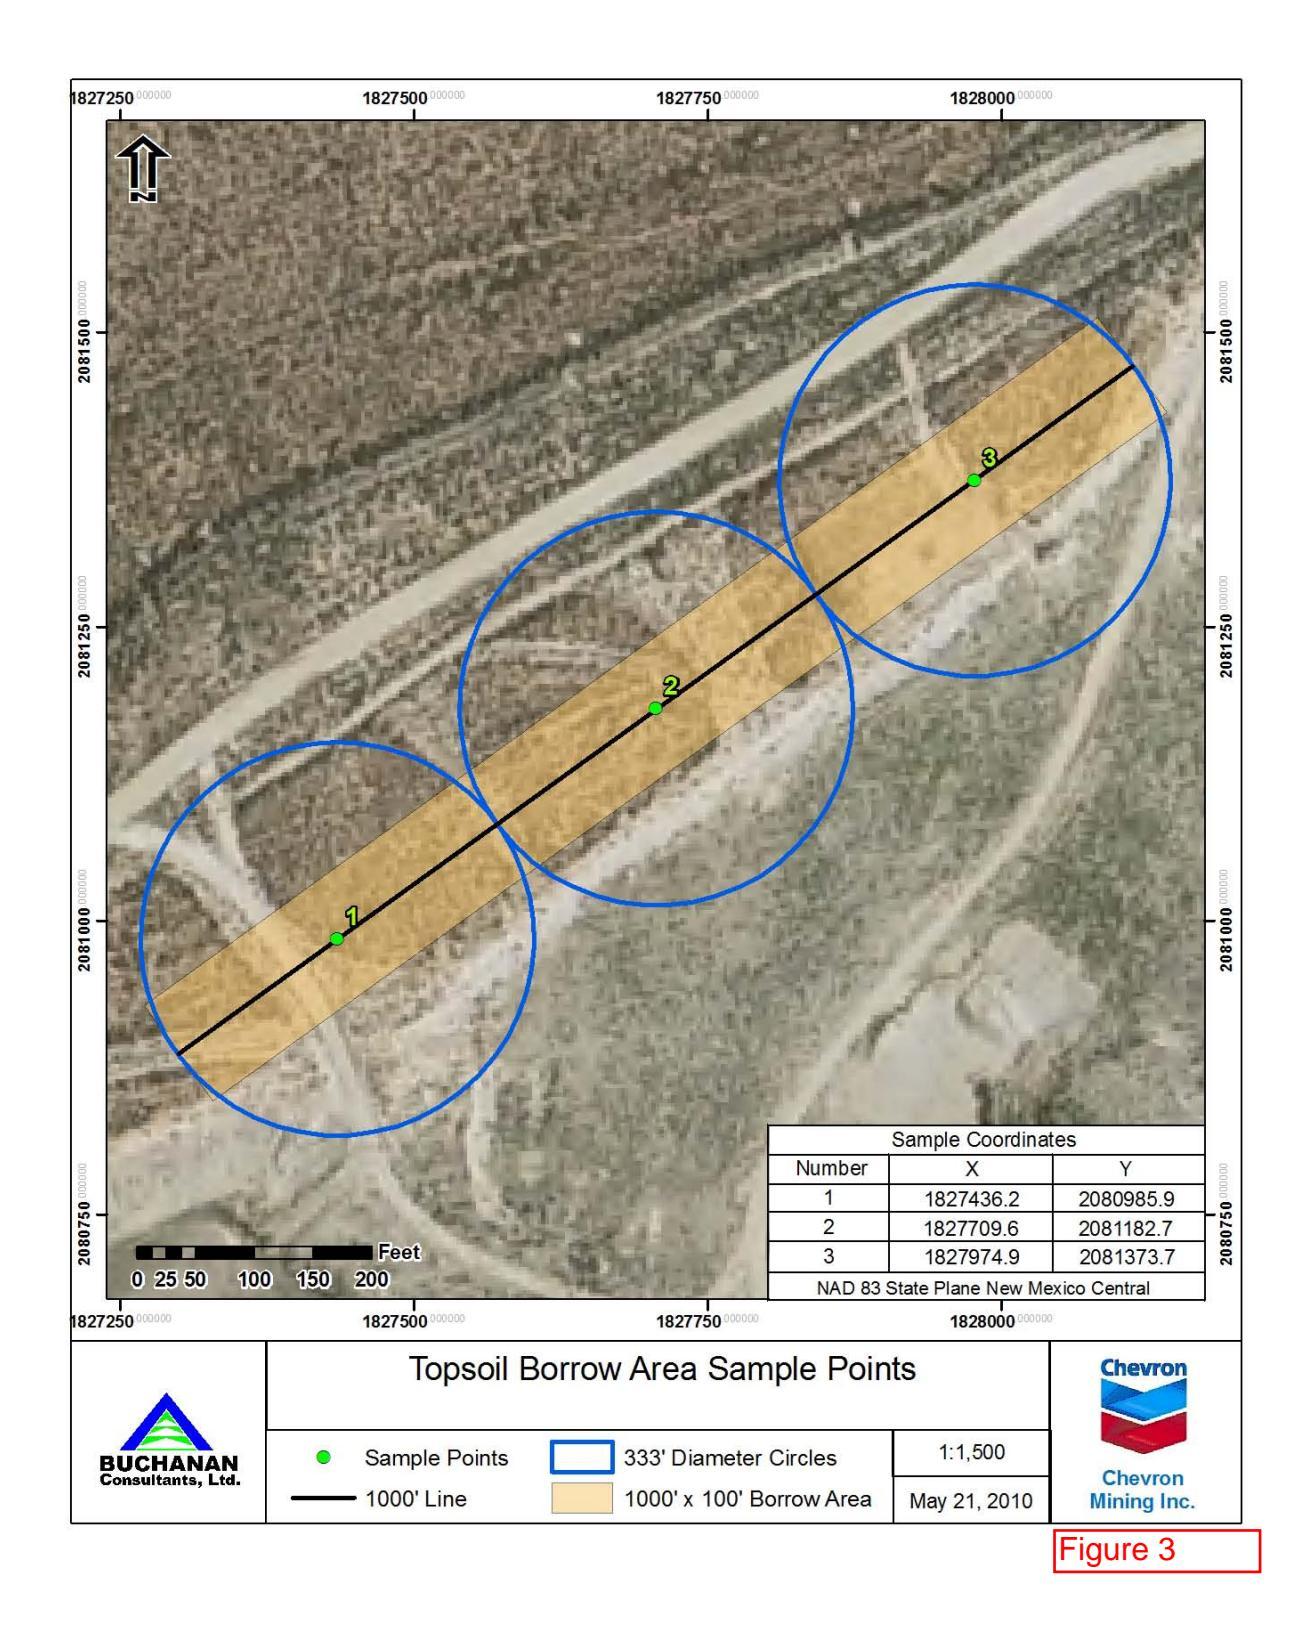
On May 20, 2010 Buchanan Consultants resampled the borrow material using three test pits excavated to a depth of approximately 18 feet (Figure 3). Composite samples were collected from the pits based on two intervals visually defined by noticeable changes in material type, texture and/or coloring (Photographs 2 -4). For each depth interval three 5-gallon buckets of mixed and composited material were collected using a shovel. The samples were shipped to Energy Laboratories and analyzed for grain size, moisture, pH, conductivity, sodium adsorption ratio, rock fragment content, texture, macro nutrient content, and micro nutrient content (Table 2). Plant available iron, zinc, manganese, calcium, magnesium, copper and molybdenum were not analyzed during the May sampling event. Results of the May sampling event are presented in Table 4 (attached).

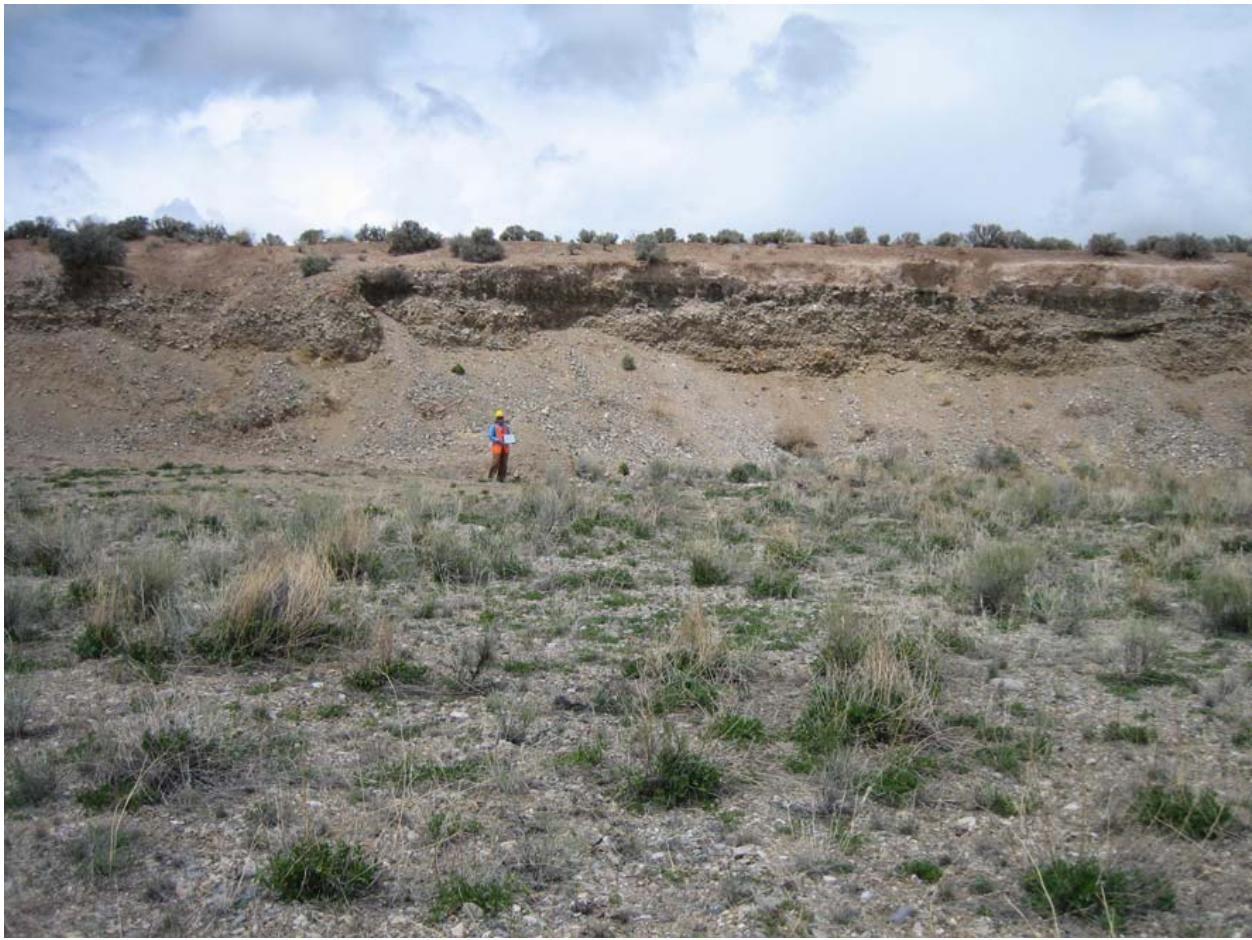
**Photo 1:** Looking north-northwest – borrow area sampling location (April sampling event).

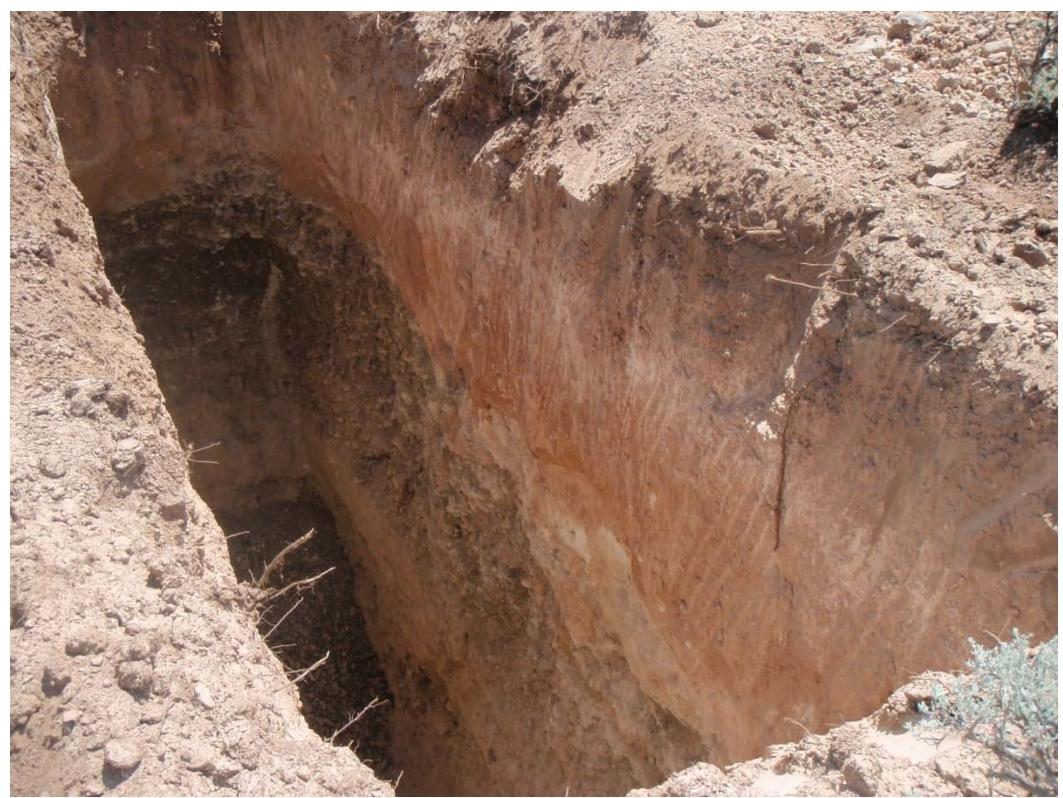
Photo 2. Test Pit #1 (southern most pit) on May 2010 sampling event.

The following briefly summarizes the 2010 results. During excavation of the test pits there was a defined difference in the color and texture of the top soil and underlying alluvial soils. A dark brownish red fine material extended from the surface down to a depth of 7 to 9 feet. Depths greater than 8 feet had more coarse frags, and cobble sized rocks. The upper 0-8 feet had a lower percent sand than was observed at depths greater than 8 ft (19% vs. 74 %, respectively). The top 0-8 feet was high in clay content 46-50% when compared to depths greater than 8 feet (average = 14%). The course fragments of the alluvial materials sampled (8 to 18 feet) make up 24%. The cobbles would likely make-up 5% to 10% of the alluvial material based on visual observation in the field. The texture of the top soil material (0 to 8') was consistent from one test pit location to the next and classified as clay. The bottom alluvial material (8 to 18") was classified as a sandy loam. As expected, in the samples collected from April 2010 where the material was mixed, the soil texture varied from a sandy clay loam, to a sandy loam to loamy sand. This is likely most representative of the texture of material once it is placed on the tailing as cover material.

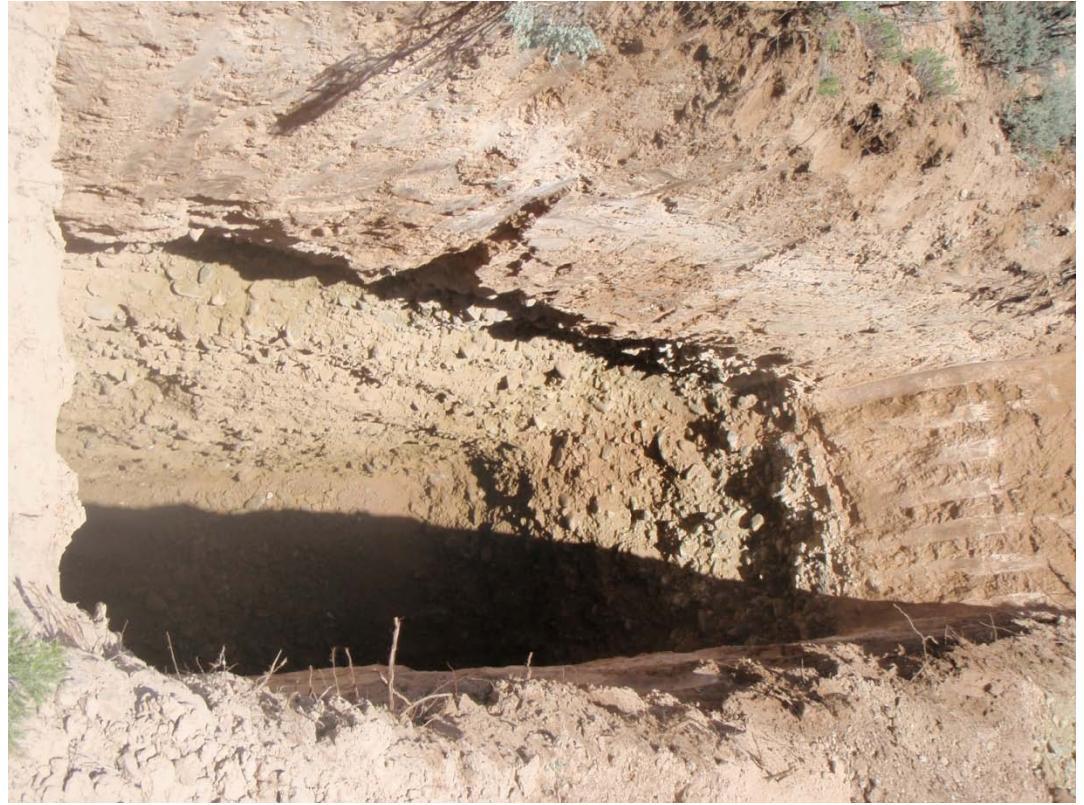
Photo 3. Test Pit #2 (center pit) on May 2010 sampling event.

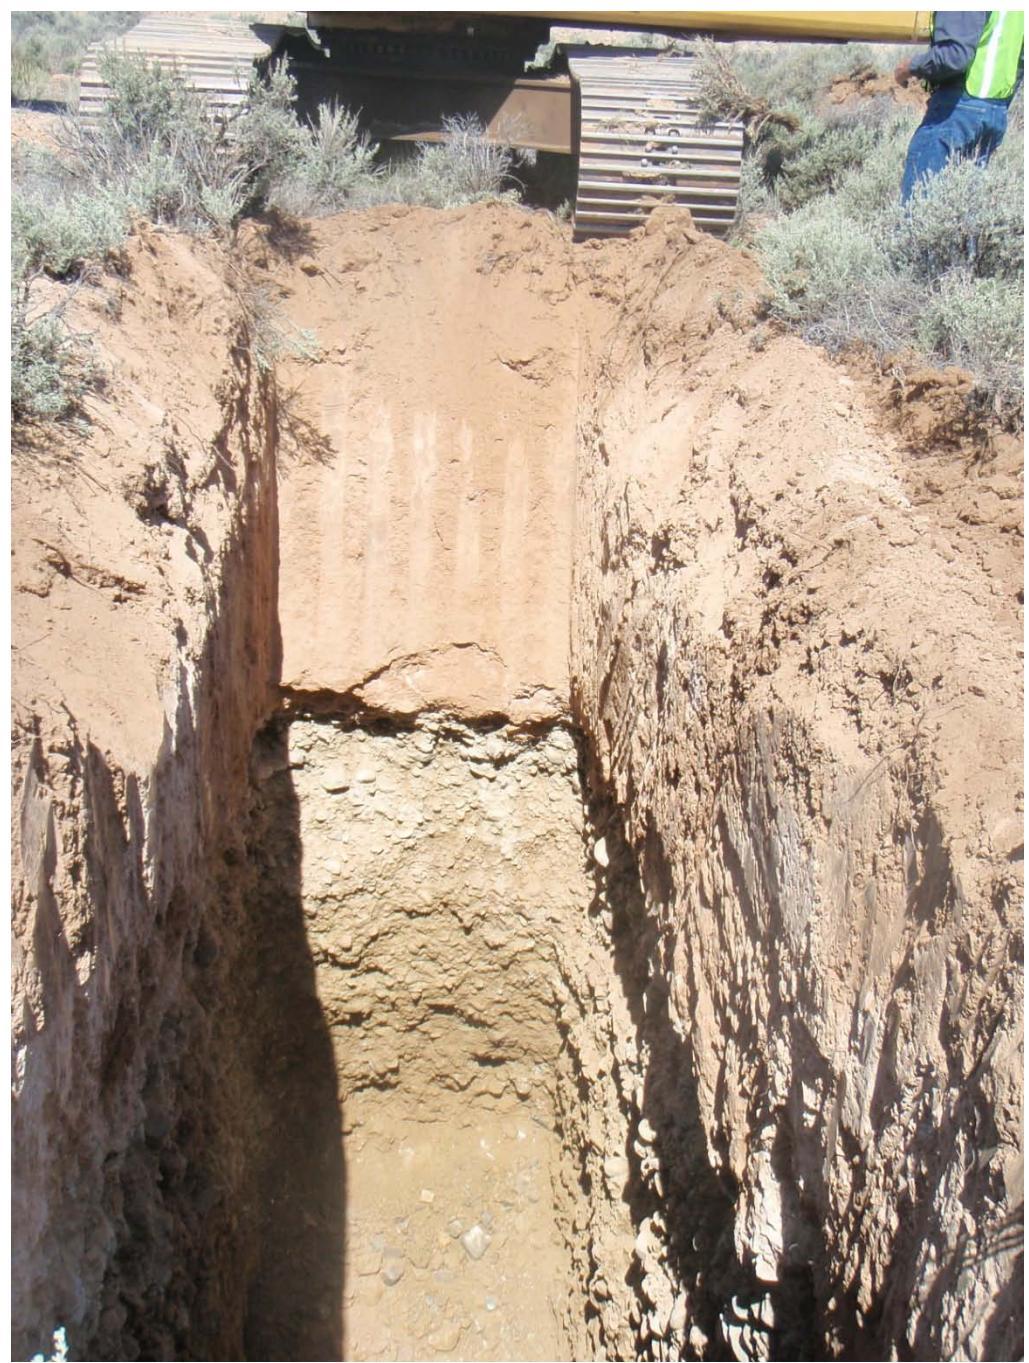
Photo 4. Test Pit #3 (northern most pit) on May 2010 sampling event.
