RE: Response to, Joint Agency Comments, Questa Tailings Pipeline Removal, Stage 8 Work Plan, Chevron Environmental Management Company, Questa Mine

ADDENDUM TO: HISTORIC TAILING SPILLS REMOVAL ACTION WORK PLAN AND STAGE 8 PIPELINE REMOVAL WORK PLAN CHEVRON QUESTA MINE SUPERFUND SITE CHEVRON MINING, INC.

November 8, 2018

The purpose of this addendum is to describe activities for the removal of structures at the Lower Dump Sump (LDS), referred to in the HST RA Completion Report as Site 24, and to identify, remove, and cap HTS, as well as to provide an overall site grading plan for the Lower Dump Sump area.

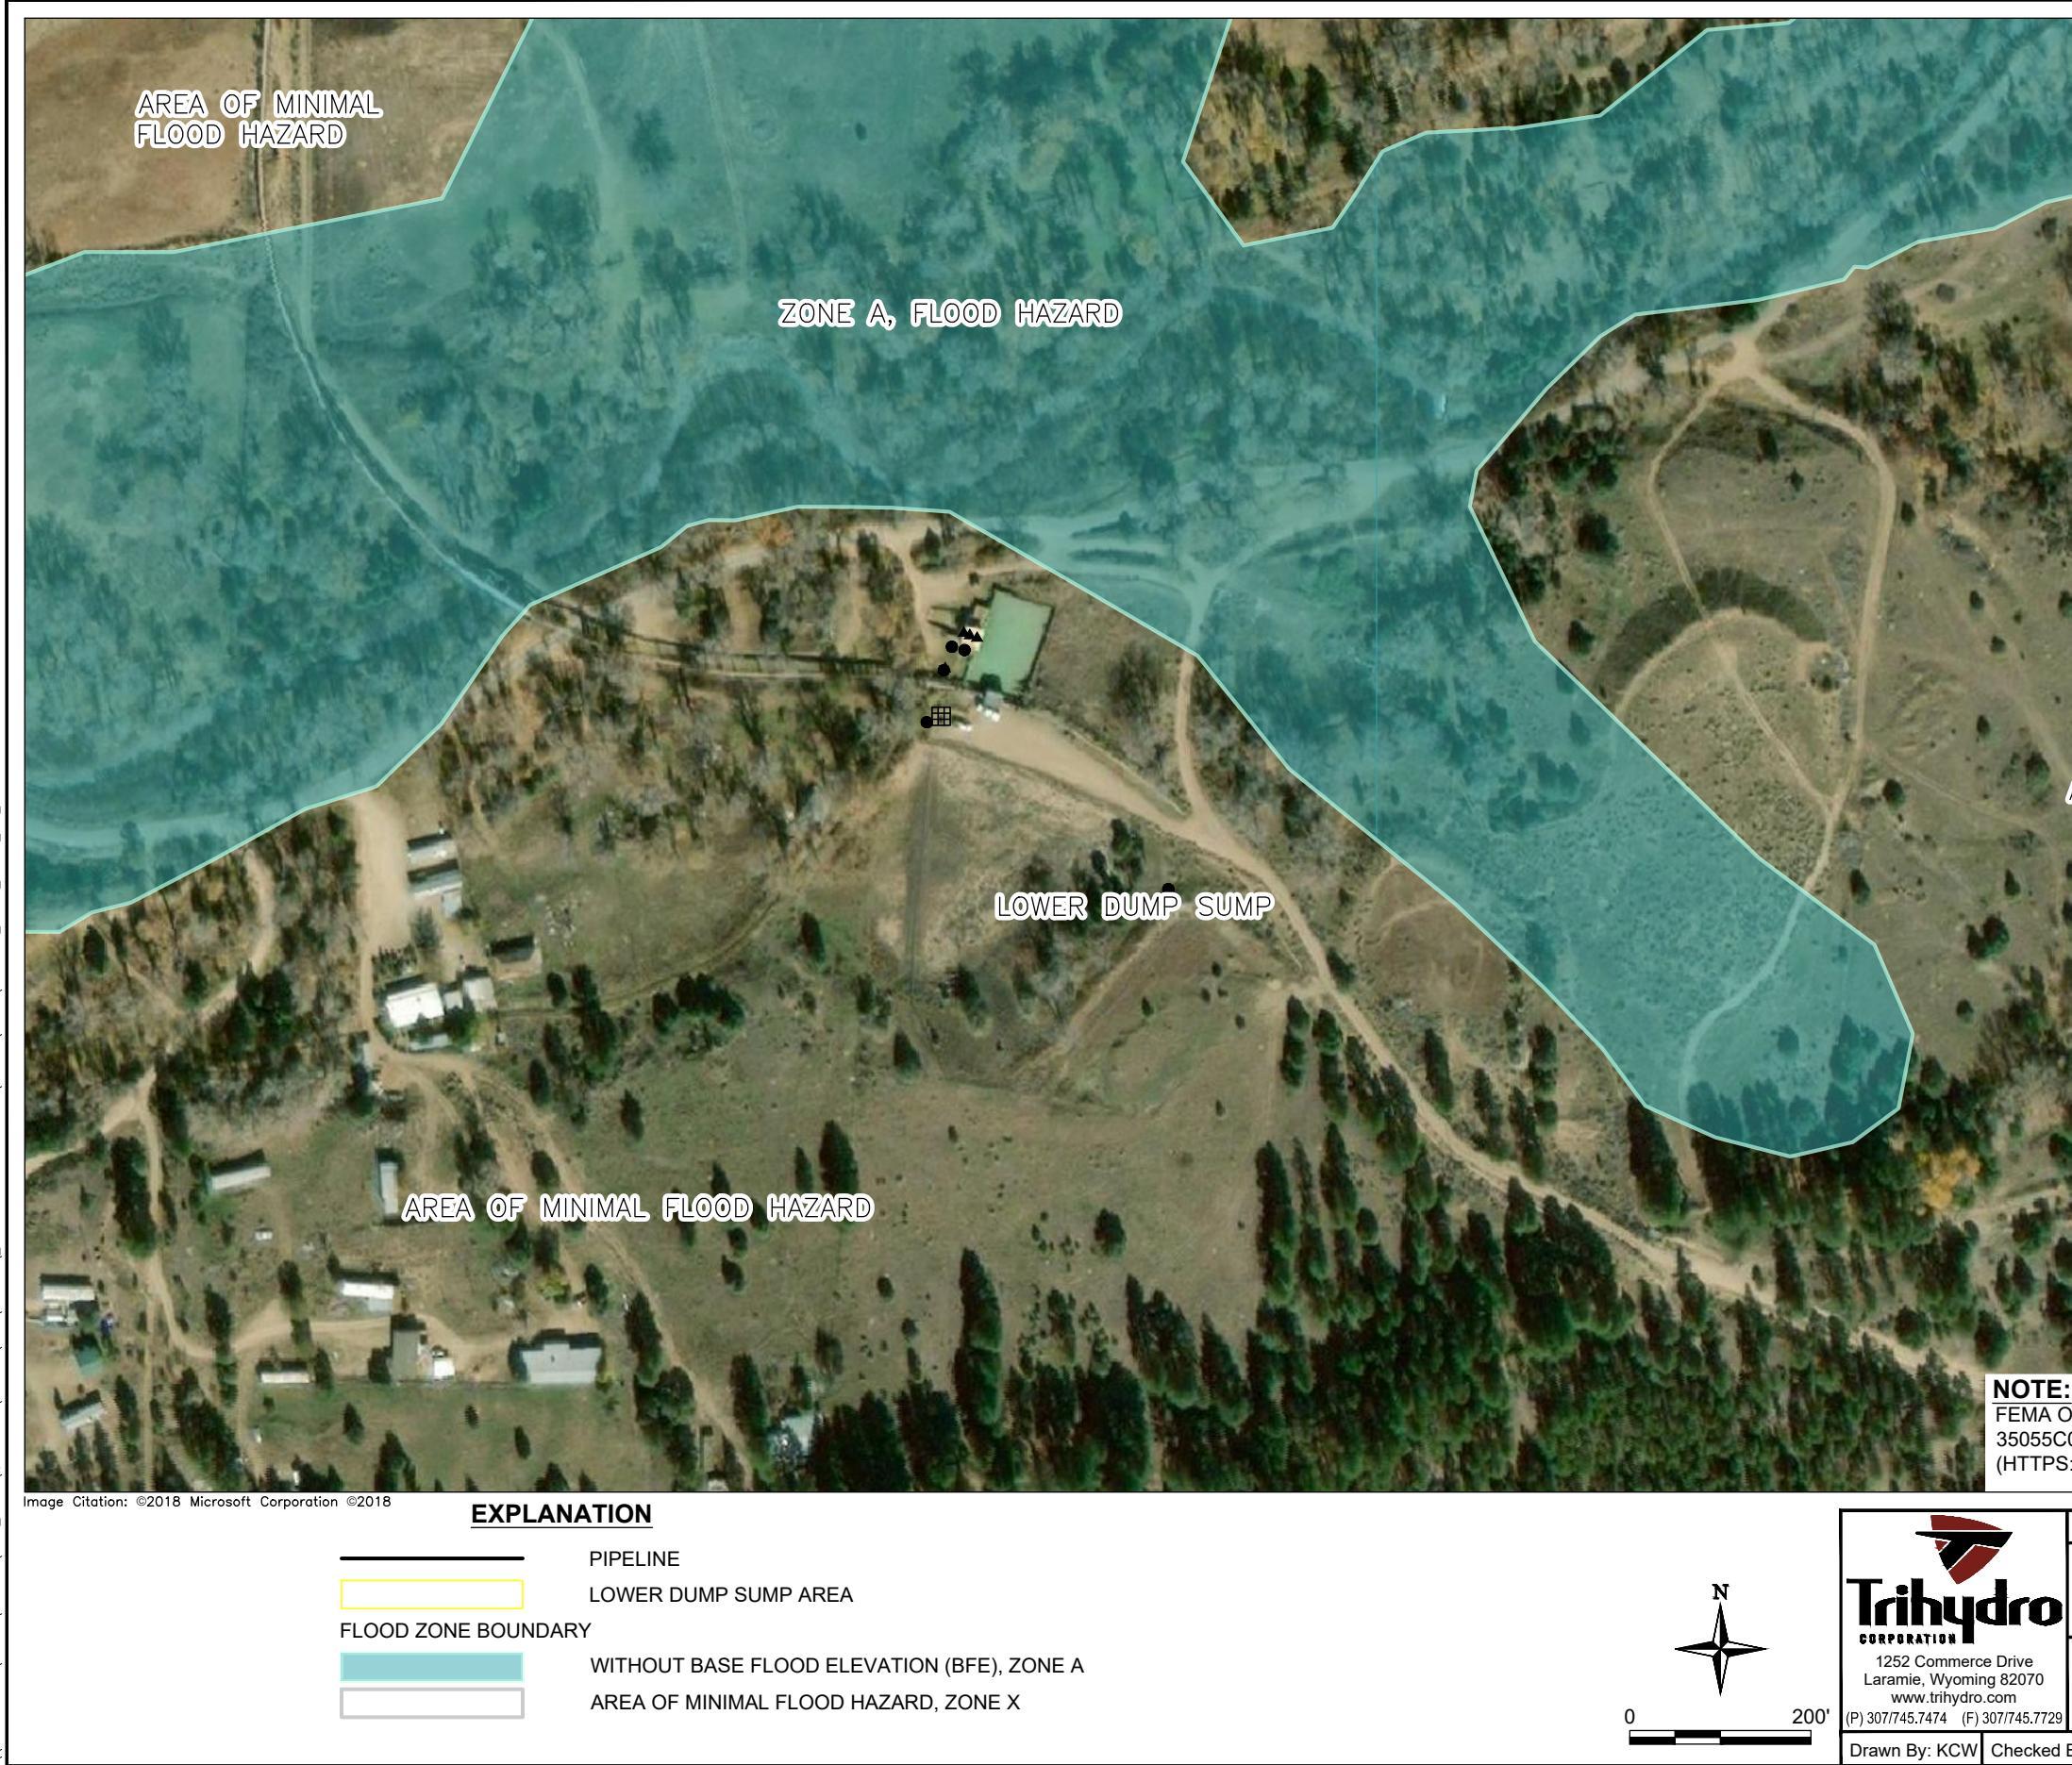
FLOOD HAZARD BOUNDARY

the flood plain and wetlands associated with the Red River. Figure 3.3 shows the Federal Emergency Management Agency (FEMA) flood hazard map (FEMA 2018) for the site. Figure 3.4 shows the wetlands in the vicinity of the Lower Dump Sump. Reclamation and grading activities are not expected to disturbed wetlands near the site.

AREA OF MINIMAL FLOOD HAZARD
E:AC 5C PS	Provide the service center, flood map s
	LOWER DUMP SUMP

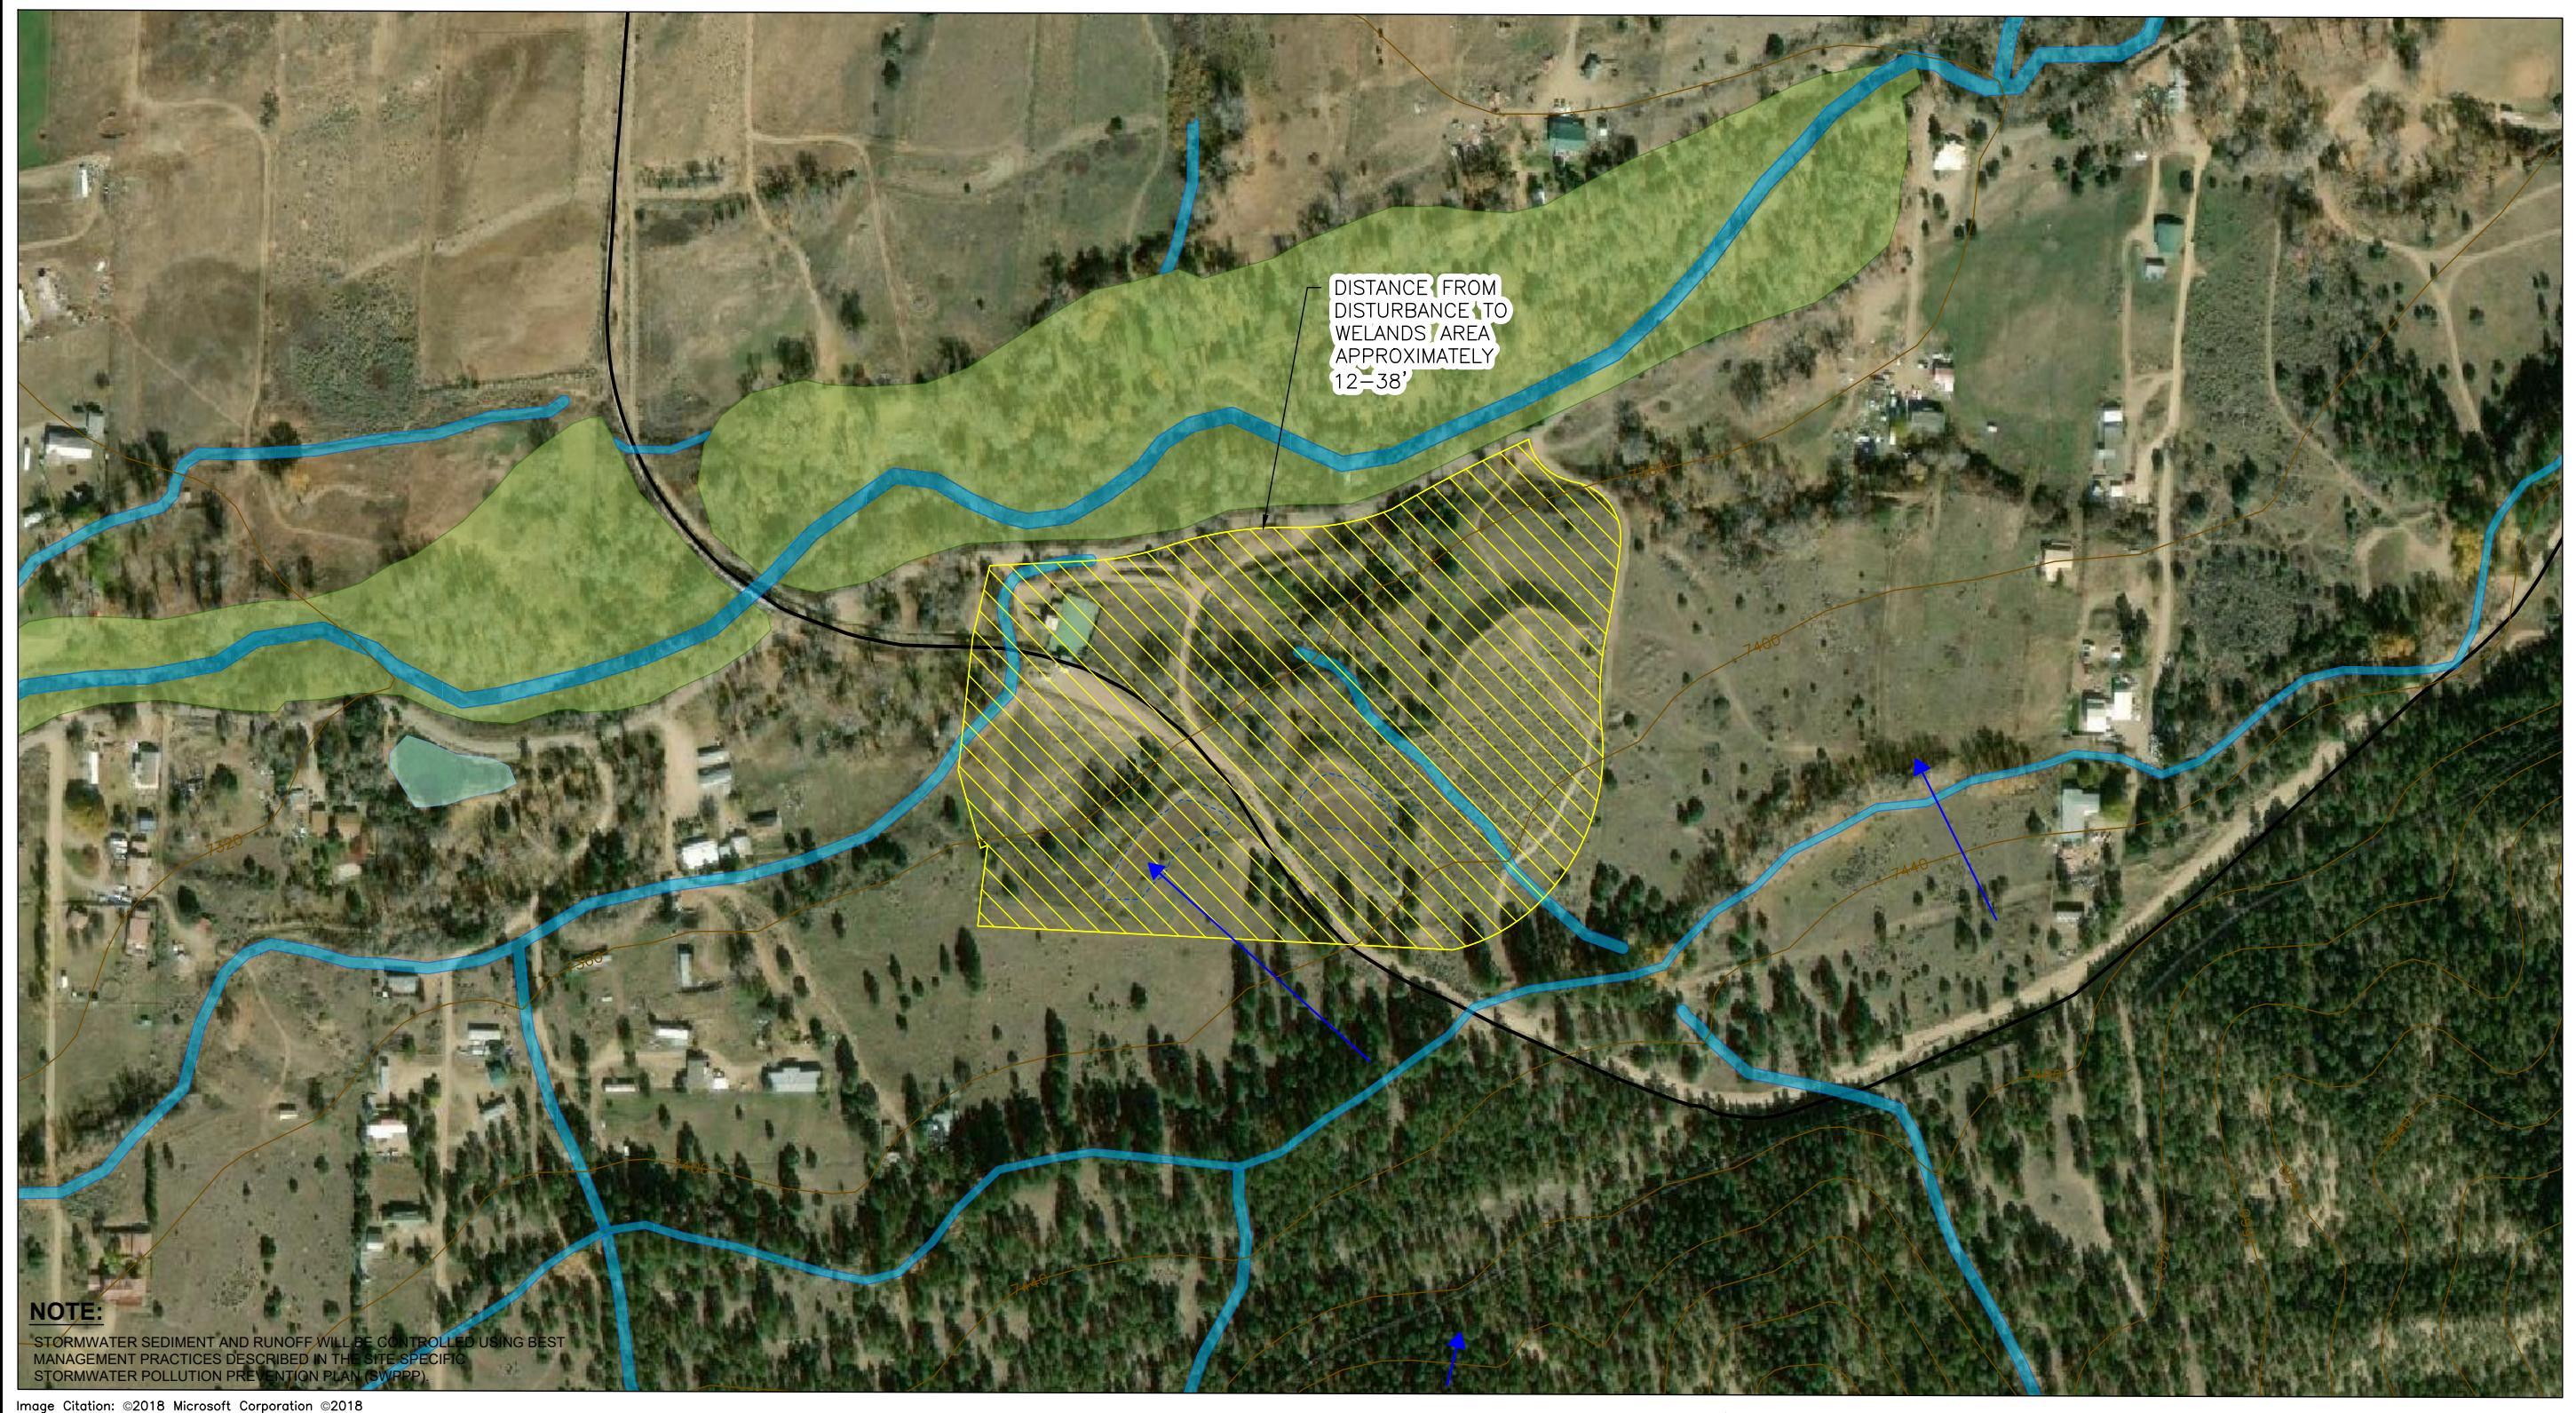
FIGURE	3-4
LOWER DUMP SUMP WETLANDS MAP QUESTA MINE QUESTA, NEW MEXICO				
				/INE MEXICO
ed By: TH		Scale:1" = 300'	Date: 11/5/18	File: 20181103_SWPPP_FIG3-4_ST8_WETLANDS
	,

CONCRETE SUMP AREA OF EXCAVATION FRESHWATER FORESTED/SHRUB WETLAND RIVERINE FORMER TAILINGS RETENTION AREA (FIELD VERIFIED NON-WETLAND)

The above text boxes were an artifact of an earlier version. Field inspections have verified that the subject areas are not wetlands. Details of this field work can be found in the "Aquatic Resource Inventory Report, July 2018" (Appendix A). The subject text boxes have been deleted from the figures.

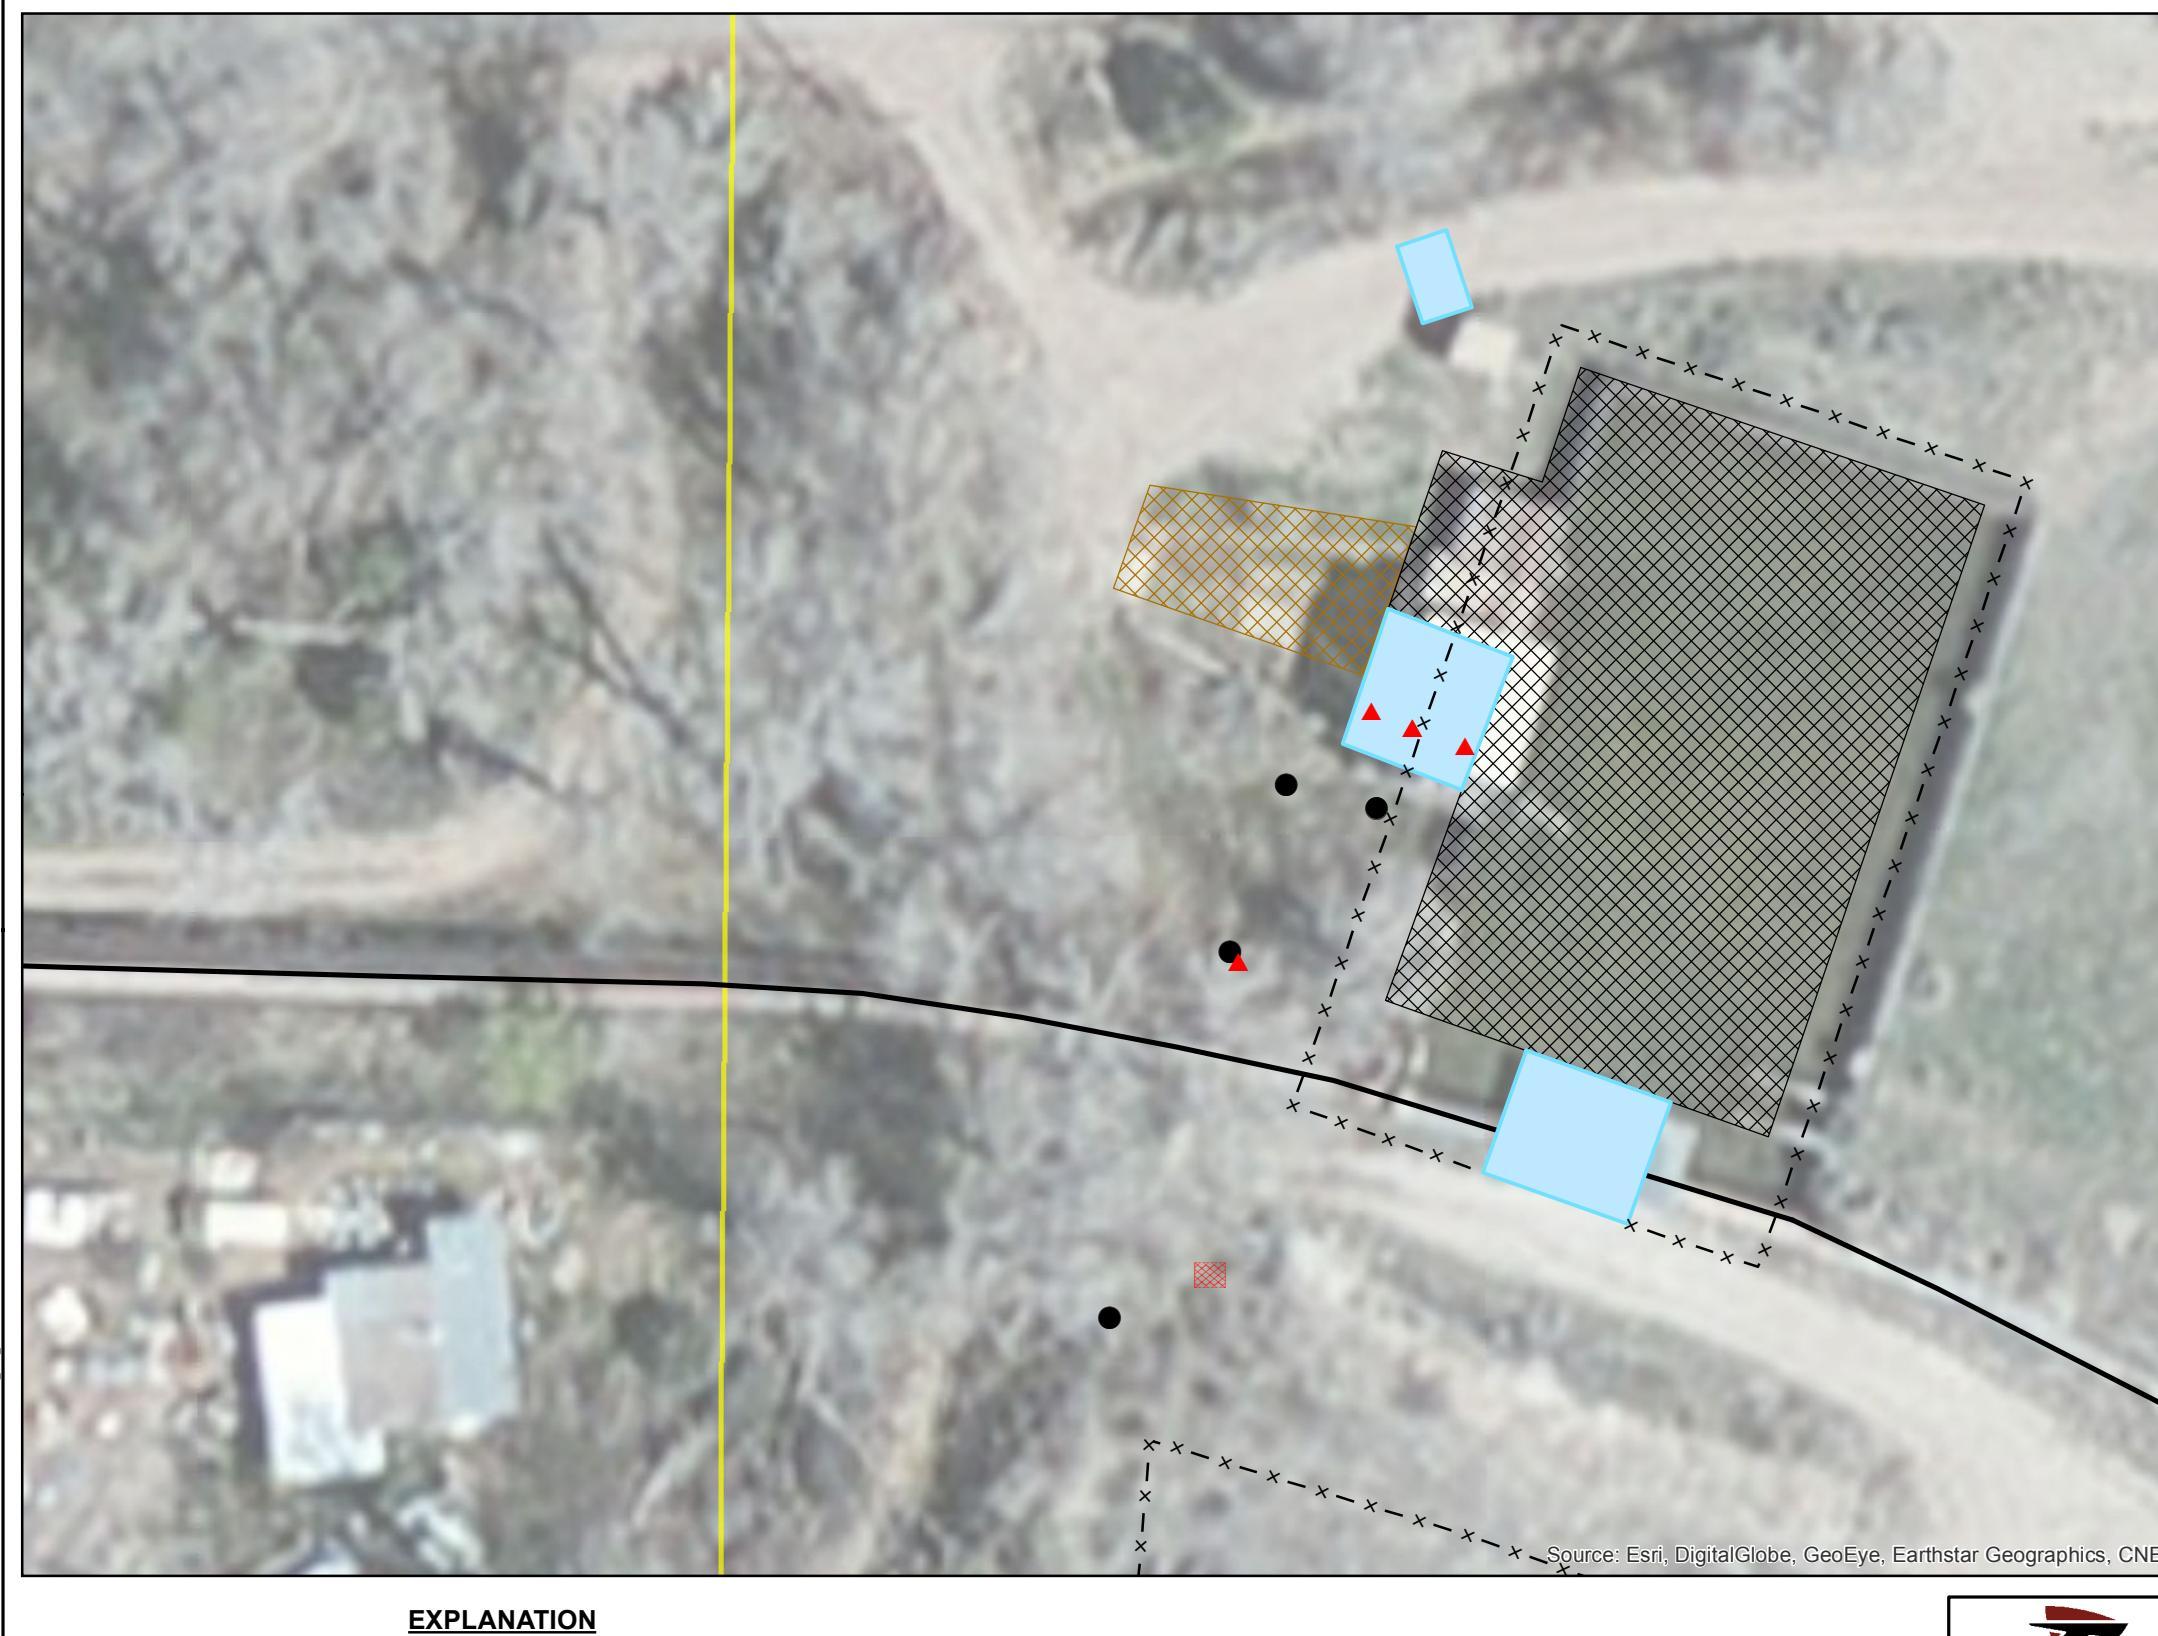
FIGURE 4-1			
SOIL SAMPLE LOCATIONS			
QUESTA MINE QUESTA, NEW MEXICO			
By: BAH	Scale: 1 " = 30 '	Date: 9/17/18	File: Fig4-1_St8_SoilSampleLocs.mxd
	By: BAH	SOIL : QUE By: BAH Scale: 1 " = 30 '	FIGURE SOIL SAMPLE LO QUESTA M QUESTA, NEW By: BAH Scale: 1 " = 30 ' Date: 9/17/18

Samples were collected on September 5, 2018 from four locations in the Lower Dump Sump adjacent to and below the on-site electrical transformers (Figure 4-1) and analyzed for PBC Aroclors. A memorandum detailing the sampling procedure is included as Appendix C. The samples were collected from the 0 to 1 foot interval. A sampling hole was dug using a clean shovel. Soil was loosened from the wall of the sampling holes using the clean shovel. A clean trowel or other appropriate clean sampling device was used to collect the loosened soil and place the soil into a clean sampling jar provided by the laboratory for that purpose. The soil jar was packed completely with soil to insure sufficient volume. The jar was sealed immediately and labeled. The jar was then submitted to TestAmerica Laboratories Inc., under a CoC protocol for analysis of PCB Aroclors by EPA Method SOM01.2 (or the most recent version). Sampling trowels and shovels were decontaminated between sampling locations using a three stage decontamination procedure consisting of an Alconox wash and two rinses of deionized water.

- ELECTRICAL BOX POWER POLE
- TRANSFORMER AND SOIL SAMPLE LOCATIONS
- $\times \times \times$ FENCE

SUPPORT BUILDING LOWER DUMP SUMP AREA

This has been corrected on the figure. Four locations have been sampled and analyzed for PCBs. The results have been received since the first version of the work plan and all samples were non-detect for PCBs.

All four of the samples collected within the LDS were non-detect for PCBs. Details of sampling locations can be found in Figure 4-1 and a summary of the analytical results can be found in Table 4-1. Further details and analytical data can be found in Appendix C.

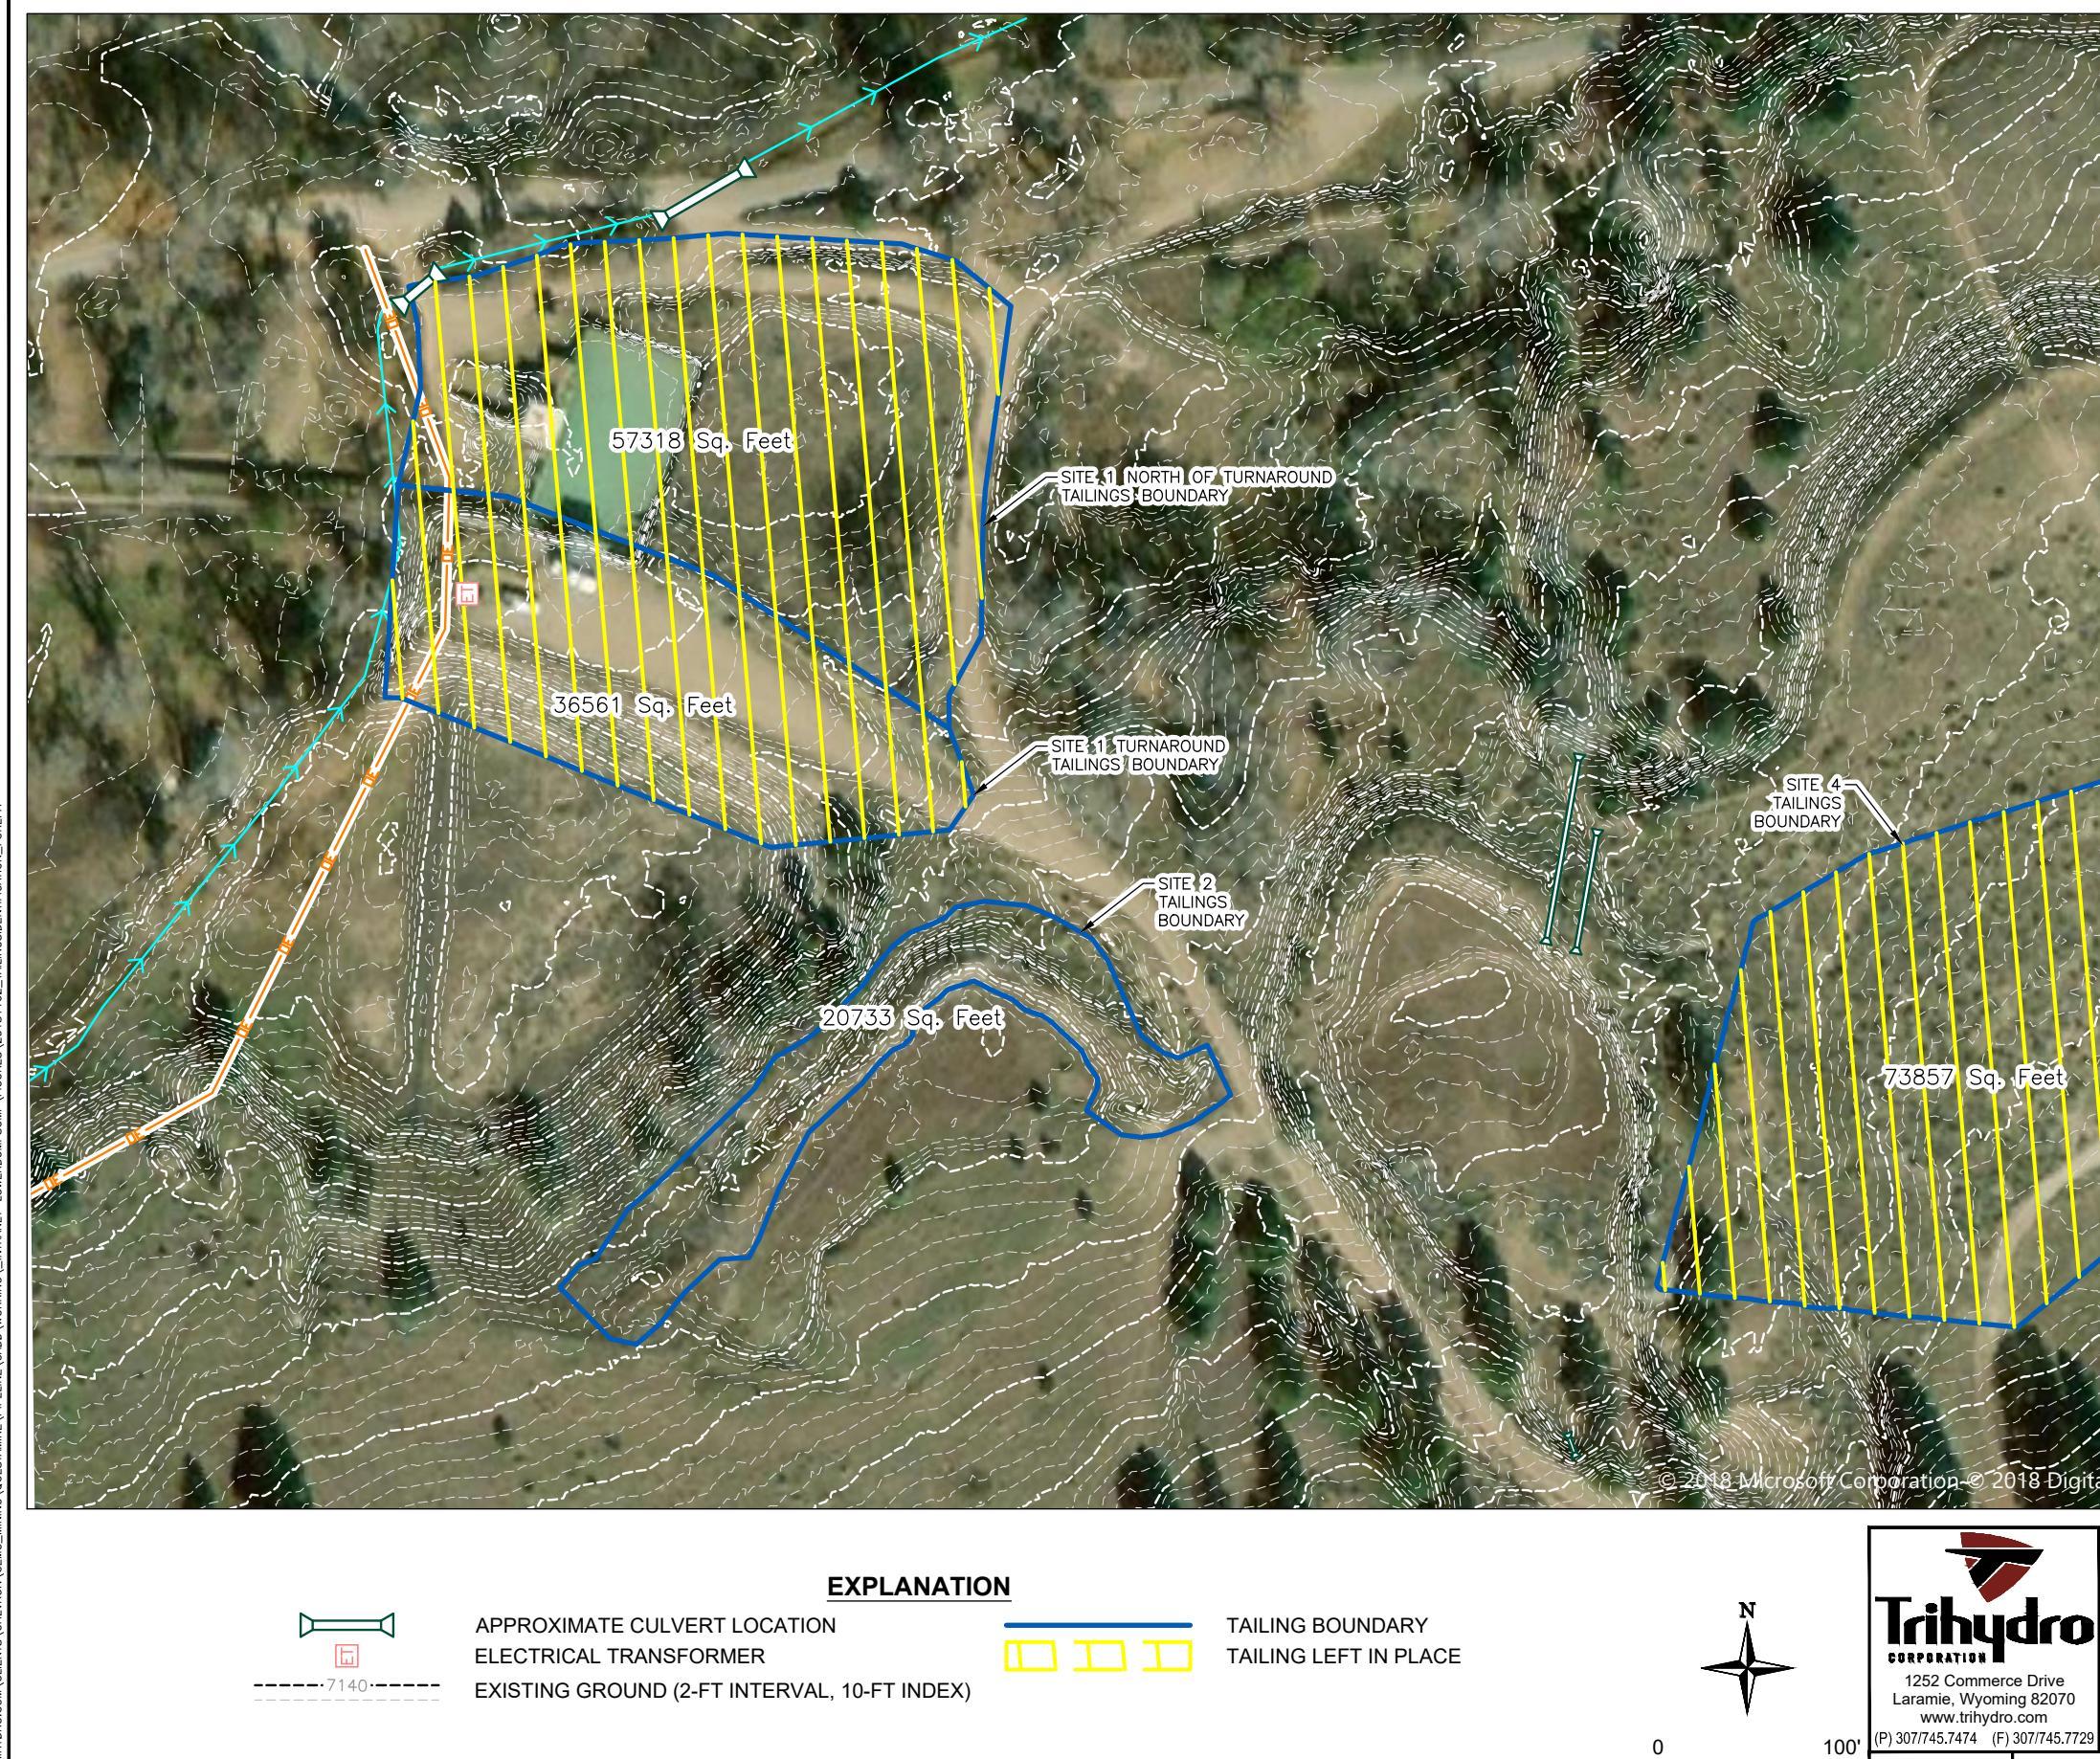
-
		1
		and the second
C V		
		120
		6.
		Che -
		N.
		-
	TAILINGS AREA SUM	MARY
		AREA (SQ FT)
	SITE 1 - NORTH OF TURNAROUND SITE 1 - TURNAROUND	36,561
Globe	SITE 2 - EMBANKMENT	20,733
SITE 4 73,857		
LOWER DUMP SUMP TAILINGS IDENTIFICATION		
QUESTA MINE CHEVRON MINING QUESTA, NEW MEXICO

Site 2 consists of mounded tailings. Areas with mounded tailing (or tailings that have a distinct stockpile shape above surrounding natural topography., i.e. Site 2) will be excavated and the tailing material will be removed to the tailing facility area, previously used for disposal during the 2013/2014 Historic Tailing Spill activities. Grading information for Site 2 is found in Sheets 1 and 2 of the Plan Sheet section. Approximately 2,700 CY of tailing is anticipated to be removed from the Site 2 area. If tailing extends below the ground surface it will be excavated to a depth of 3 feet below ground surface (BGS) and capped with clean fill according to the process outlined in Section 5.3.3.

For areas where tailing was found below grade (i.e. Site 4), a uniform removal of 3 feet of tailings material will be completed and the removed tailing will be disposed of at the tailing facility. The area will then be backfill to near existing contour with clean borrow. No less than 3.3 feet of clean fill will top the disturbed areas. Clean fill will be placed, graded, and verified with by GPS guided equipment to match the original topography and the designed drainages for the Lower Dump Sump. Sheet 2 and subsequent earthwork cross-sections detail the final grading plan for Site 4. The proposed final grading is consistent with the May 19, 2017 approved workplan.
