BASELINE DATA REPORT

Section 10.0

Prior Mining Operations

PRIOR MINING OPERATIONS
ROCA HONDA PERMIT AREA
McKinley/Cibola County, New Mexico

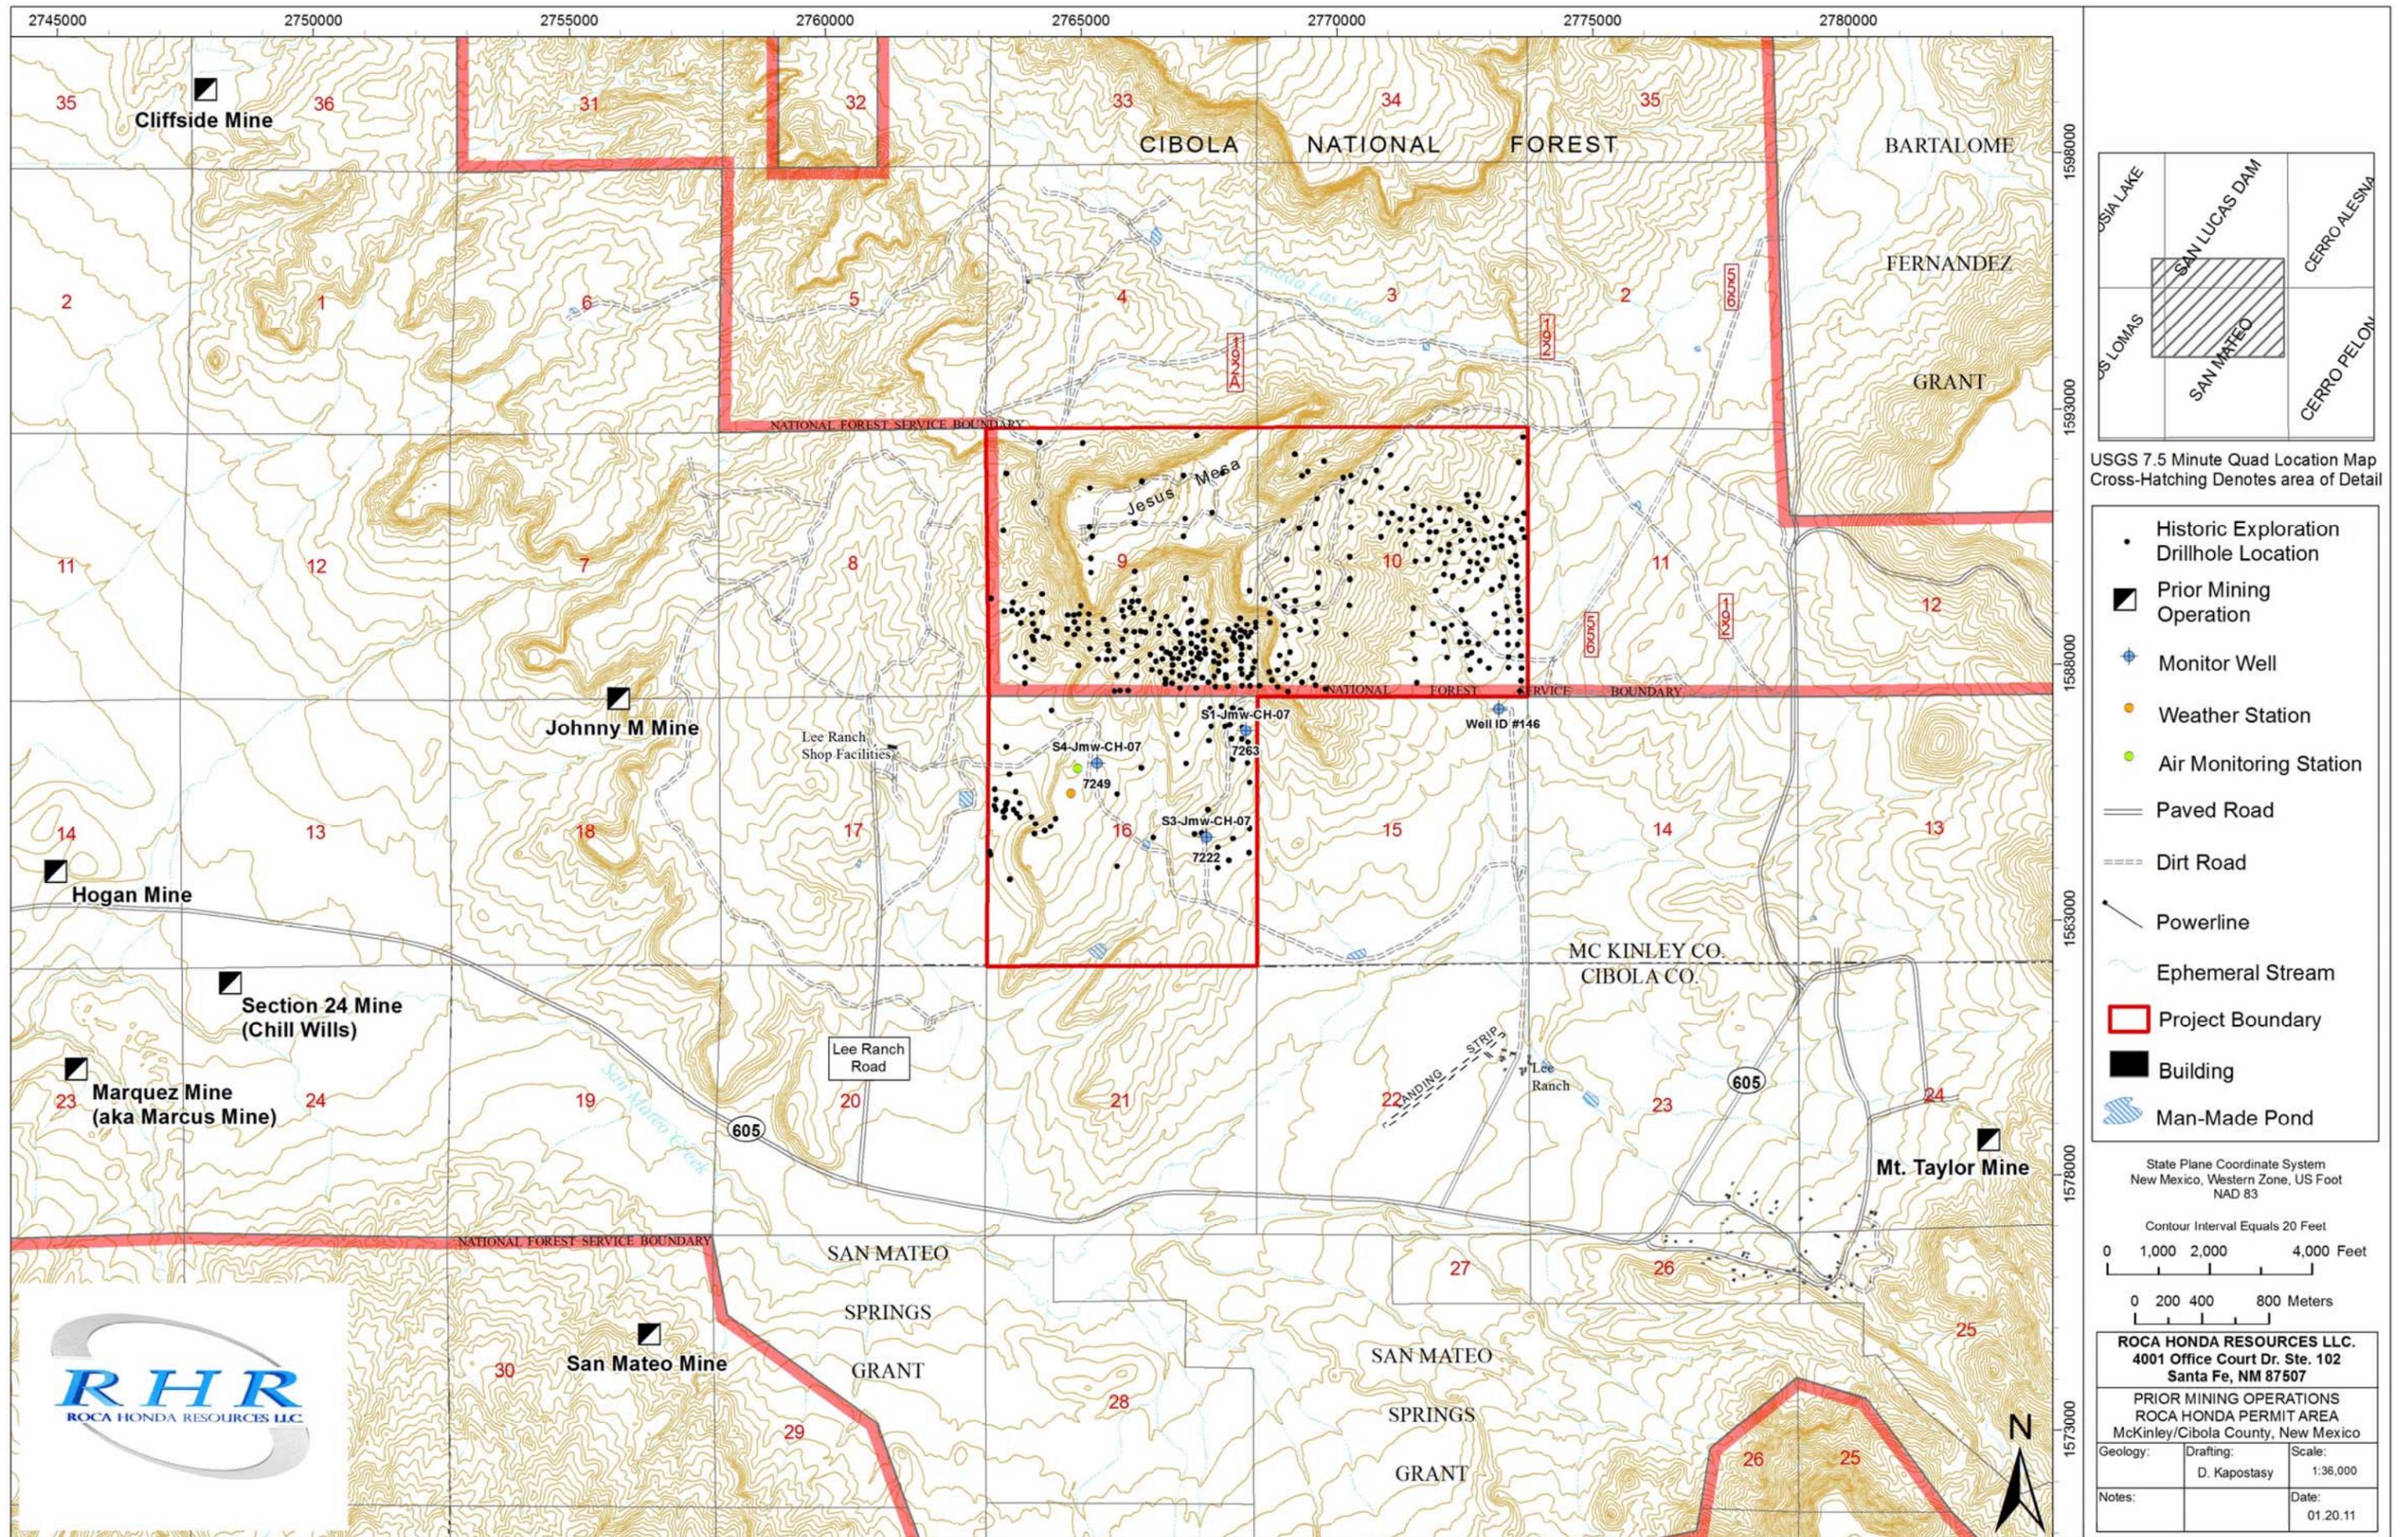
Figure 10-1. Topographic Base Map Showing Prior Mining Operations (1:36,000)

No previous mining operations exist on the permit area which may have affected the permit area. There were, however, more than 400 historic exploration boreholes drilled from the late 1960s to the early 1980s in various locations of the permit area. Figure 10-1 illustrates the density of drilling, particularly in Sections 9 and 10 of the permit area. The Kerr-McGee Corporation began drilling on Sections 9 and 10 in 1966; approximately 362 drill holes (839,687 ft) were completed. Most holes in Sections 9 and 10 were drilled from 1966 to 1985. Rare Metals Corporation completed 13 drill holes of unknown footage on Section 16 in the 1950s. Western Nuclear drilled 63 exploration holes (121,164 ft) through the 1980s. Historic drilling (prior to RHR) on Sections 9, 10 and 16 was approximately 438 drill holes totaling approximately 960,851 ft. RHR drilled 4 holes in 2007. RHR has compiled information regarding the location (UTM coordinates), and depth of each hole. This information is considered confidential and is, therefore, submitted under separate cover in accordance with NMAC 19.10.6.602.B.

The Section 17 Lee Ranch shop facilities can be seen in Figures 10-1 and 10-2. This area is the location of an uncompleted mine shaft that was constructed in the late 1970s and early 1980s by Kerr-McGee. Construction of the shaft stopped near the top of the Westwater Formation, i.e., the ore bearing formation. Few details of the particulars of shaft construction are available to RHR. It has been reported (but not confirmed) that the shaft was completed to approximately 1700 ft below ground surface. That would place the bottom of the shaft near the top of the Westwater Formation. As such, it cannot and does not act as a “ground water sink.”

Although no prior mining operations affect the RHR permit area, Figures 10-1 and 10-2 identify several prior mining operations in the vicinity. Approximately 3 miles southeast of the permit area is the RGRC (aka, Gulf Mt. Taylor) underground uranium mine facility. This mine has been on standby since the early 1990s. Similarly, only limited data is available from the Mt. Taylor mine. RHR has reviewed and has included as part of its BDR data set, much of the publicly available information to assist it in developing background, including water quality of the mine discharge water. However, mine dewatering information is not otherwise currently available for RHR's use.

Also shown on Figures 10-1 and 10-2 in the vicinity of RHR's permit area are the San Mateo, Marquez (also called Marcus on some maps), Hogan, Cliffside, Section 24 (Chill Wills), and Johnny M Mines. These mines have not been in operation for many years.
