CHANNEL RESTORATION

Madrid's Mining Landscape / Madrid, NM
Community Meeting #2 07.28.2010

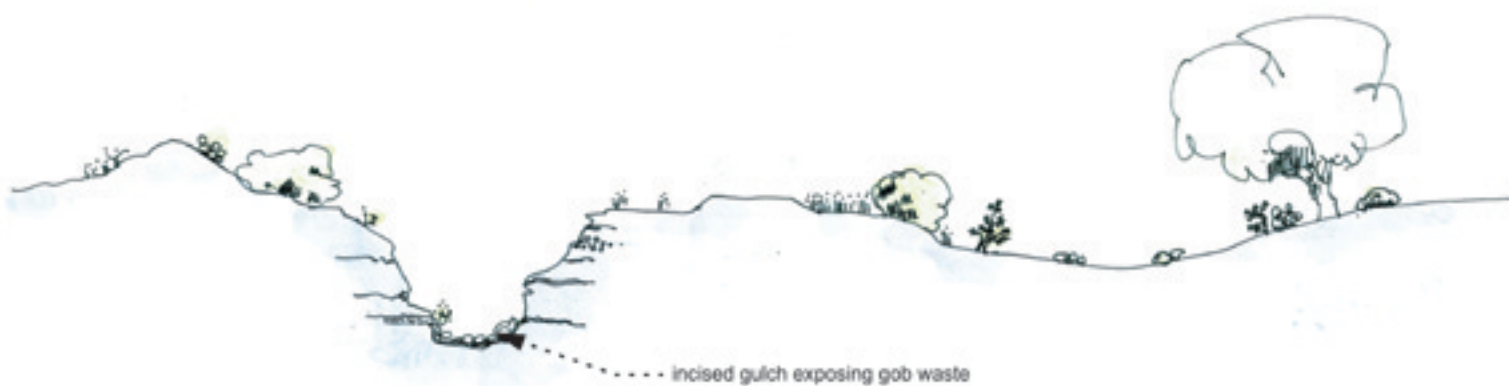
Existing Typical Gulch Section, n.t.s.

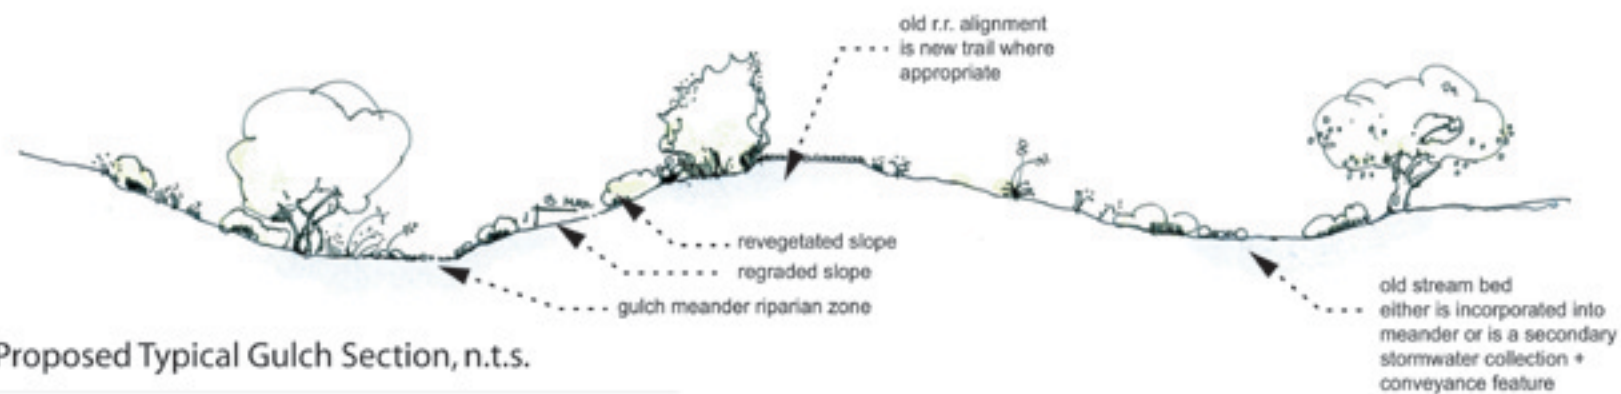
Proposed Typical Gulch Section, n.t.s.
