**MEMORANDUM
OFFICE OF THE STATE ENGINEER
HYDROLOGY BUREAU**

DATE: November 15, 2022
TO: David Otori, Permit Lead, Mining Act Reclamation Program (MARF)/MMD
Holland Shepherd, Program Manager, MARF/MMD
THROUGH: Katie Zemlick, Ph.D., Chief, Hydrology Bureau *KZ*
Laura Petronis, Water Resources Manager 1, Hydrology Bureau *LJP*
FROM: Brad Wolaver, Ph.D., Senior Hydrologist, Hydrology Bureau *BDW*
Christopher E. Angel, P.G., Senior Hydrologist, Hydrology Bureau *CEA*
SUBJECT: Review and Comments, Revision 22-1 to Mt. Taylor Mine, Permit No. CI002RE,
Rio Grande Resources Corporation

1. Introduction and Conclusions

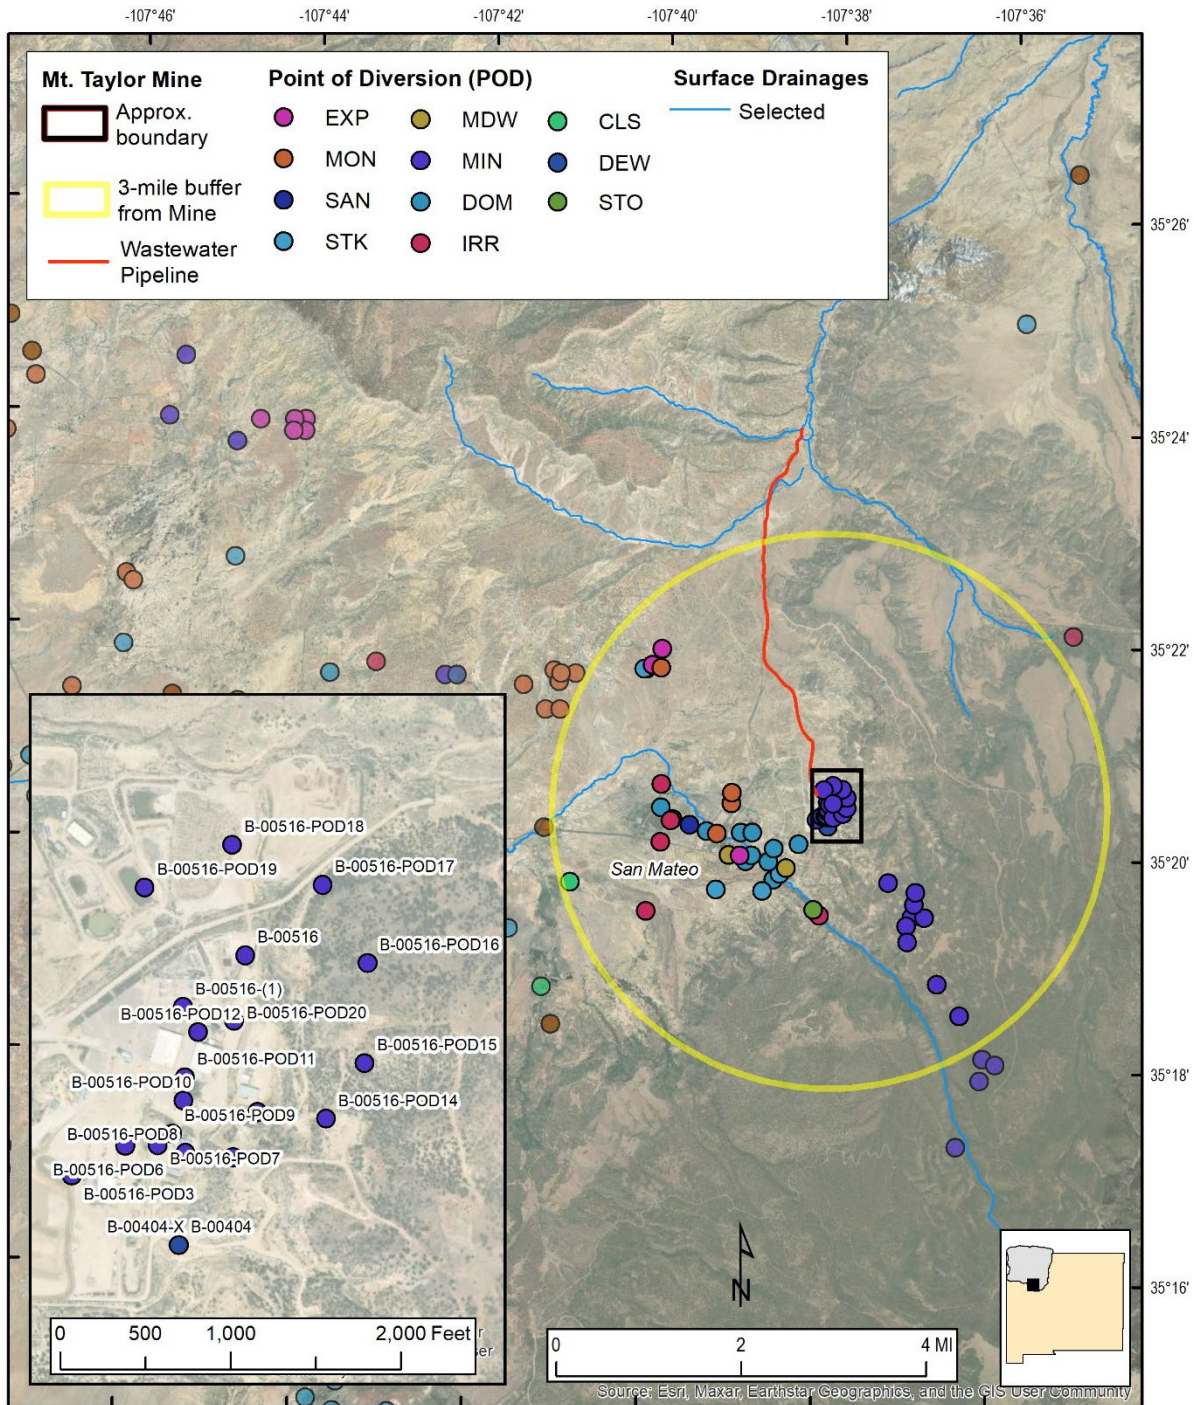
Figure 1. Mount Taylor Mine, surface hydrology, groundwater wells (NMOSE, 2022)

Notes: Large inset map shows wells on the approximate extent of the Mine property. Three-mile buffer around Mine used to identify groundwater wells. Black rectangle shows the approximate extent of the Mine property. Gray polygon of inset map identifies the San Juan Structural Basin. POD types are: EXP = exploration, MON = monitoring, SAN = sanitary (commercial use), STK = stock, MDW = community water supply, MIN = mining, DOM = domestic, IRR = irrigation, CLS = closed file, DEW = dewatering, STO = storage.

The Mine is in the southeast corner of the San Juan Structural Basin (Basin) in the Grants Mineral Belt (McLemore and Chenoweth 2003) (**Figure 1**). The Basin hosts multiple aquifers and aquitards, with groundwater recharging along elevated Basin margins and discharging to Rio Grande tributaries and the San Juan River (Stone et al. 1983; Kelley et al. 2014; Craigg 2001) (**Figure 2**). Subsurface Mine infrastructure, including wells, utility conduits, and shafts interacts with several aquifers, including San Mateo Creek alluvium, Point Lookout (Wright 1986), Tres Hermanos Member of the Mancos Shale (Tres Hermanos; Hook et al., 1985), Dakota Sandstone Member of the Mesaverde Group (Dakota; Craigg, 2001), and the Westwater Canyon (T.W. Kelly 1977) (**Figure 3, Figure 4**).

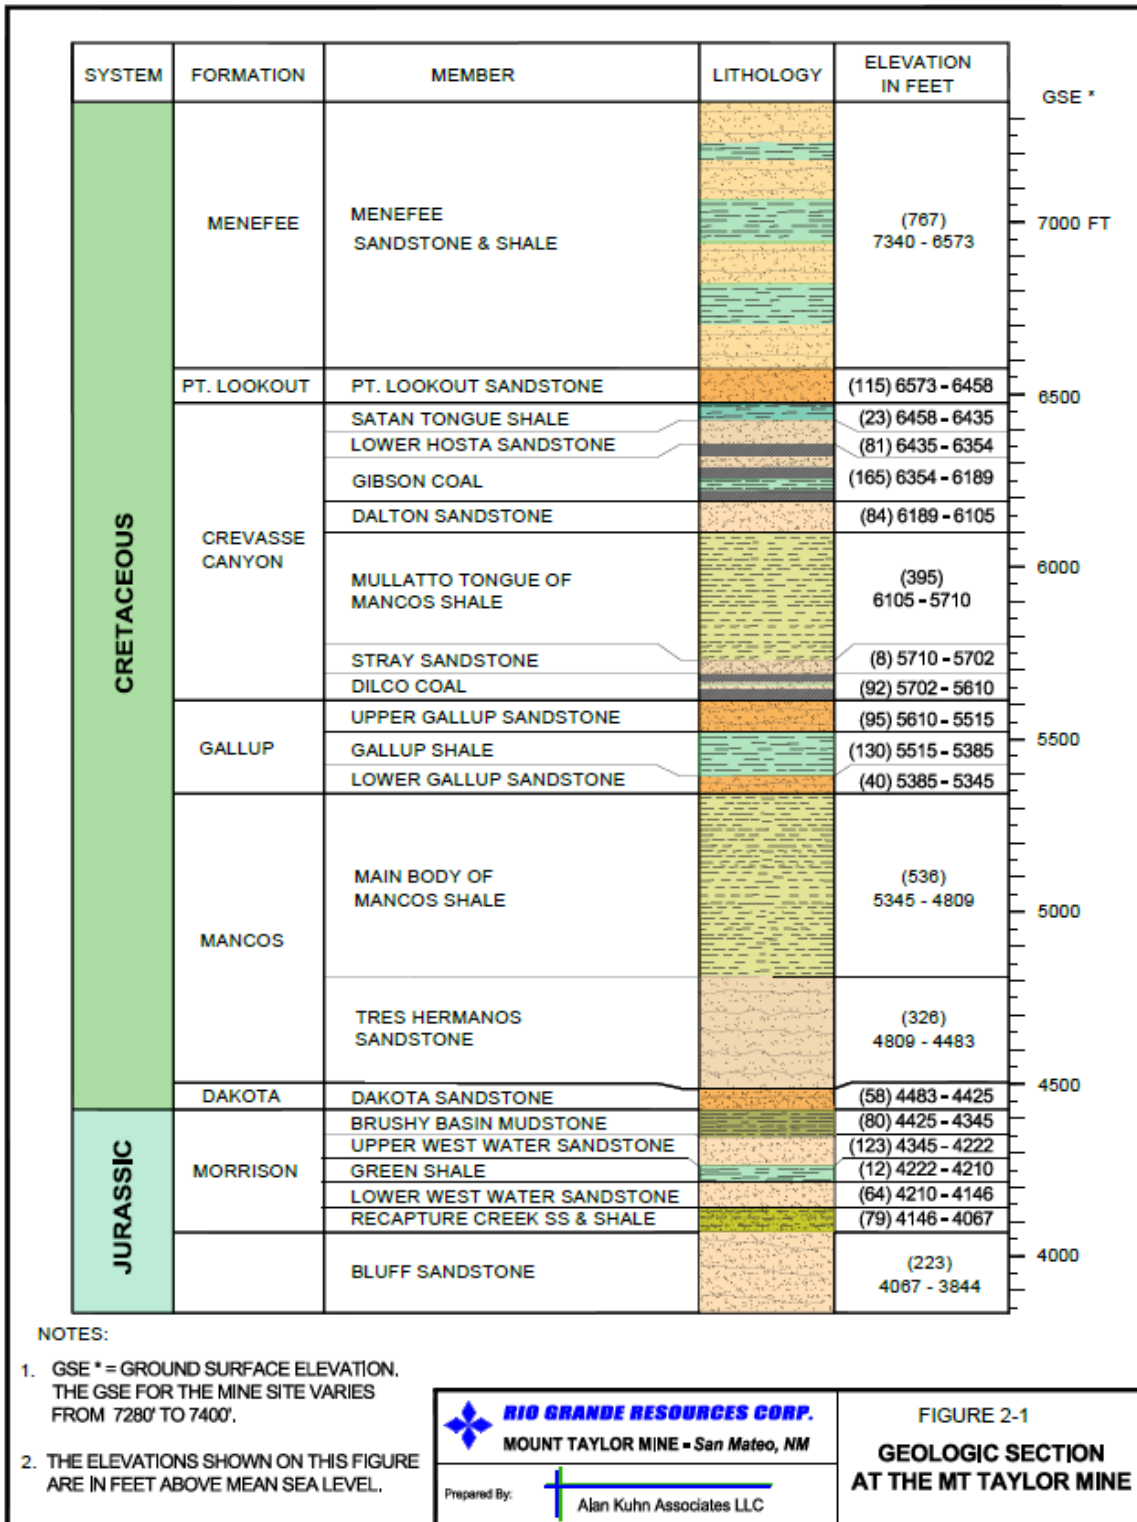
Figure 3. Geologic section at the Mine

Source: RGR (2022).

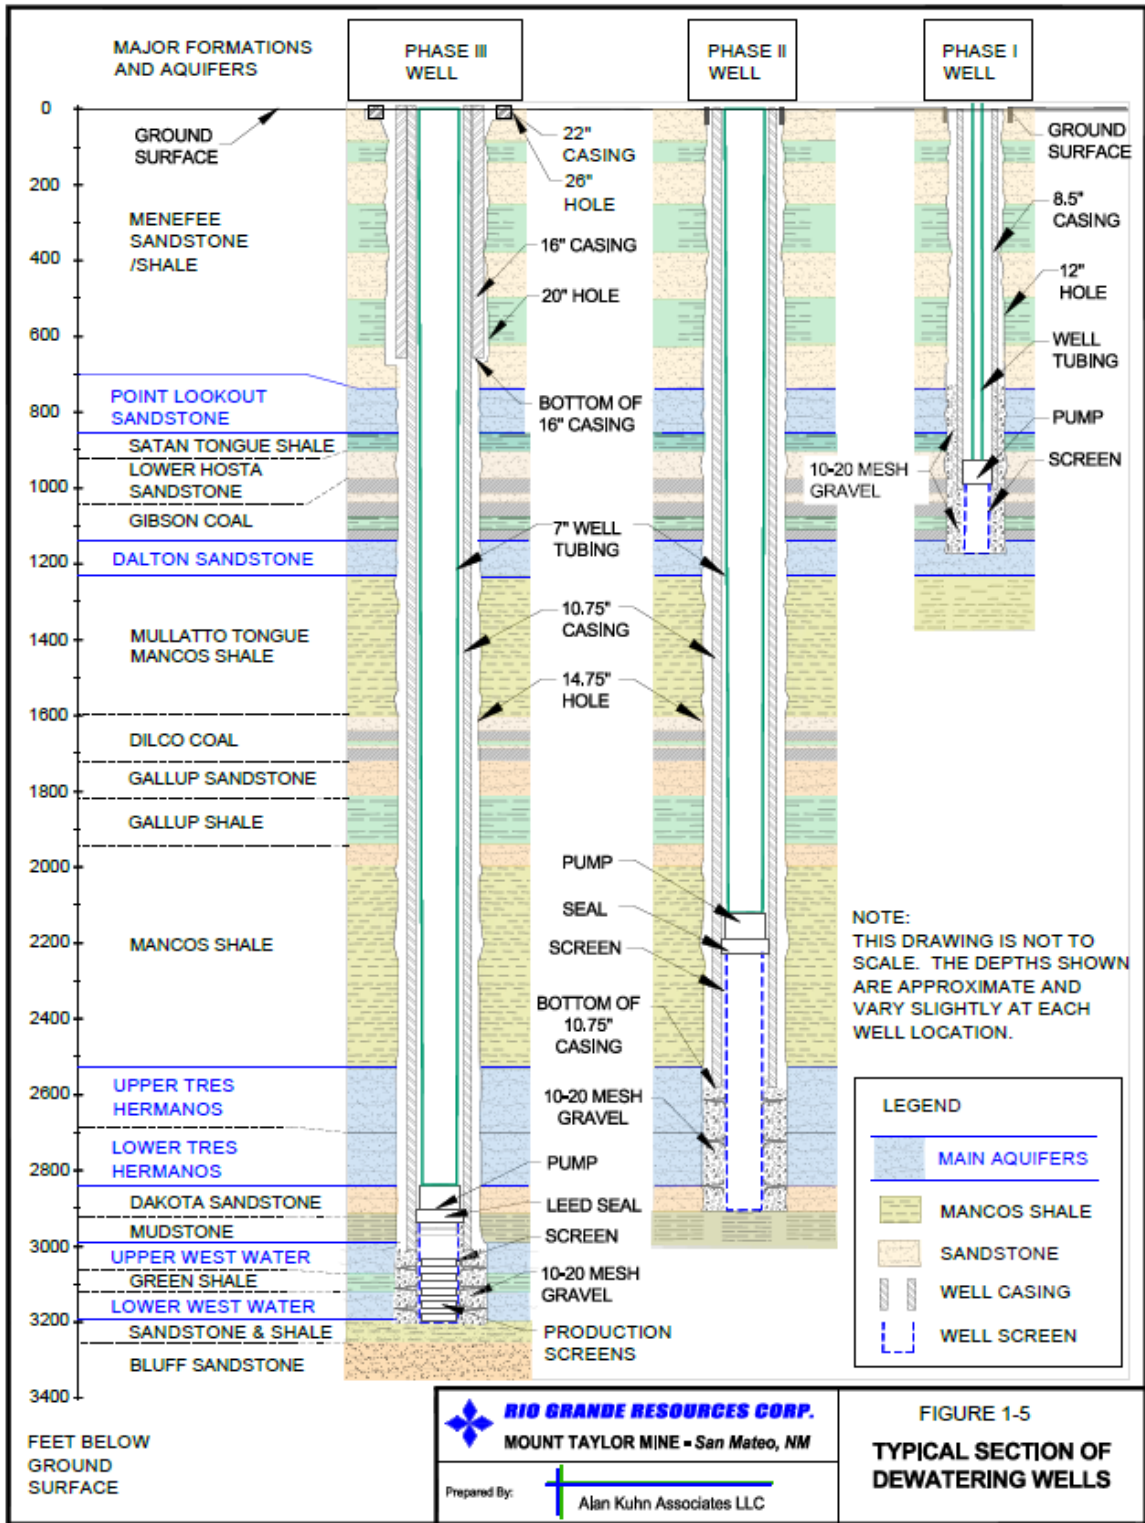
Figure 4. Aquifers penetrated by shafts and dewatering wells

Source: RGR (2022).

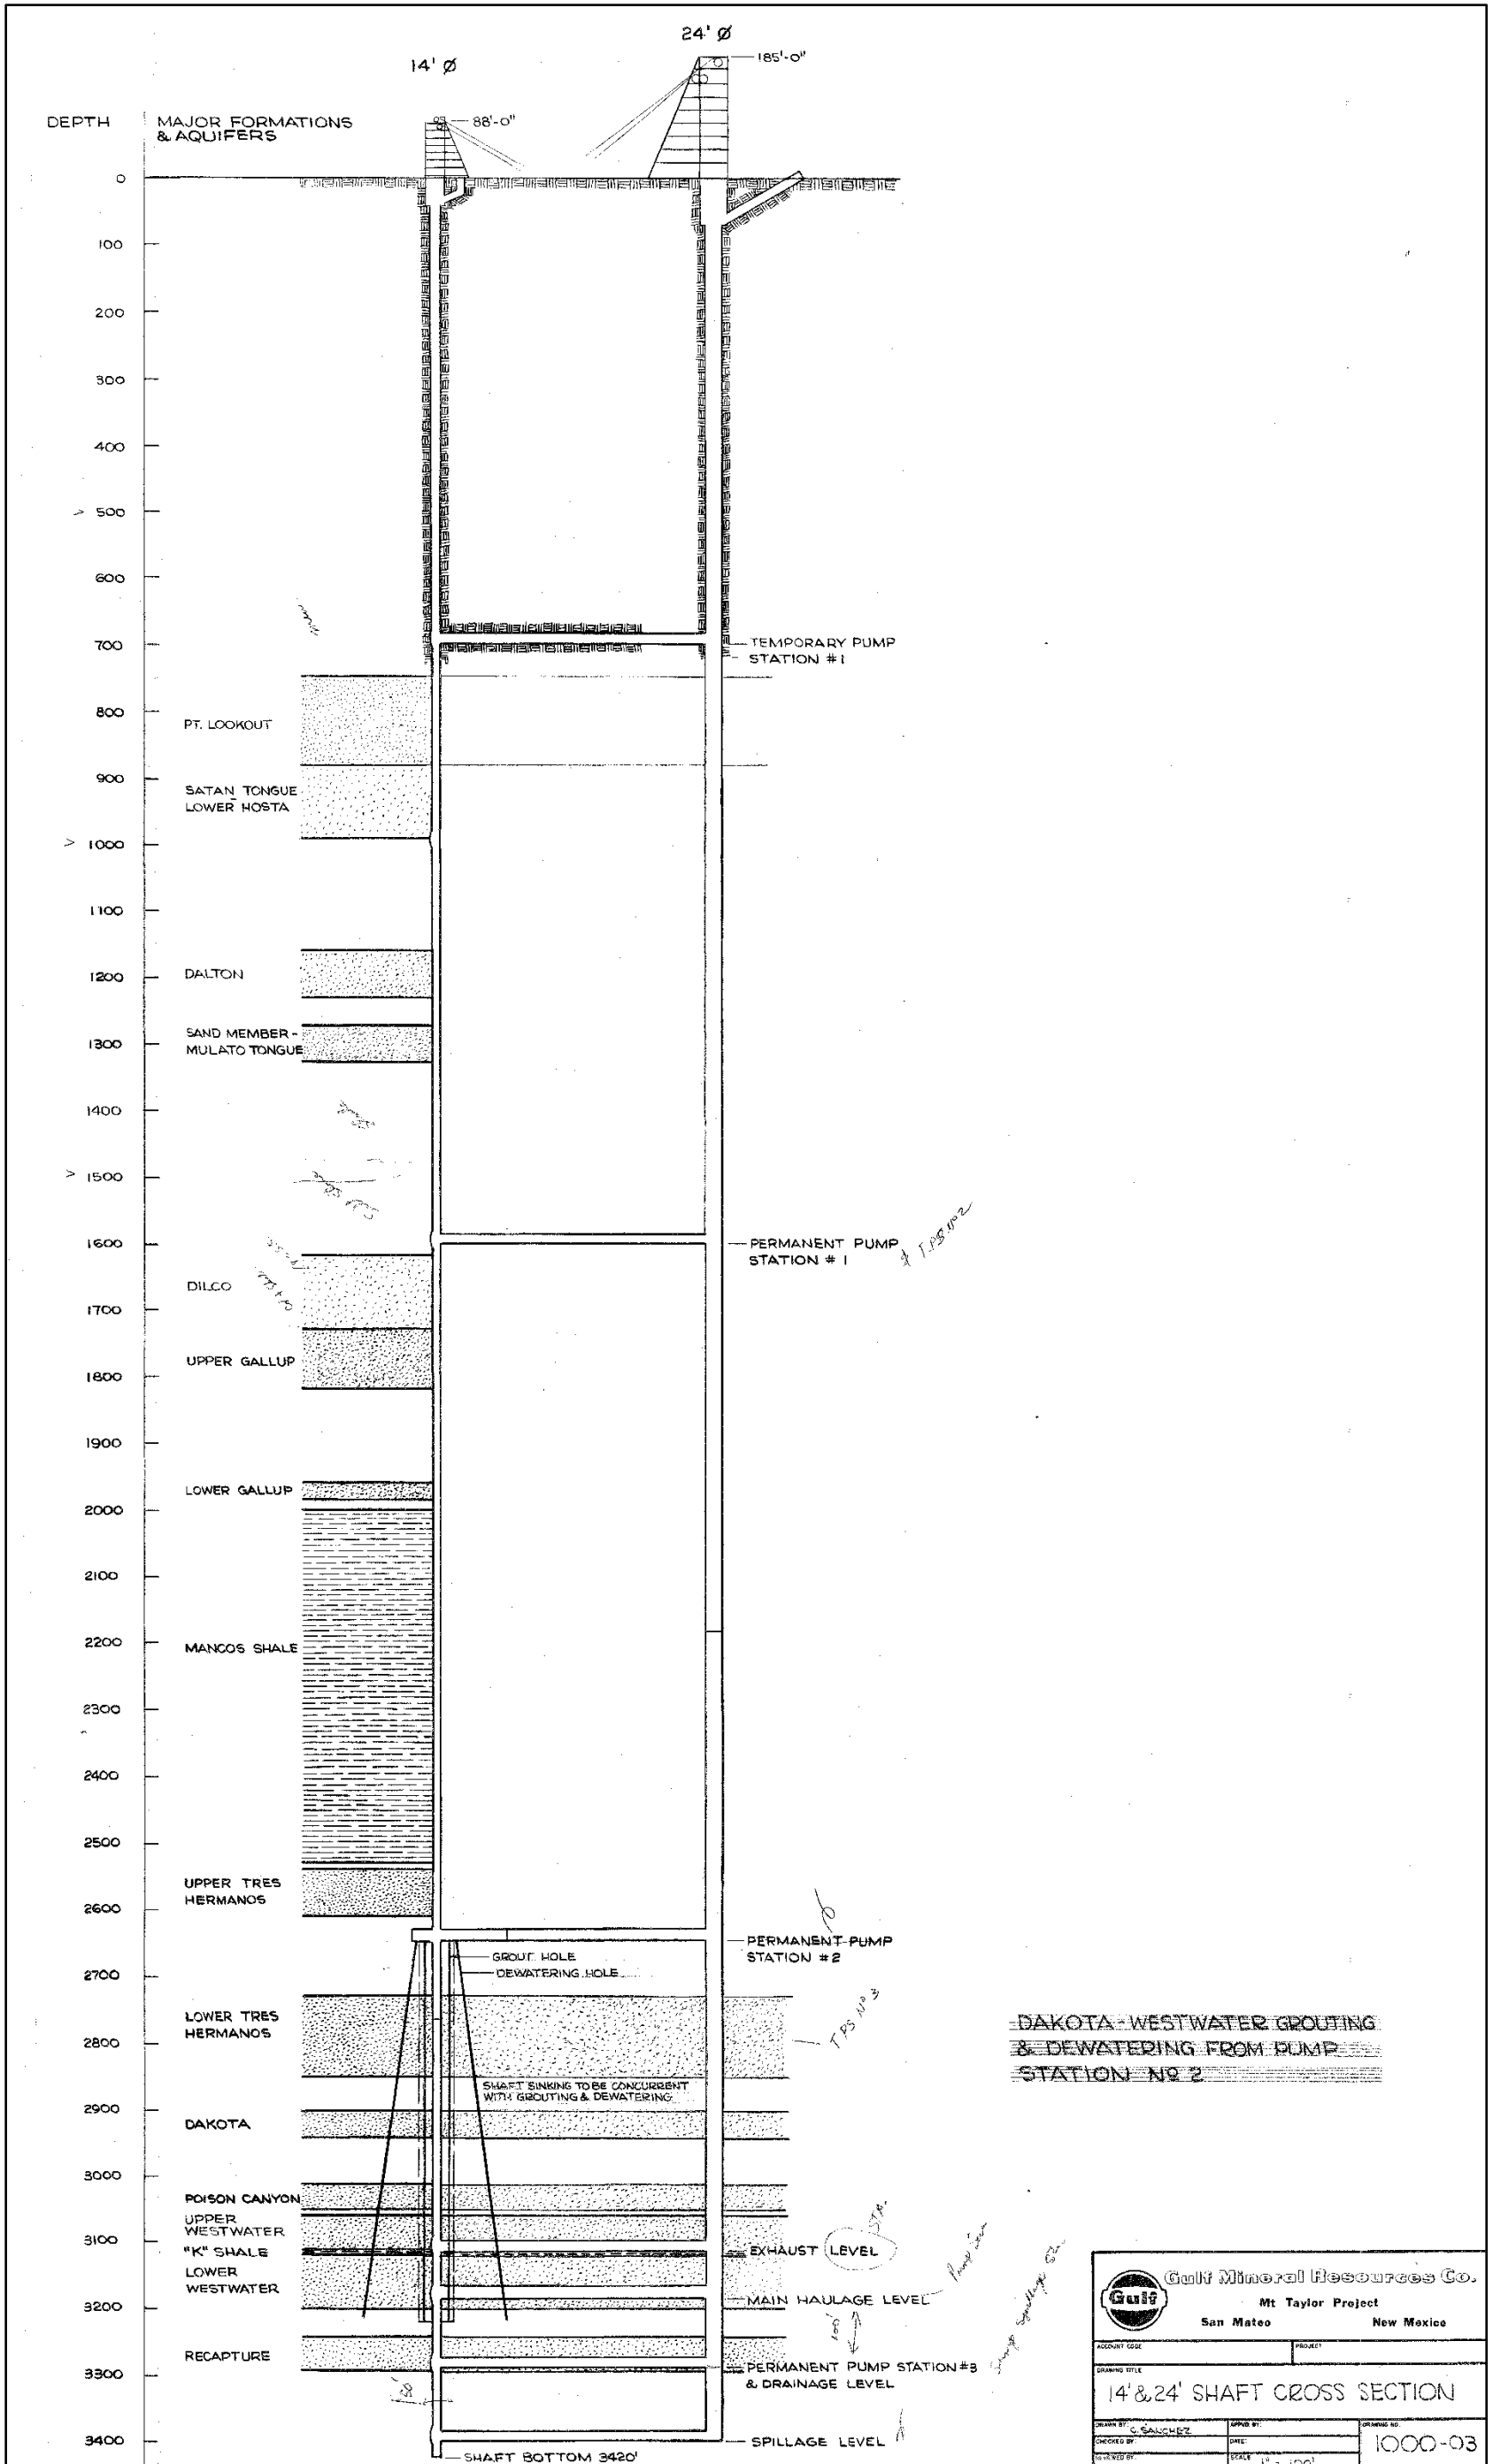
**Appendix A. Mine Shaft Proposed Design with Pump Stations and Stratigraphy
(Drawing No. 1000-03)**

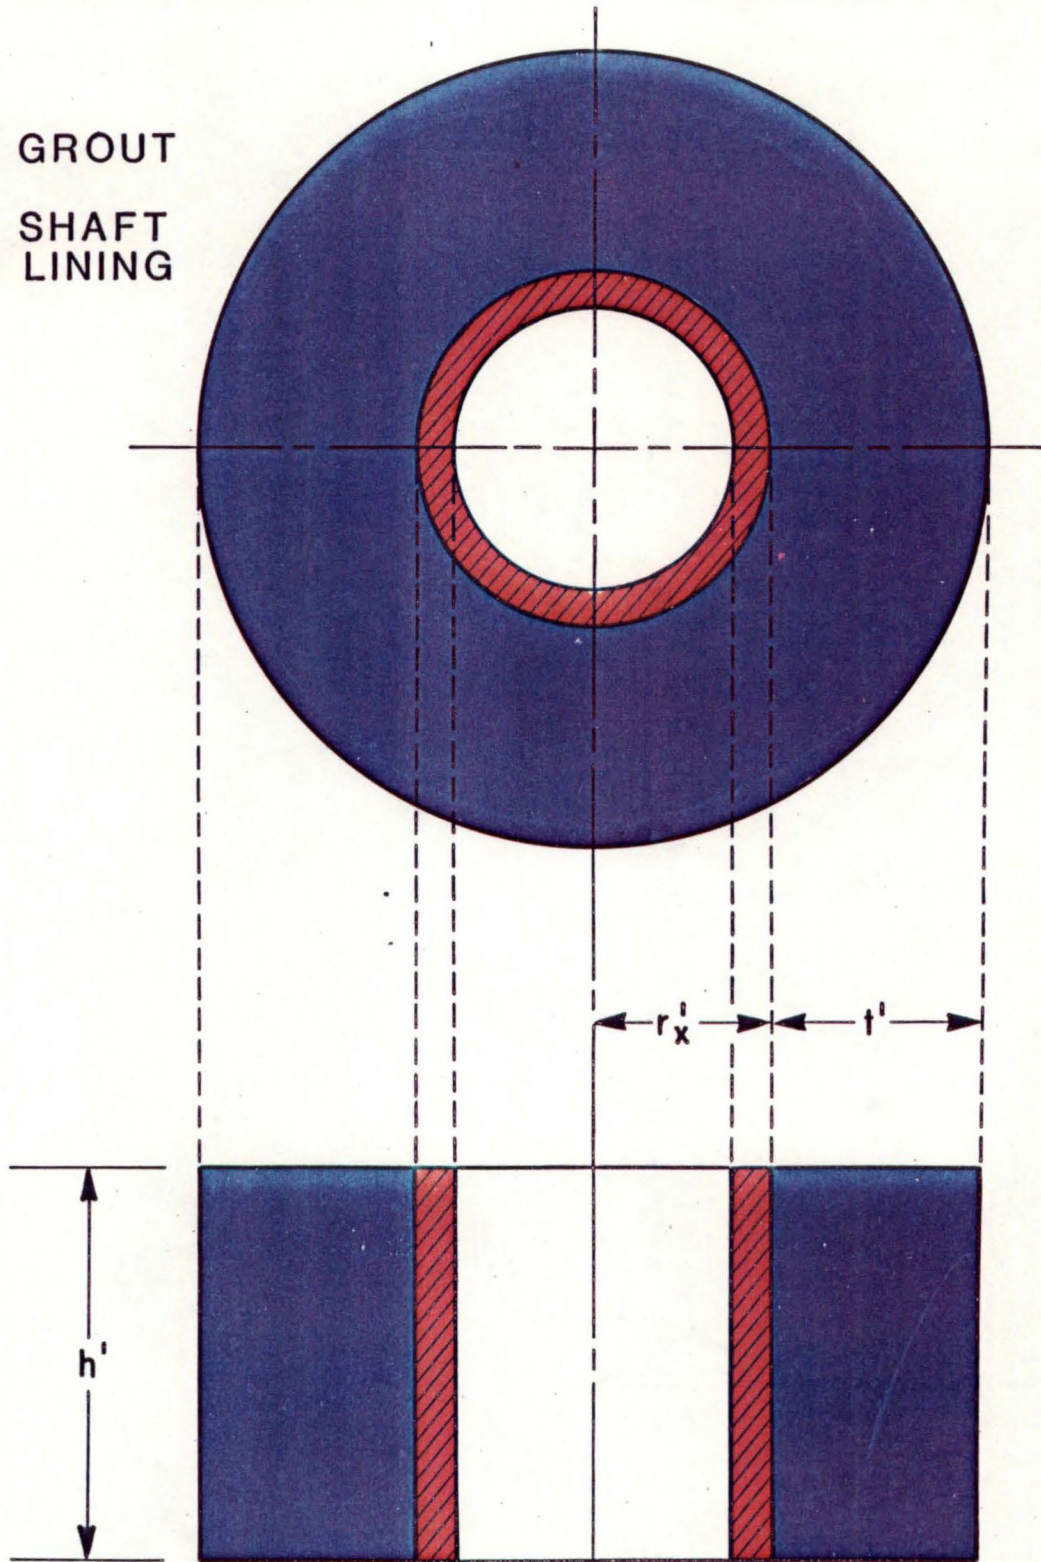
FIGURE 2

GROUT MATERIAL VOLUME REQUIREMENTS

-   GROUT
-   SHAFT LINING

$$Q = 7.05 h [(r_x + t)^2 - r_x^2] \text{ gal}$$

GROUTING THE DAKOTA

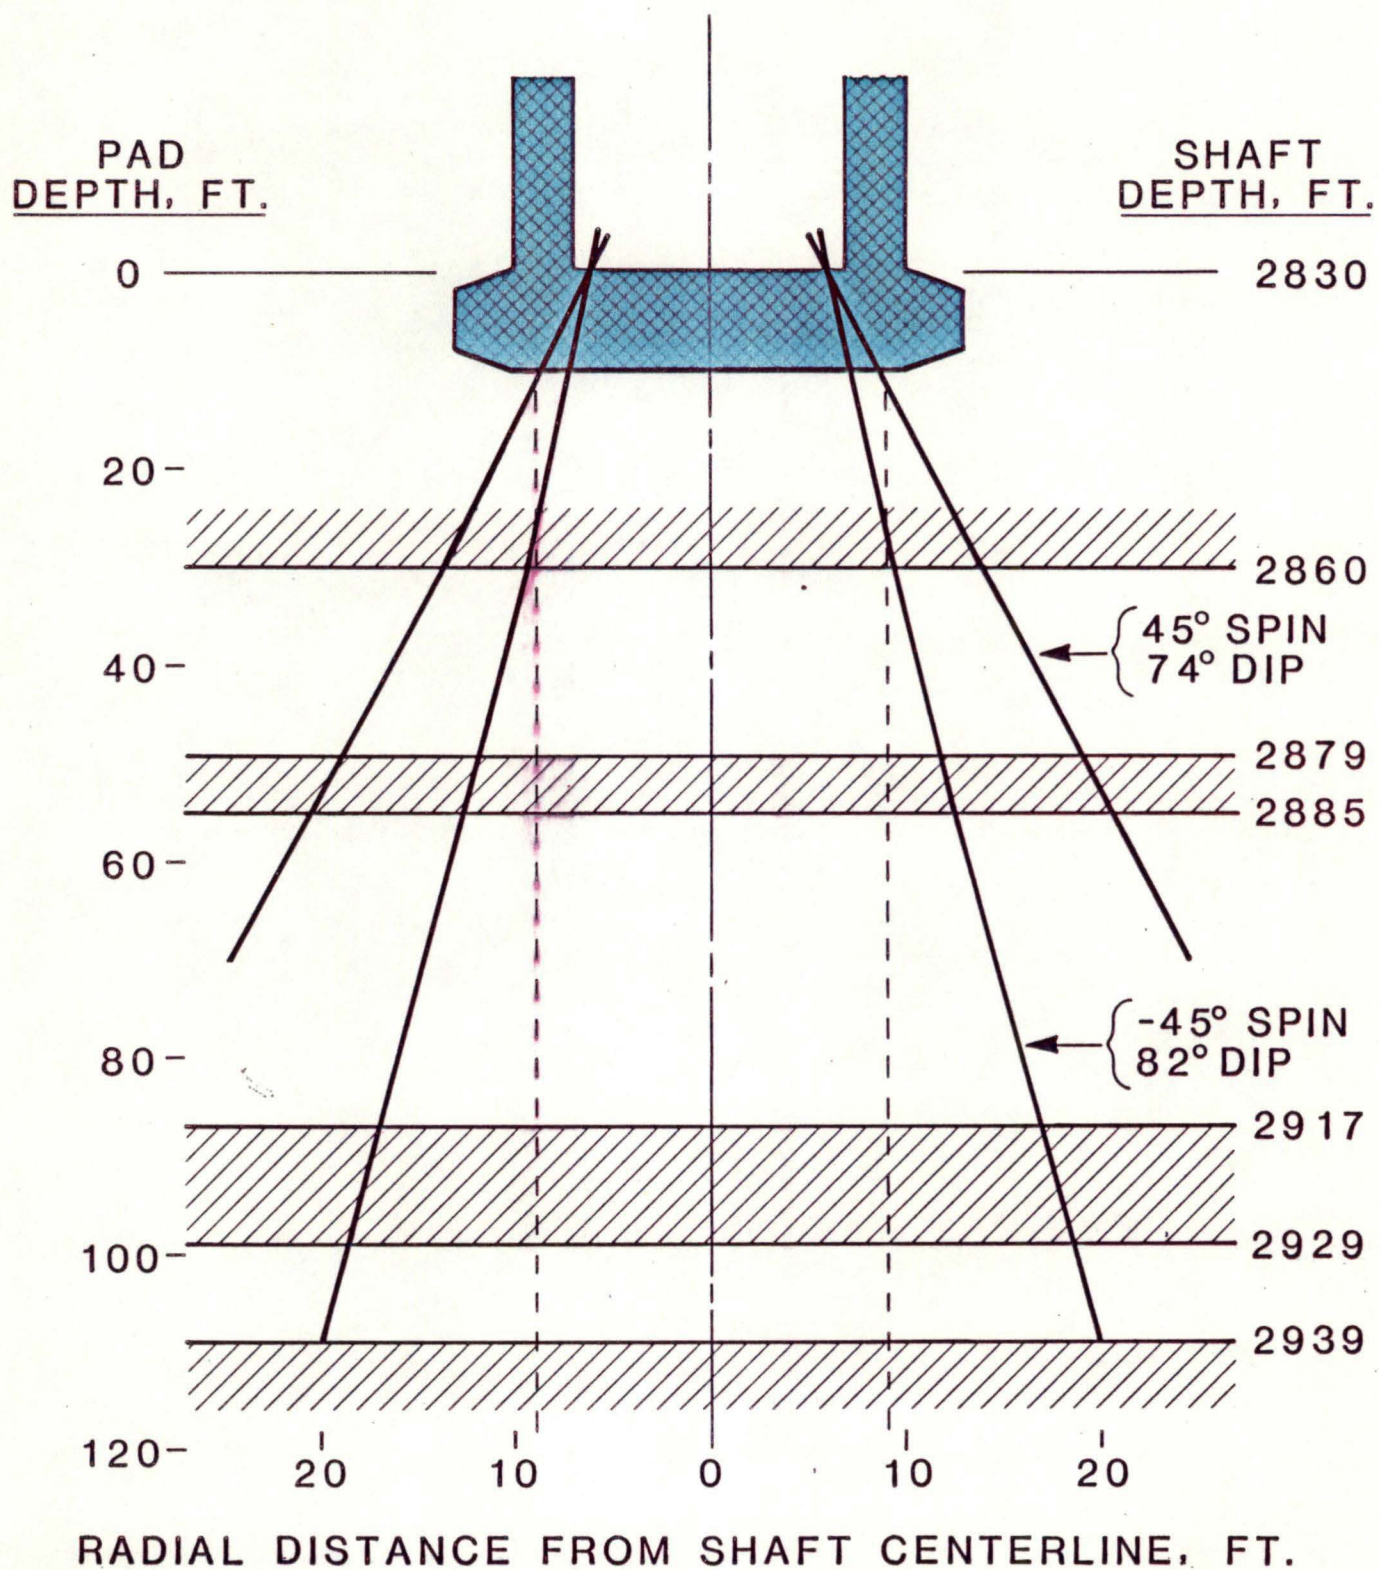
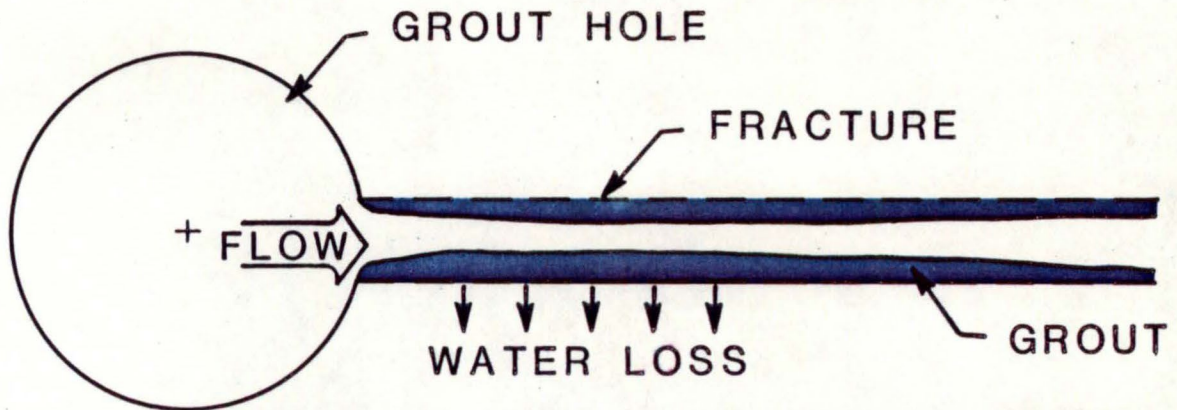
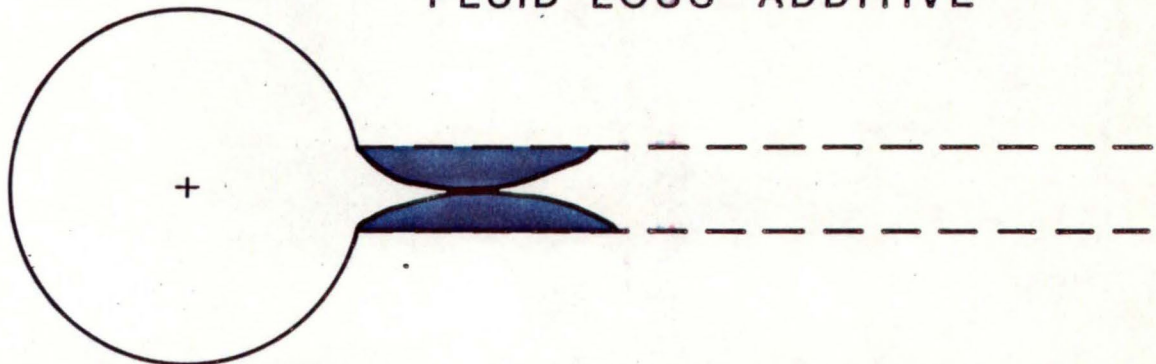
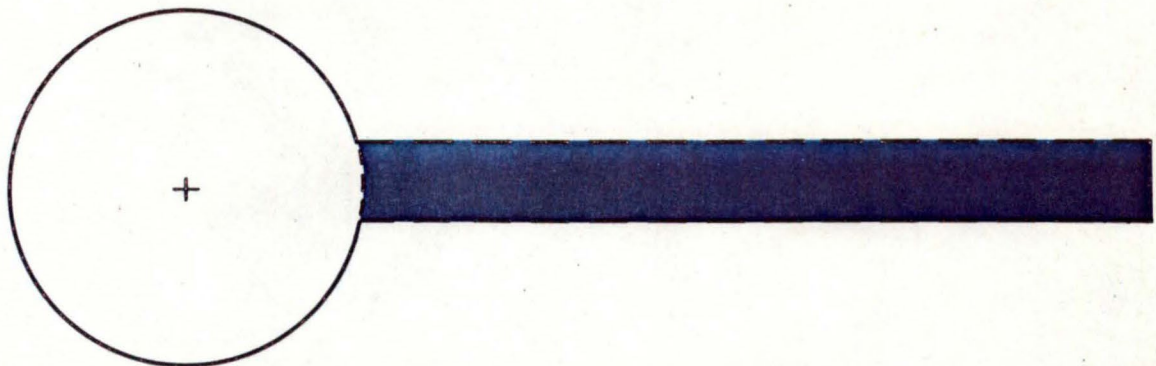
FIGURE 3

GROUTING A FRACTURED FORMATION

(A) GROUTING WITH LOW CONCENTRATION CEMENT OR WITH HIGH CONCENTRATION CEMENT AND FLUID LOSS ADDITIVE

(B) GROUTING WITH HIGH CONCENTRATION CEMENT AND NO FLUID LOSS ADDITIVE

(C) GROUTING WITH CHEMICAL GROUT OR WITH VERY HIGH CONCENTRATION CEMENT WITH FLUID LOSS AND GELLING ADDITIVES

with cement. Before discussing these additives it would be of value to have a better understanding of what occurs when a fracture is being grouted with cement. One theory of how this occurs is described pictorially in Figure 3. As the cement mixture enters a fracture, some of the water in the mixture leaks out through the walls of the fracture, depositing some cement on the wall. If the concentration of cement is relatively high, the amount of cement that deposits on the wall may be sufficient to plug the fracture near the entrance, as shown in Figure 3(b), resulting in a plugged grout hole, but not a plugged fracture, as far as the overall grout curtain is concerned. One way to get the cement to travel further is to use a very dilute mixture (Figure 3(a)), but this approach is very time consuming, since it is not the gallons of grout mix that count in this case, but rather the number of sacks of cement. One sack will yield about 10 gal of cement fill.

A more effective and efficient way to increase the grouting rate is to use a "fluid loss" additive and a higher concentration of cement. This will permit a geometry as shown in (a), even with a moderately high concentration of cement, since the leakage rate of water through the walls of the fracture is reduced.

When grouting with chemical grouts the filtration process discussed above is not part of the grouting mechanism. All the grout fluid would gel wherever it is as shown in (c). Some of the grout would leak into the pores on the sides of the fracture and would gel in the pores (not shown in (c)). It might be possible to obtain a similar effect in the fracture by using a high concentration of cement and fluid loss additive, and with another additive (e.g. Cal-Seal, CaCl_2 , Preco Plug, Geoseal Z, etc.) to make the cement mixture gel in place. This type of mix would probably be most useful in finishing off a grout treatment, to plug the grout hole and not have an excessive waiting time, but its application might be more general.

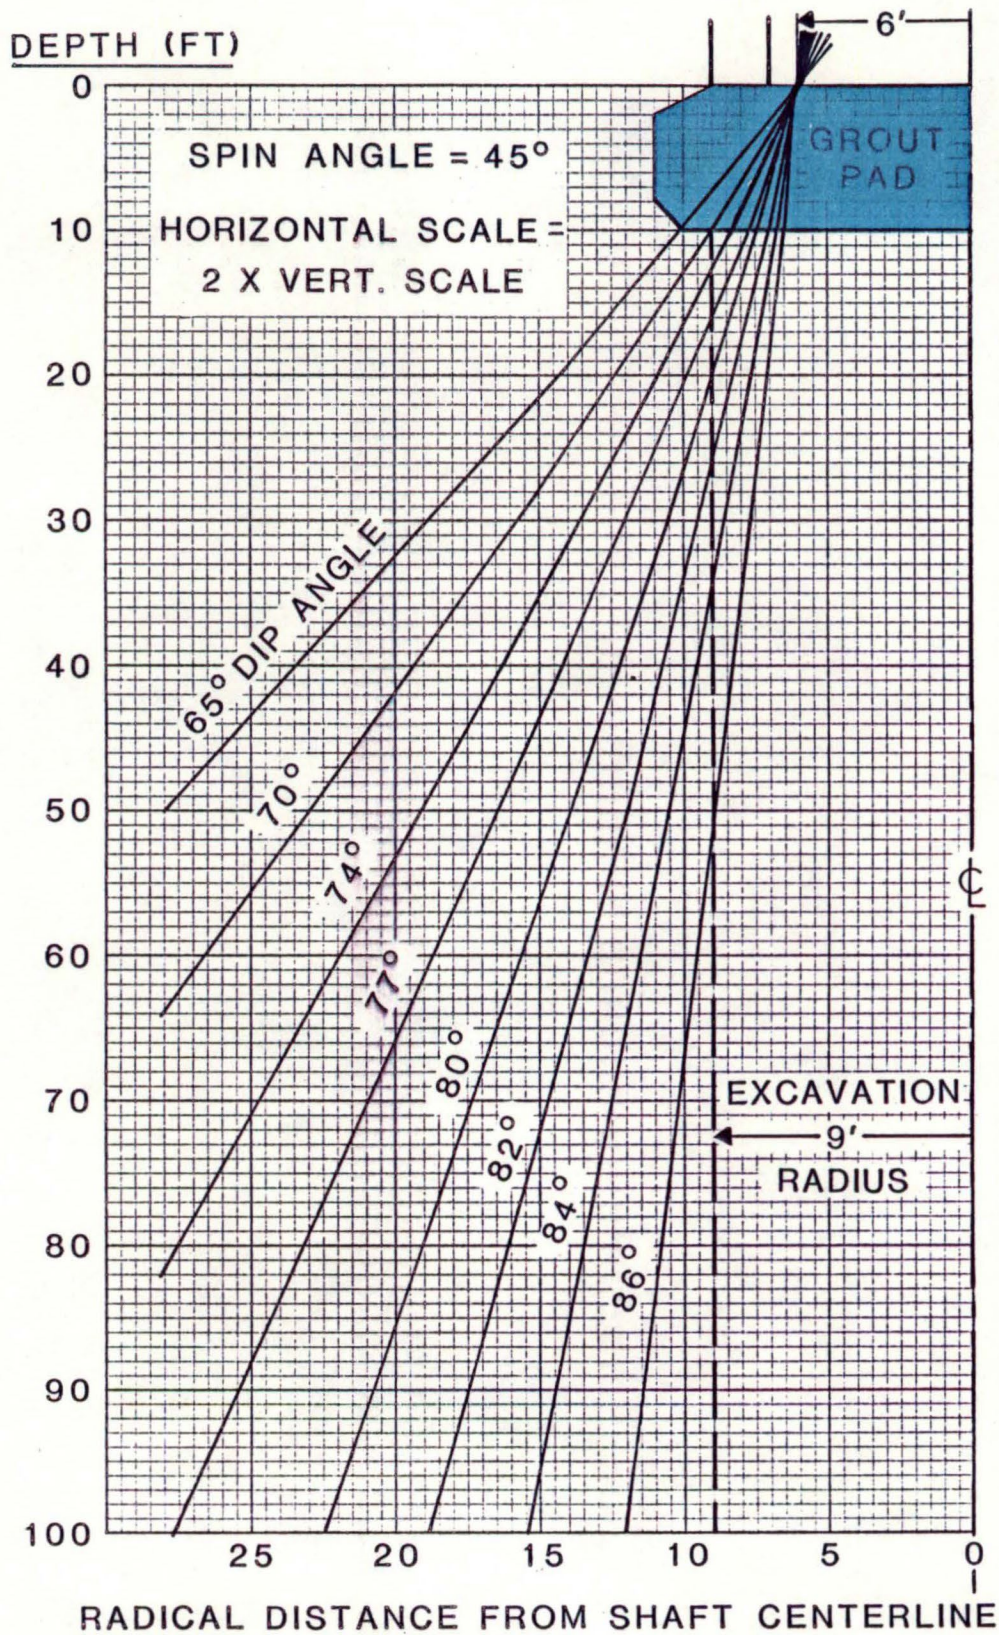
FIGURE 4

LOCATION OF GROUT HOLE VS. DEPTH AND DIP ANGLE

The objective of the grouting program will be to place the grout material in a continuous curtain around the shaft, more or less as indicated in Figure 1. This will require a large number of grout holes with adequate spin and dip so that the vertical fractures in the Dakota can be intercepted and filled with grout. The location of the grout holes must be a reasonable distance outside the shaft excavation radius (e.g., 3 ft minimum), and yet not too far out from the shaft center-line (e.g., 20 ft maximum). These suggested limits are indicated with dashed lines in Table I, where it is assumed that a spin angle of 45° will be used.

1. Holes have to be close to vertical (dip angle in excess of 80°) thereby reducing the probability of intersecting all the vertical fractures.
2. Hole deviation becomes excessive when the holes are drilled with the Watson drills. A deviation of only 2° would cause an

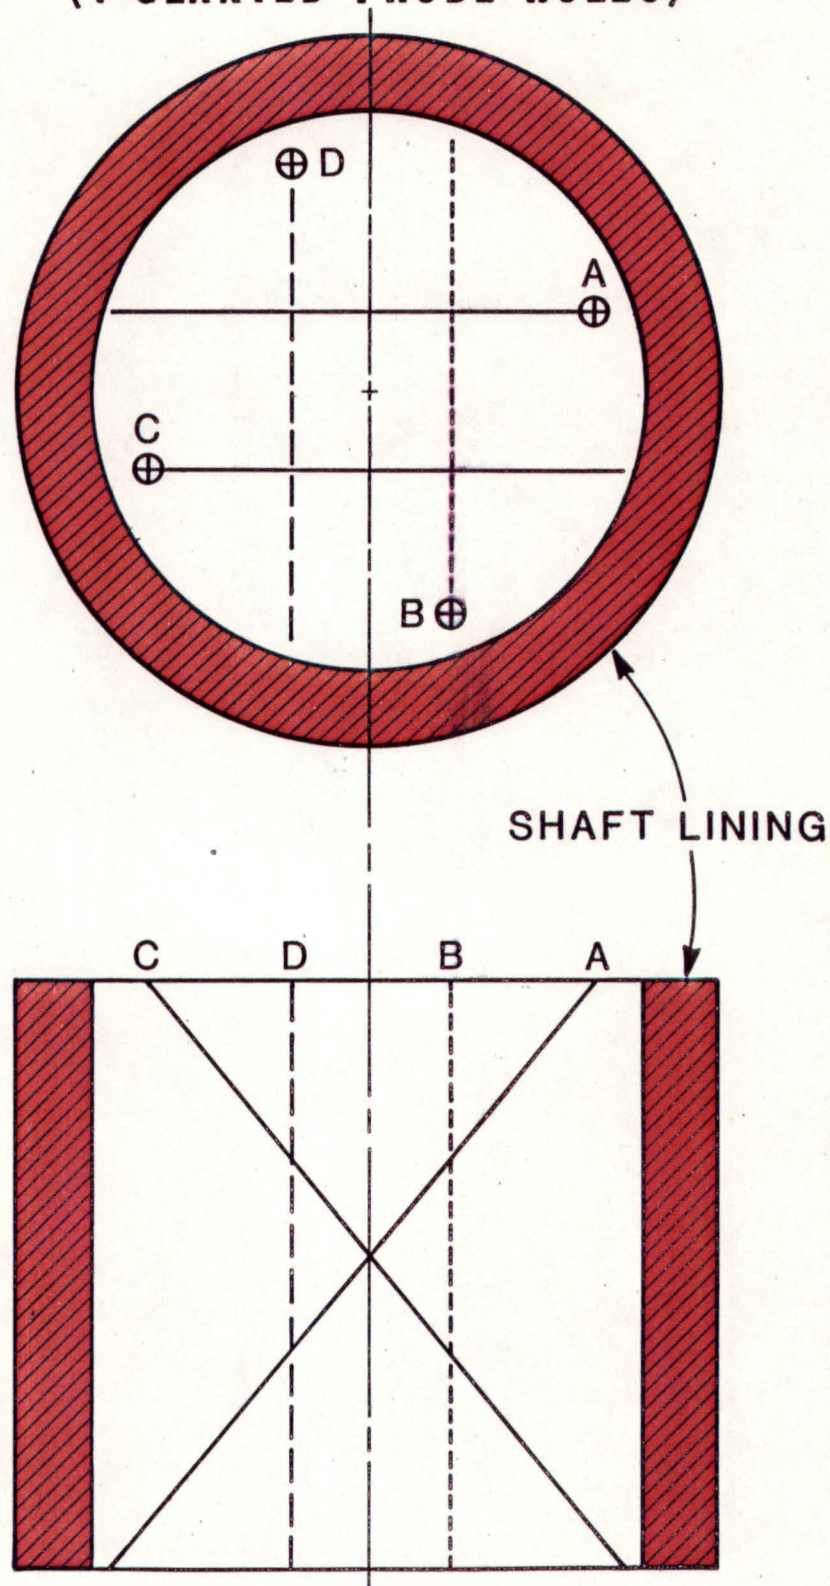
FIGURE 5

**PROBE PATTERN IN FRACTURED FORMATION
(4 SLANTED PROBE HOLES)**

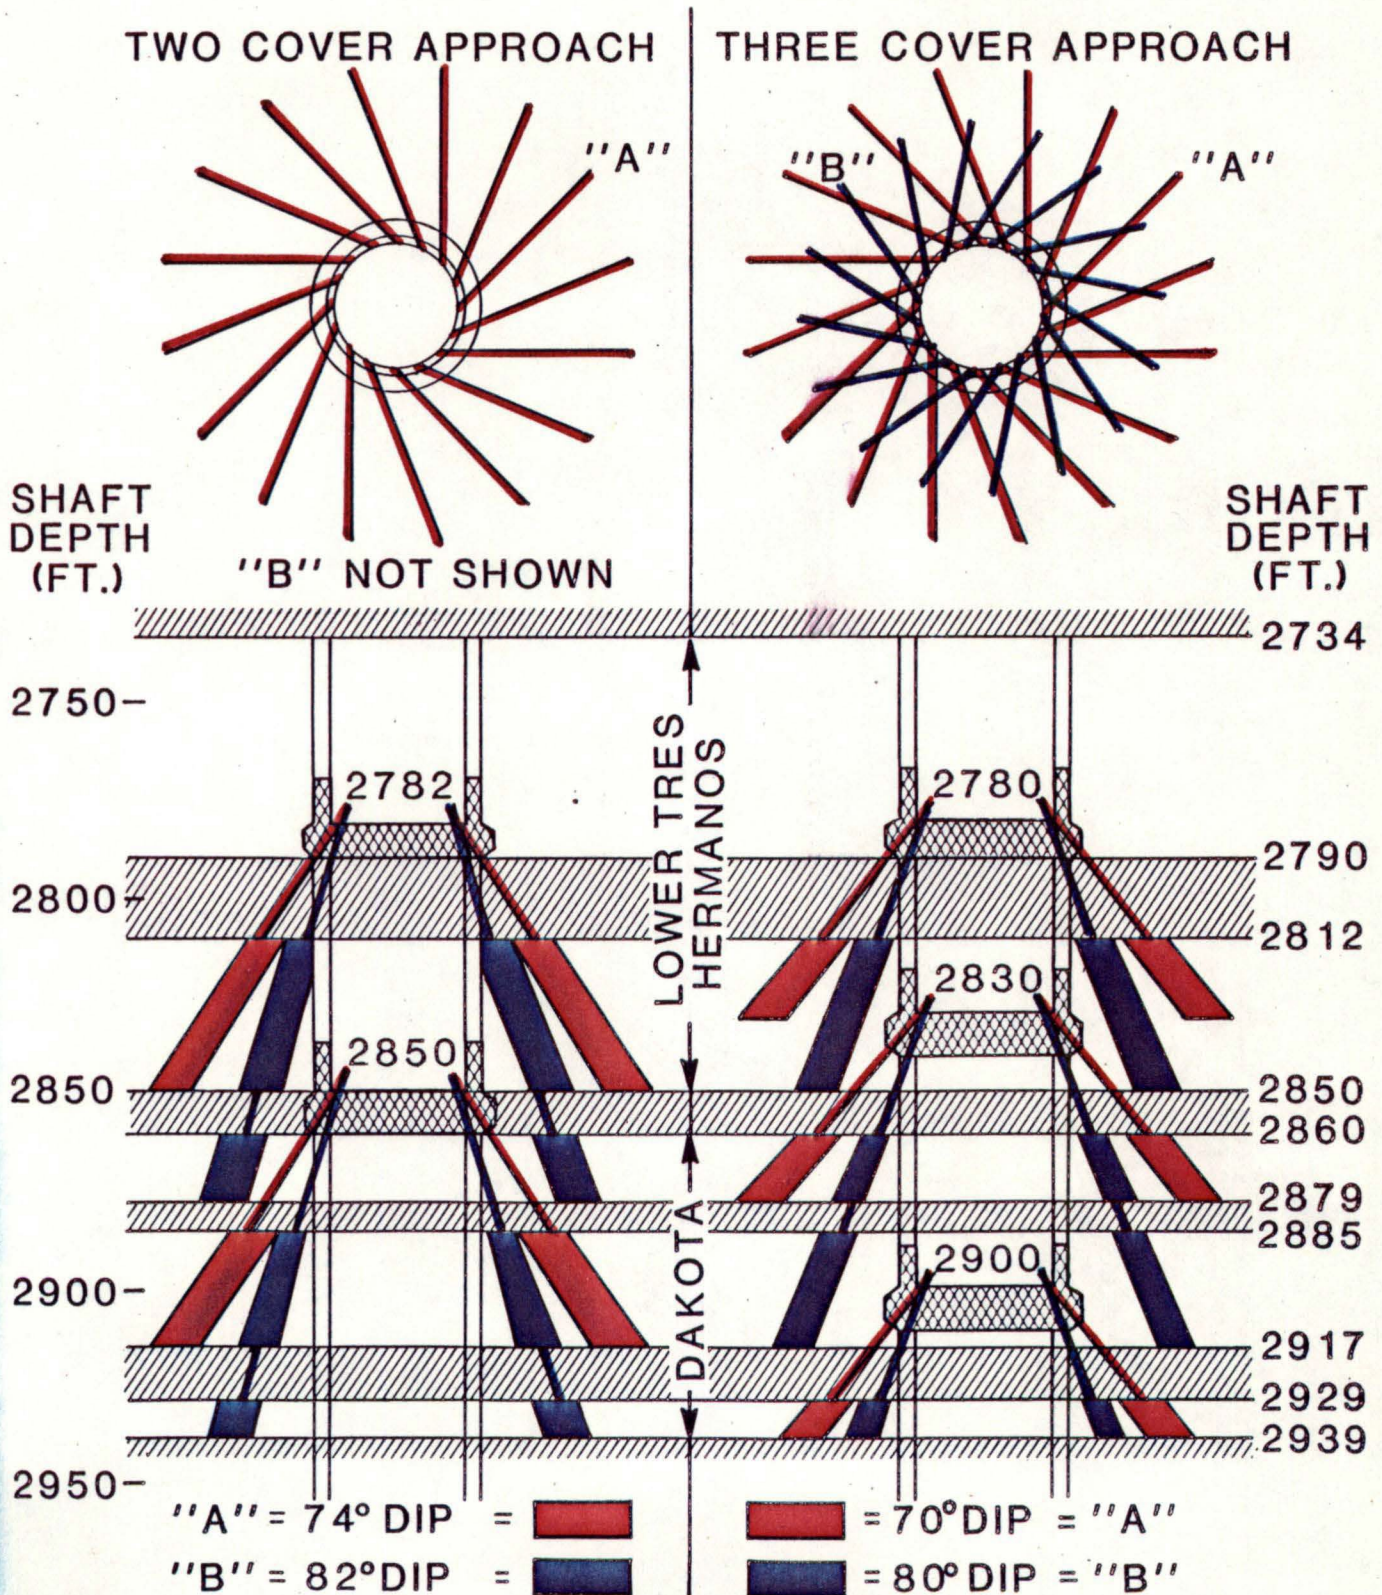
FIGURE 6

COMBINED GROUT PROGRAM FOR THE
LOWER TRES HERMANOS AND THE DAKOTA

In view of the above, one grout cover might be insufficient for grouting all three intervals in the Dakota. However, the lowest of the three intervals to be grouted is only about 10 ft thick, and probably not very prolific, so it might be possible to grout it with the "B" pattern of holes from the 2,830-ft grout pad. Improved coverage in the middle and lower zones can be achieved by using a "C" pattern with $+45^\circ$ spin and 82° dip. This approach would increase the probability of intersecting all the fractures in the Dakota.
