**MEMORANDUM
OFFICE OF THE STATE ENGINEER
HYDROLOGY BUREAU**

DATE: November 15, 2022
TO: David Otori, Permit Lead, Mining Act Reclamation Program (MARF)/MMD
Holland Shepherd, Program Manager, MARF/MMD
THROUGH: Katie Zemlick, Ph.D., Chief, Hydrology Bureau *KZ*
Laura Petronis, Water Resources Manager 1, Hydrology Bureau *LJP*
FROM: Brad Wolaver, Ph.D., Senior Hydrologist, Hydrology Bureau *BDW*
Christopher E. Angel, P.G., Senior Hydrologist, Hydrology Bureau *CEA*
SUBJECT: Review and Comments, Revision 22-1 to Mt. Taylor Mine, Permit No. CI002RE,
Rio Grande Resources Corporation

1. Introduction and Conclusions

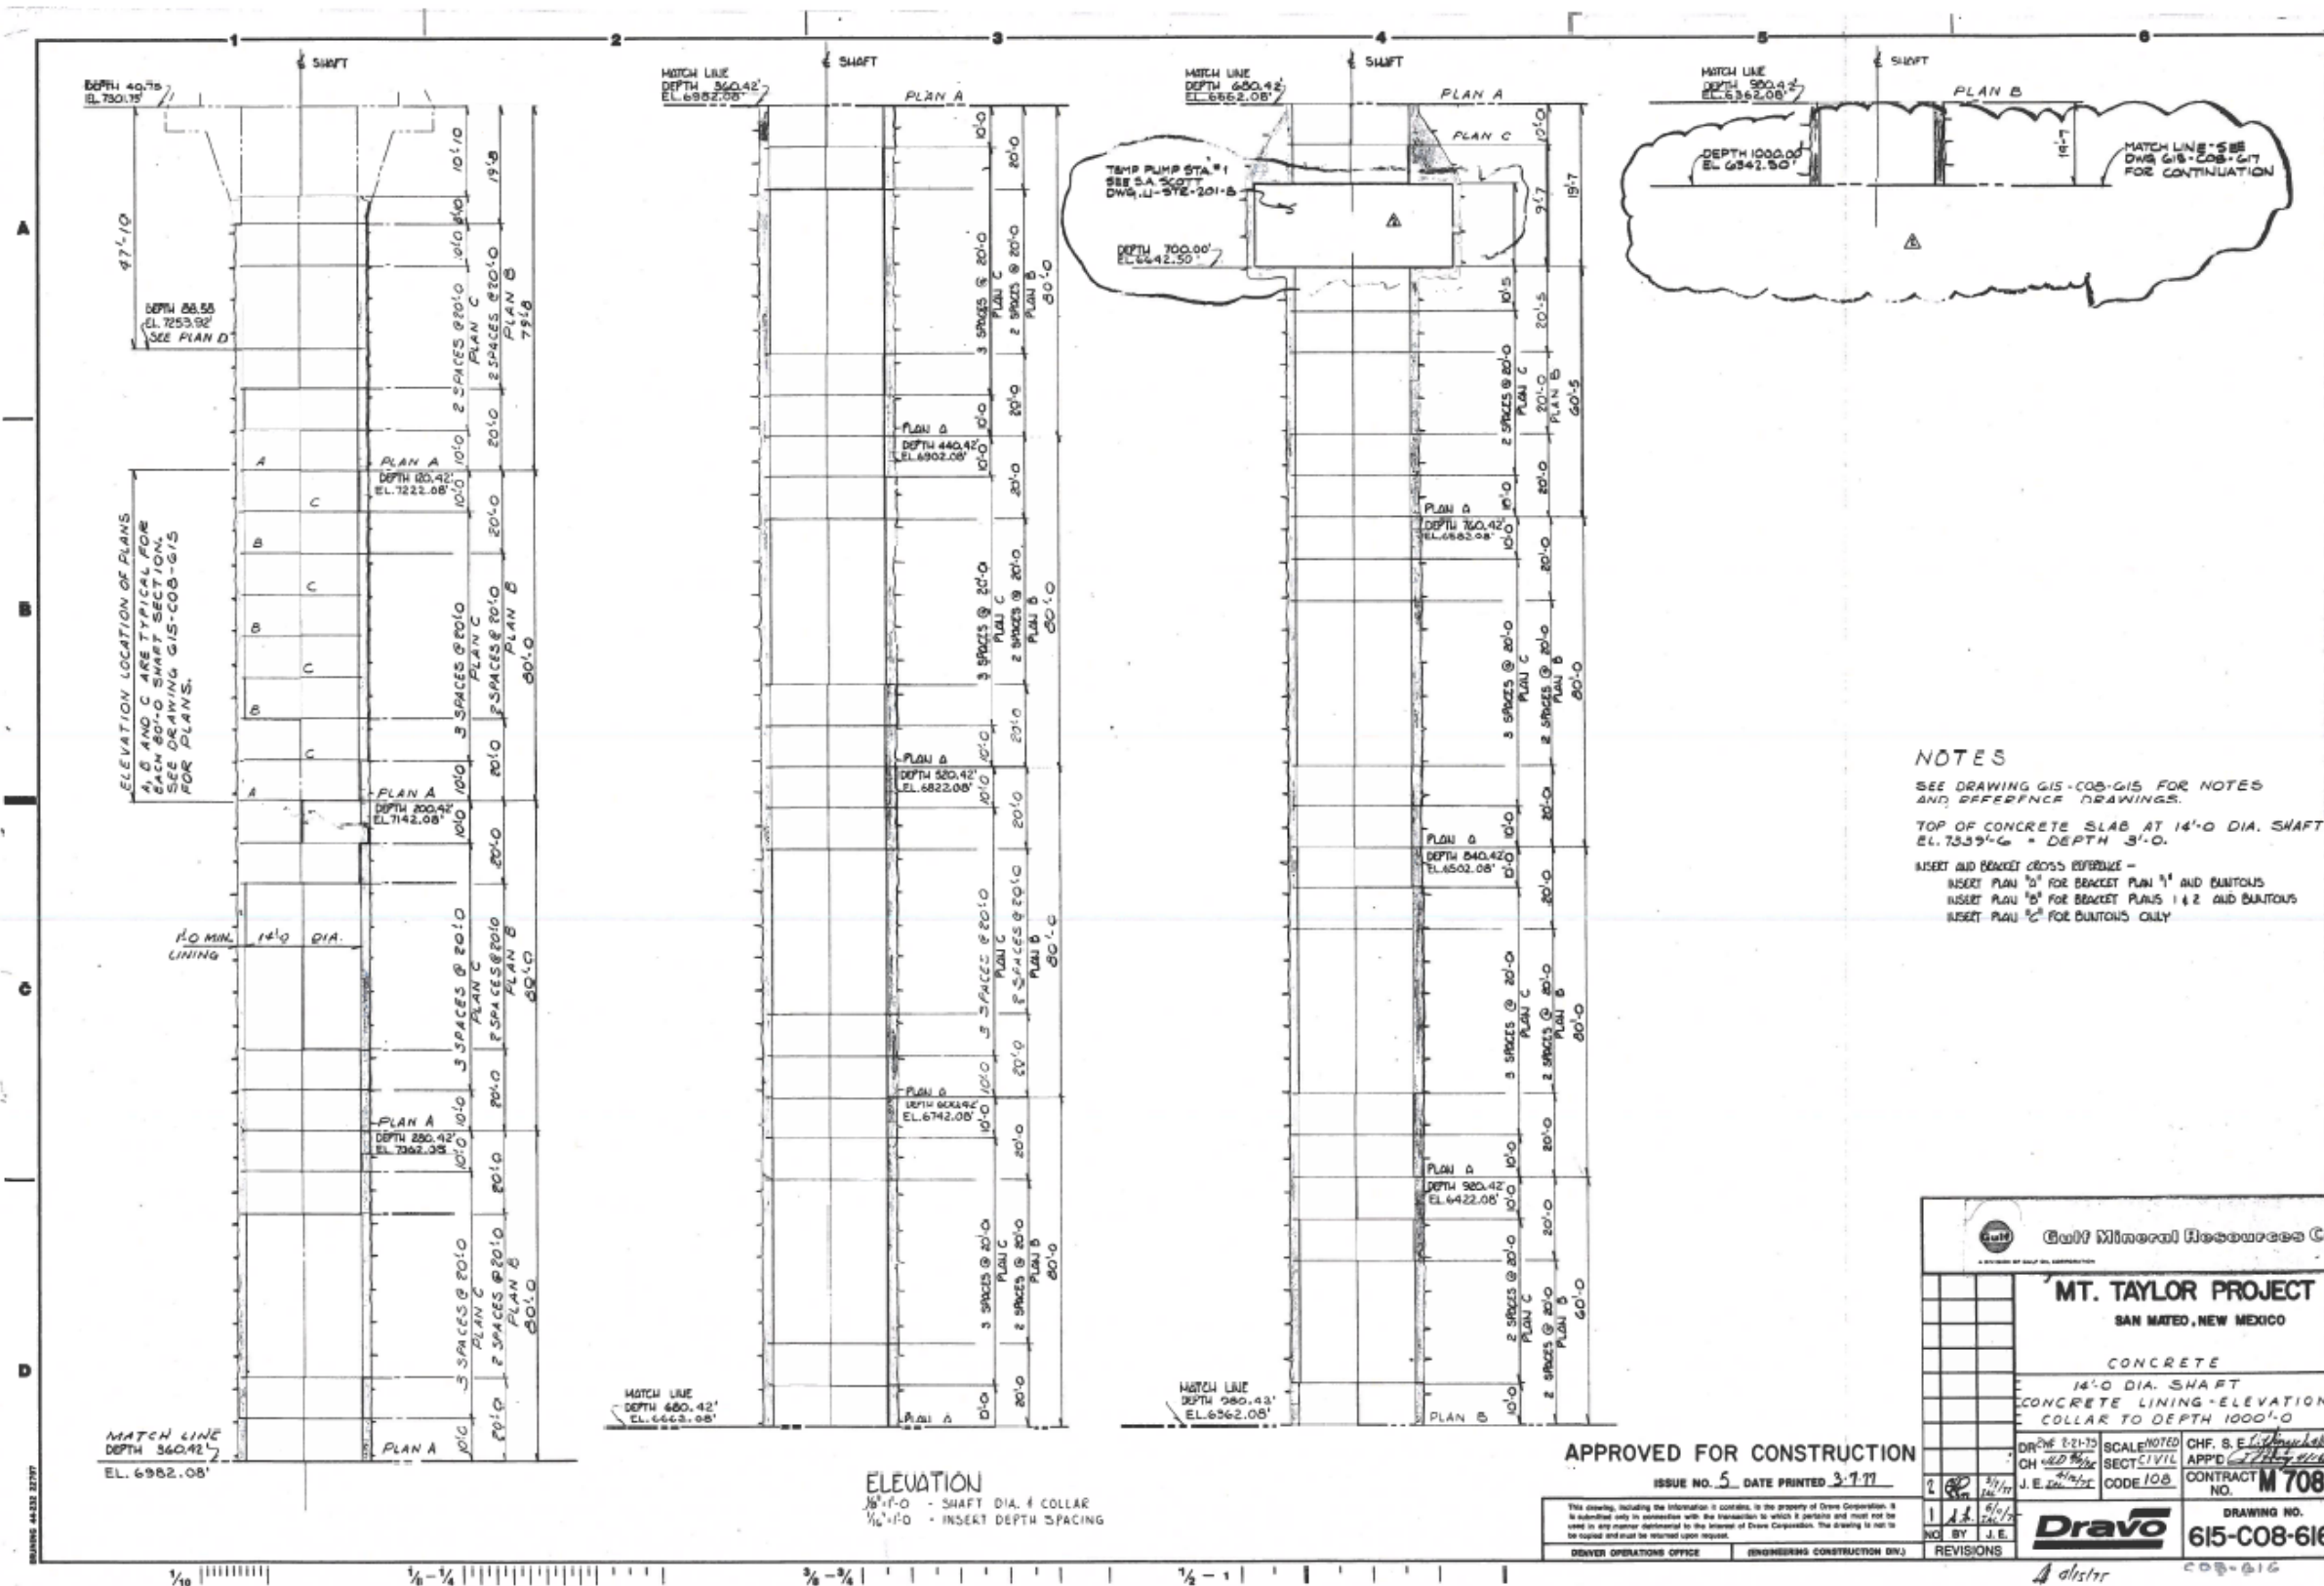
Appendix C. Proposed Shaft Lining Design (Drawing No. 615-C08-616)

Dravo		Gulf Mineral Resources Co.	
MT. TAYLOR PROJECT			
SAN MATEO, NEW MEXICO			
CONCRETE			
14'-0" DIA. SHAFT			
CONCRETE LINING - ELEVATION			
COLLAR TO DEPTH 1000'-0"			
DR: 2-21-77	SCALE: NOTED	CH: 4-10-77	APP'D: <i>[Signature]</i>
J.E. [Signature]	SECT: CIVIL	CODE: 108	CONTRACT NO. M 708
NO. BY J.E.		DRAWING NO. 615-C08-616	
DENVER OPERATIONS OFFICE		dister

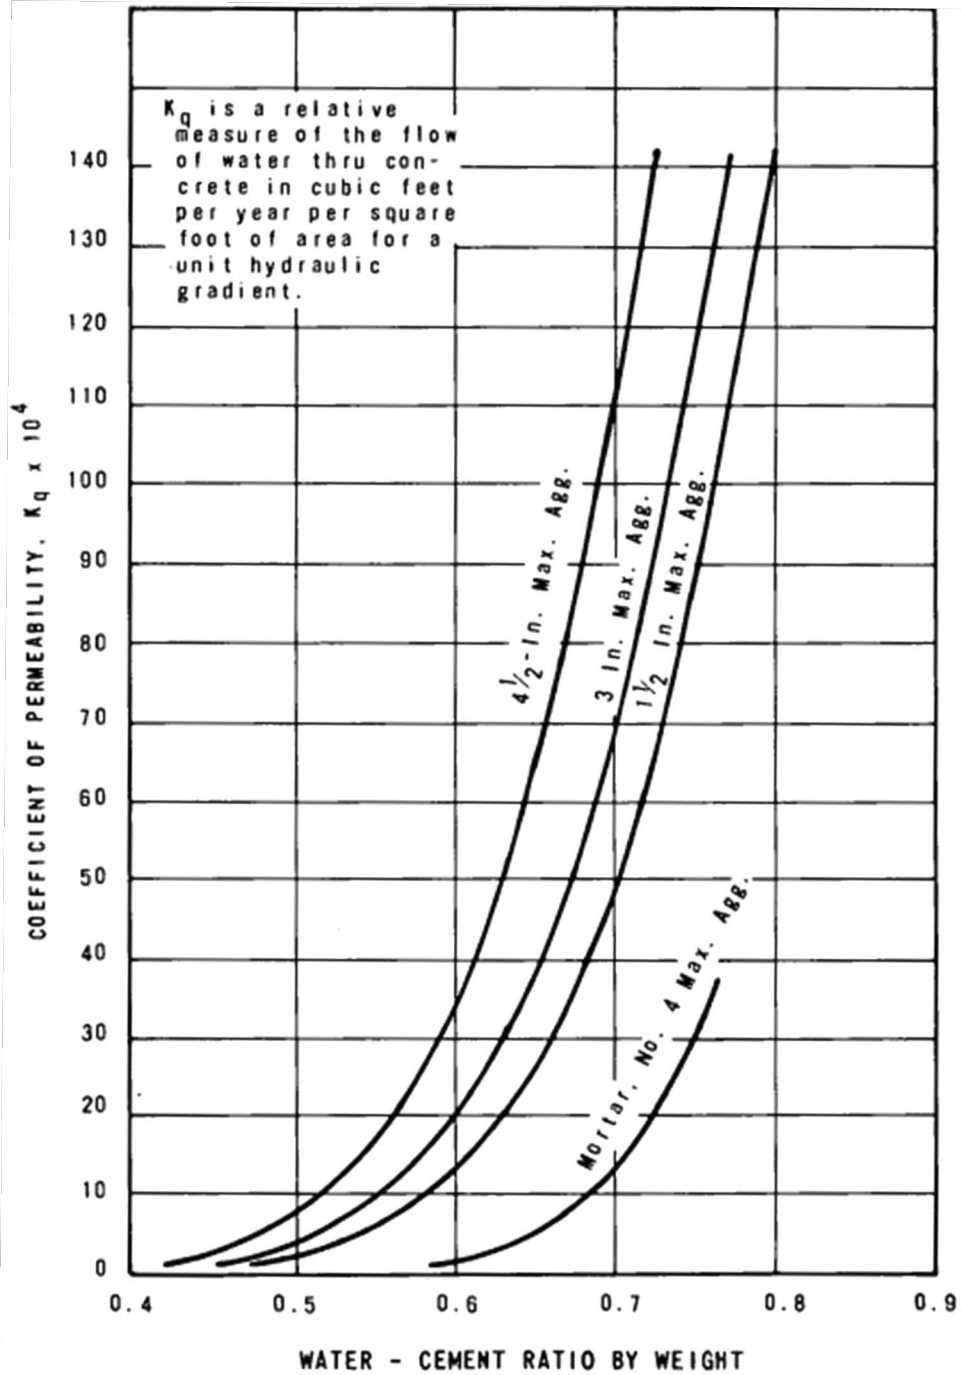
Figure 17.—Relationship between coefficient of permeability and water-cement ratio, for mortar and concrete of three maximum sizes. Relatively low water-cement ratios are essential to impermeability of concrete. 288-D-1522.

- Shaft liner concrete permeability: results of any permeability tests would help to understand the potential for flow of groundwater through shaft liner concrete, maps of groundwater potentiometric surface for all monitored aquifers for two different time periods (current and pre-dewatering conditions, or the earliest data available), and a narrative interpretation of each map to understand inferred vertical and horizontal groundwater flow conditions and the potential for groundwater inflows to the shafts,
