| MADRID NEW MEXICO | SHEET |
| MADRID STORM WATERIMPROVEMENT PROJECT | 1 |
| TREATMENT LEGEND | OF |

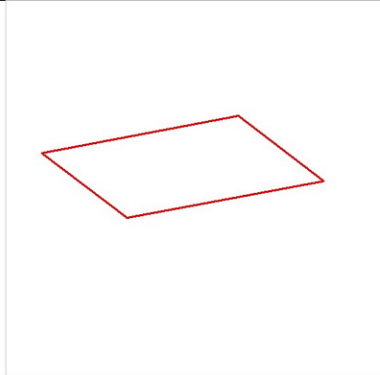
ROLLING DIP

The Material that is removed (cut) from the drain area is moved up on the roadway and becomes the fill for the elevated portion of the rolling dip. In some instances, fill is brought in.

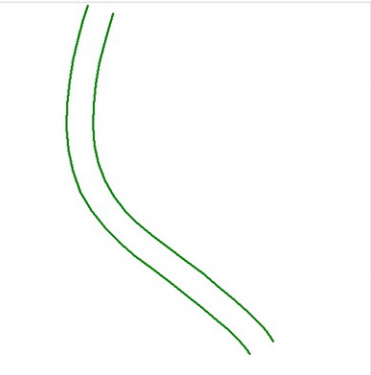
GOB TOE TREATMENT

Gob Pile Runoff Treatment:  
Rock Mulch Detail
