- **NMCC Copper Flat Mine Operations Permit**
- **Overview of Permit Application Package (PAP) & Mining Operations & Reclamation Plan (MORP)**

Copper Flat Mine

COPPER FLAT MINE LOCATION

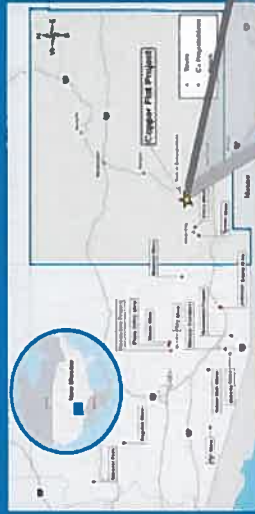
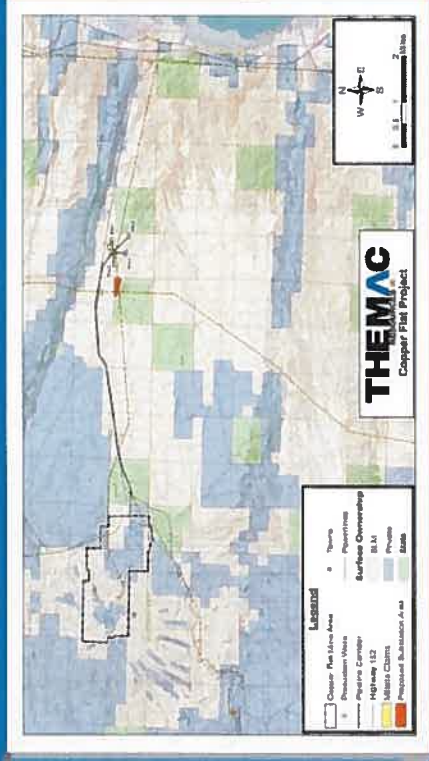
- LOCATED 20 MILES SOUTH OF TRUTH OR CONSEQUENCES AND 4 MILES EAST OF HILLSBORO
- FOUNDATIONS
- POWERLINES
- FLOOD CONTROL (GREYBACK ARROYO DIVERSION)
- WATER WELLS, PIPELINES
- ACCESS ROADS

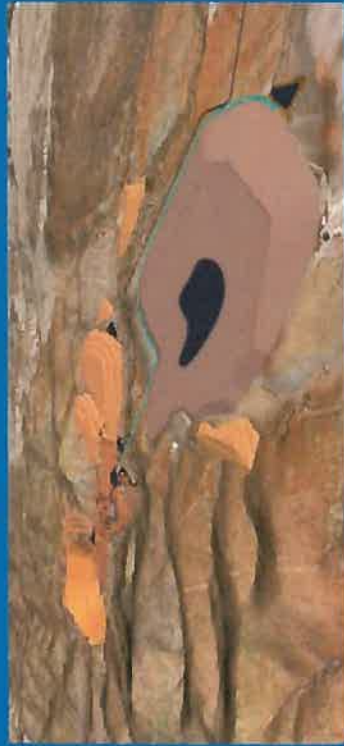
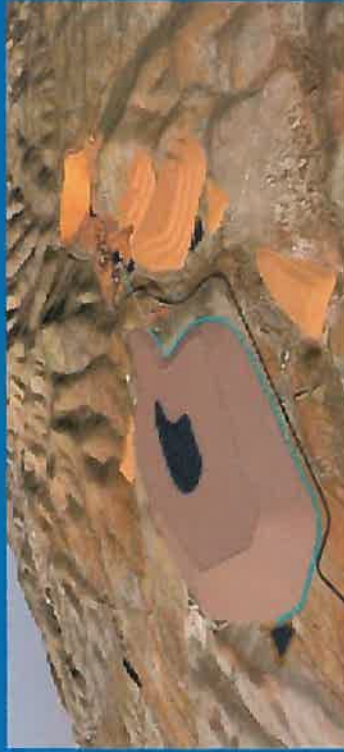
COPPER FLAT MINE—AT BUILD OUT

- 2 Years of Development
- Mine Pit
- Plant Site
- WRSPS
- TSF
- GMSPS
- EWRSP Reclamation

- 12 Years of Operation
- 30,000 TPD Processing
- 125 Acre Plant Site
- 166 Acre Mine Pit
- 220 Acres WRSPS
- 604 Acres TSF

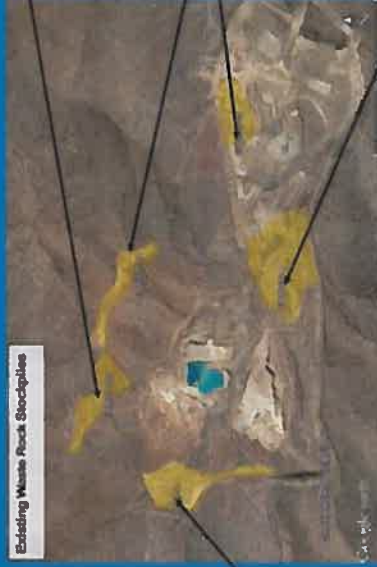
EXISTING WRSP RECLAMATION

- Performed during site development phase
- Regraded
- Recontoured
- 3 ft of growth media
- Revegetated
- Provide test plot area to evaluate future vegetation success
- EWRSP 2a & 3 to be reclaimed at mine closure

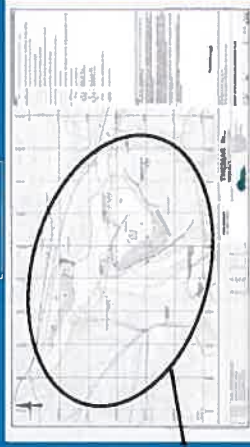
EWRSP 2b

Reclaimed at mine closure
