Lake Valley Mine Safeguard Project - Phase IV

The Lake Valley Mine Safeguard Project - Phase IV area is located in and around the ghost town of Lake Valley, seventeen miles south of the town of Hillsboro, in Sierra County, New Mexico. The project area (see Figures 1 and 2) is on private land in Sections 20, 21, and 33, of Township 18 South, Range 7 West.

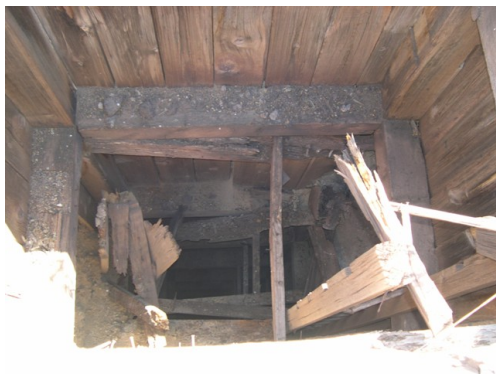
Feature 048-35 Strieby Shaft Looking down

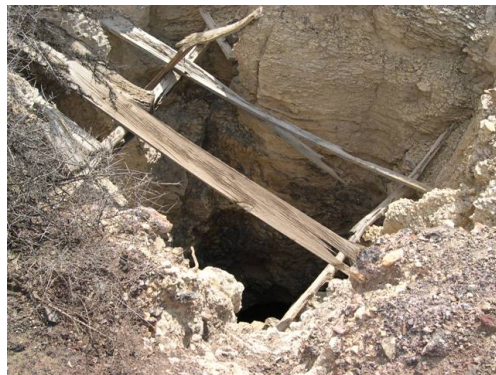
Feature 049-87 Shaft looking down

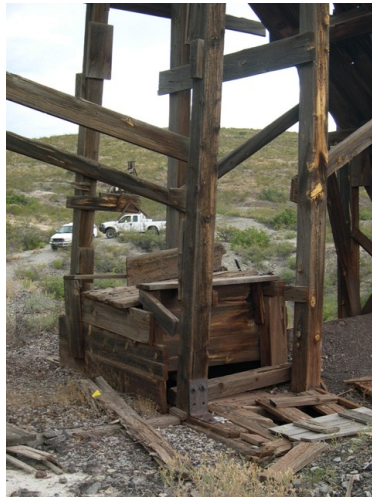
Feature 052-89 Shaft Cover
