DRAFT FINAL RECLAMATION PLAN

SECTION 12 MINE

SOUTHWEST RESOURCES INC.

Rev. 0, 2/19/2020

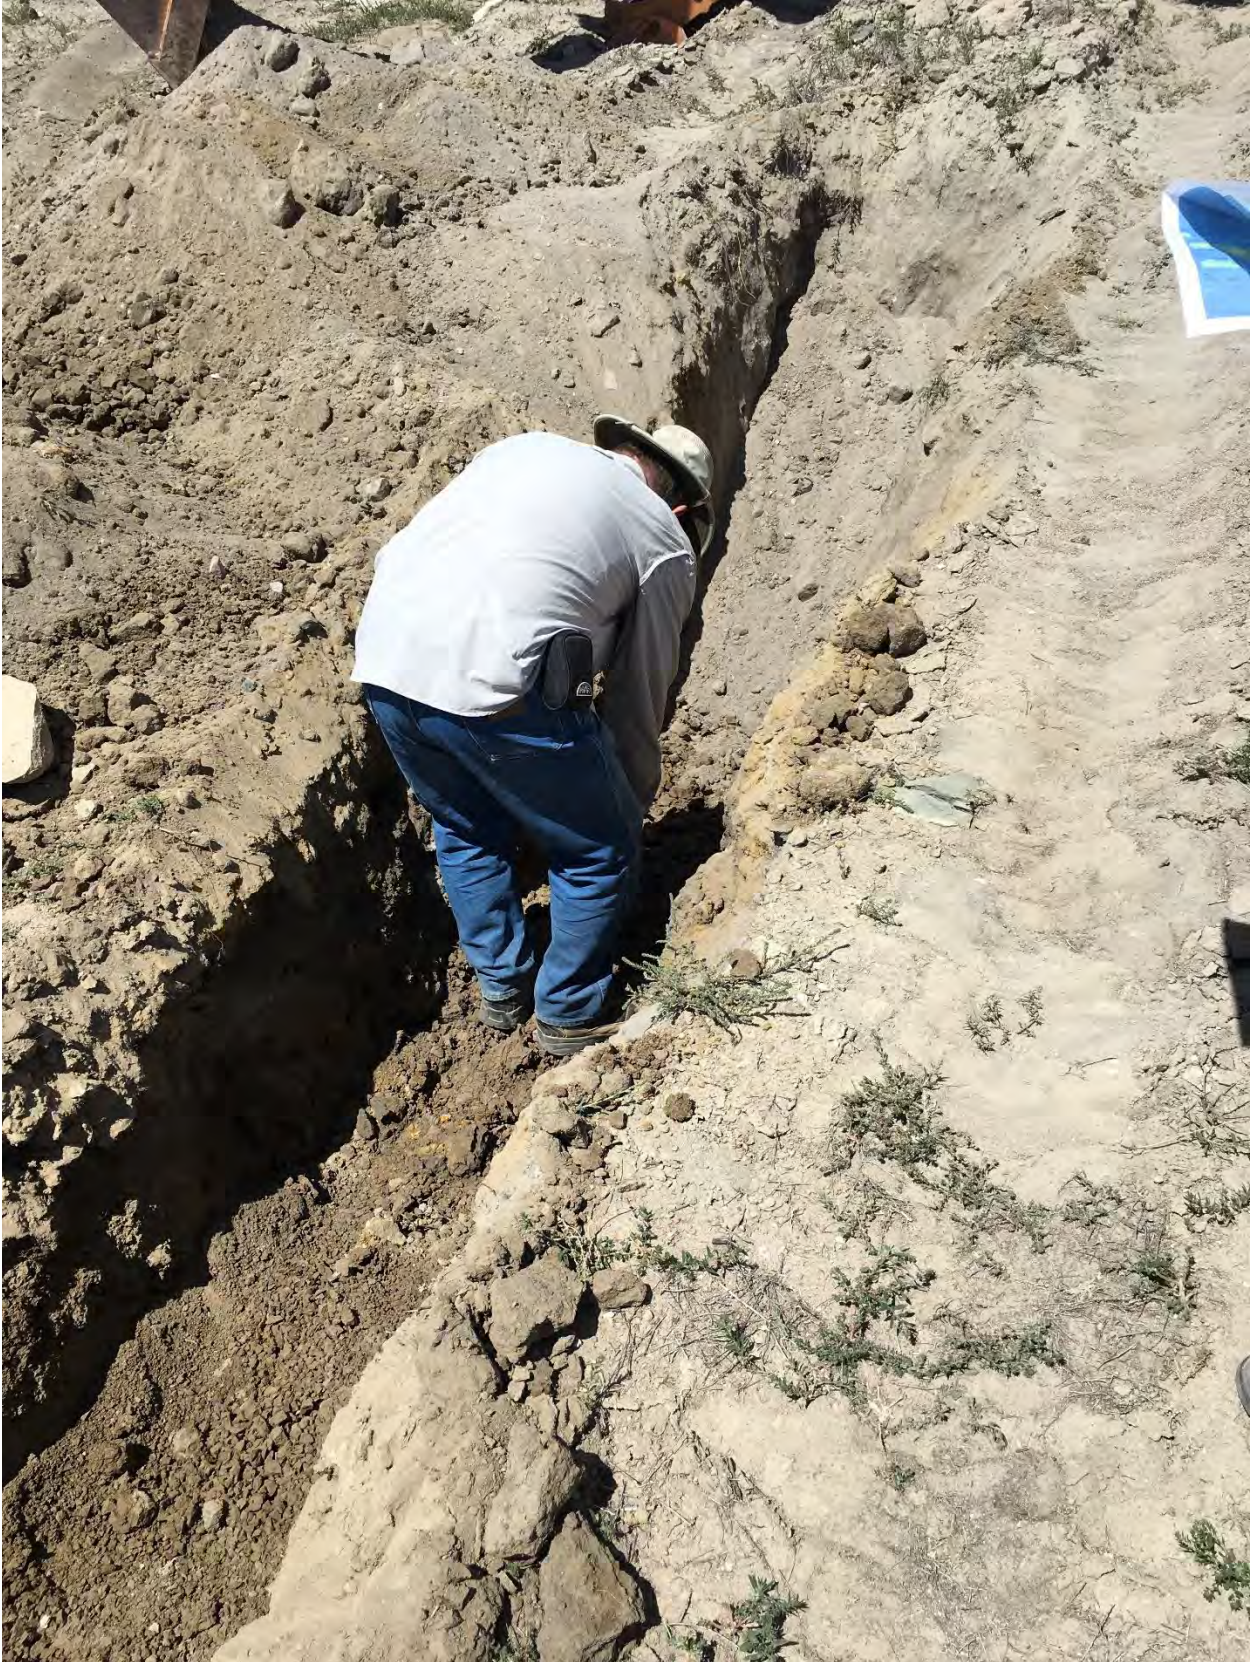
Figure 5. Photo: UQXW5676. Michael Coleman samples the sidewalls of waste characterization trench T-1.

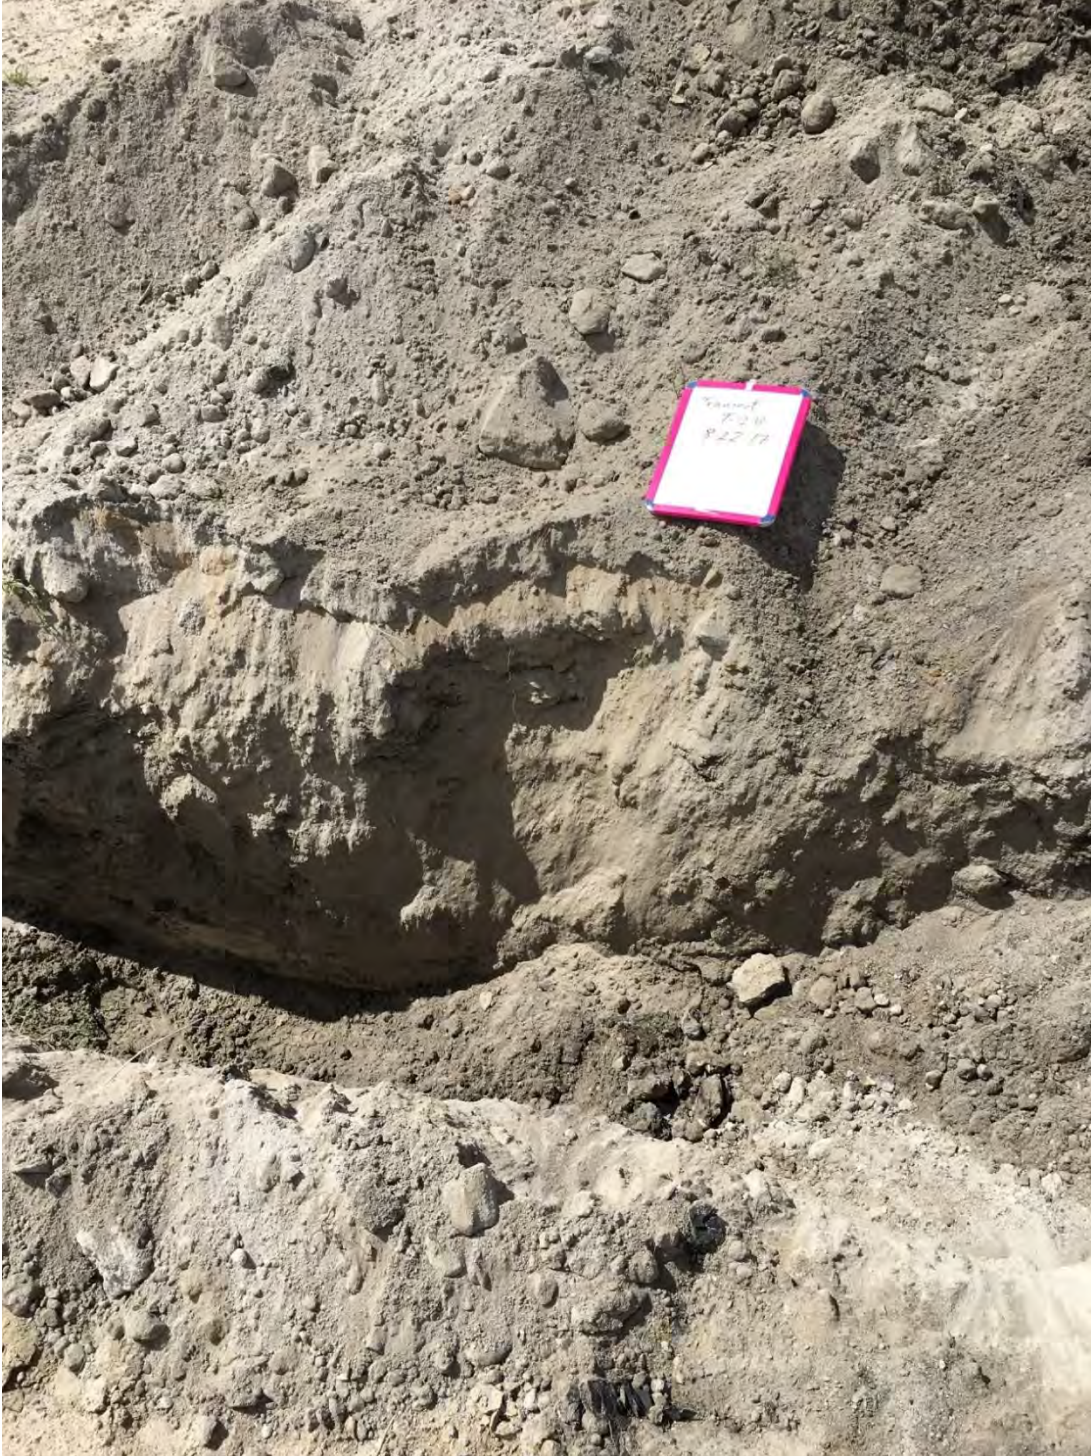
Figure 6. Photo: AMNI18284. Trench 1-B (south end of trench)

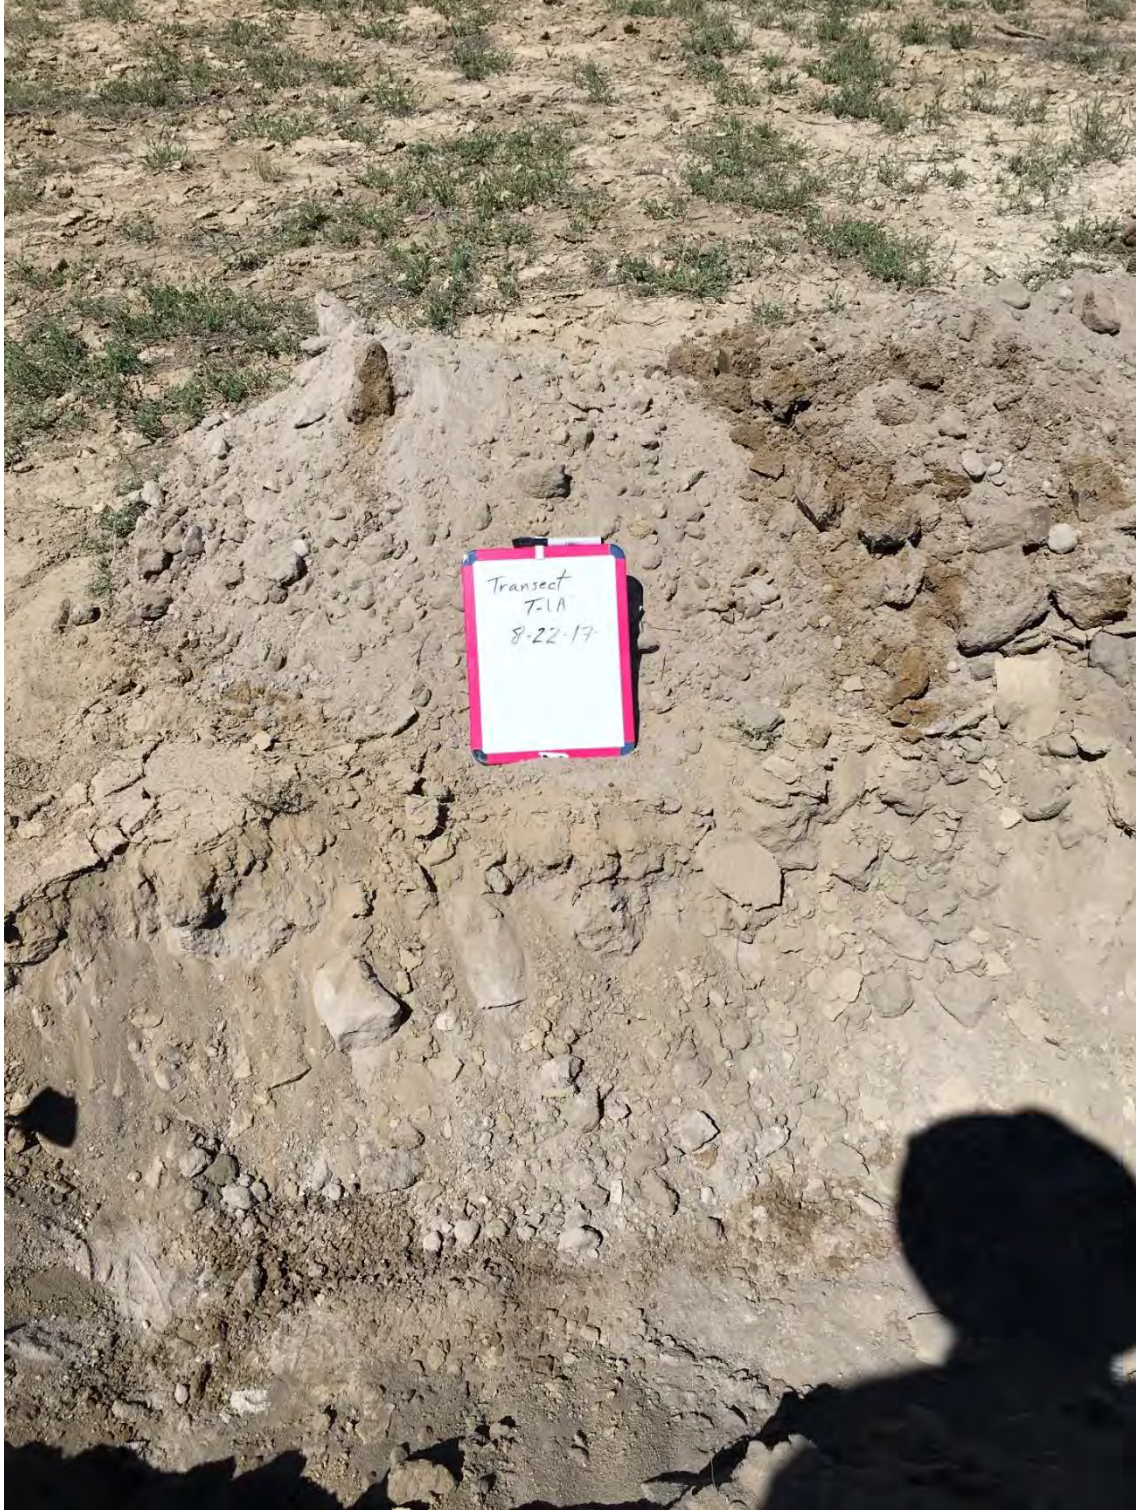
Figure 7. Photo: CRER5389. Trench 1-A (north end of trench at fenceline)

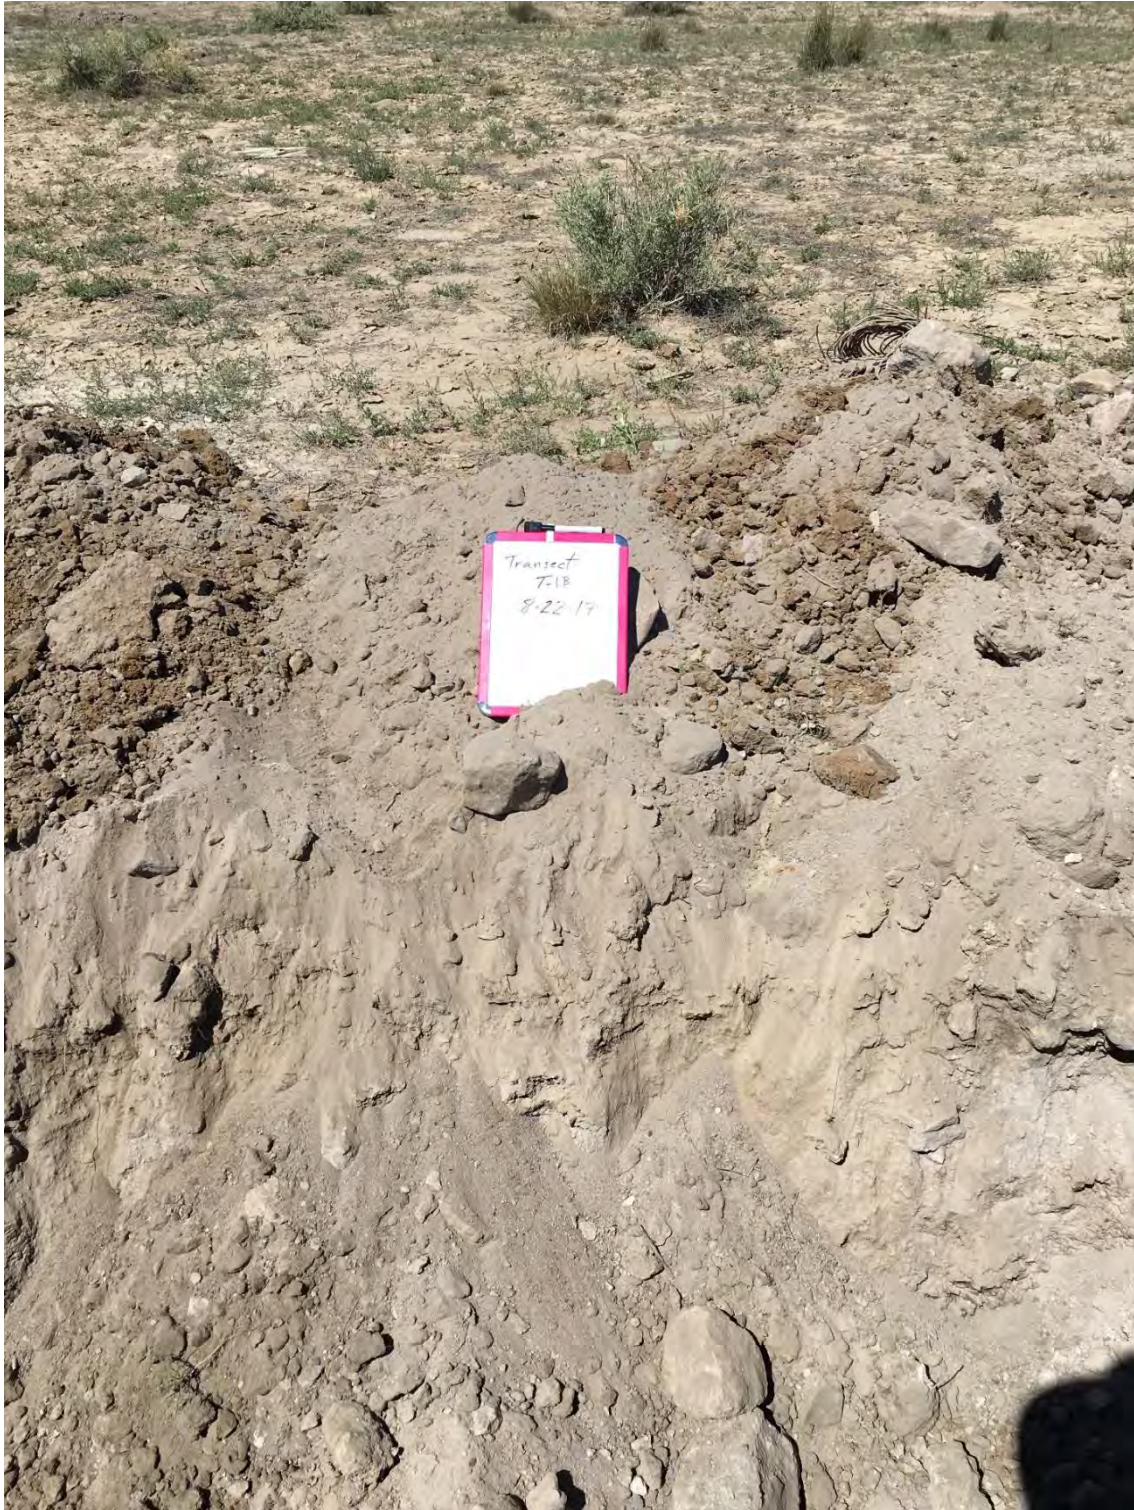
Figure 8. Photo: UEES6706. Trench 1-B (south end of trench)

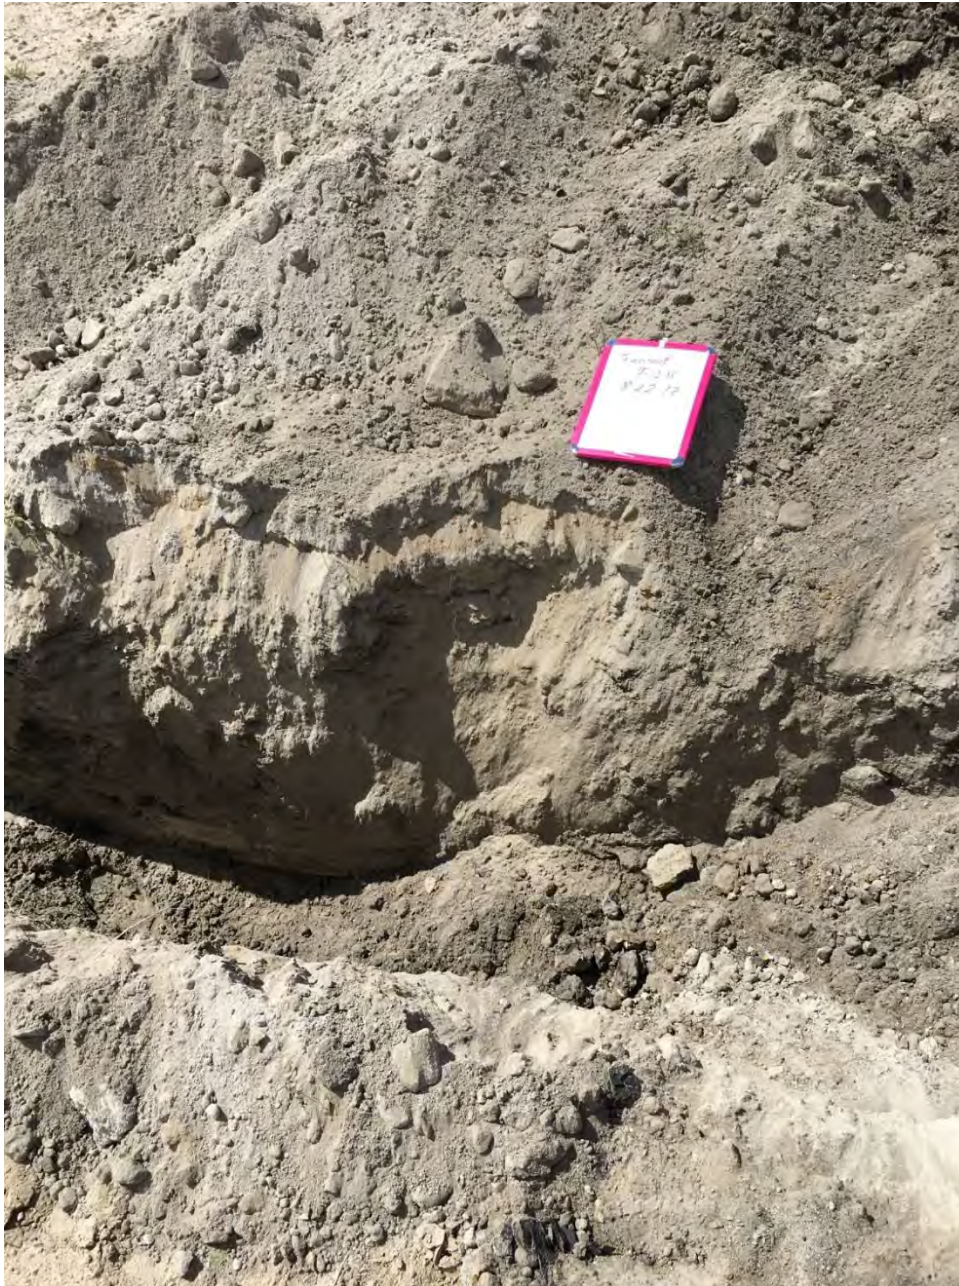
Figure 9. Photo: AMNI18284. Trench 2-B (southwest end of trench). Note darker grey inclusions or materials in left mid-frame of photograph.

Readings at the northeast end of the T-2 trench were elevated (3,400 cps or counts per second) to a depth of 18 inches. The introduced materials were a distinct light grey with darker organic inclusions to a depth of 18 inches and were distinguished from the underlying layer of consolidated brownish lakebed clays below. Readings from these lakebed clays were not elevated and approached the baseline of 300 cps (400 – 600 cps). This suggests these lakebed clays may act as a barrier to downward leaching of materials. Readings of grey materials in the upper 18 inches at the southwest end of trench were also elevated (3,000 – 4,500 cps range).

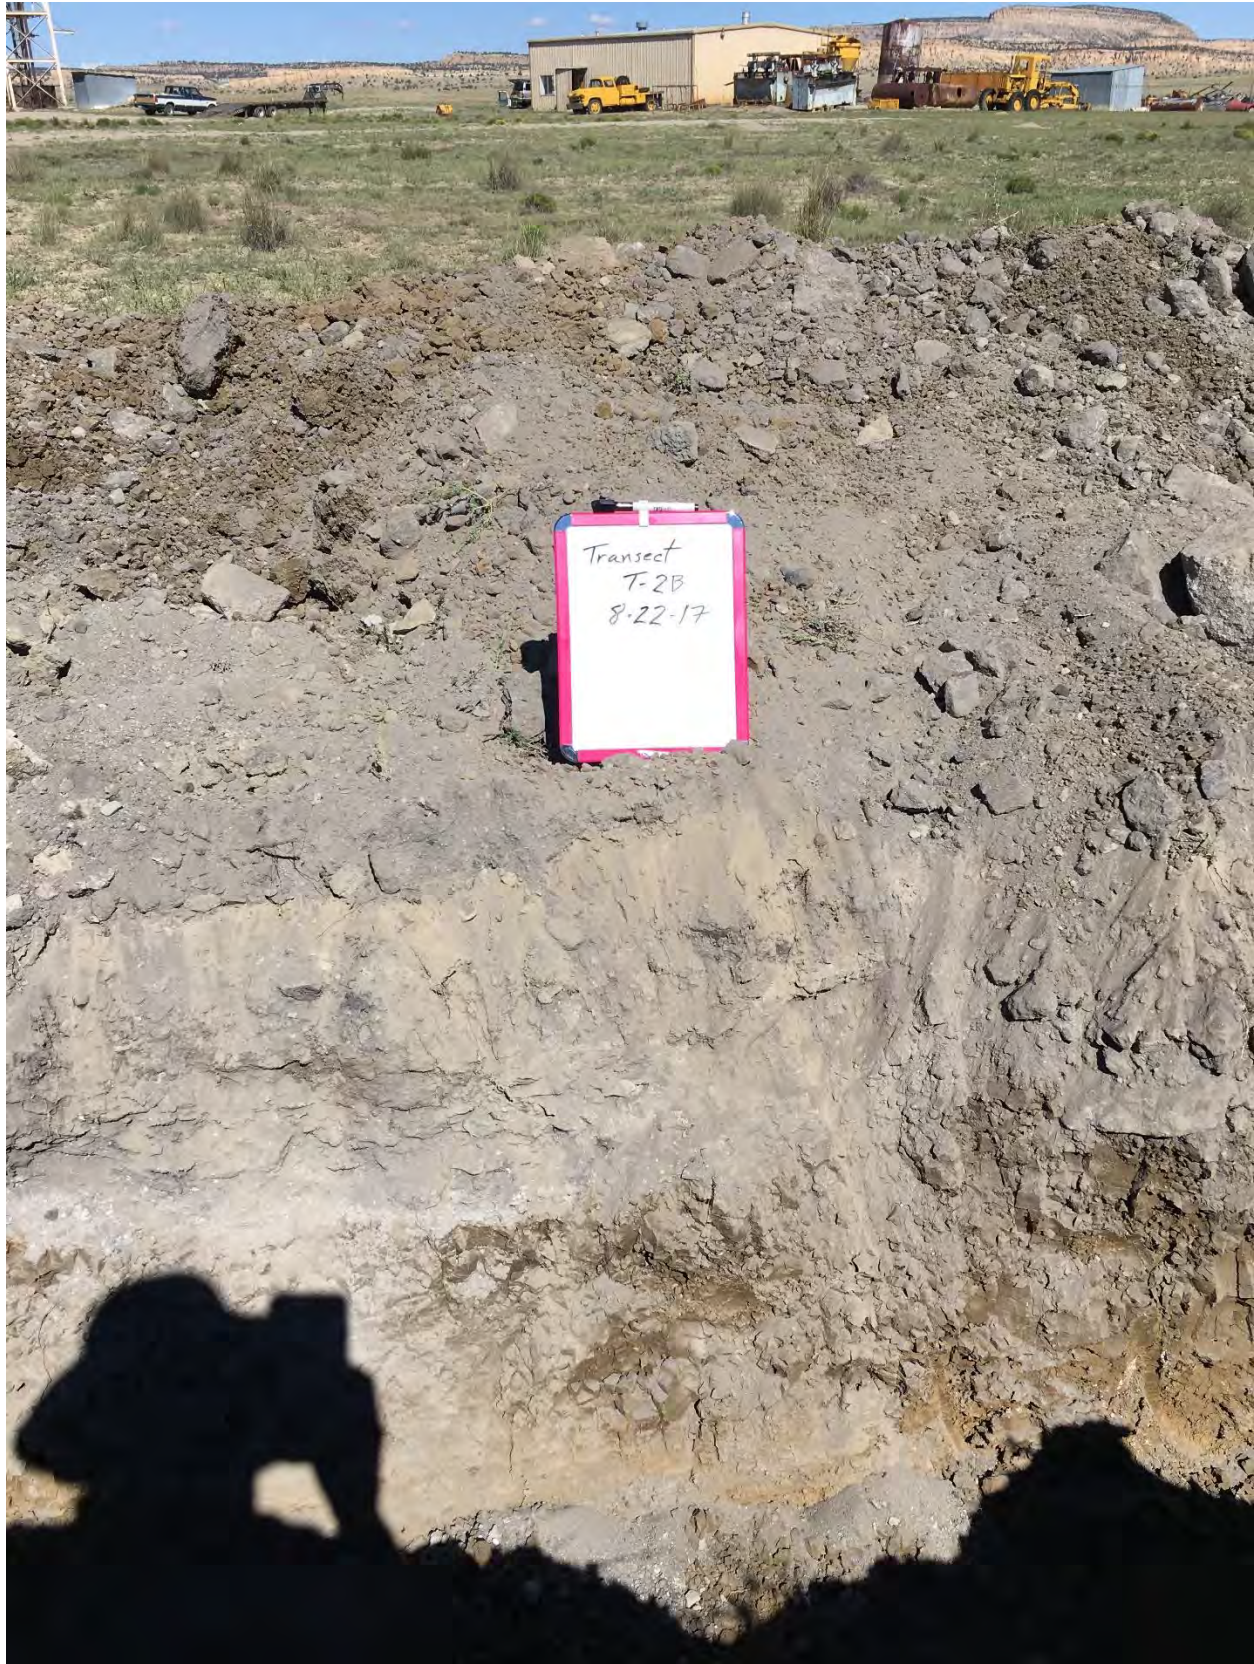
Figure 11. Photo: OBCG5018. Trench 2-B (southwest end of trench). Note brownish clay layer below 18 inches.

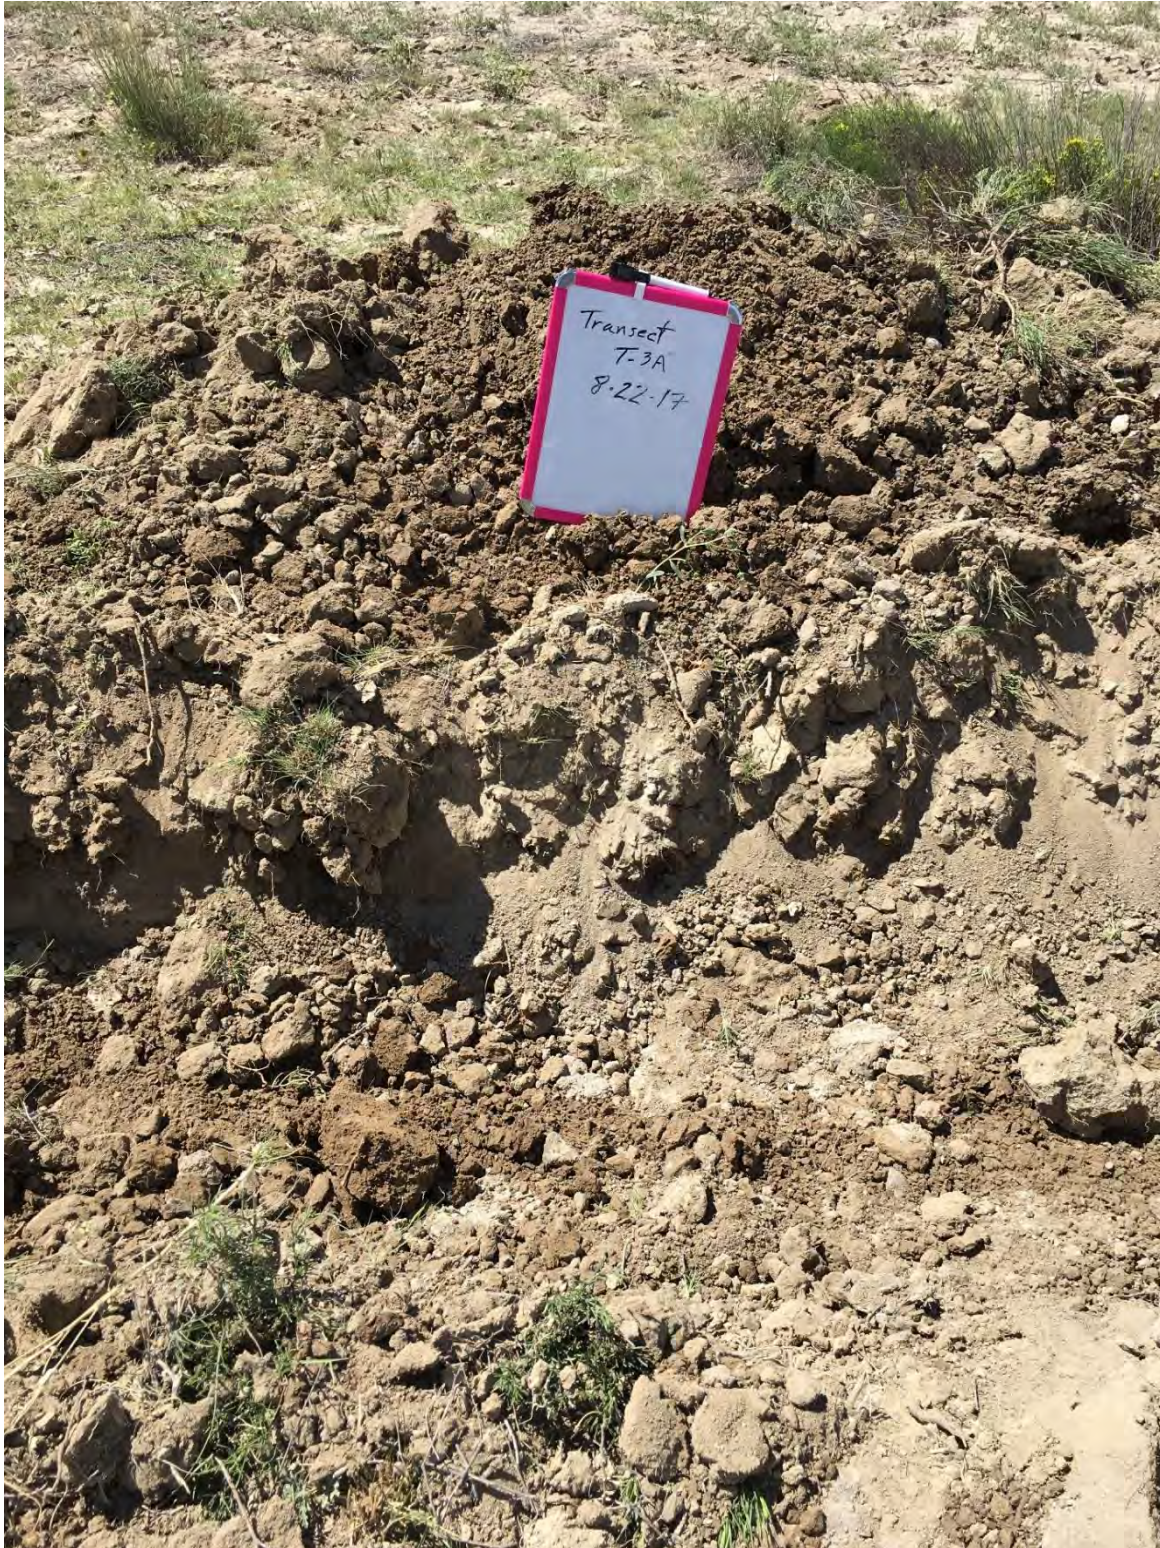
Figure 15. Photo: ANTE4371. Beginning of trench T-3 on east of waste pile. Note brownish lakebed clays in mid-frame of photograph.

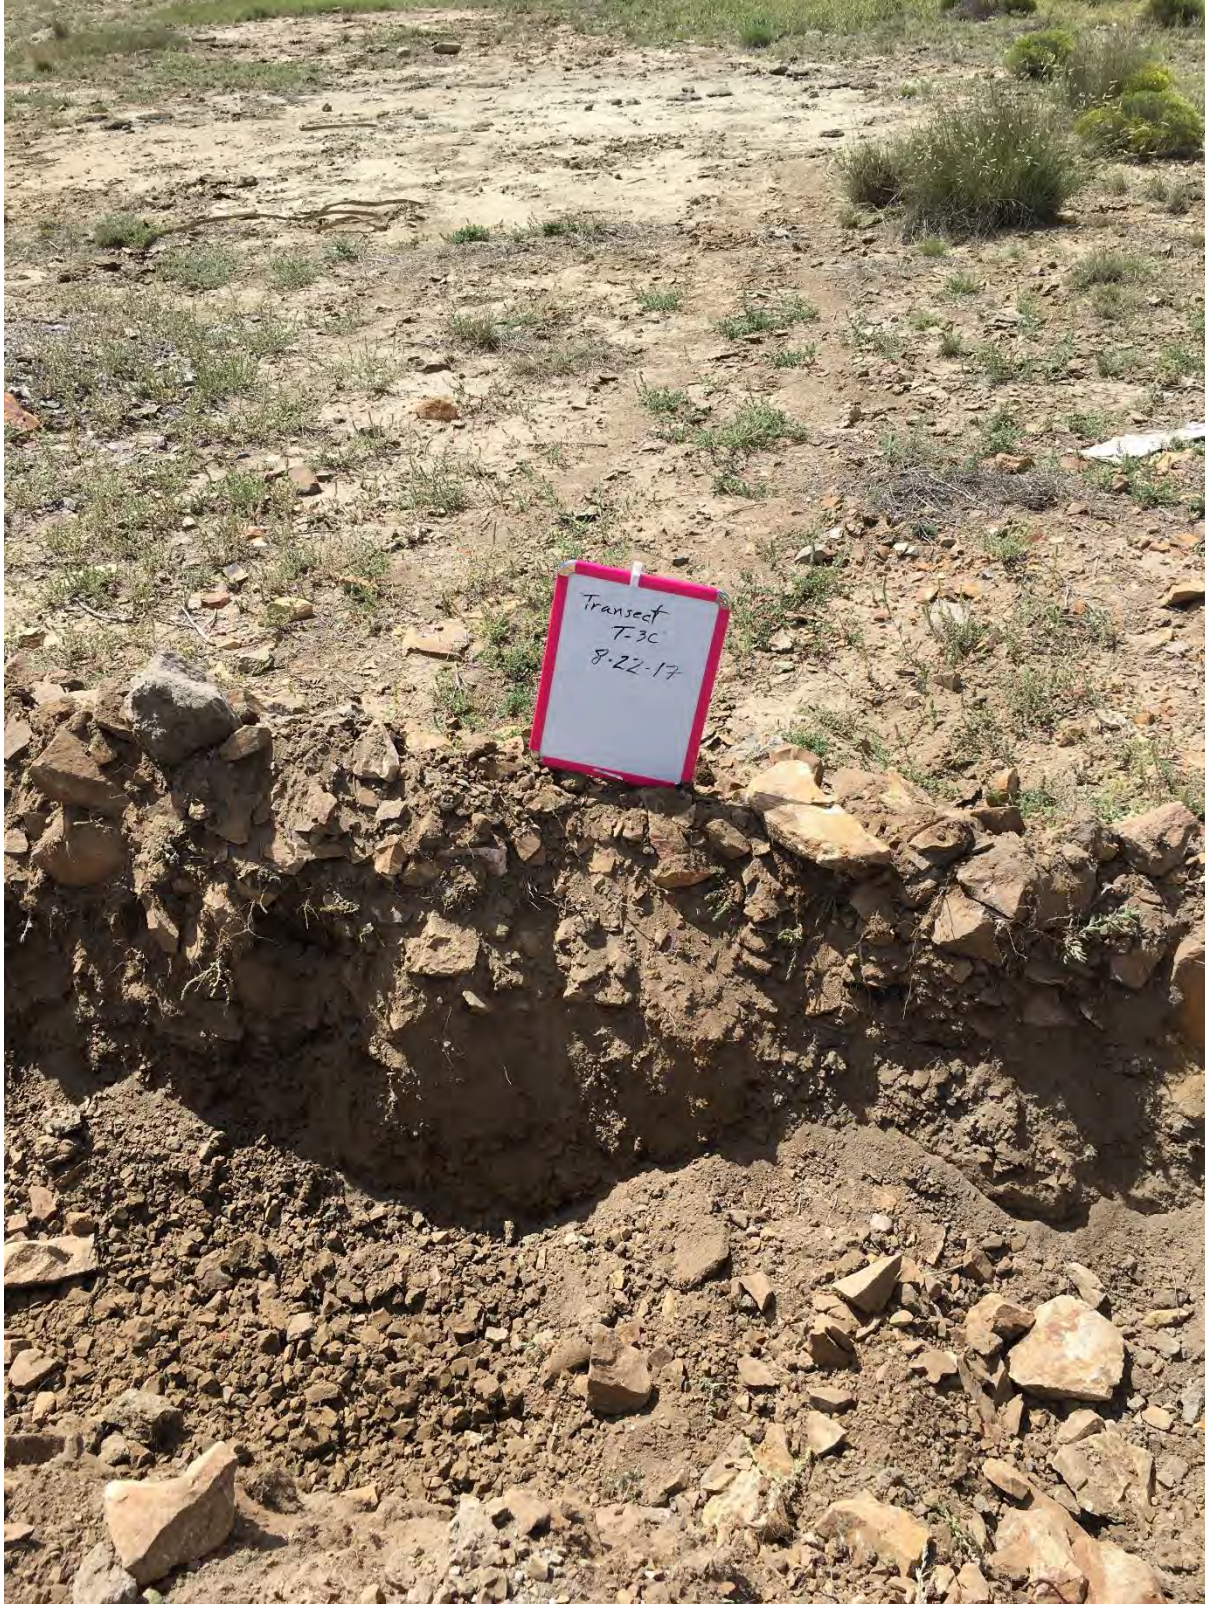
Figure 17. Photo: QLUH0714. Trench T-3C on east side of waste pile. Note blocky and angular lakebed clays as well as fragments of sandstone rock with yellowish chroma (limonite).
