TECHNICAL MEMORANDUM

To:	Andrew Conover
From:	Marcus Erdmann
Reviewed B	y: Ryan T. Baker, P.E.
Project:	Summit Mine DMS Slide Corrective Action
Project No:	475.0386.000
Subject:	Summit Mine QA/QC Report
Date:	25 January 2019

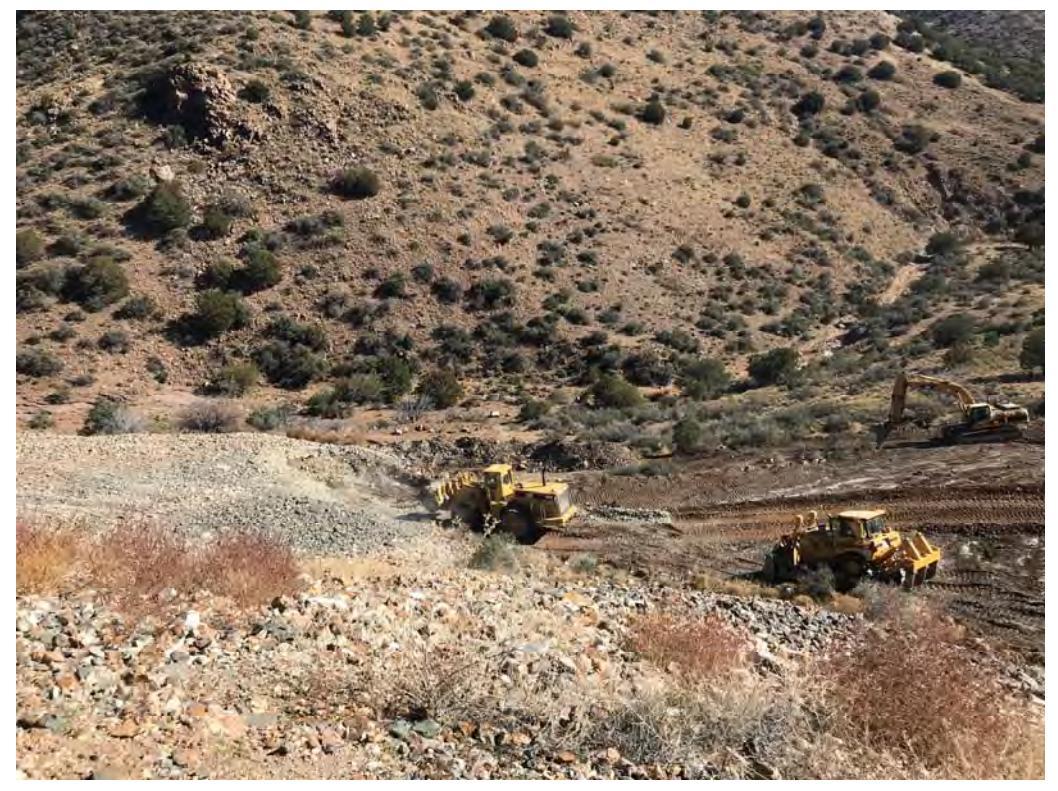
11.27.18 Waste Rock Removal

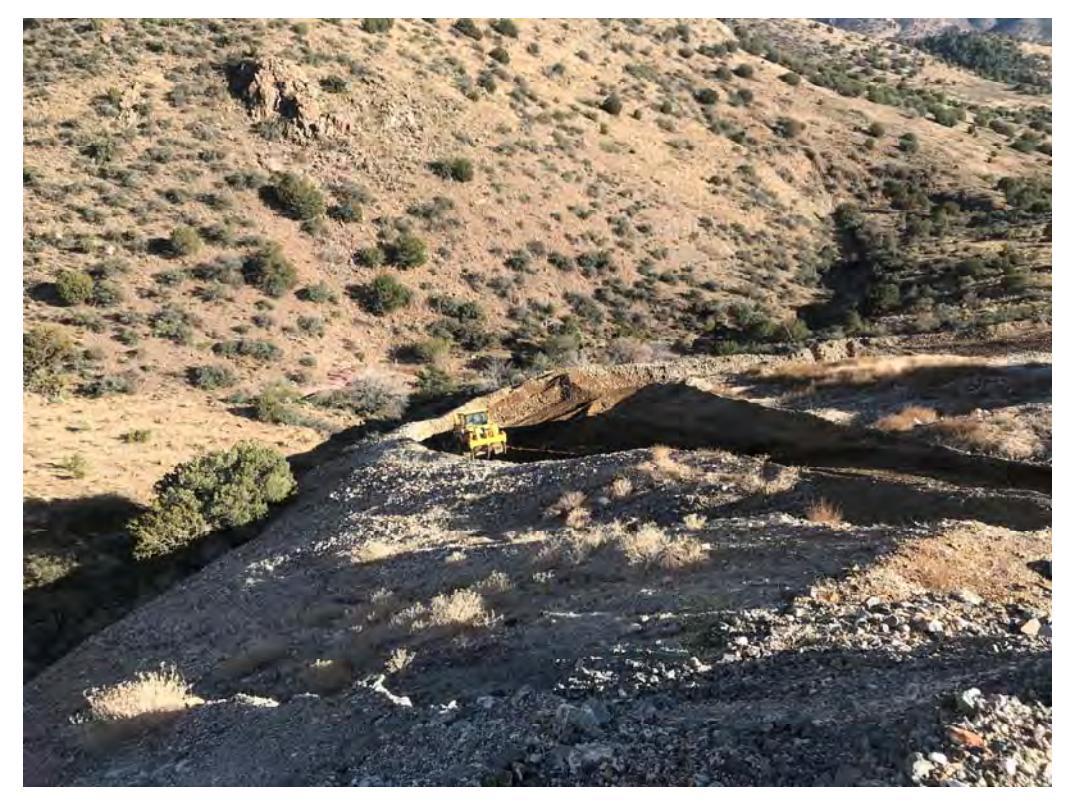
12.4.18 Waste Rock Removal

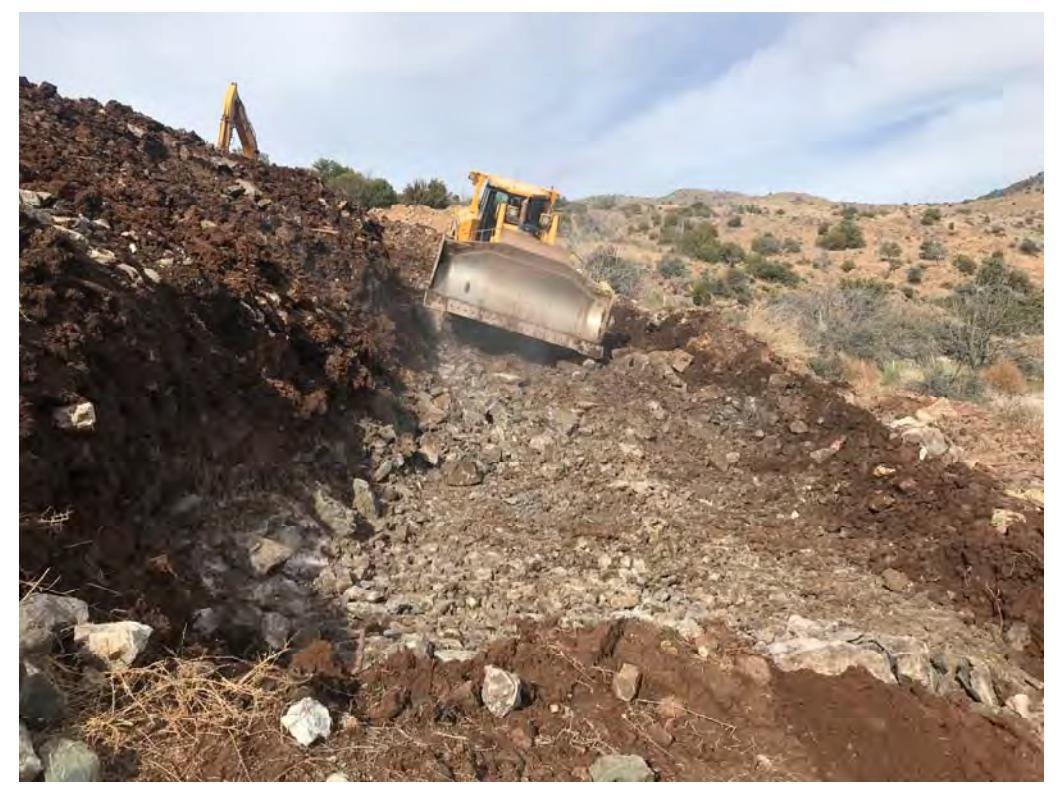
12.11.18 D8T Compacting Buttress Lift

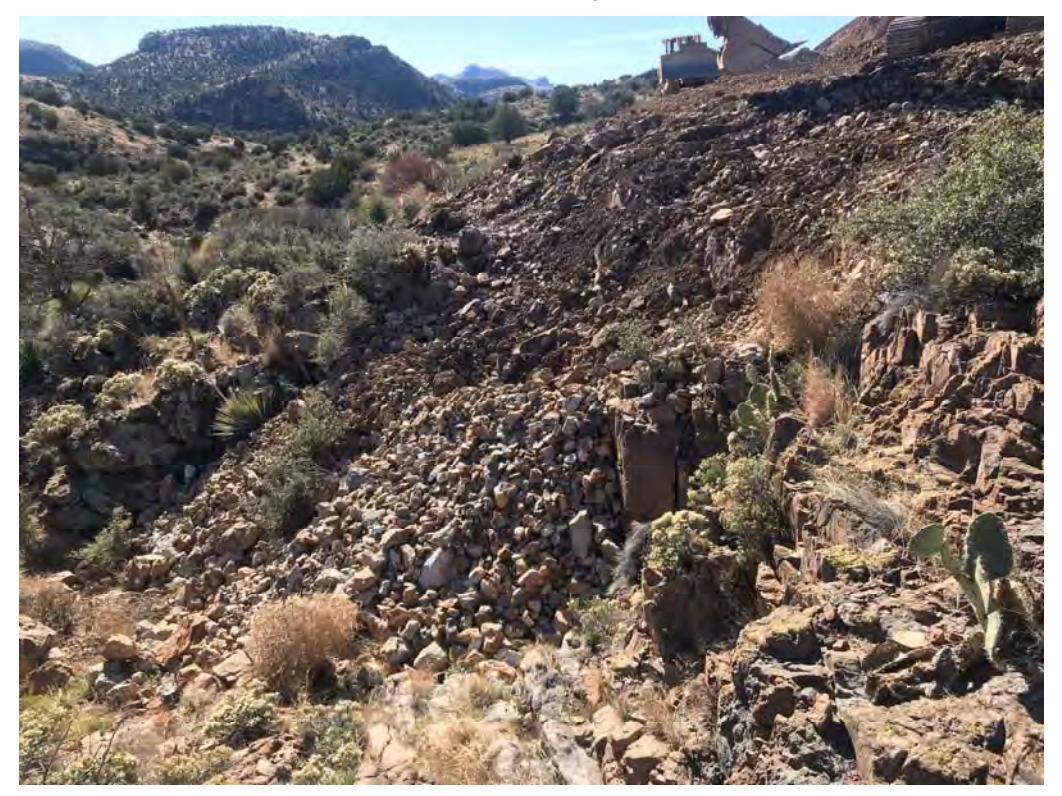
12.13.18 Waste Rock Spill

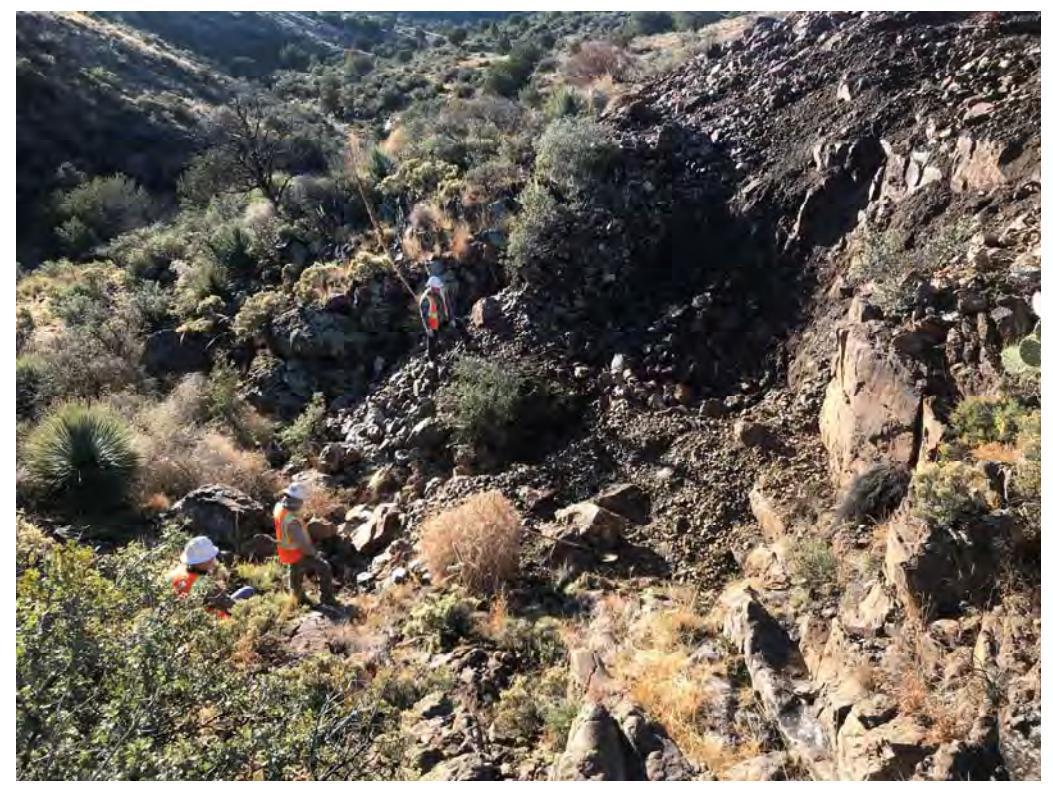
12.18.18 Laborers Removing Waste Rock

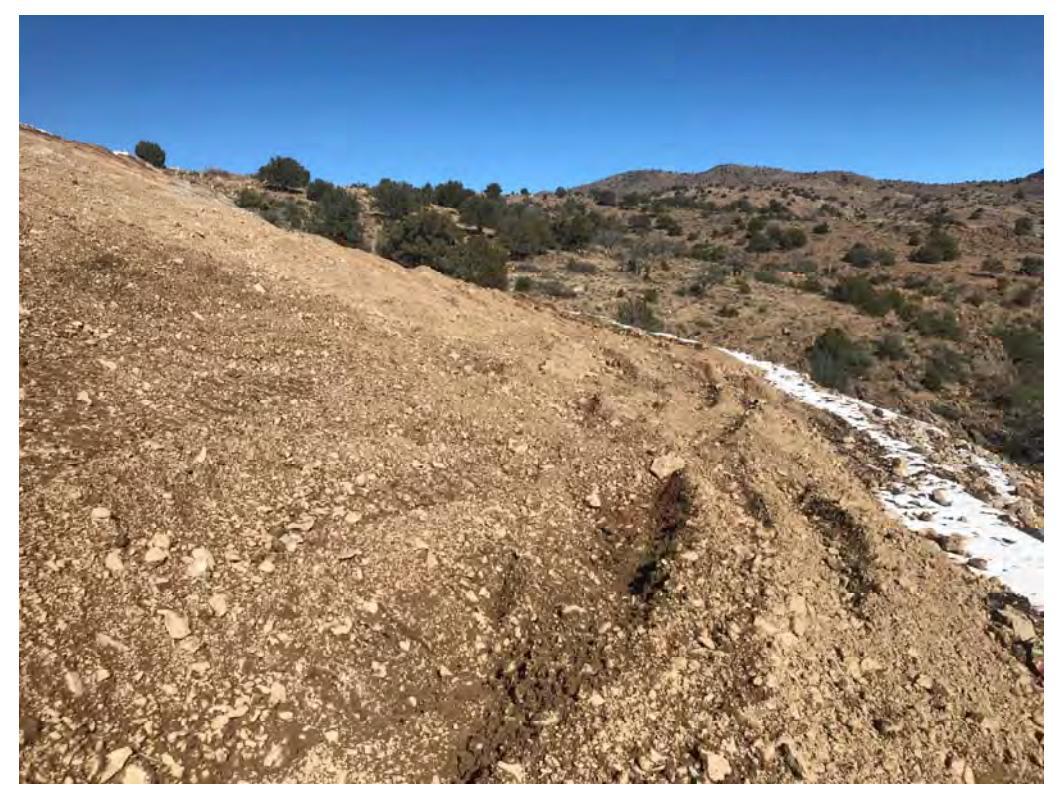
01.04.19 Slope Tied into Buttress

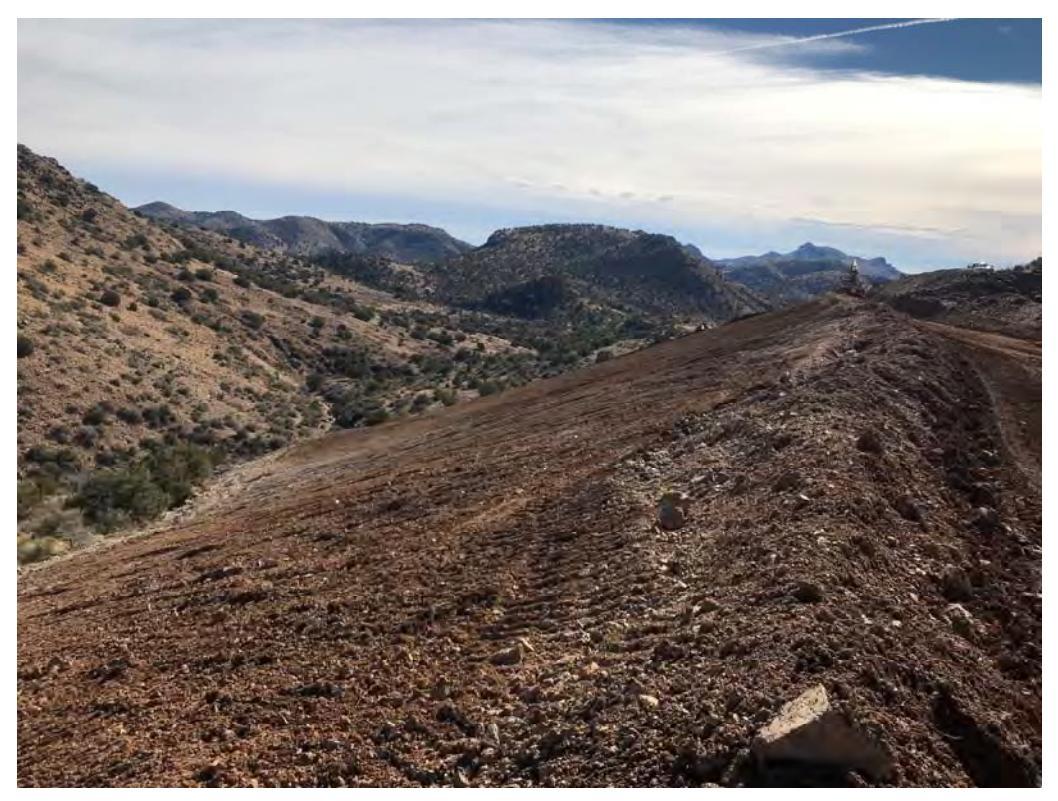
01.08.19 Completed Waste Dump Regrade

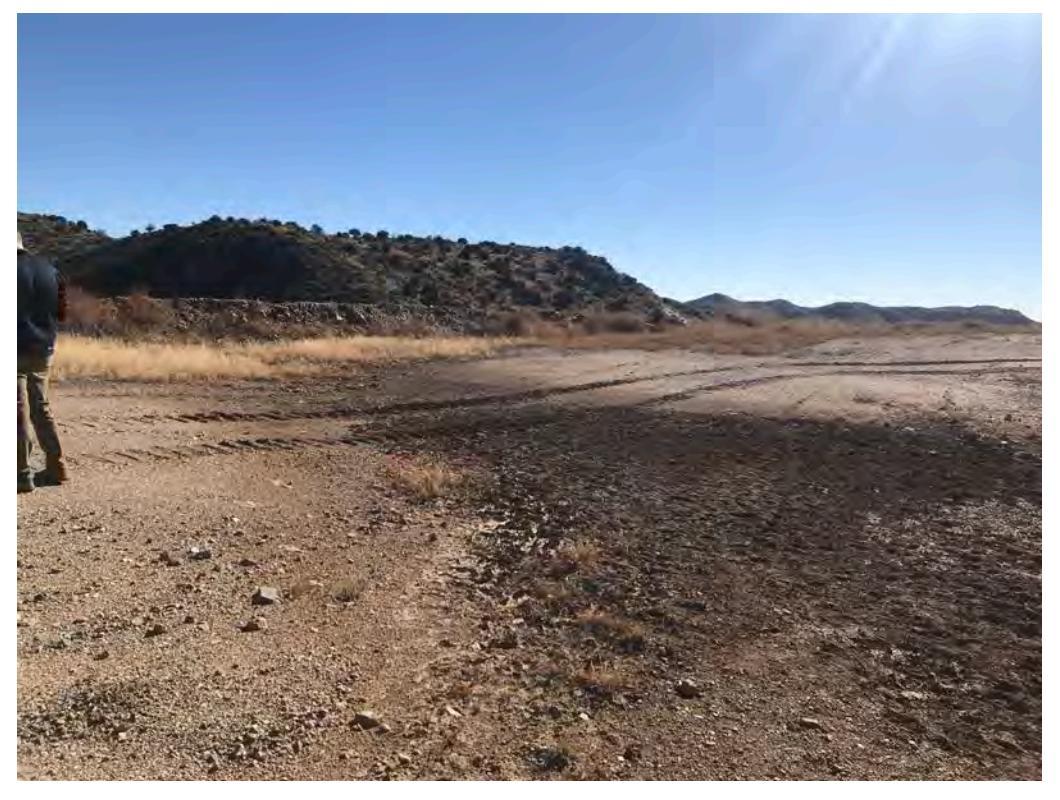
Ponding on Mining Pad

- > Kickoff Meeting, attended by Elko Mining Group, NewFields, and TG McCauley:
 - There is evidence of water pooling at the top of the slope, Rusty McCauley recommended grading the area to allow for better drainage. The designed spillway at the top of the slope would then need to be built to fit rather than built from the drawings. The plan was OK'd by Eric (Environmental) and Riley (Engineer) of Elko Mining Group, LLC
 - BLM (Bureau of Land Management) has given TG McCauley 20' past the property boundary to perform necessary work.

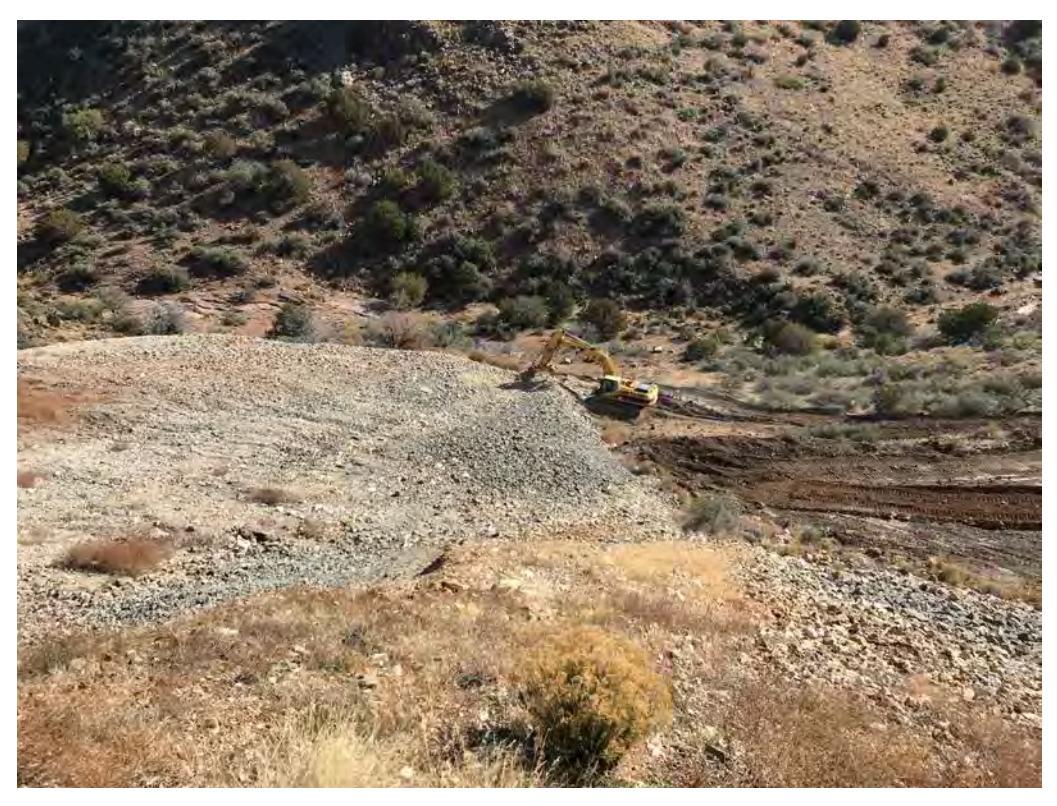
Excavator Testing Slope Stability

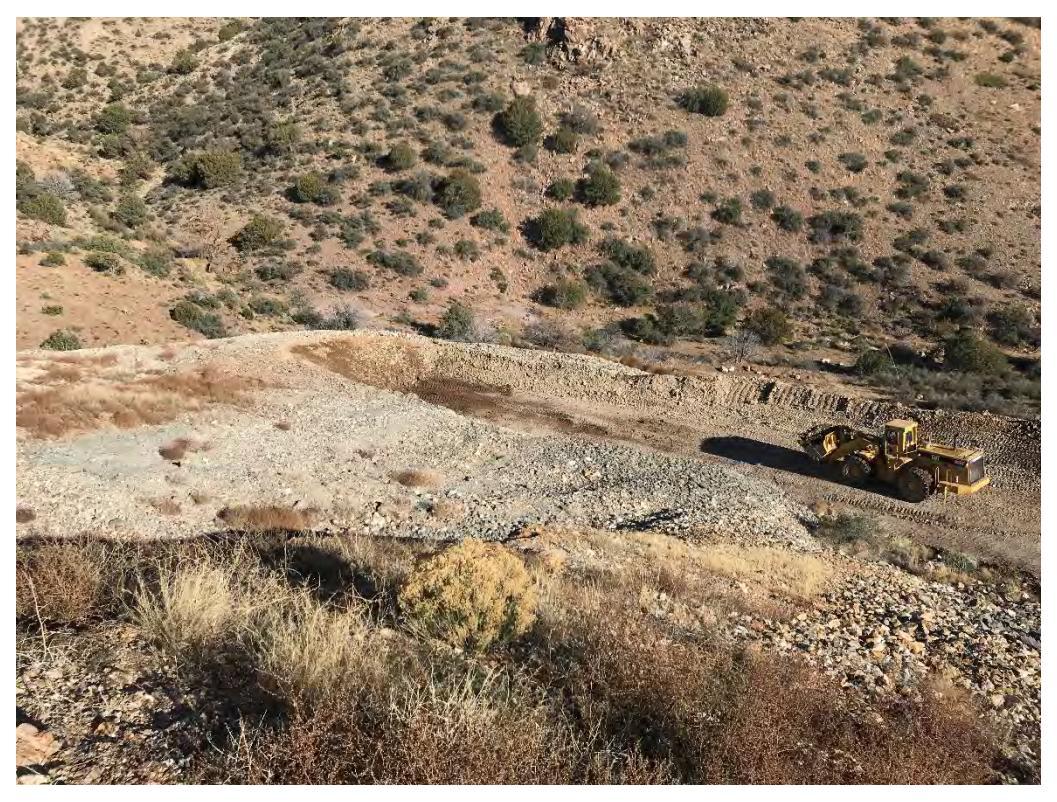
Road Cut along the Toe of Slide Material

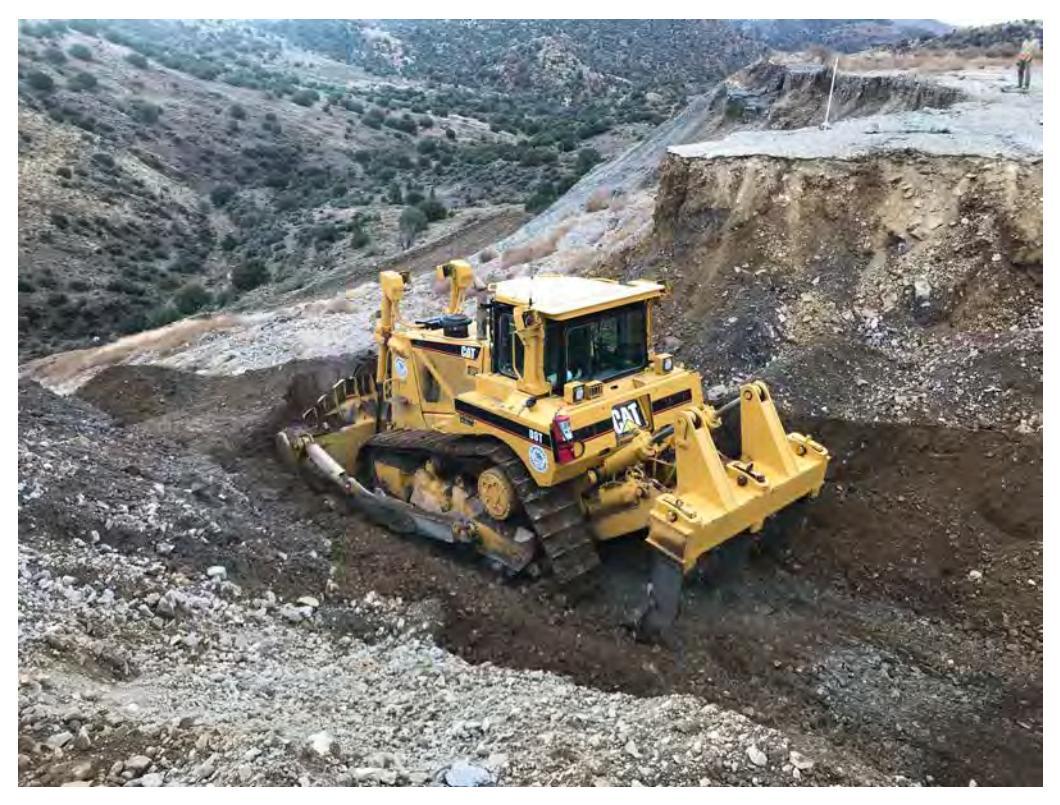
D8T Pushing Down From Crest

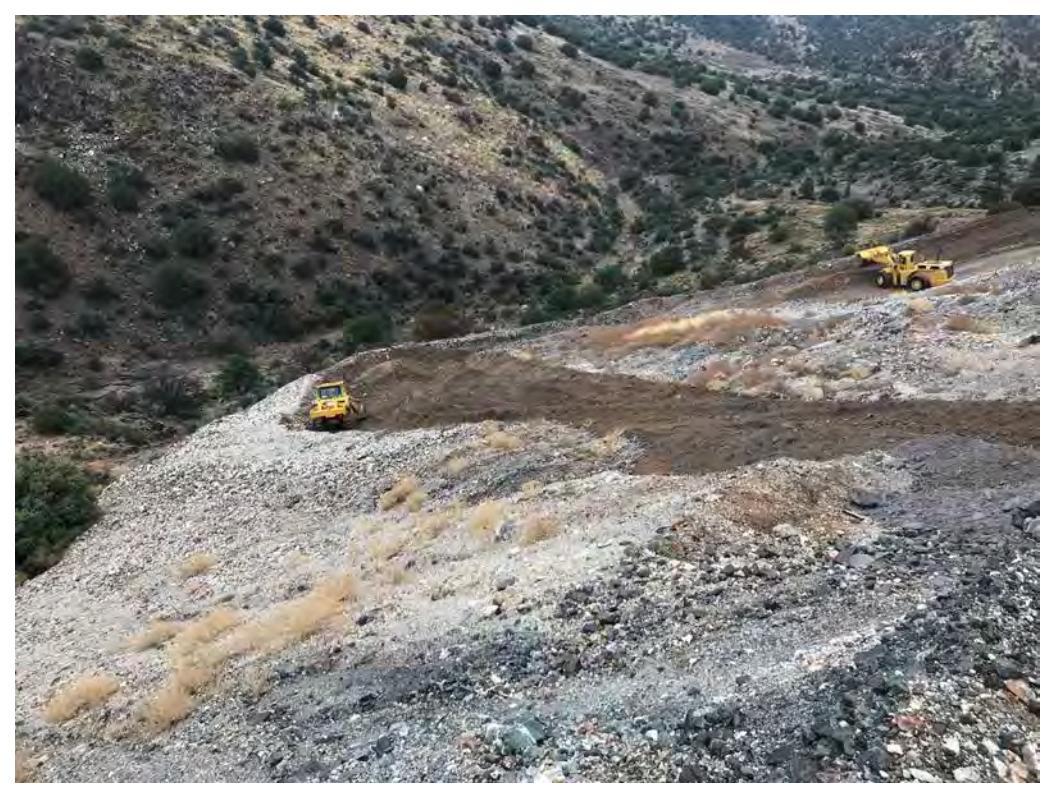
D8T Pushing Down Slide Material

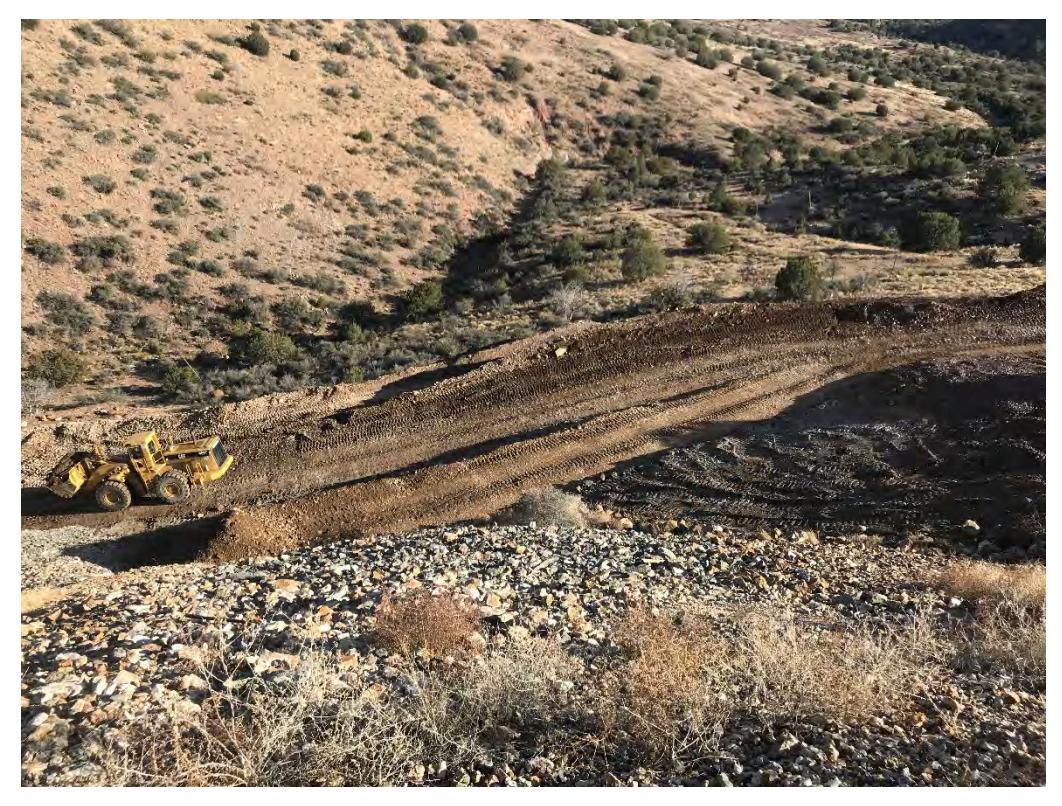
Compacted Waste Rock

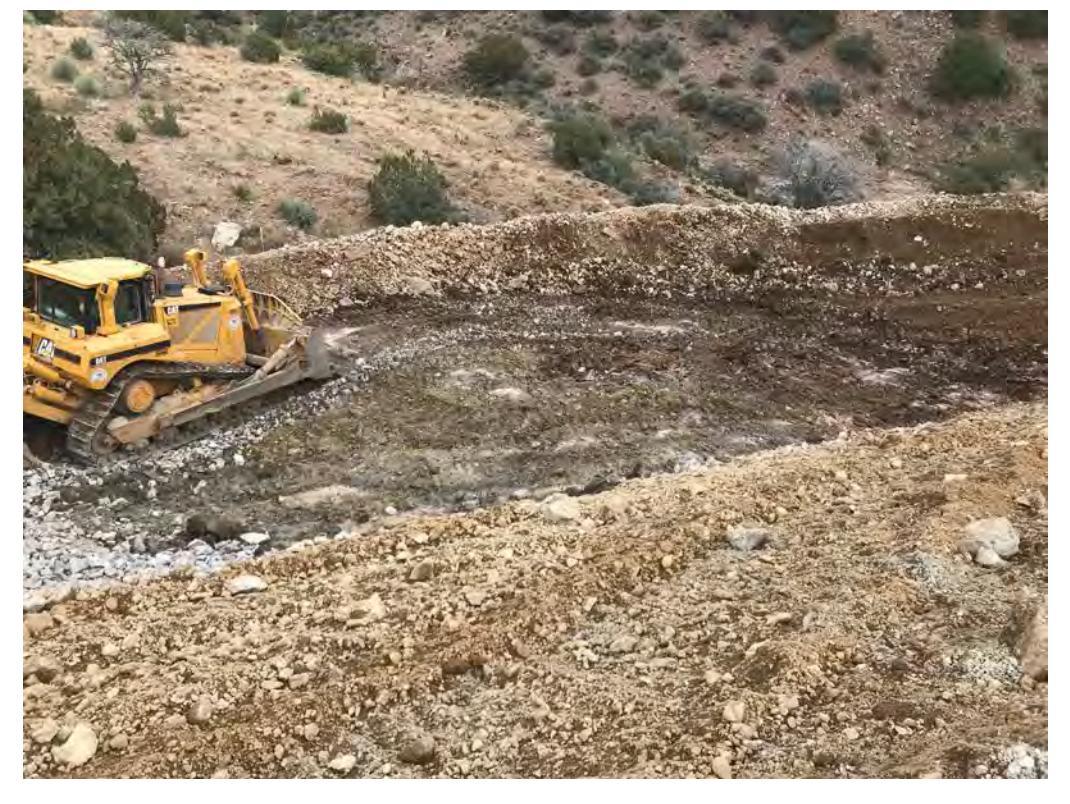
Slide Material Cut to Bedrock at Toe of the Slope

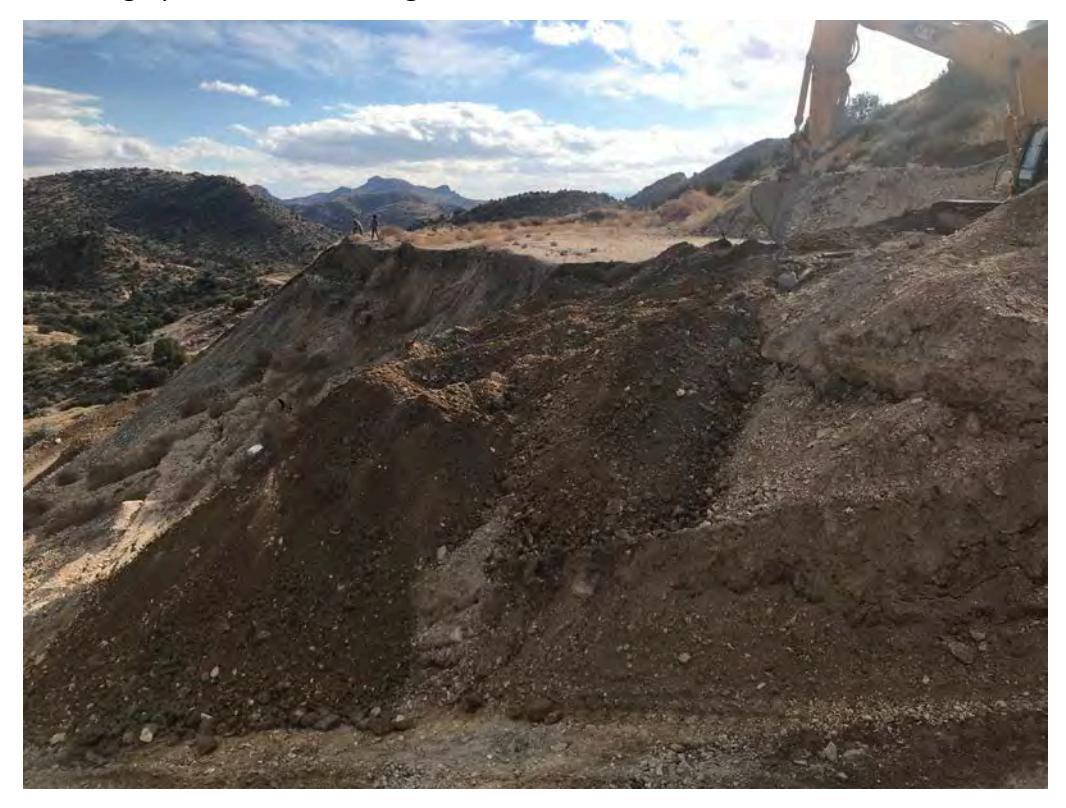
Excavator Pushing Down Scarp

NewFields, it was determined necessary to remove the driving force on the slope by removing uphill material, along the tension cracks.

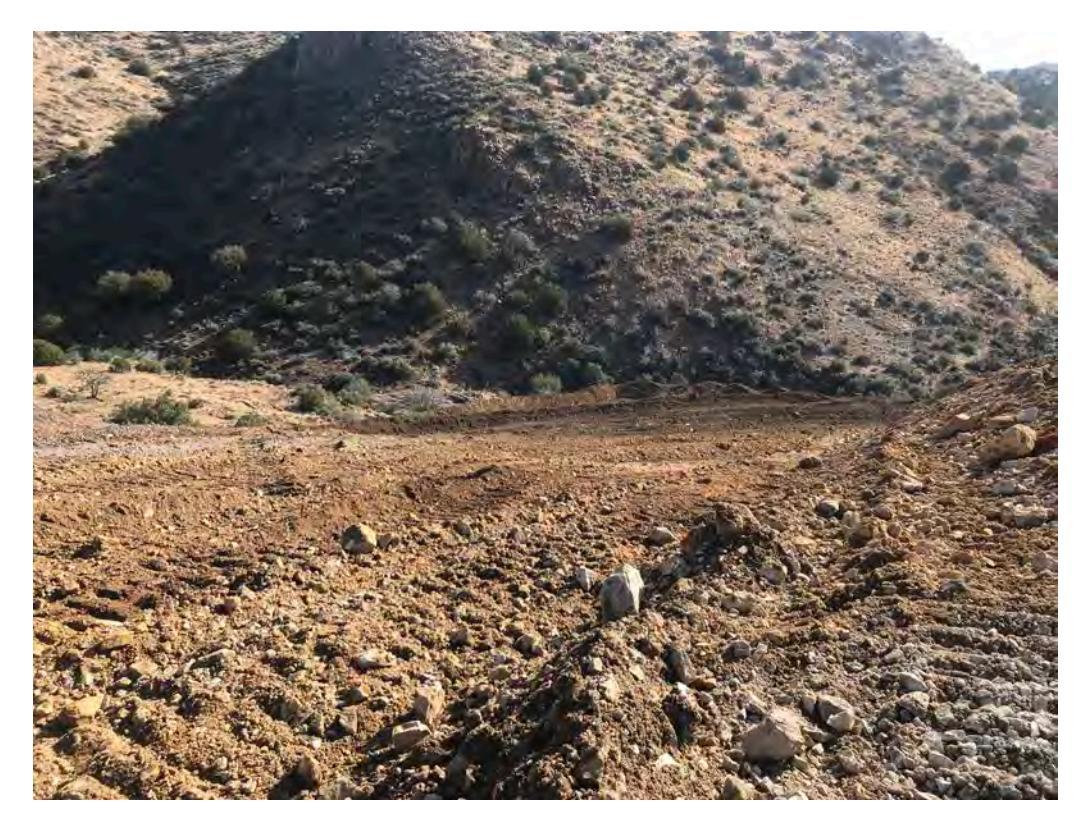
Driving Force Removed from Slope

- McCauley operator Abel was not on site today
- > D8T pushed slide material downhill to remove driving forces from the slope.
- D8T continued cut through the toe of the failed slope. The loader removed cut material and dumped in the grub and cleared section on the south of the property, uphill of the road.

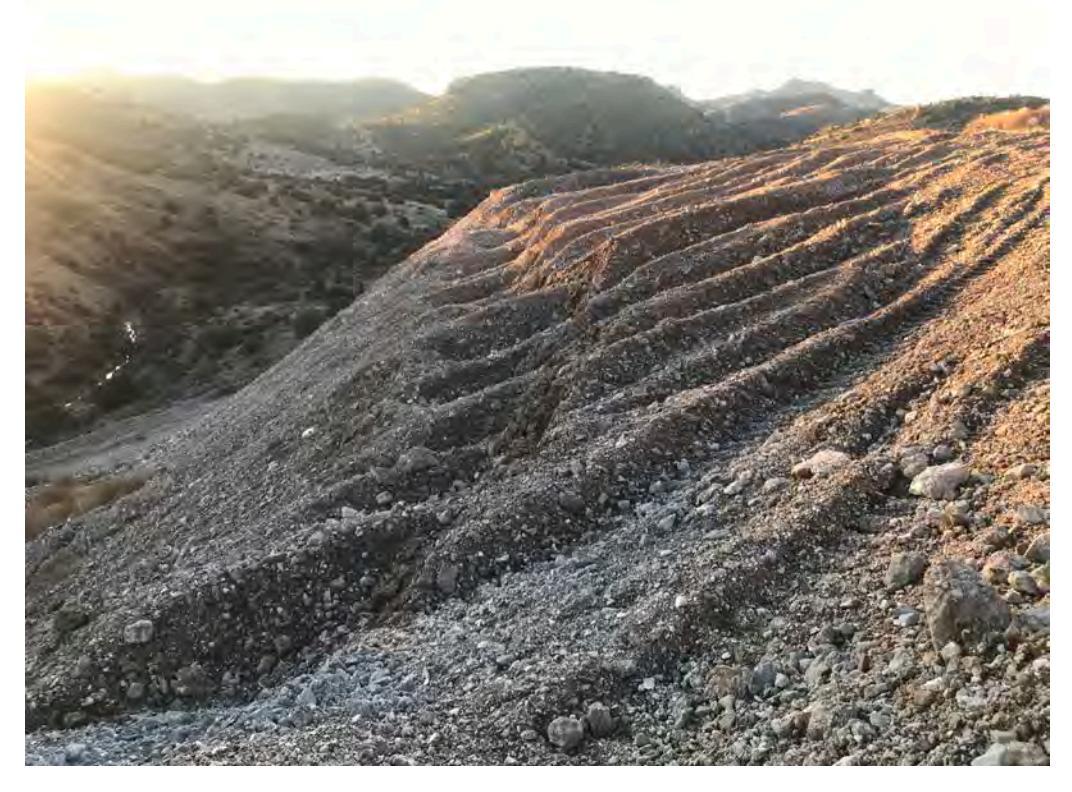
Continued Failed Slope

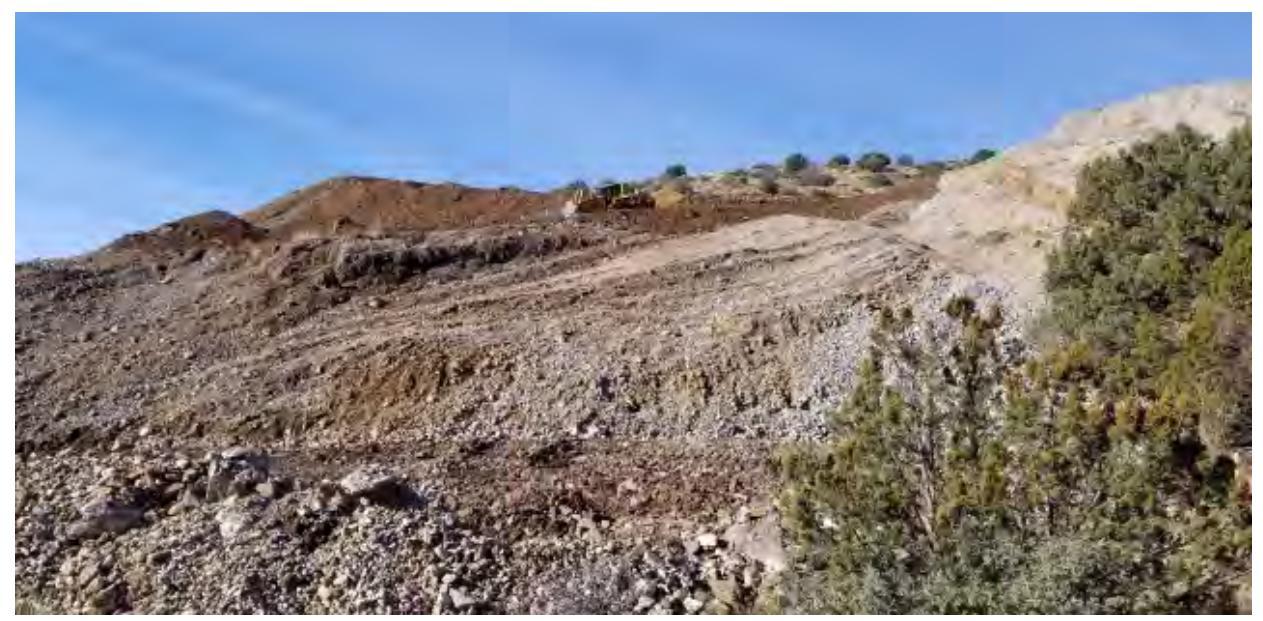
Photo 1: Offloading top of slope

Off loaded the top of slope pushing/cutting material from the north crest to the southeast (photo 1). Work completed by 10:00am. Equipment: Cat D8T dozer and Cat 988F loader.

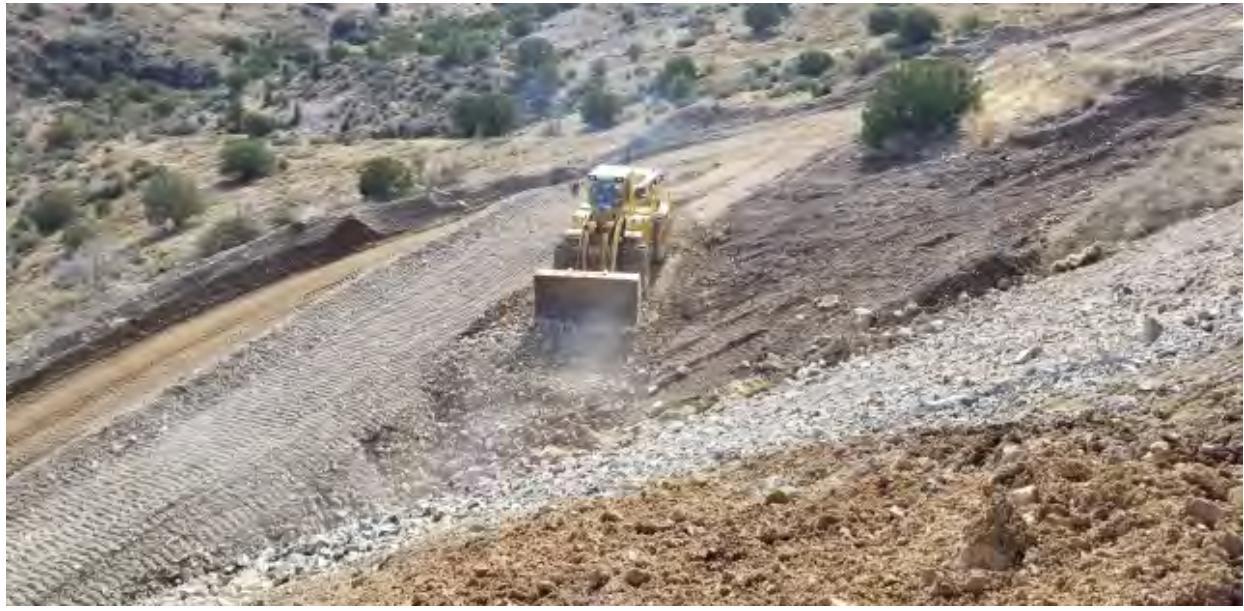
Photo 3: Placement of waste rock in grub and clear area.

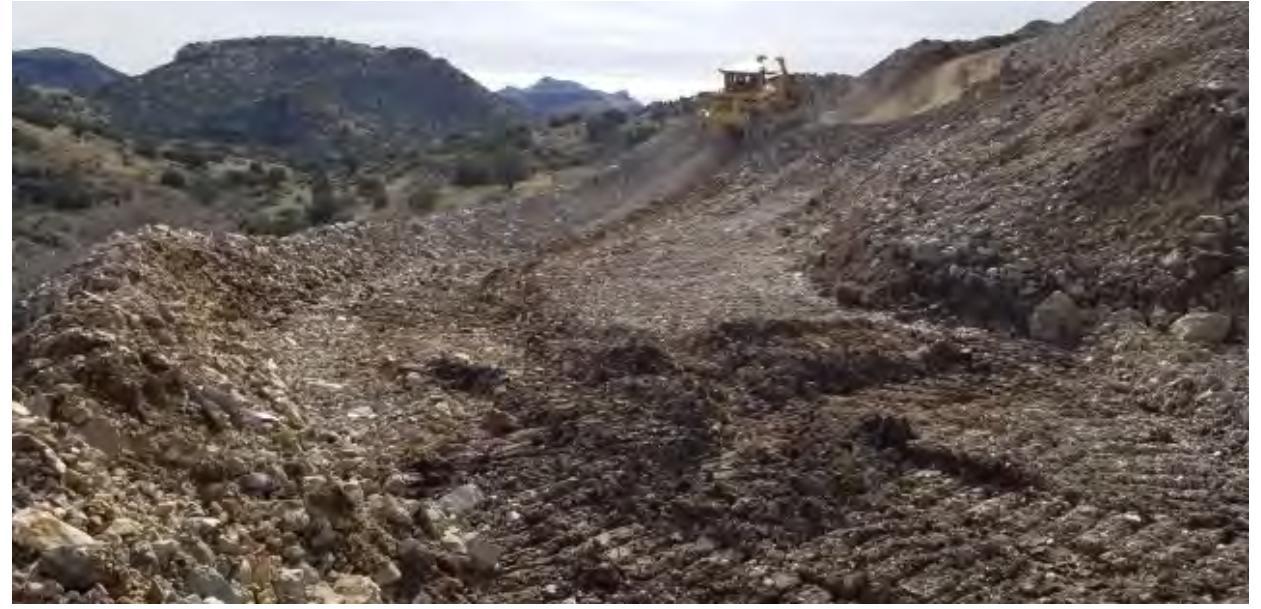
Photo 4: Native soils (clayey gravel) exposed at south keyway excavation.

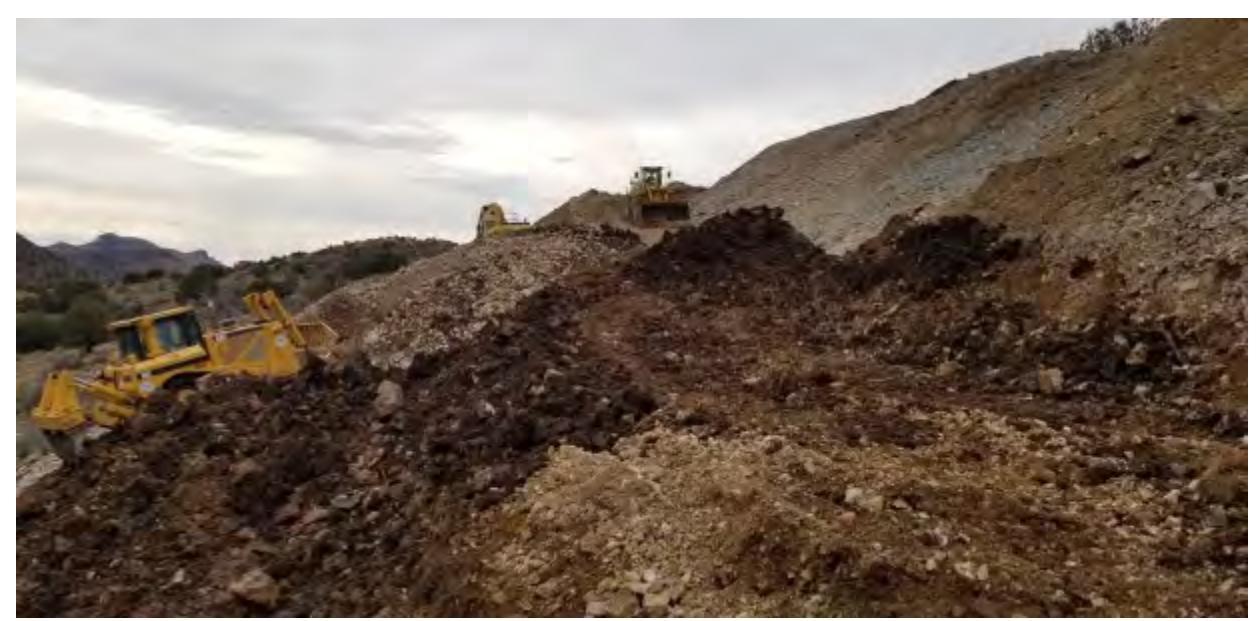
Photo 1: Removing clay soils along the buttress keyway alignment.

Started removing clayey gravel and clay (photo 1) along the anticipated alignment per Summit Mine DMS Slide Corrective Action Program, A010, Draft. Clayey soils stockpiled up slope in the grub and clear area (photo 2). Equipment: Cat D8T dozer, Cat 988F loader and Cat excavator. No survey available.

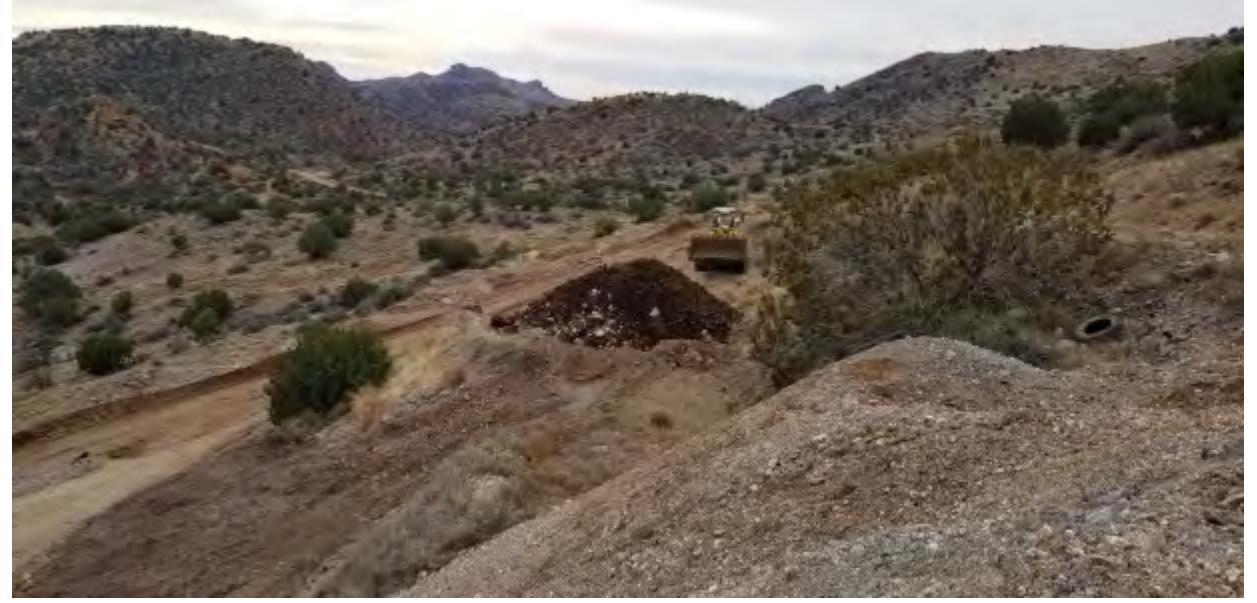
Photo 2: Clay soil stockpile.

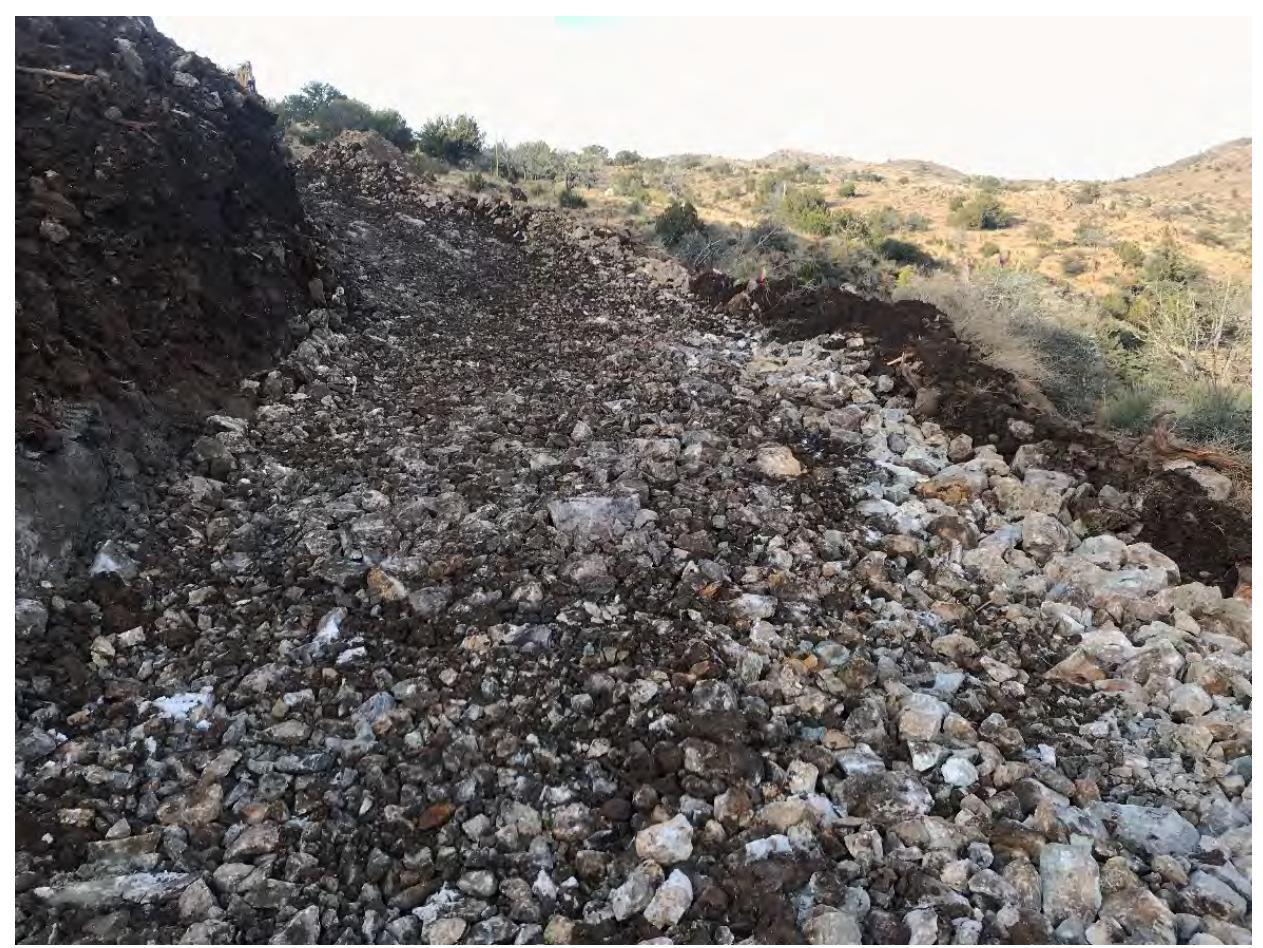
Buttress Progress End of Day

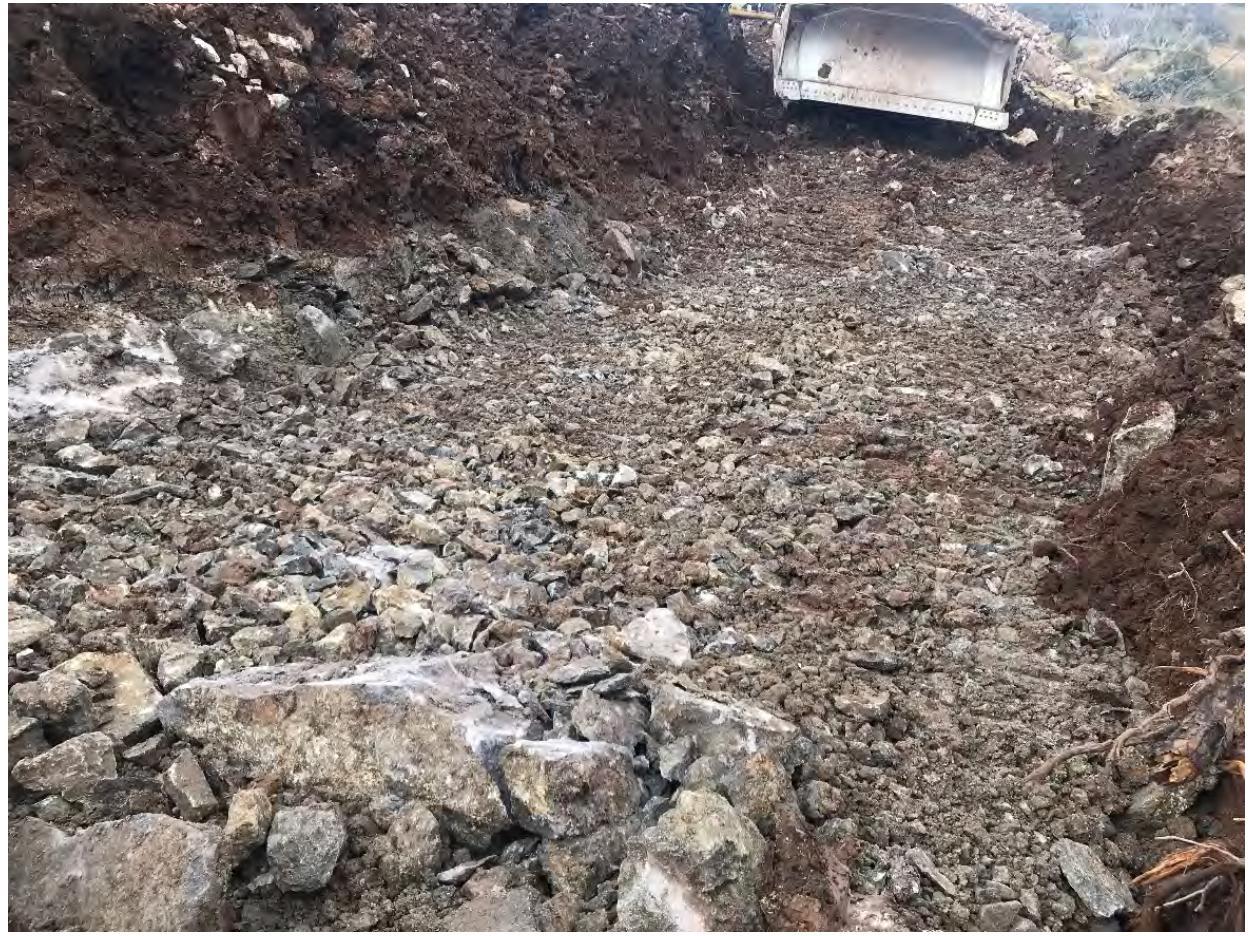
Graded and Compacted Buttress (1st Lift)

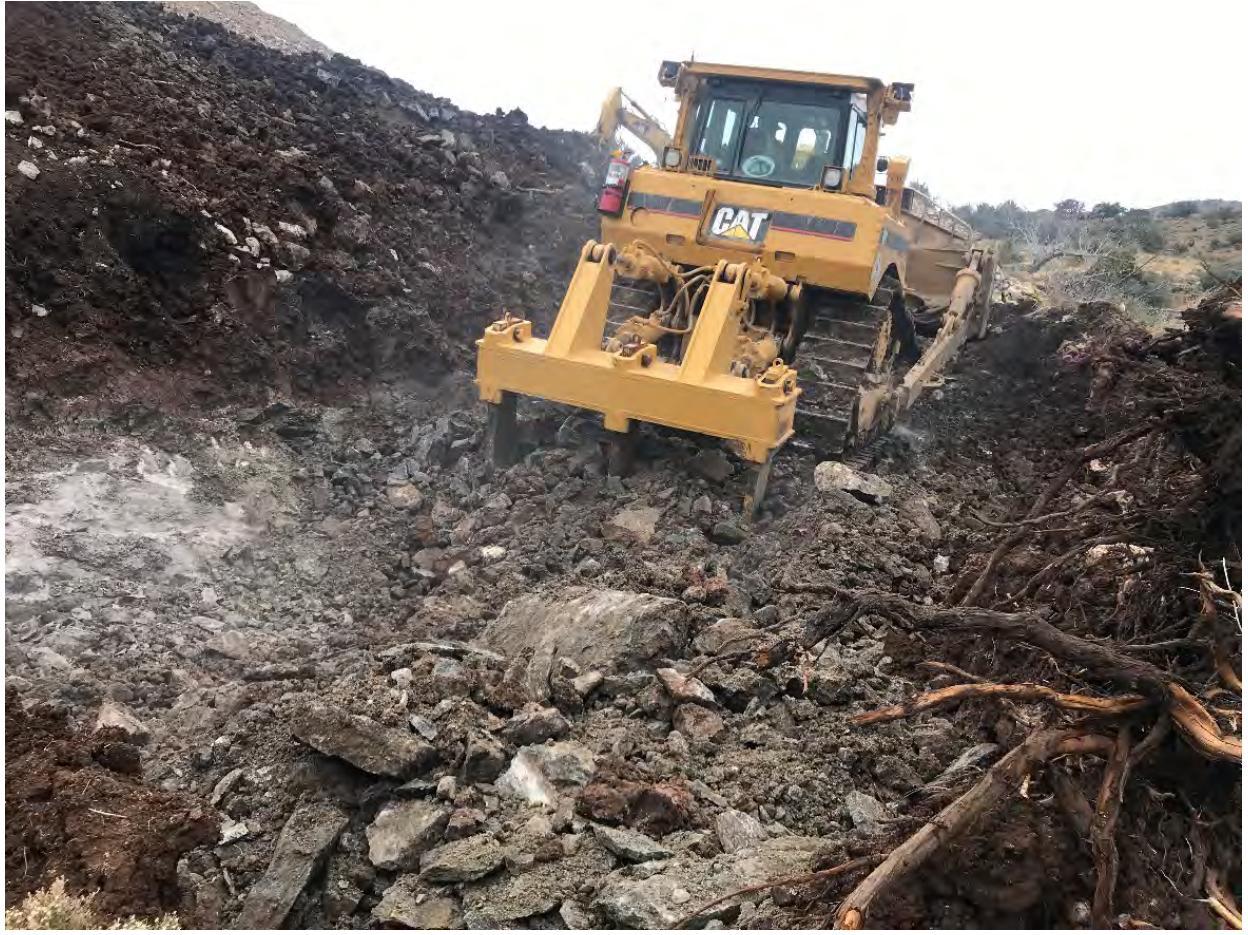
D8T Ripping Bedrock to Grade
