TECHNICAL MEMORANDUM

To:	Andrew Conover
From:	Marcus Erdmann
Reviewed B	y: Ryan T. Baker, P.E.
Project:	Summit Mine DMS Slide Corrective Action
Project No:	475.0386.000
Subject:	Summit Mine QA/QC Report
Date:	25 January 2019

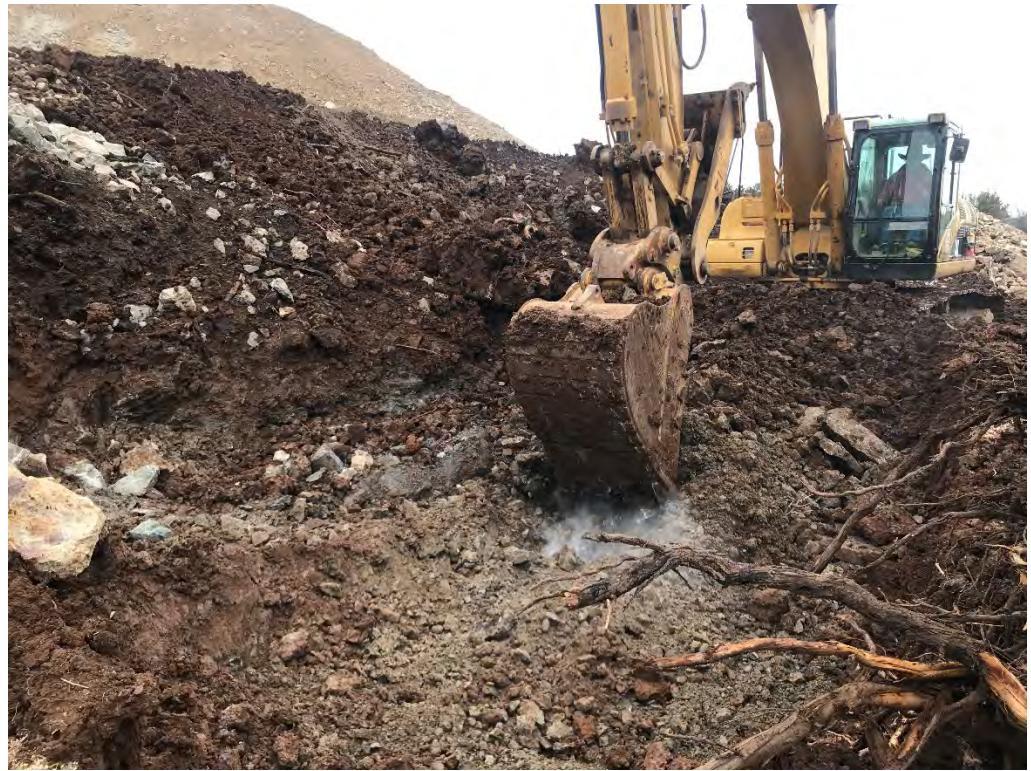
Excavator Cutting Topsoil to Bedrock

- > McCauley operator Abel was not on site today
- D8T and excavator cut topsoil at the toe of the failed slope down to bedrock. The loader was used to remove topsoil and dump it at the top of the built road, just below the county road. Once bedrock was reached, the excavator attempted to grade bedrock to level.
- The D8T ripped bedrock to create a level foundation for the buttress. Competent rock (gravel-boulder) was placed on level bedrock with the D8T in 1ft lifts and track rolled approximately 10 times per lift.
 - 1, 1-foot lift was placed from the south end of the buttress approximately 80ft north. A second lift was placed from the south end of the buttress approximately 30 feet north.
 - Buttress was built with a width of approximately 15' due to the size of equipment used.
- The excavator began removing spilled slide material from BLM land at the southernmost spill area.

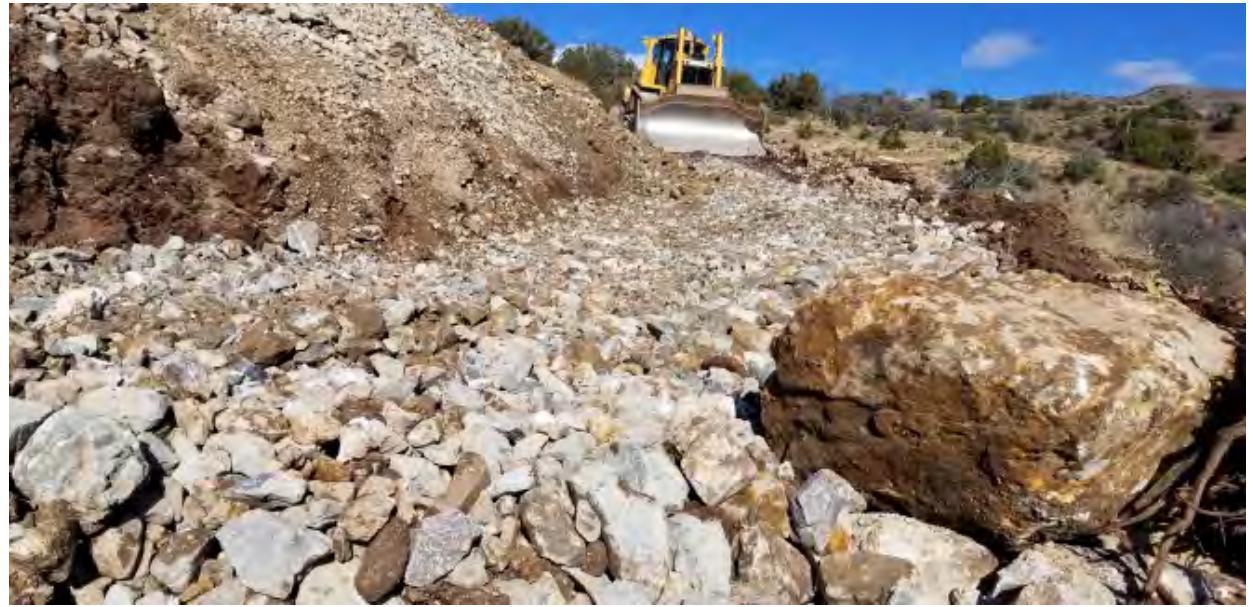
- 2) 8:30am Contractor laying back slope above the southern and center portion of the buttress keyway, ~ 1:1H:V to 1.5:1 H:V. For ~12 linear feet on the south end of the buttress keyway, the adjacent slope is vertical for approximately 4 feet high below the laid-back slope due to the limited reach of the excavator. However, the keyway in this area is 18 feet wide, so the total rocked up buttress up to the top of the vertical clay section is wider than the design section detail A/A020 (photo 1).

Photo 1: South end, buttress keyway alignment, exposed vertical clay surface to the left.

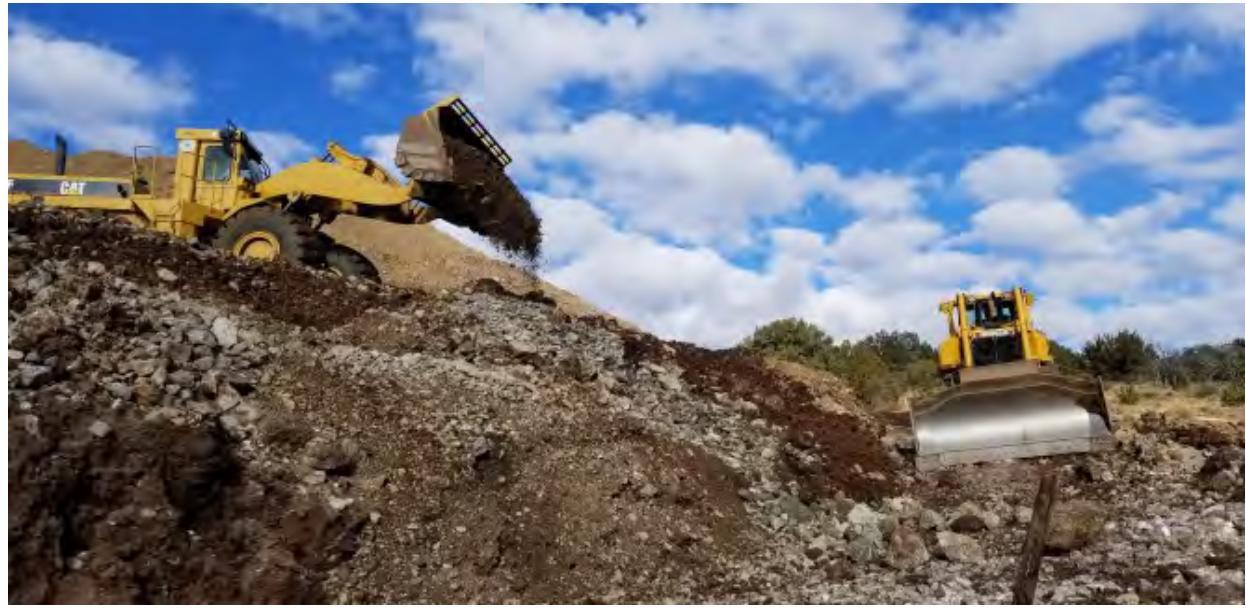
Photo 2: Top feed for south buttress alignment.

- 9:30am Contractor top feeding clean rock (angular gravel, cobbles and boulders) to the buttress keyway, south end (photo 2). Rock spread in ~ 1-foot lifts and tracked in placed, minimum of four passes (back and forth per pass).

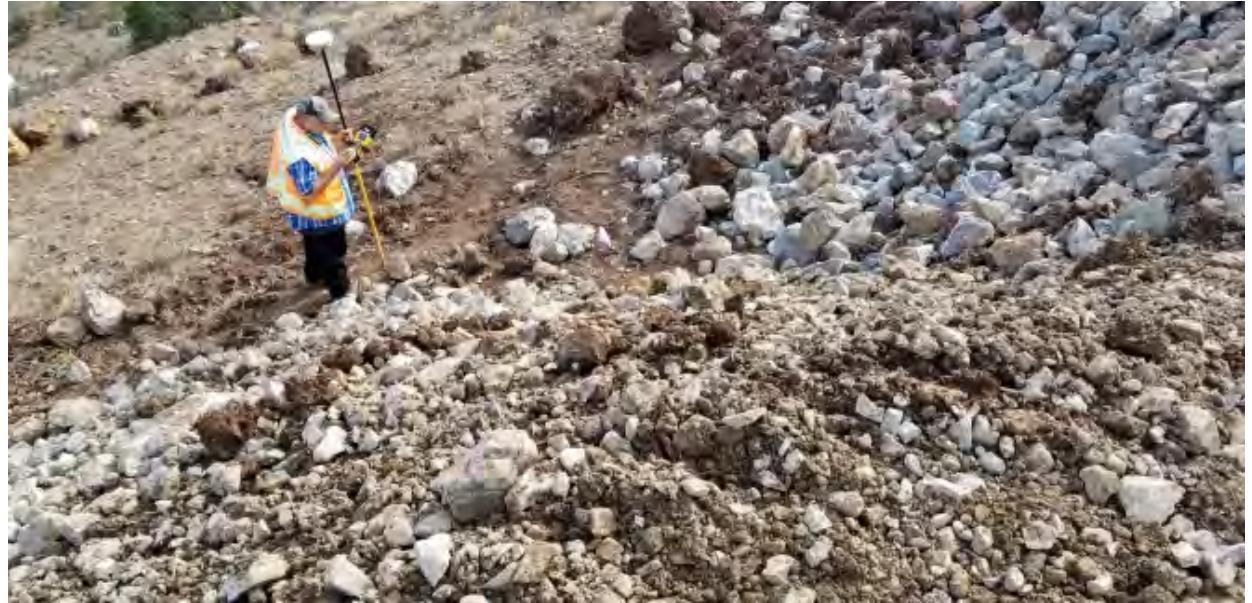
Photo 3: South end buttress rock fill. 9th lift, with surveyor taking south end, buttress, centerline location.

- 12:00pm nine lifts in place on the south end of the buttress keyway (photo 3). Contractor began removing waste rock outside of the property line from ~ center of the estimated buttress keyway.

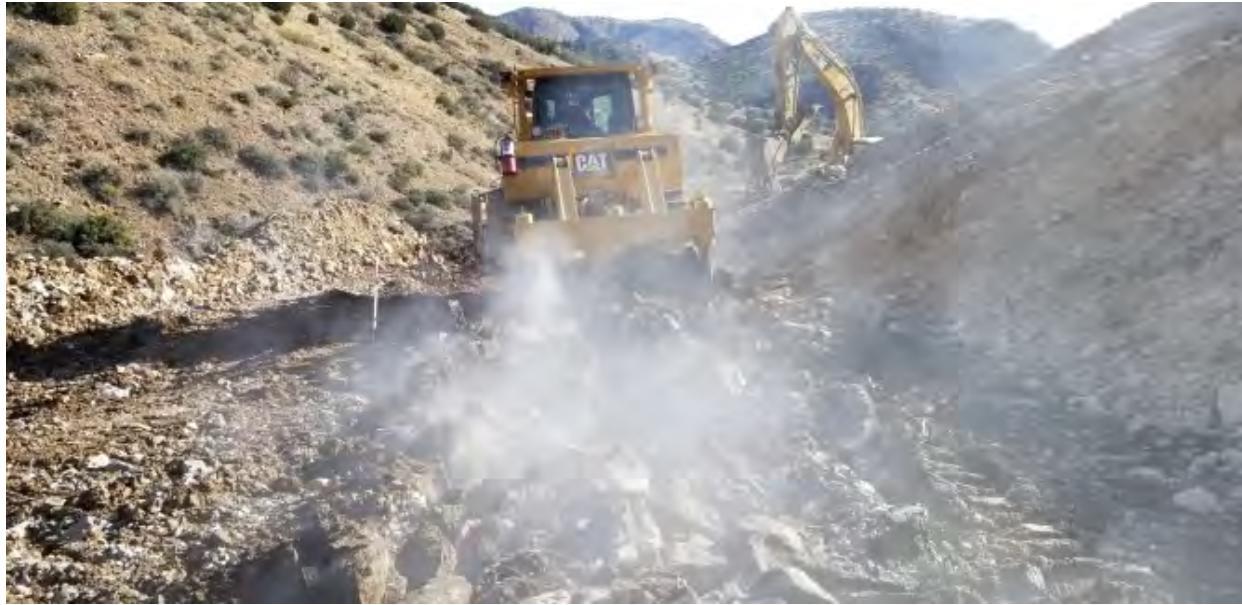
Photo 4: Bedrock ripping, north end.

- 6) 2:00pm Contractor started ripping of the bedrock along the north and center sections of the buttress keyway (photo 4).
- 7) 2:30pm Contractor completed ripping, depth ~ 2 feet along the upslope side. Completed rock surface (photo 5). Contractor returned to removing waste rock outside of the property line from ~ center of the estimated buttress keyway. Contractor only able to reach down approximately ½ of the slope height (photo 6). Waste rock dumped into the center and southern buttress keyway.
- 8) 3:30pm Waste rock dozed into place.
- 9) 4:00pm Left message with Ryan Baker, NewFields on the day progess.

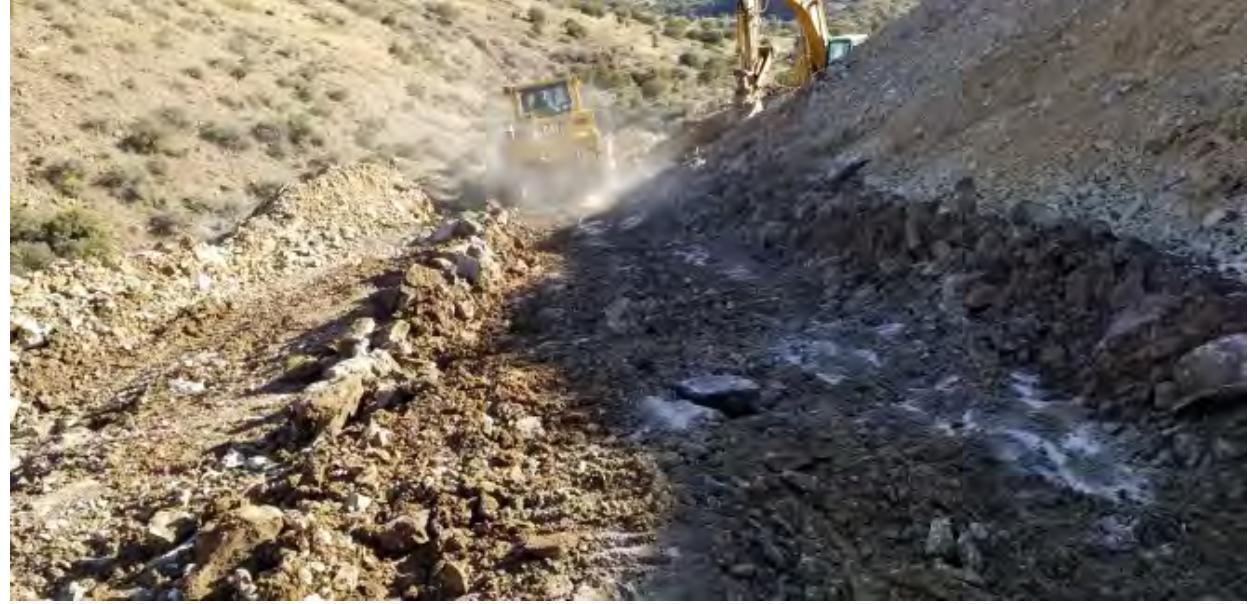
Photo 5: North and center rock surface

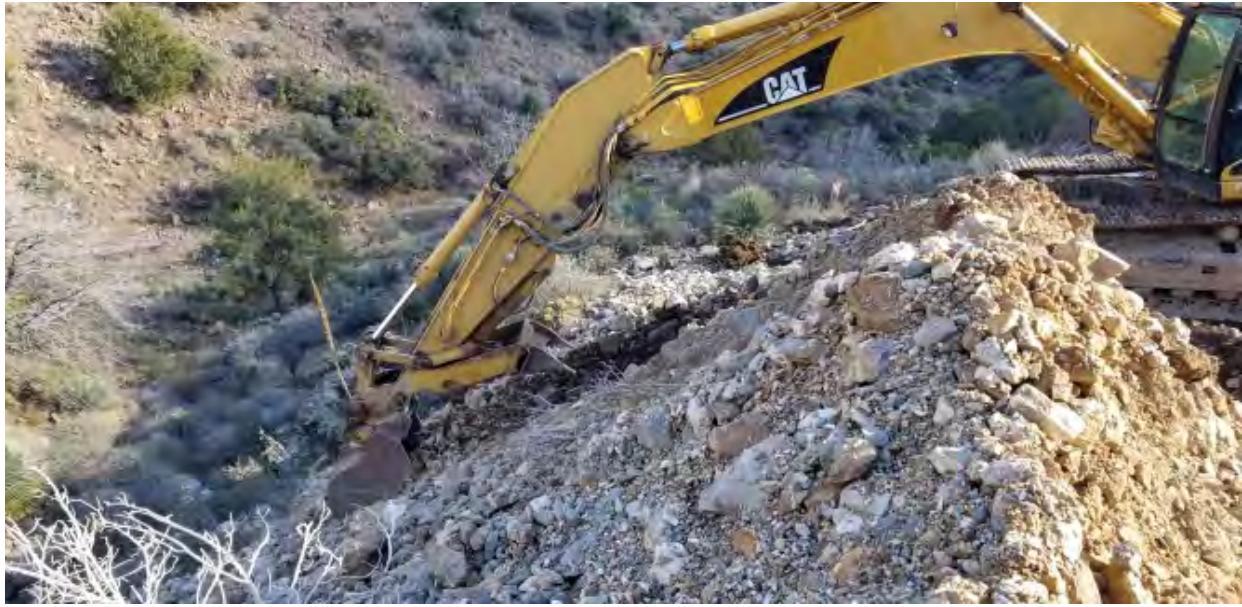
Photo 6: Remove of waste rock beyond the property line.

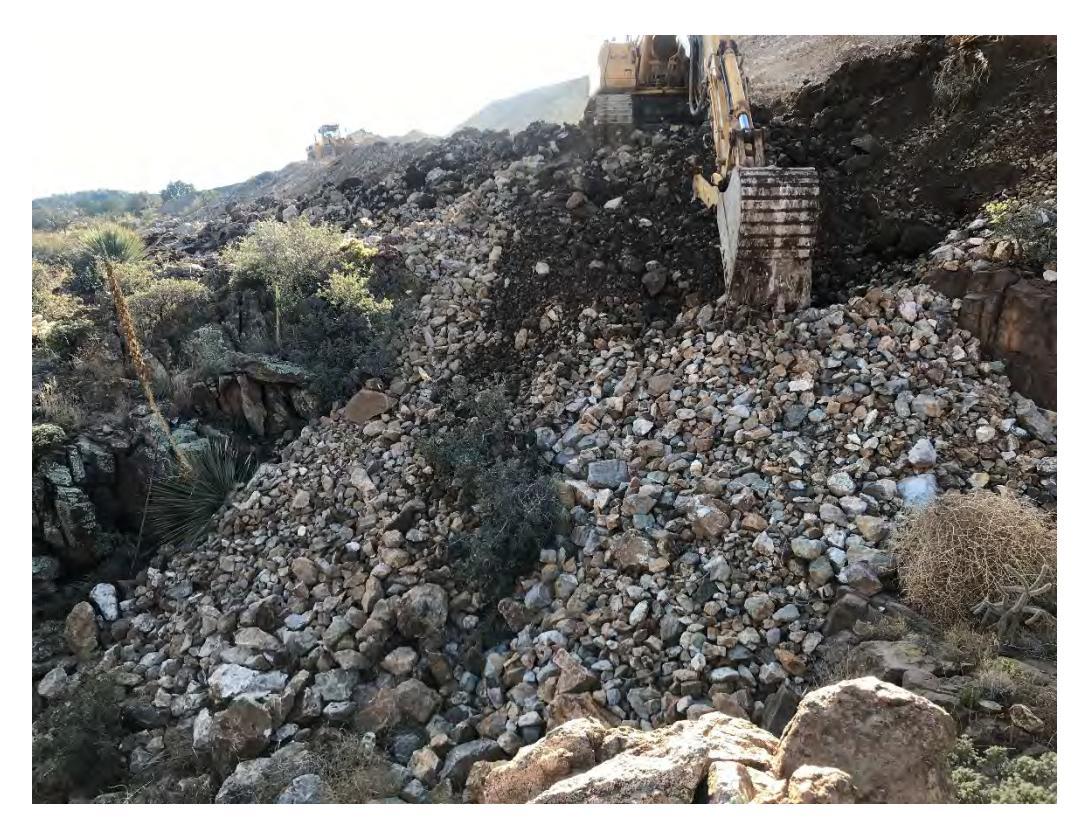
Excavator Removing Spilled Material

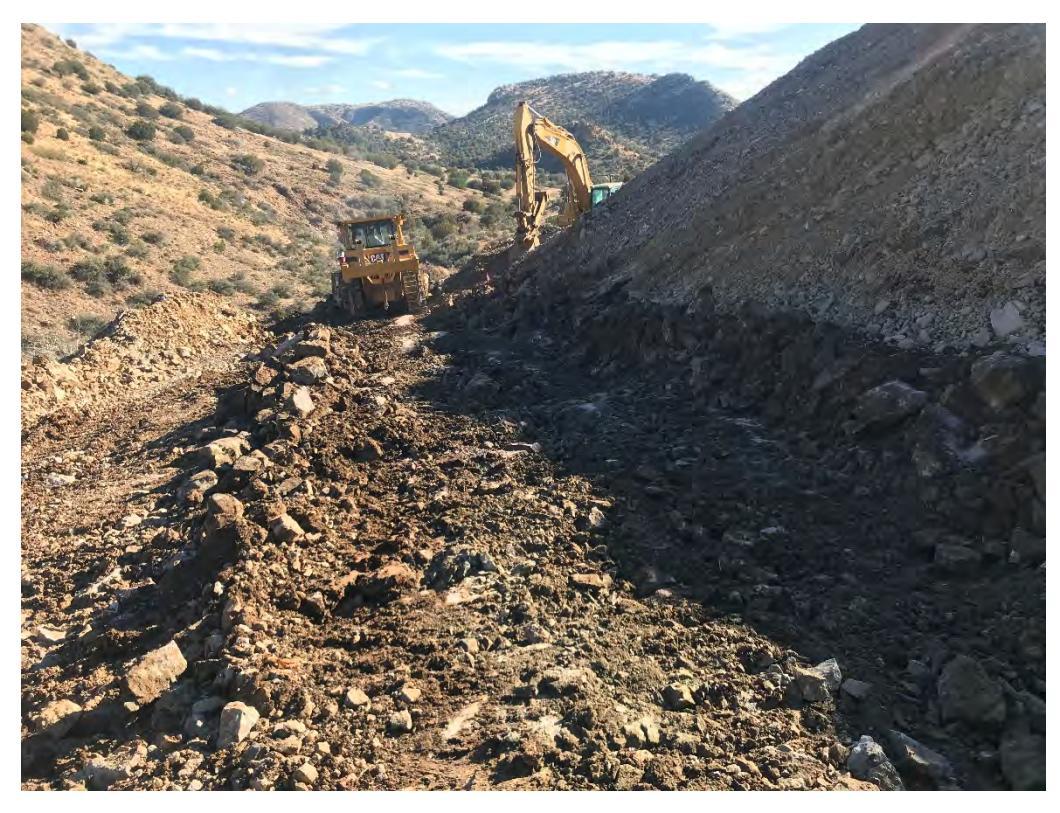
Level Bedrock for Northern Buttress

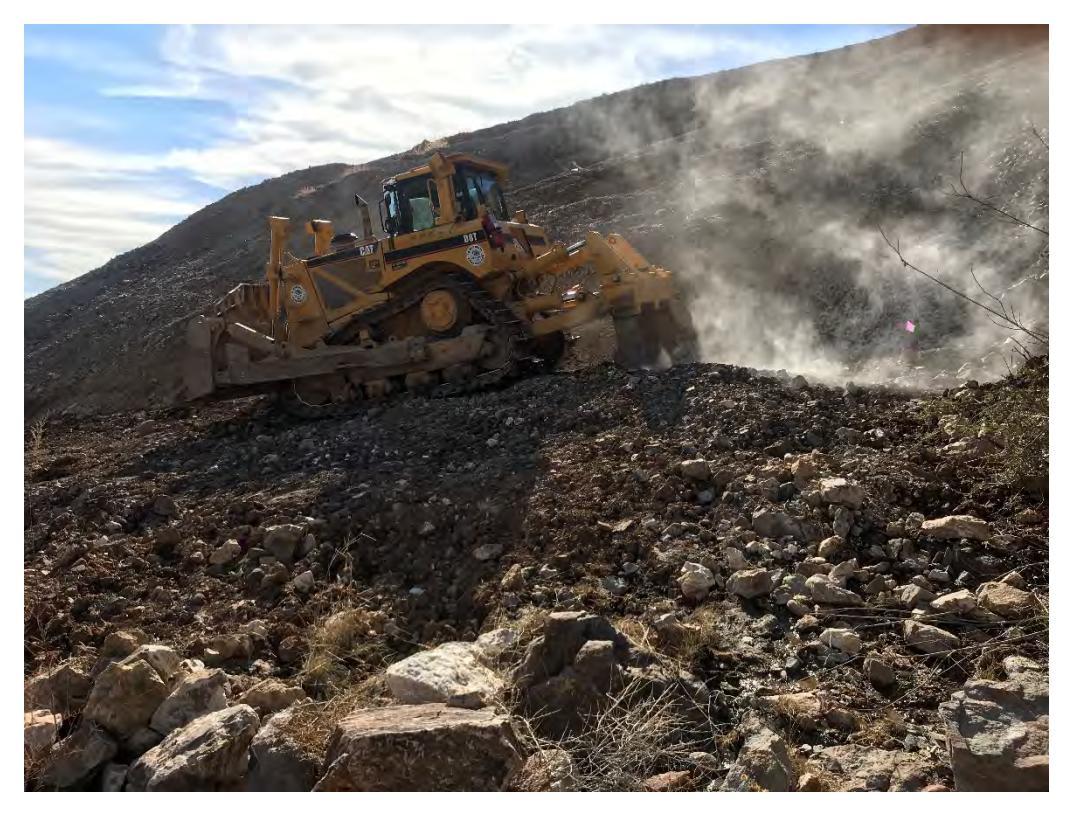
D8T Ripping Bedrock

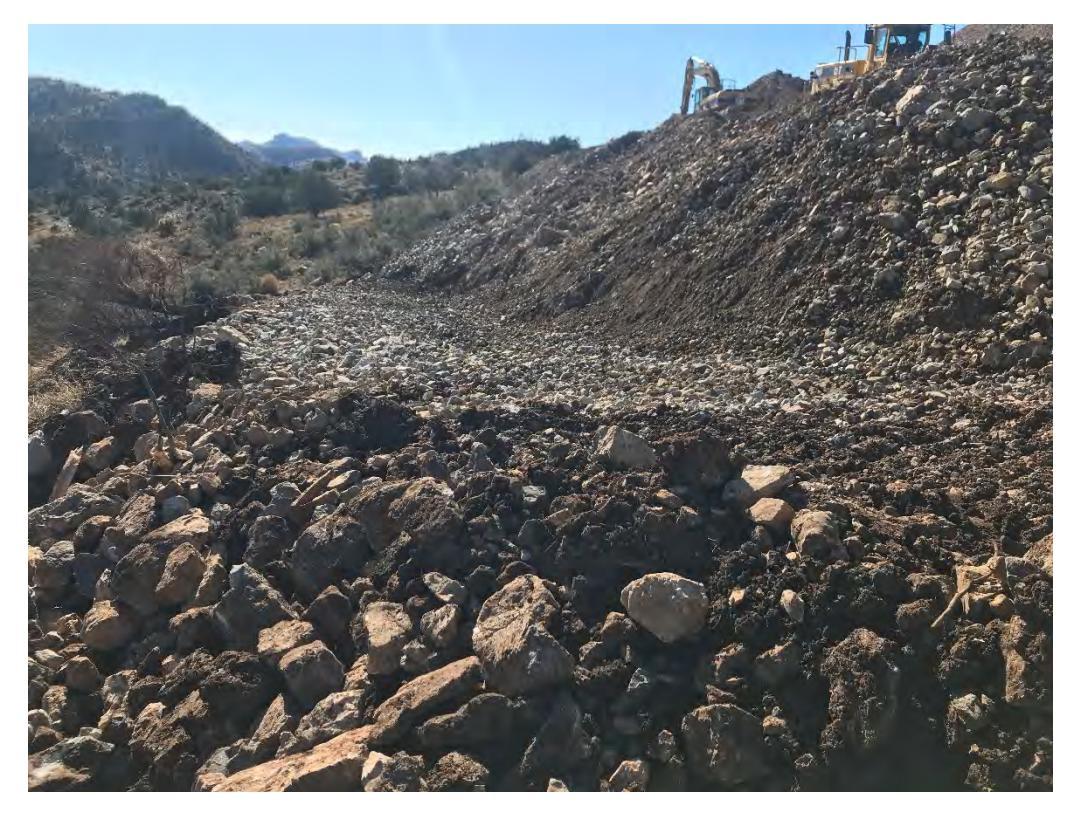
South Buttress

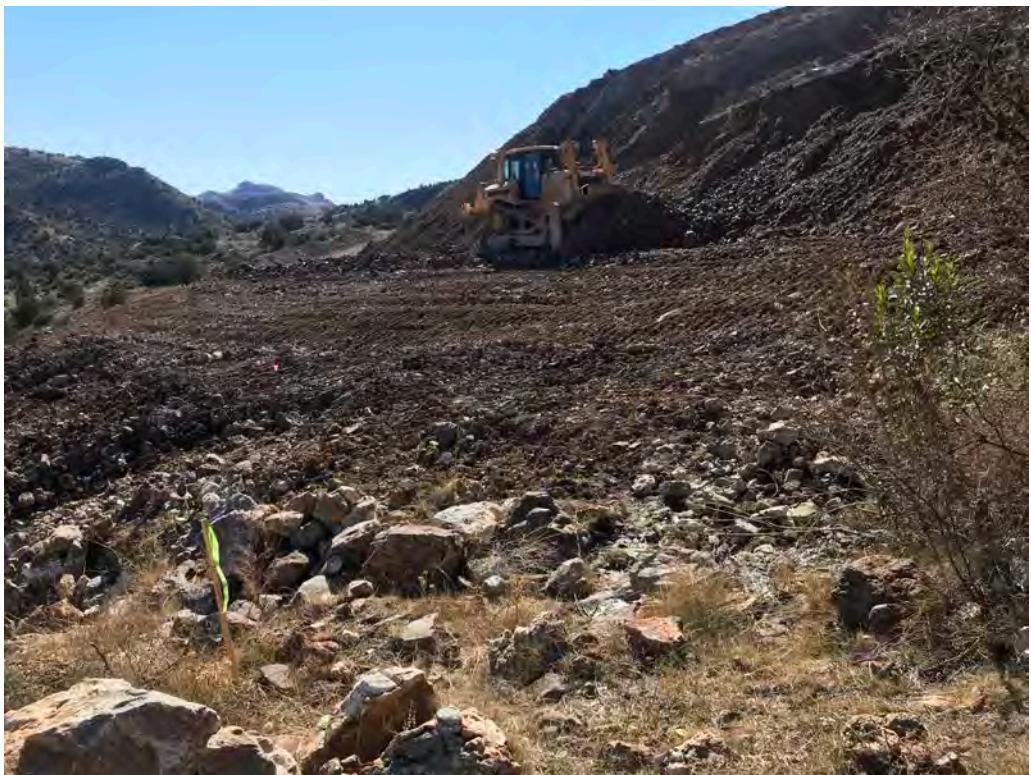
D8T Building Buttress

- > McCauley operator Abel was not on site today
- The excavator removed slide material from the upslope and dumped on the buttress. The D8T graded the dumped material to 1 foot lifts and track rolled each lift 4+ times.
 - Note that the bedrock material changed from a cobble with gravel to a sandy gravel with cobble.
- The excavator cleared slide material that spilled onto BLM land to the extent of the equipment.
- Construction of the buttress was nearly completed (missing a few lifts to tie into the regraded slope). Slope regrading is to begin tomorrow. Once slope is tied in with the buttress, the last lifts of the buttress will be placed and compacted.

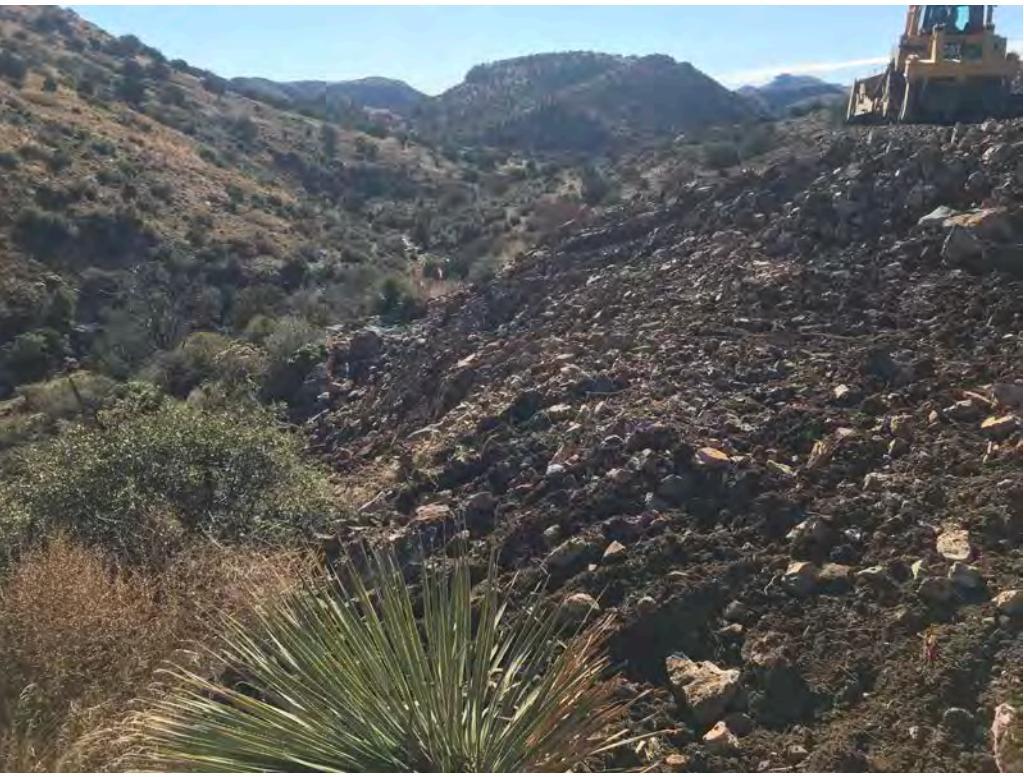
Spilled Material Removed

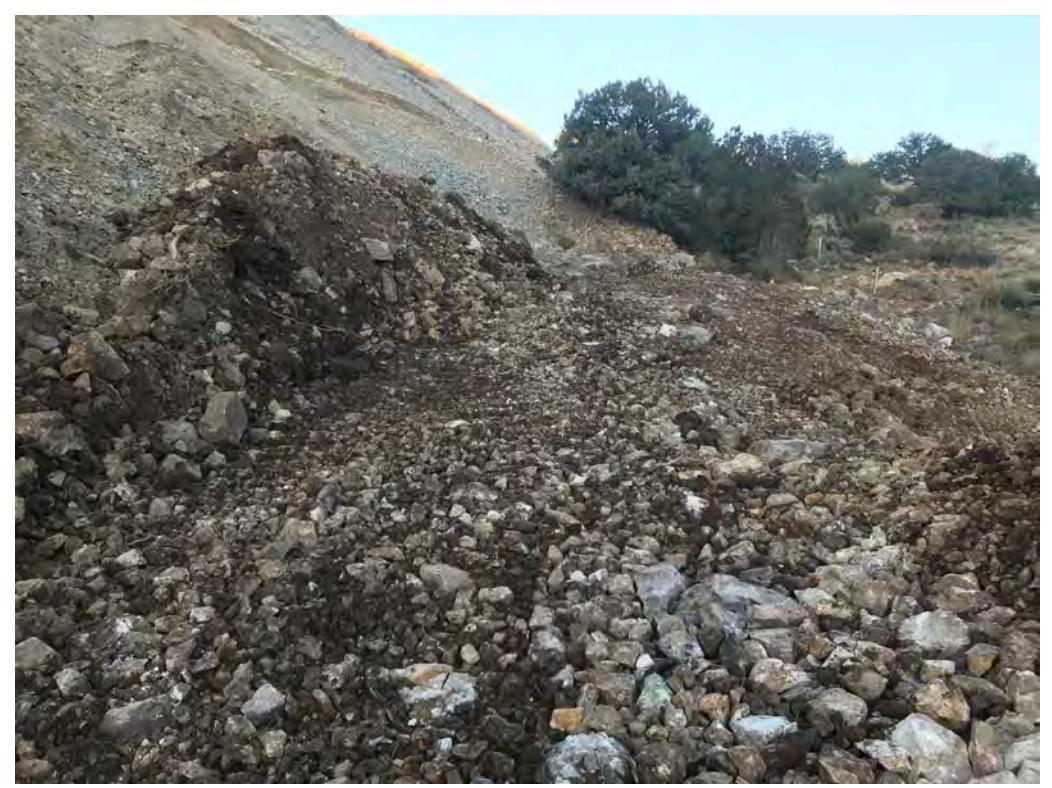
Buttress

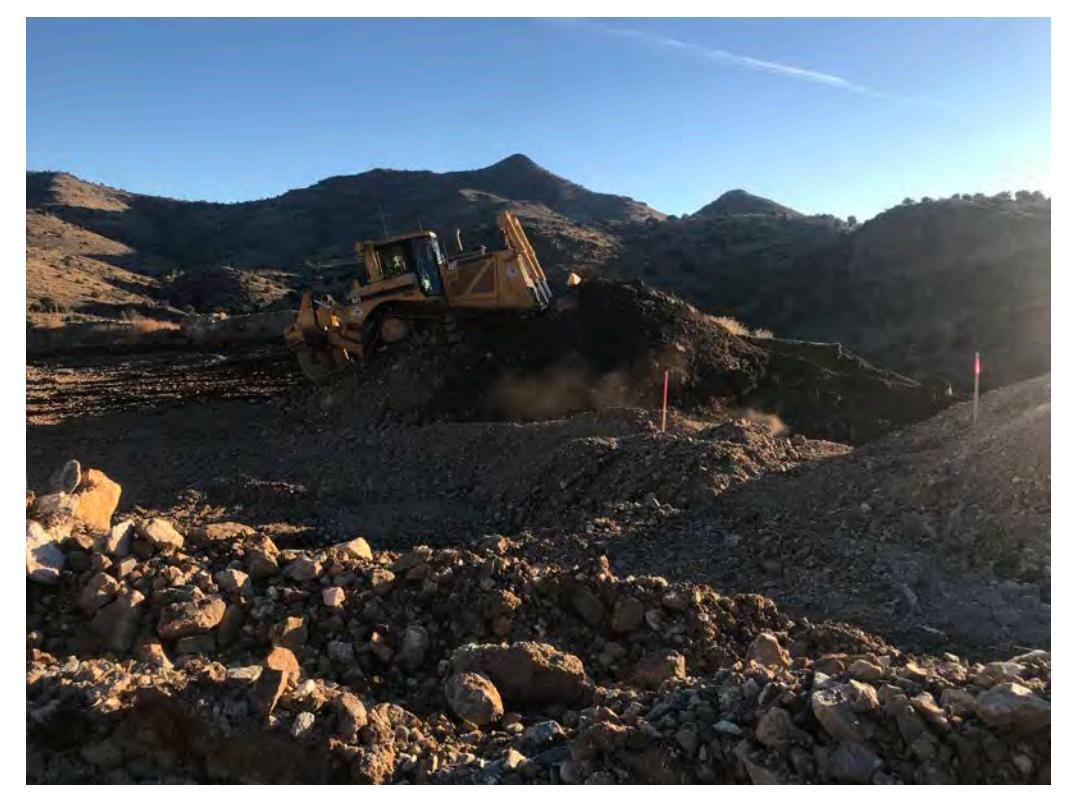
D8T Regrading Slope

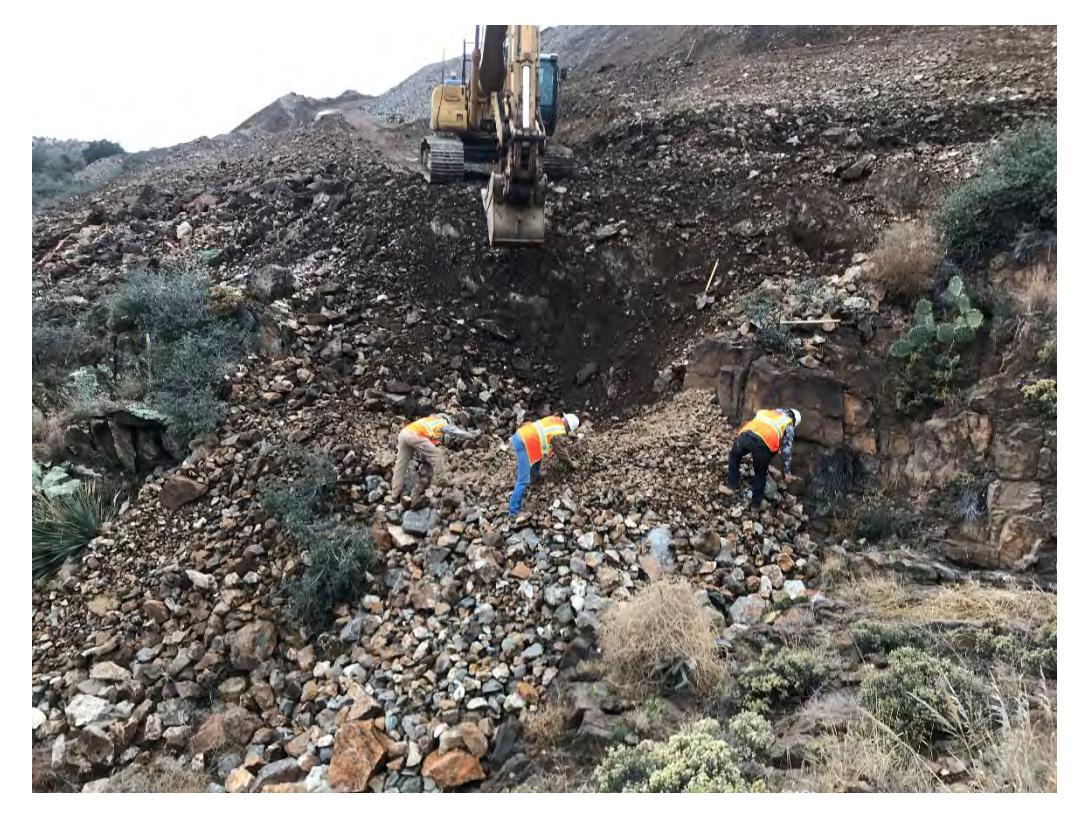
Laborers removing Waste Rock

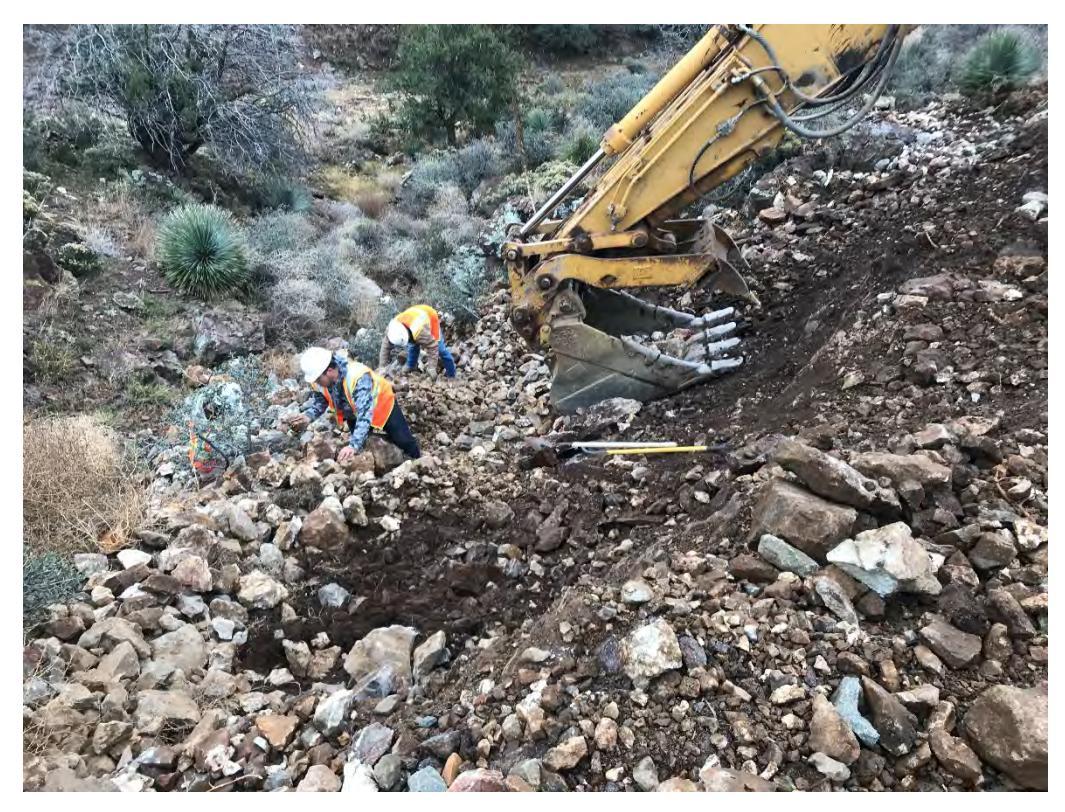
Laborers Removing Waste Rock

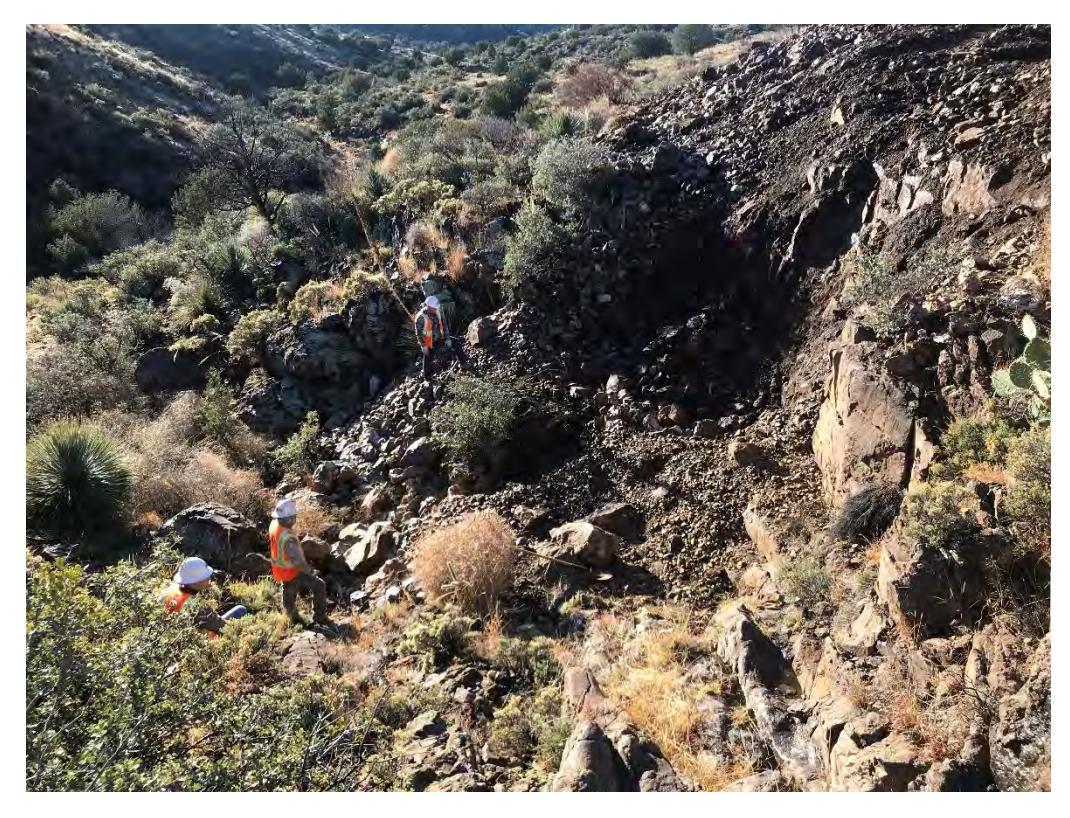
Spilled Material Beginning of Day

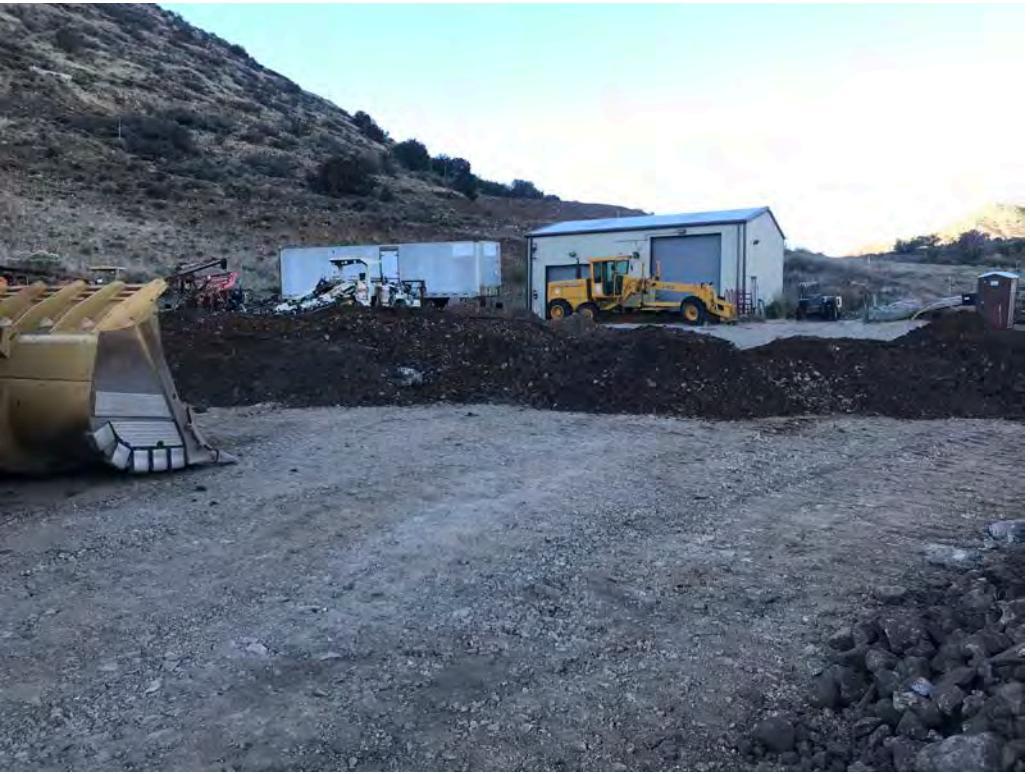
Fill on North Pad

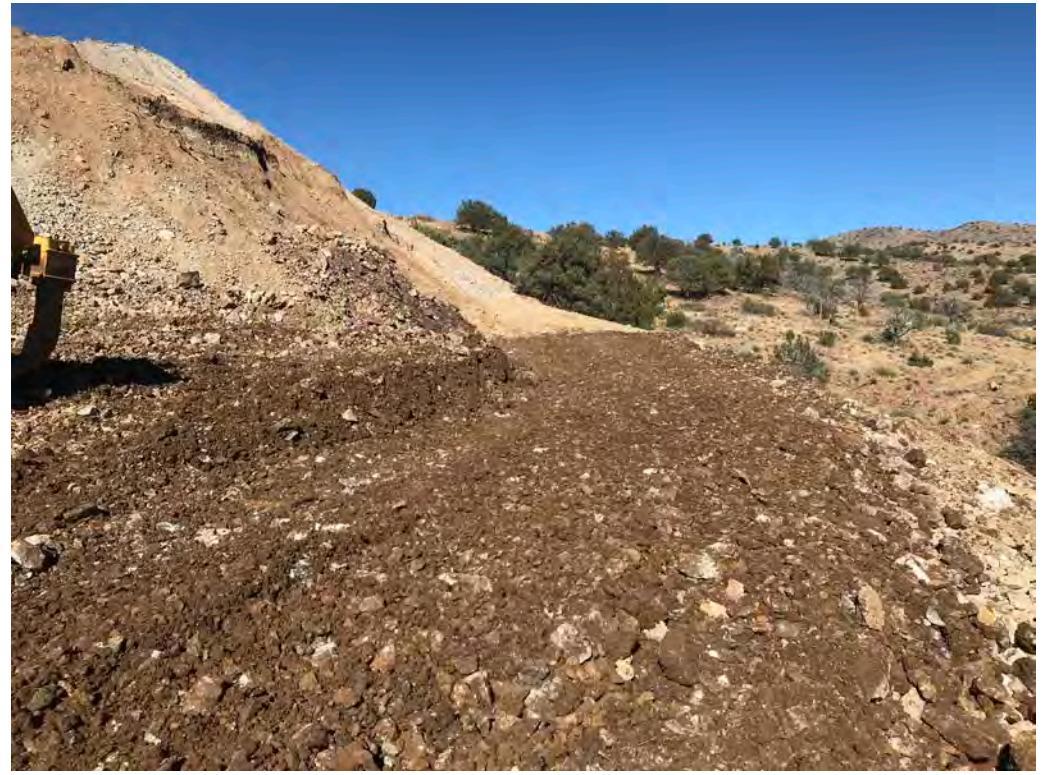
Rebuilt Buttress

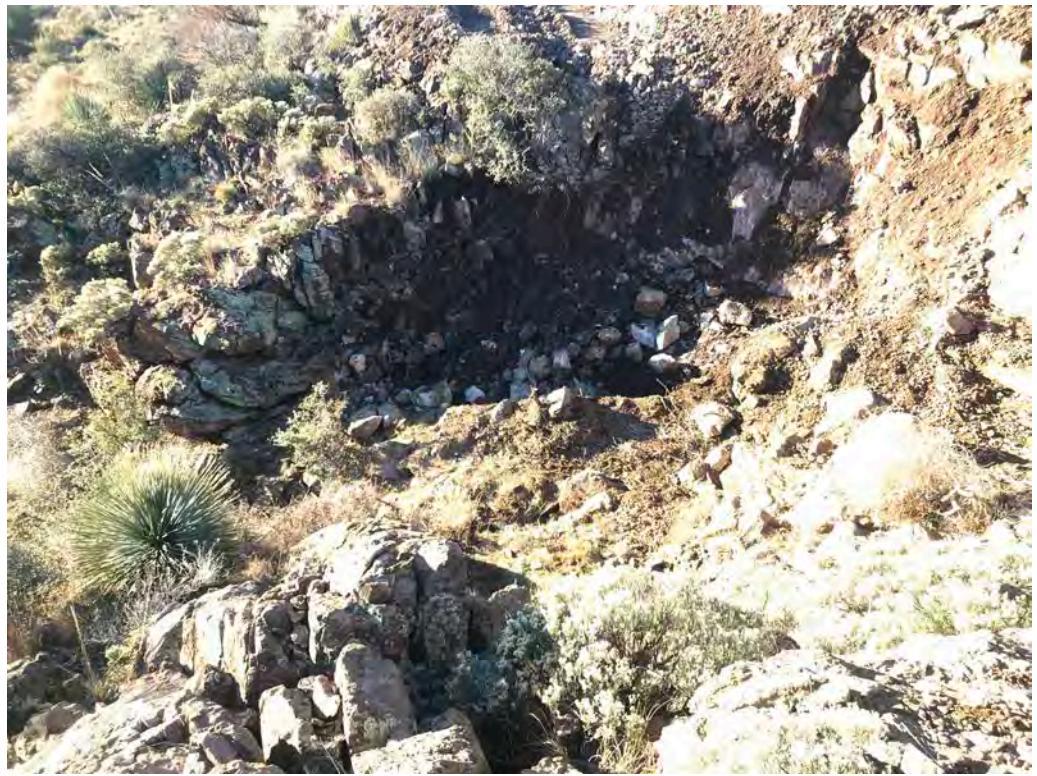
Approved Spilled Cleanup

Cleaning effort on the spilled material onto BLM land was approved by Elko Mining Group.

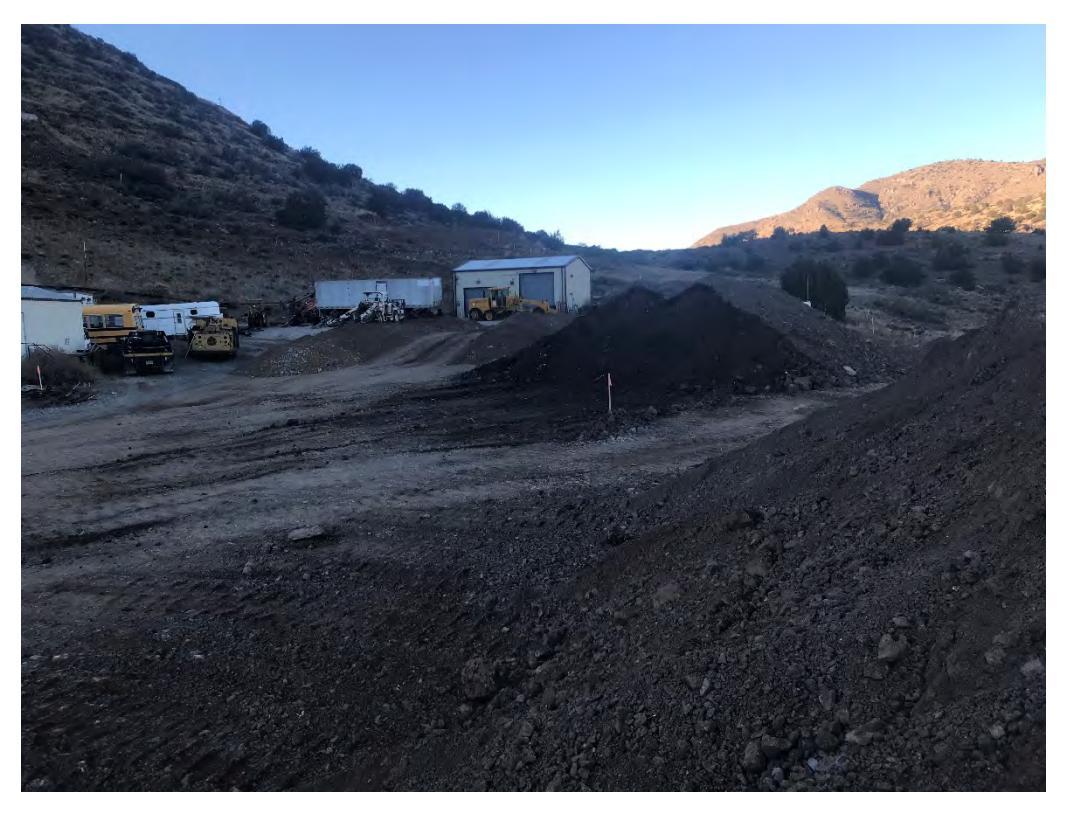
Cut Topsoil Stockpile and North Fill

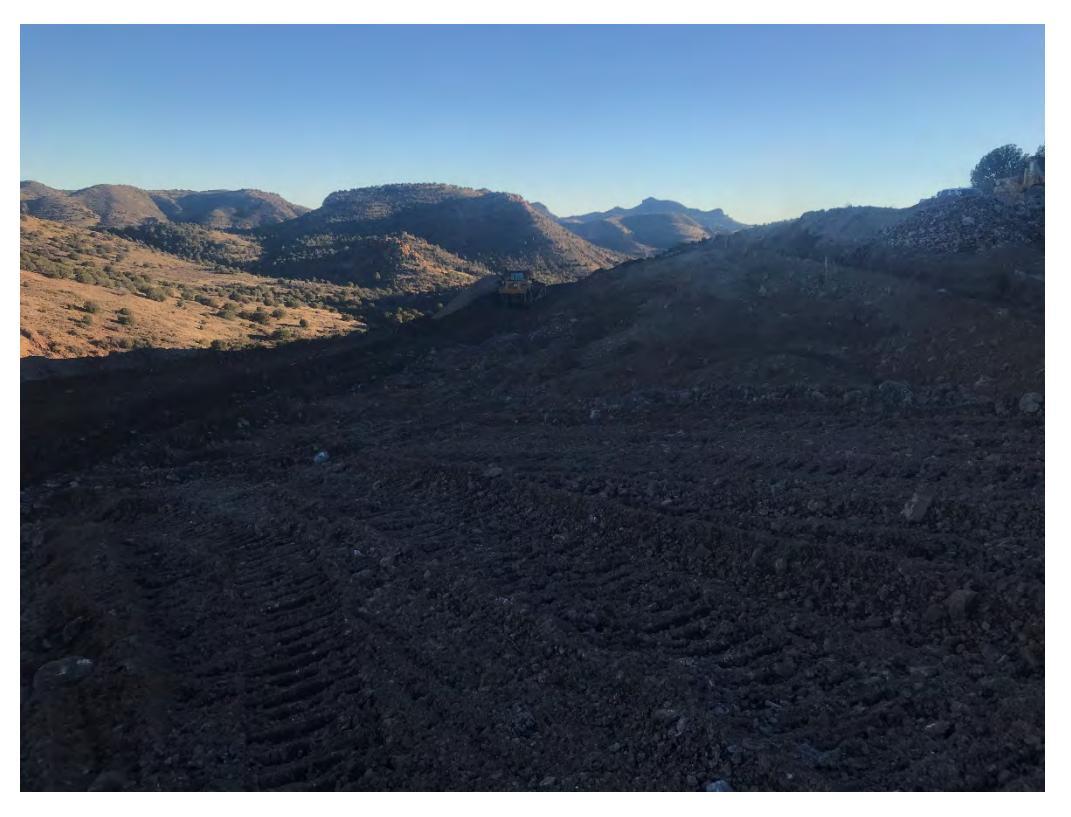
D8T Regrading Slope

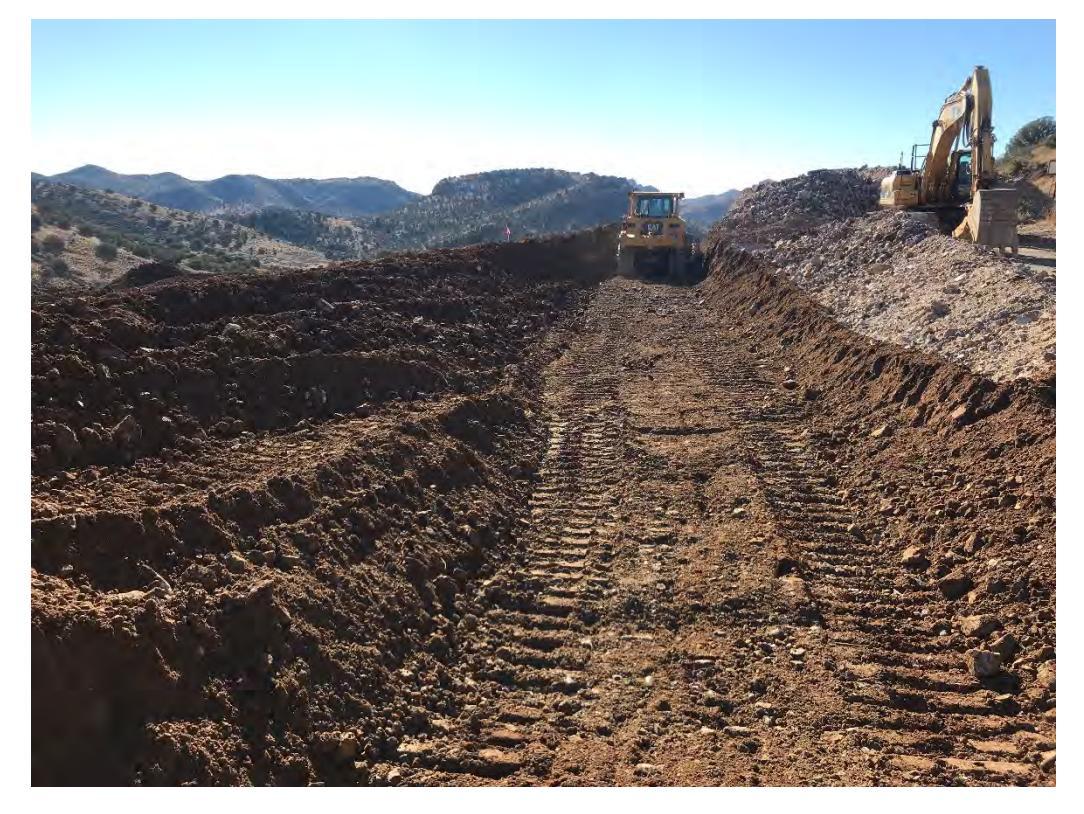
Cut Ditch

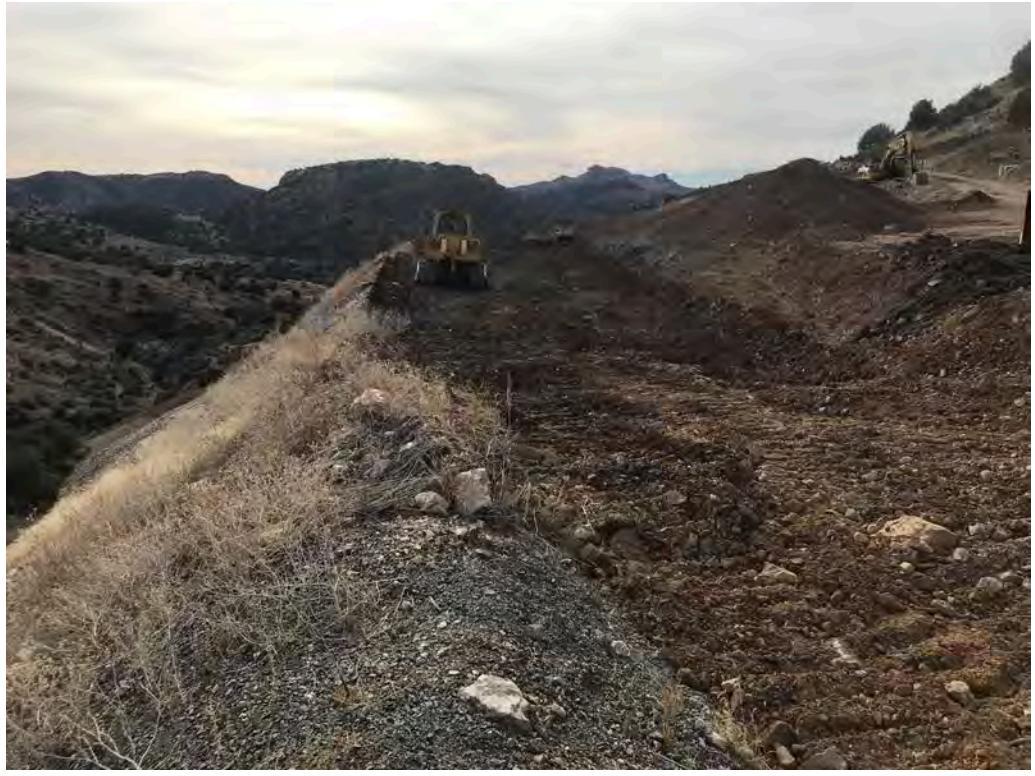
Slope Cut

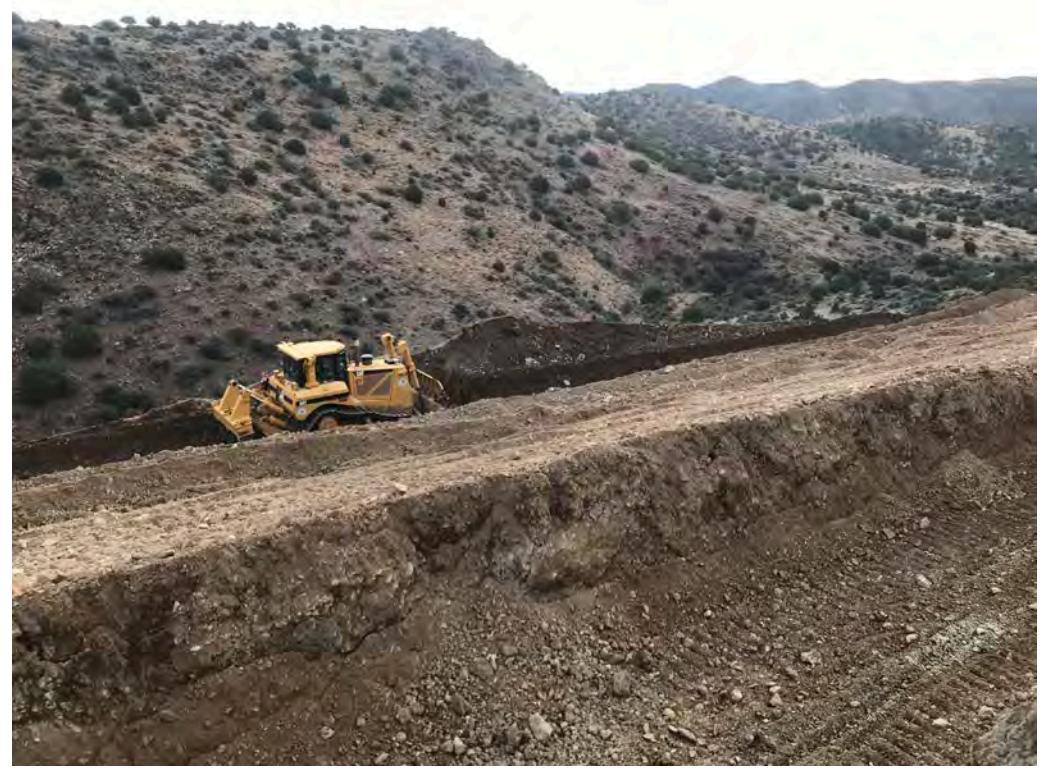
D8T Grading Slope
