TECHNICAL MEMORANDUM

To:	Andrew Conover
From:	Marcus Erdmann
Reviewed B	y: Ryan T. Baker, P.E.
Project:	Summit Mine DMS Slide Corrective Action
Project No:	475.0386.000
Subject:	Summit Mine QA/QC Report
Date:	25 January 2019

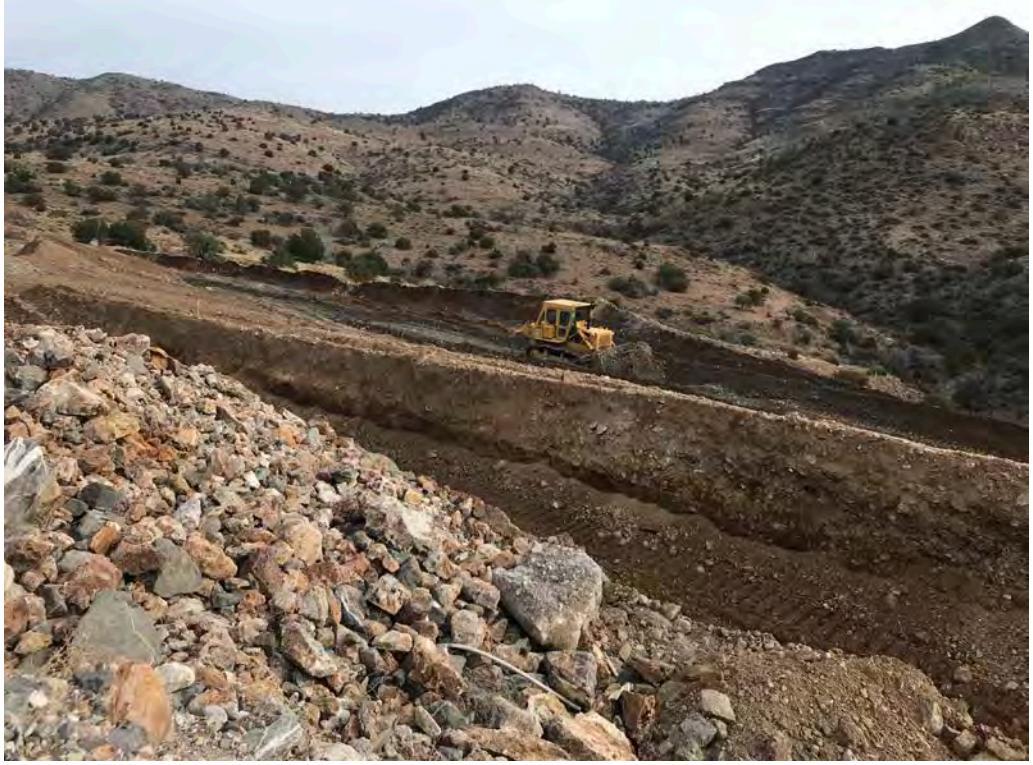
D7 Grading Slope

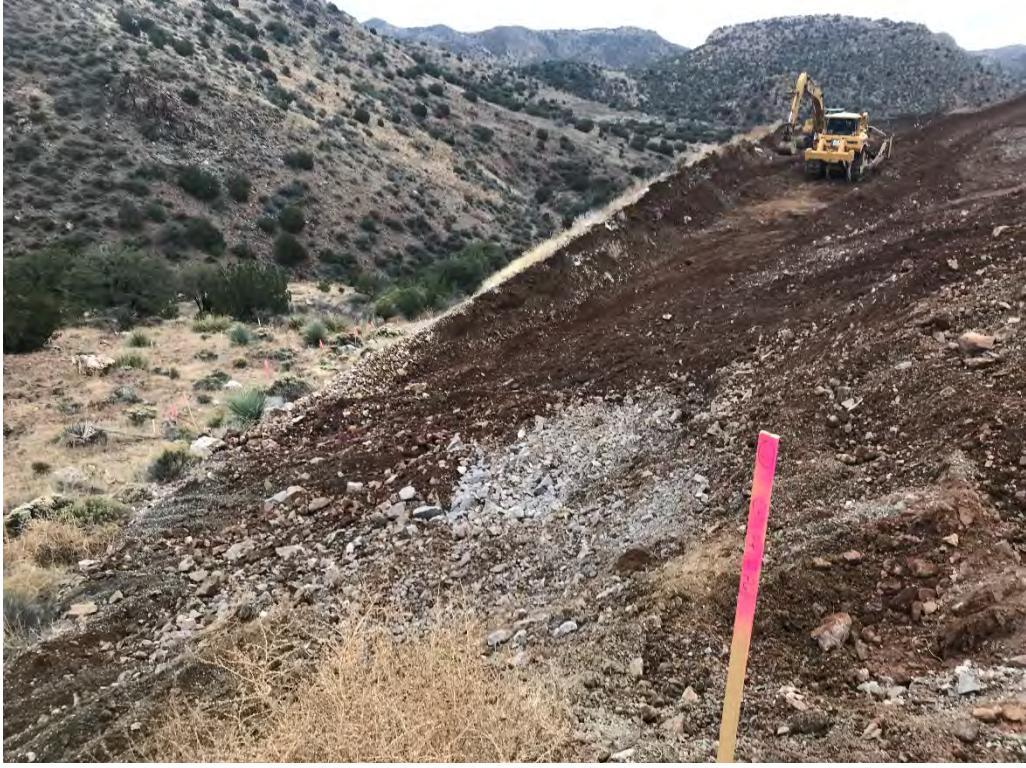
North Graded Slope

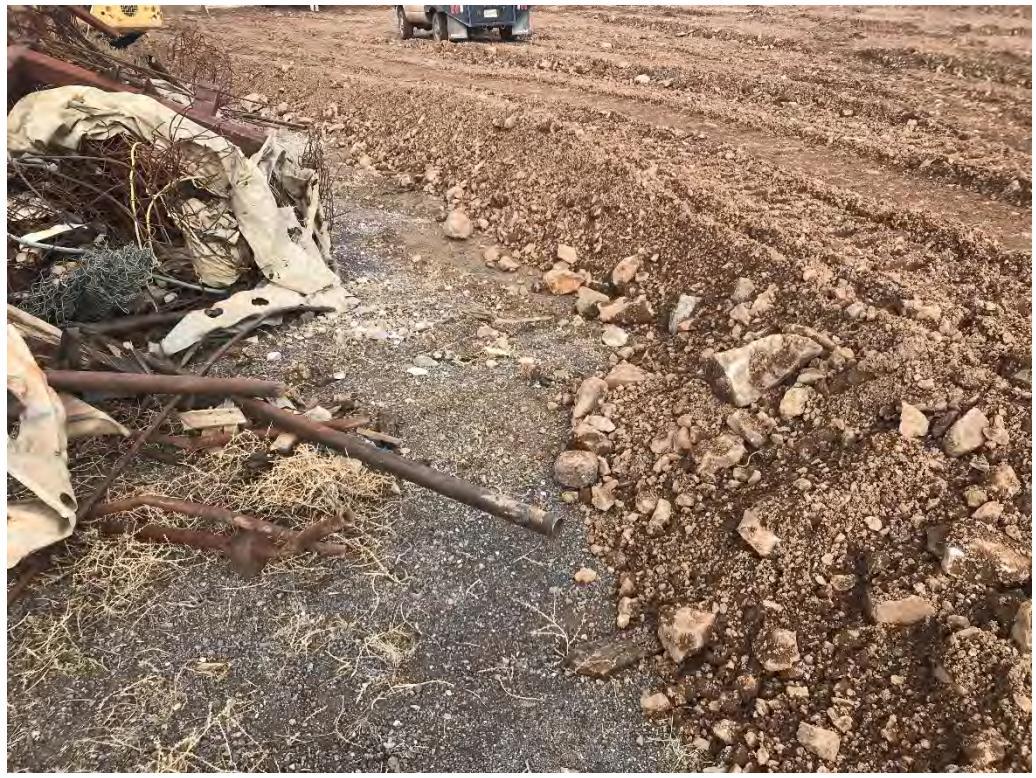
- McCauley Construction wanted to grade the mining pad to allow drainage to the west and south, but was corrected to drain east and south by NewFields.
- Once the D8 graded the mining to allow for proper drainage, NewFields QAQC and McCauley discussed the issue of filling along the west of the property in the buildings and equipment. There is approximately 8 inches to 1 foot of fill along the west without a clear was to tie it into the existing ground. (See picture below)

End of Fill

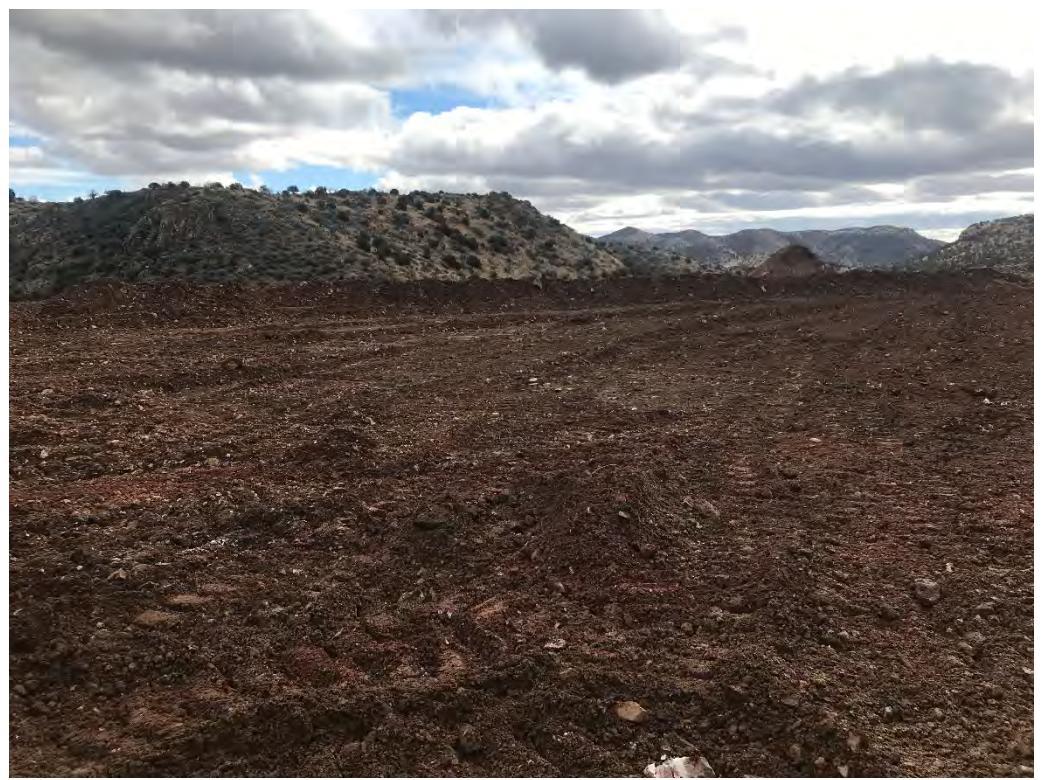
Graded Mining Pad

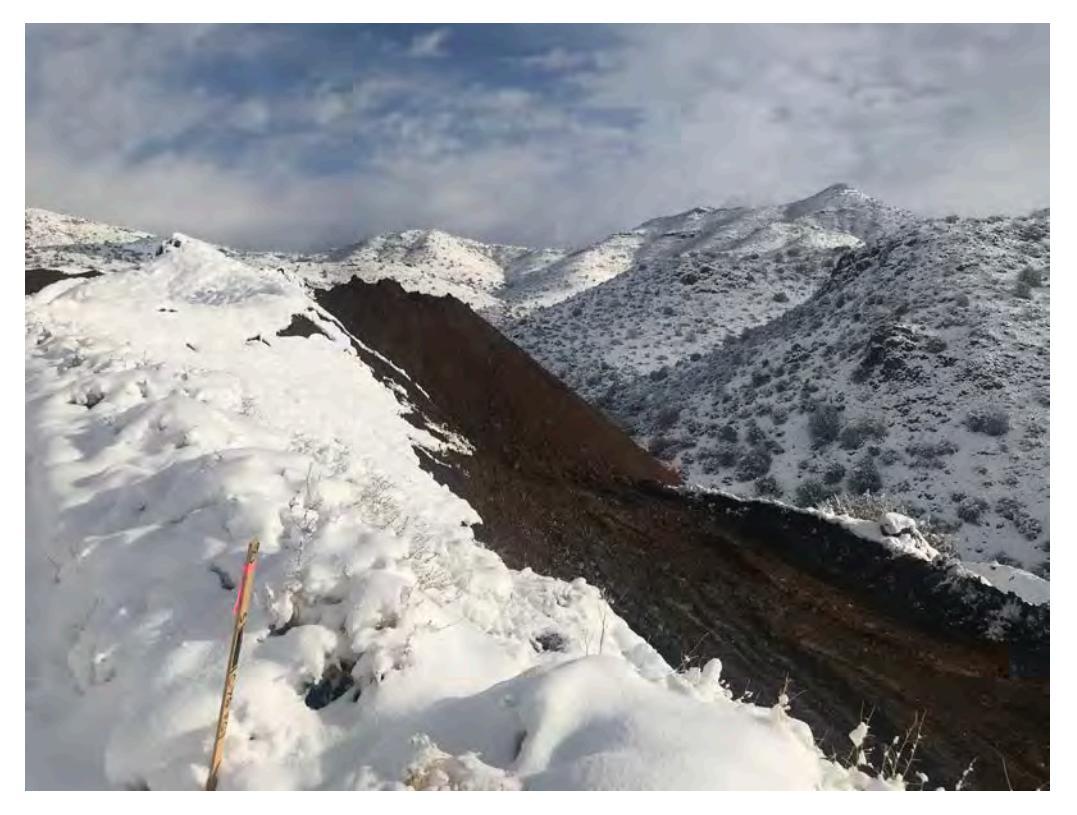
South Fill

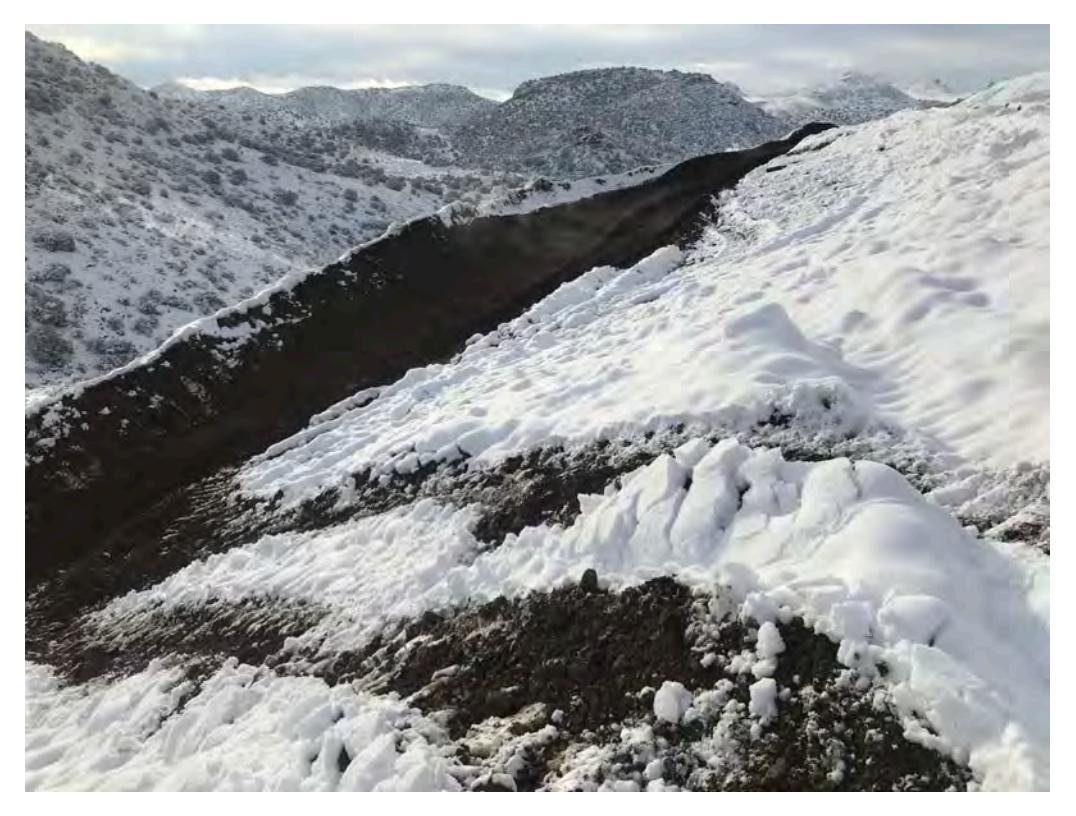
North Cut

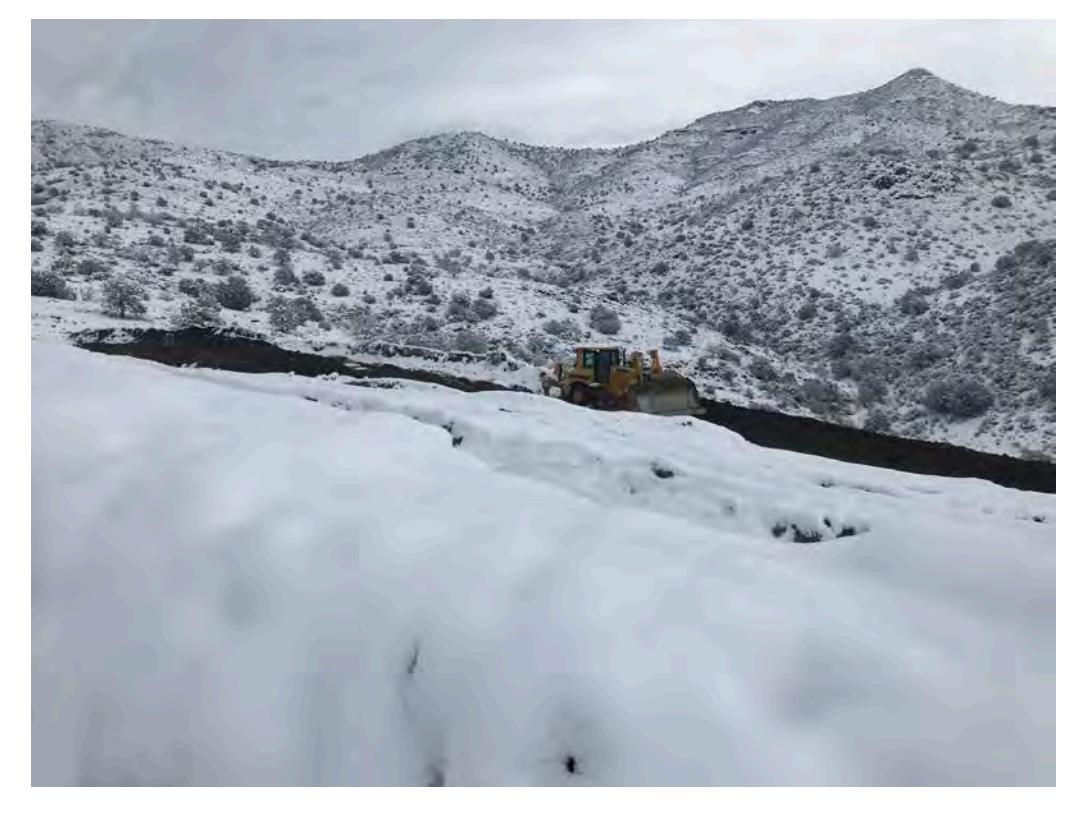
D8 Cutting North Slope

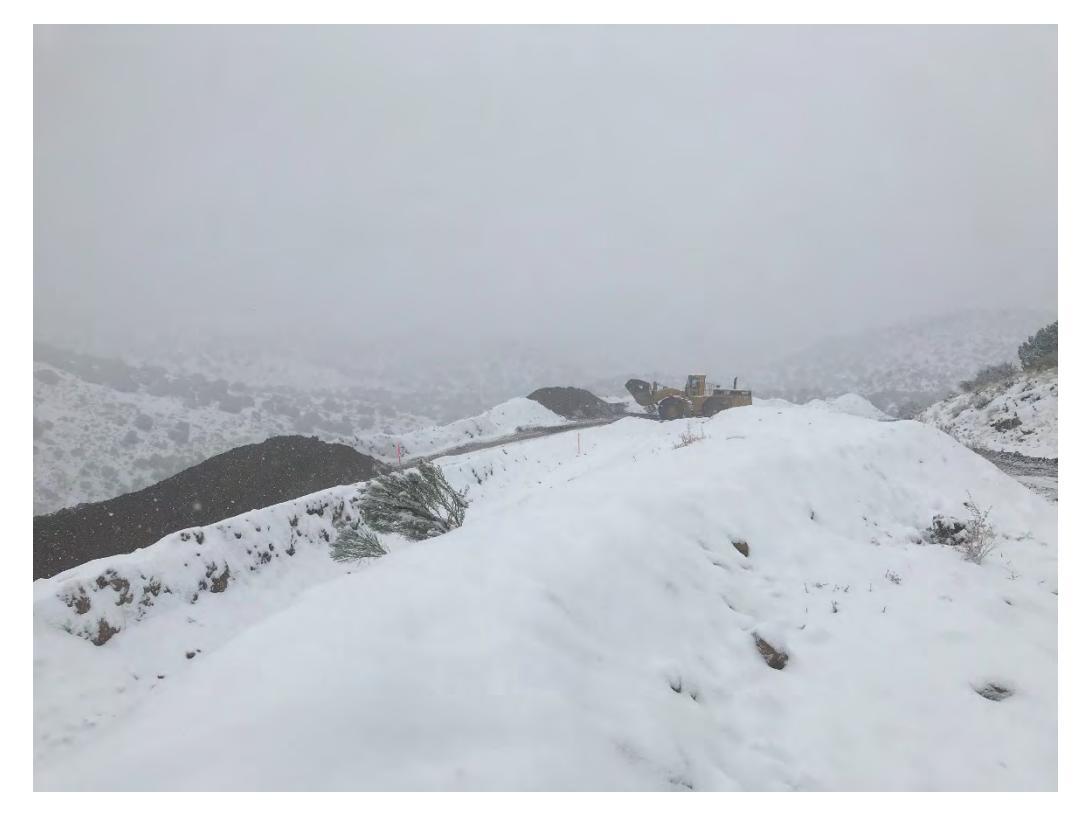
South Fill

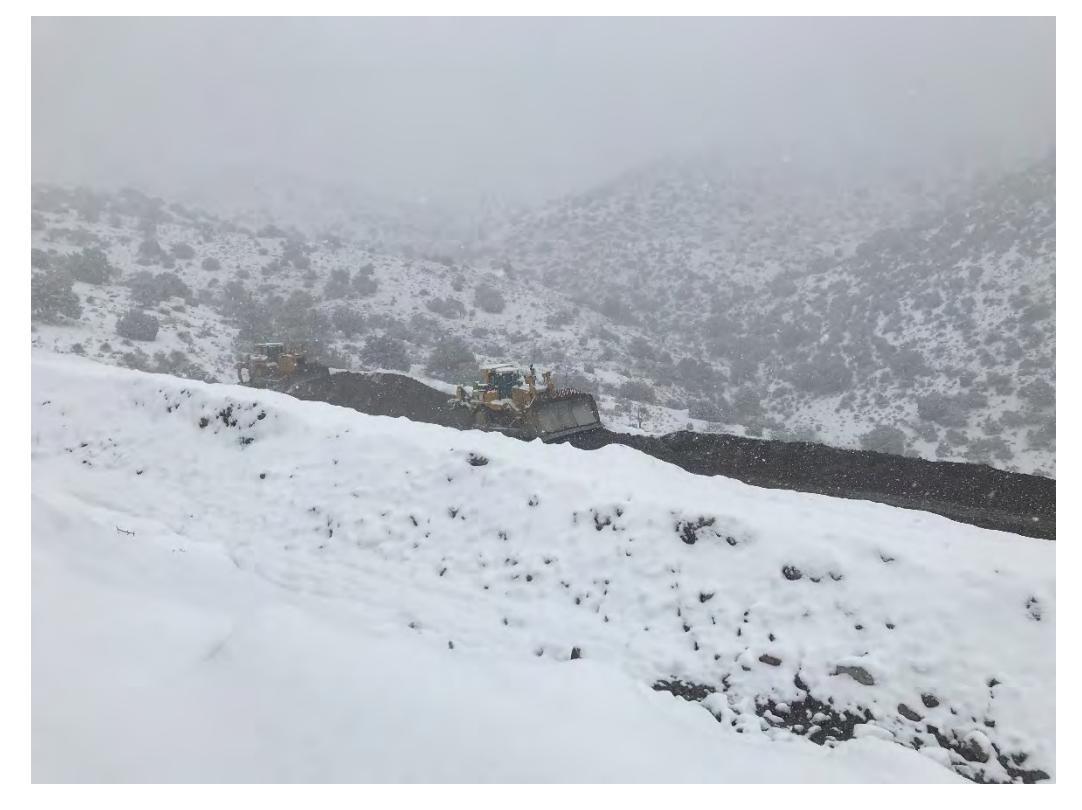
North Cut

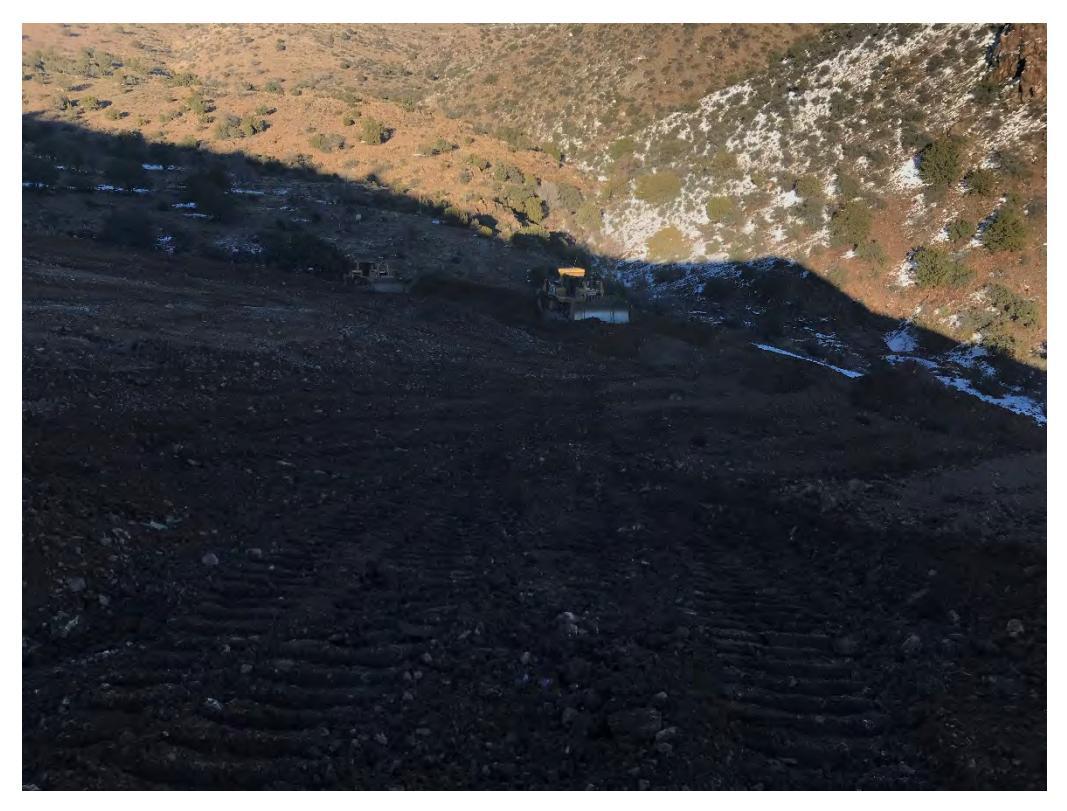
End of Day Progress

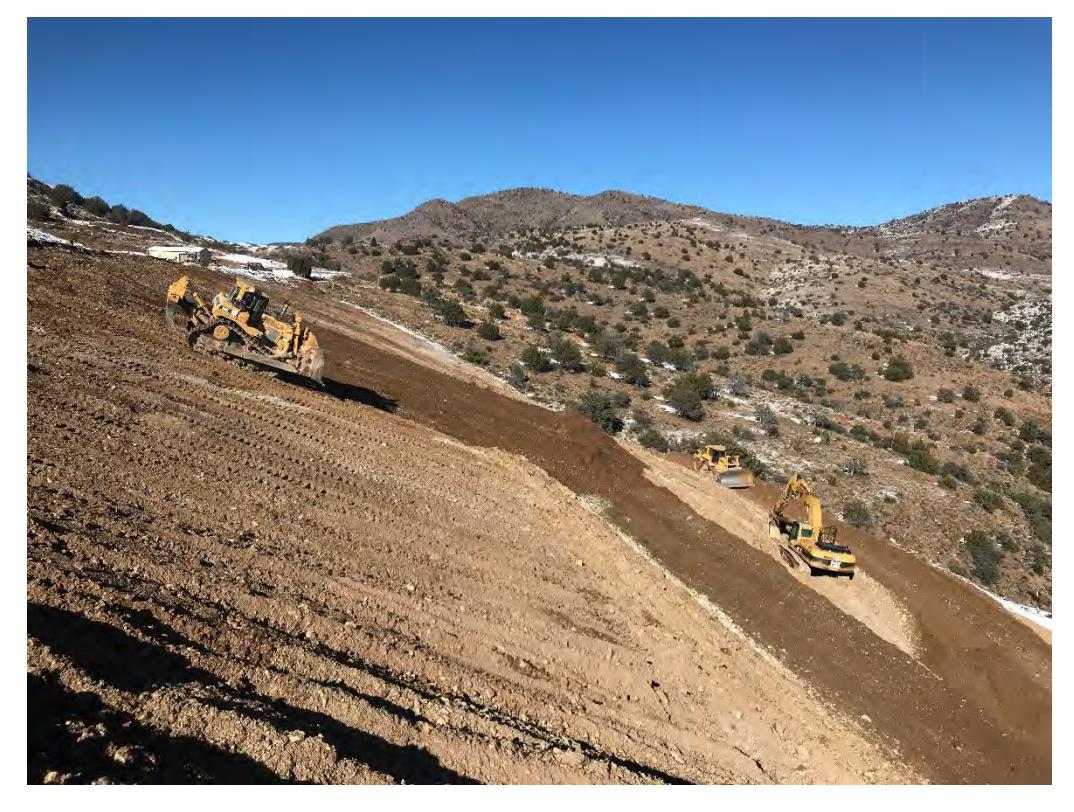
Graded Slope

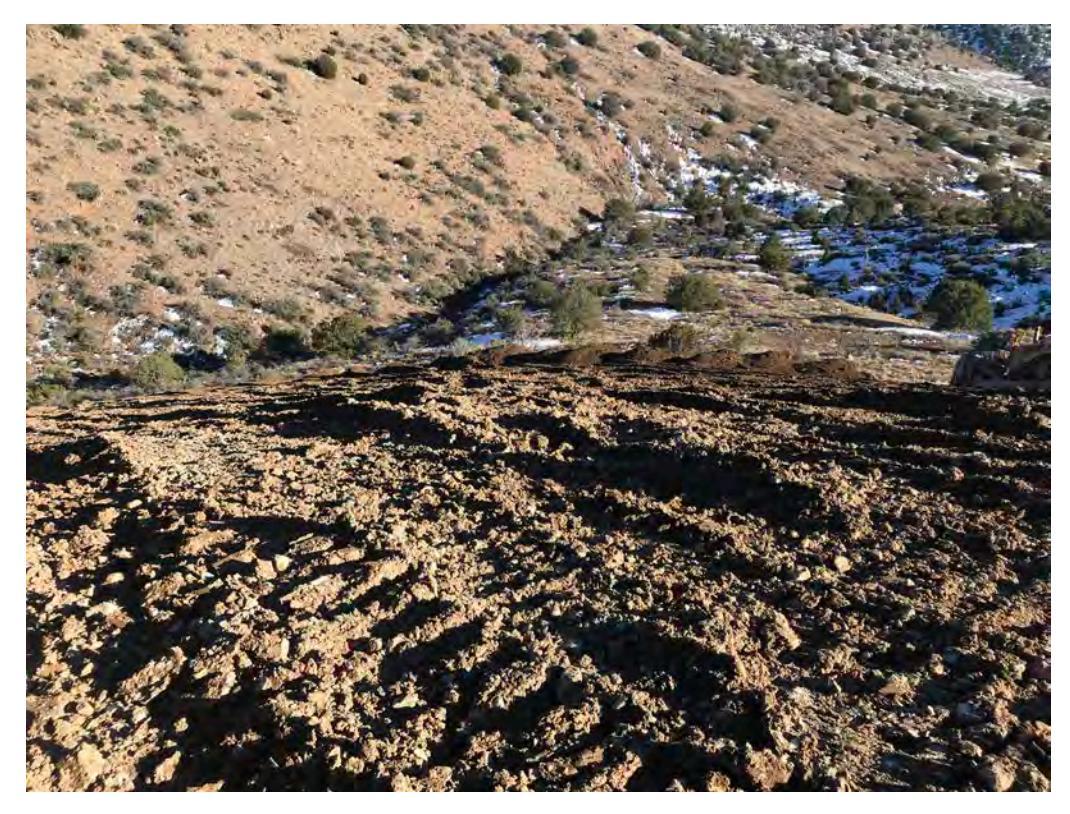
South Slope

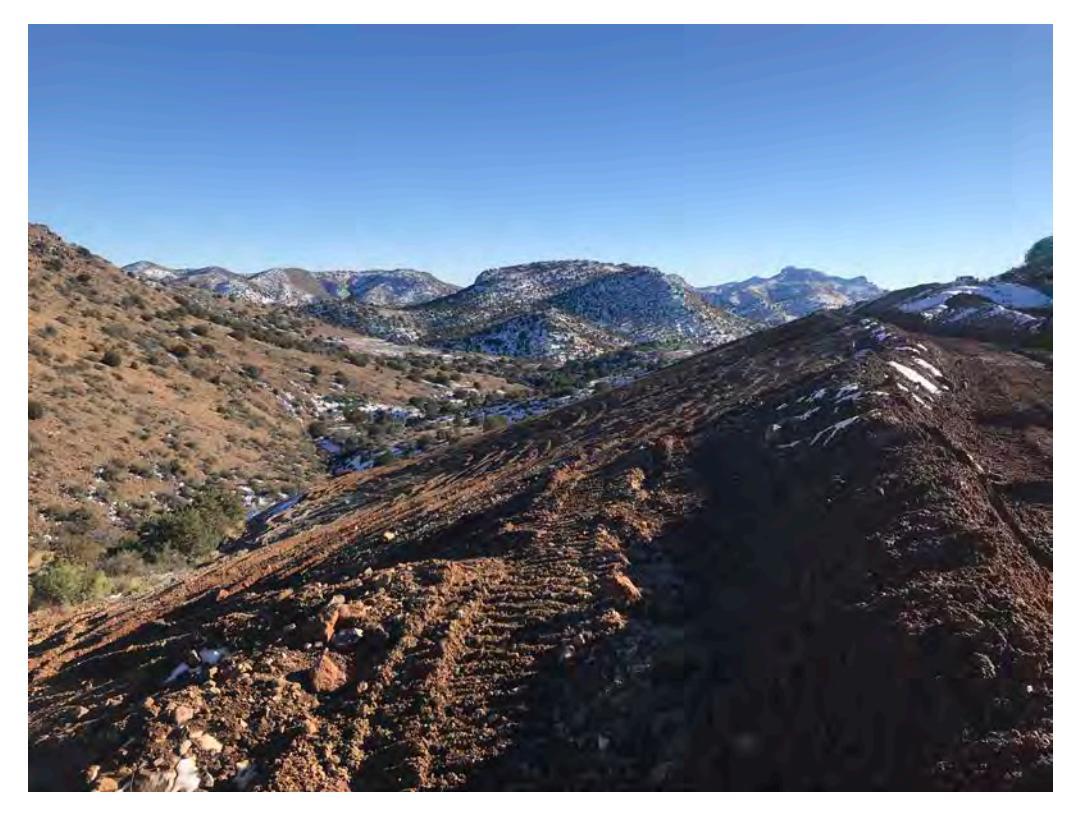
Graded Slope

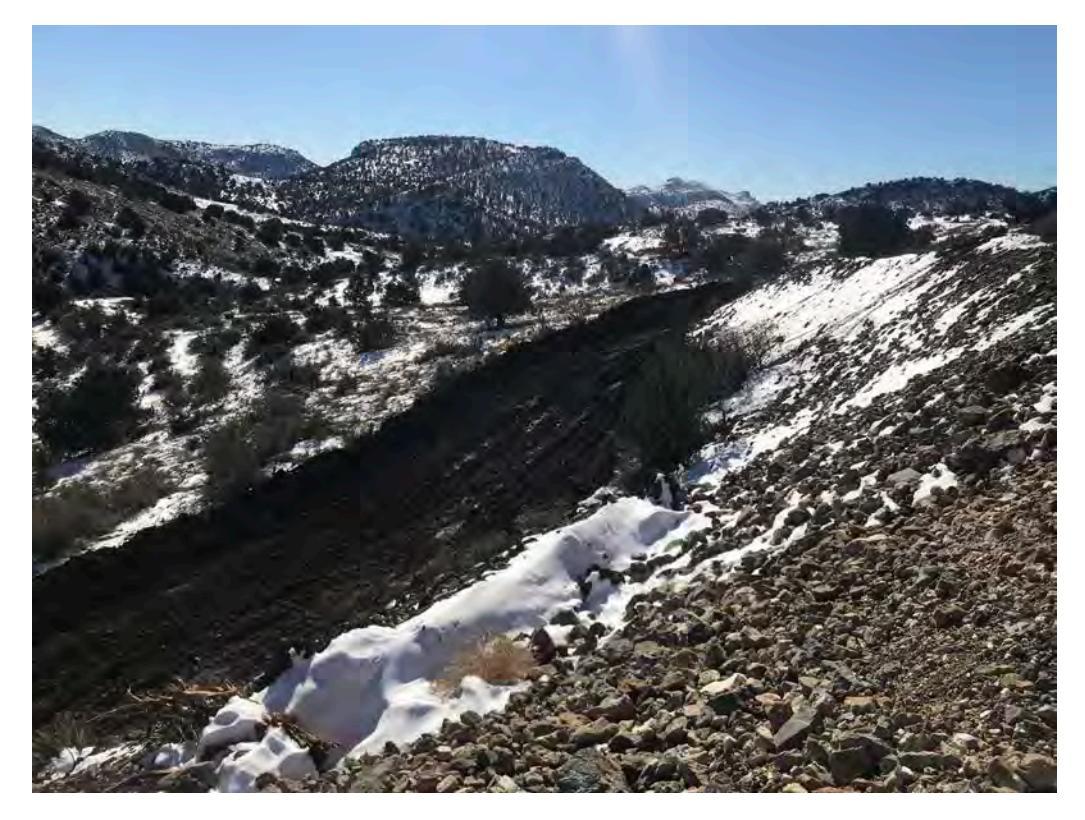
Grub and Cleared Area for South Slope

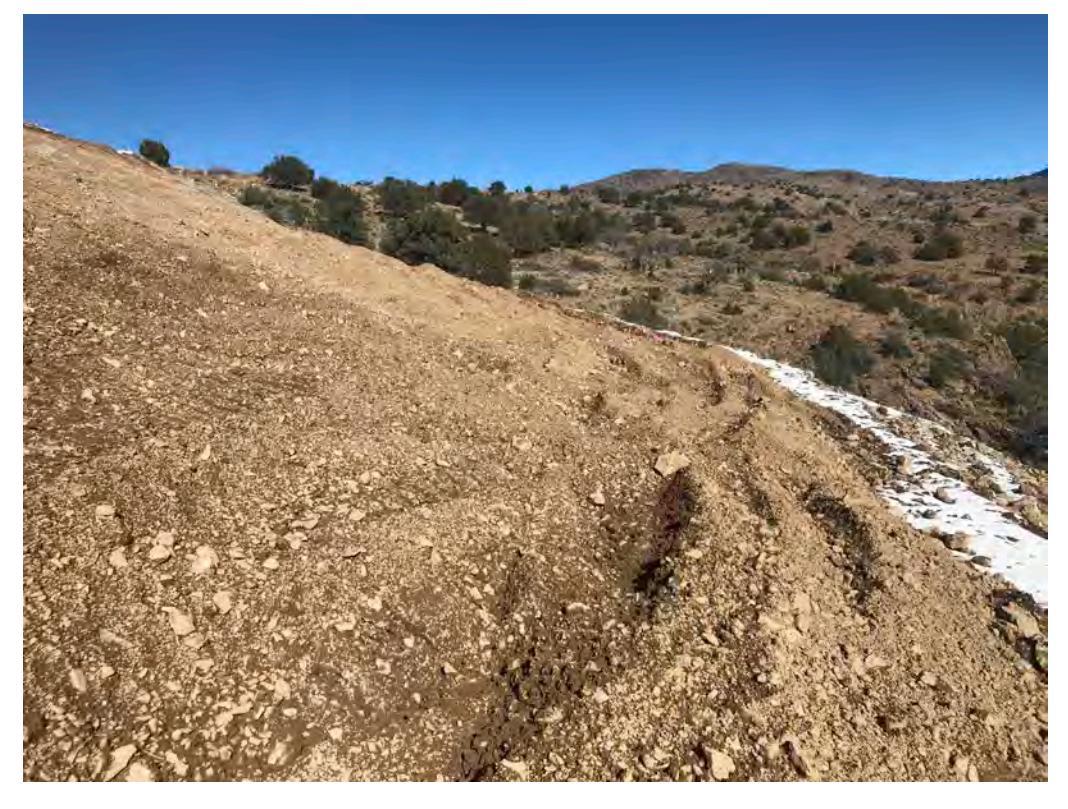
Slope Tied into Buttress

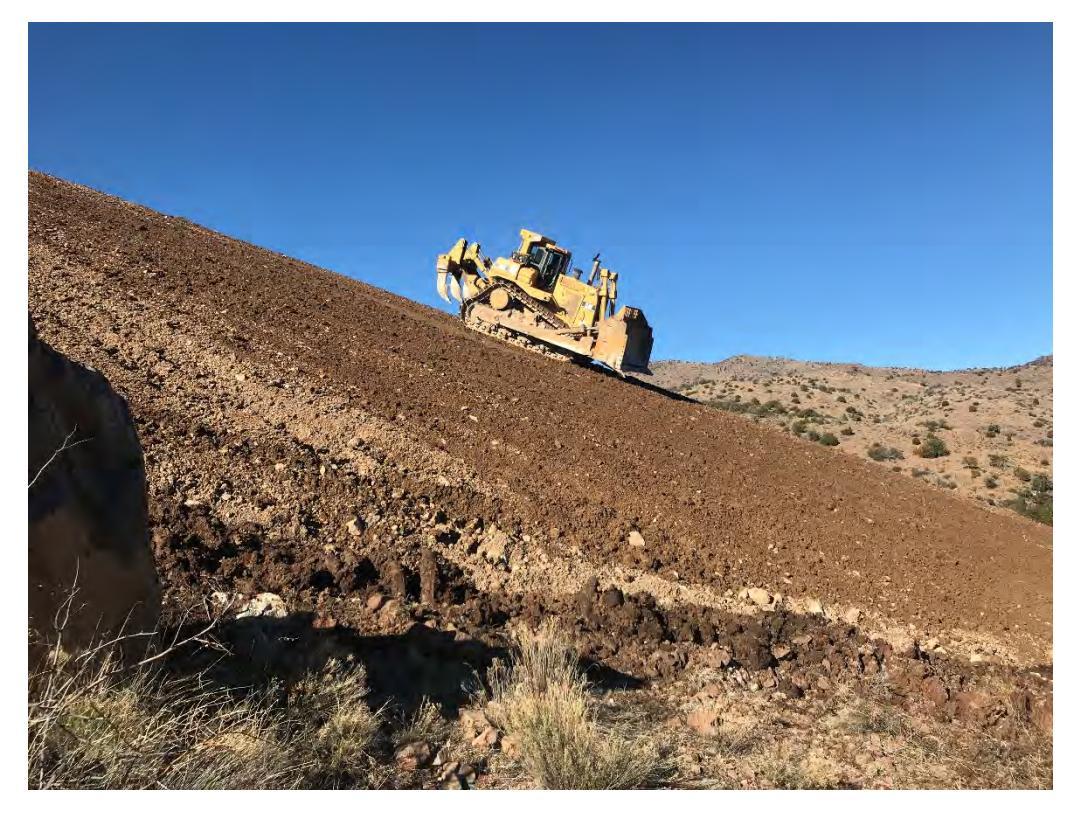
D9 Grading South Toe

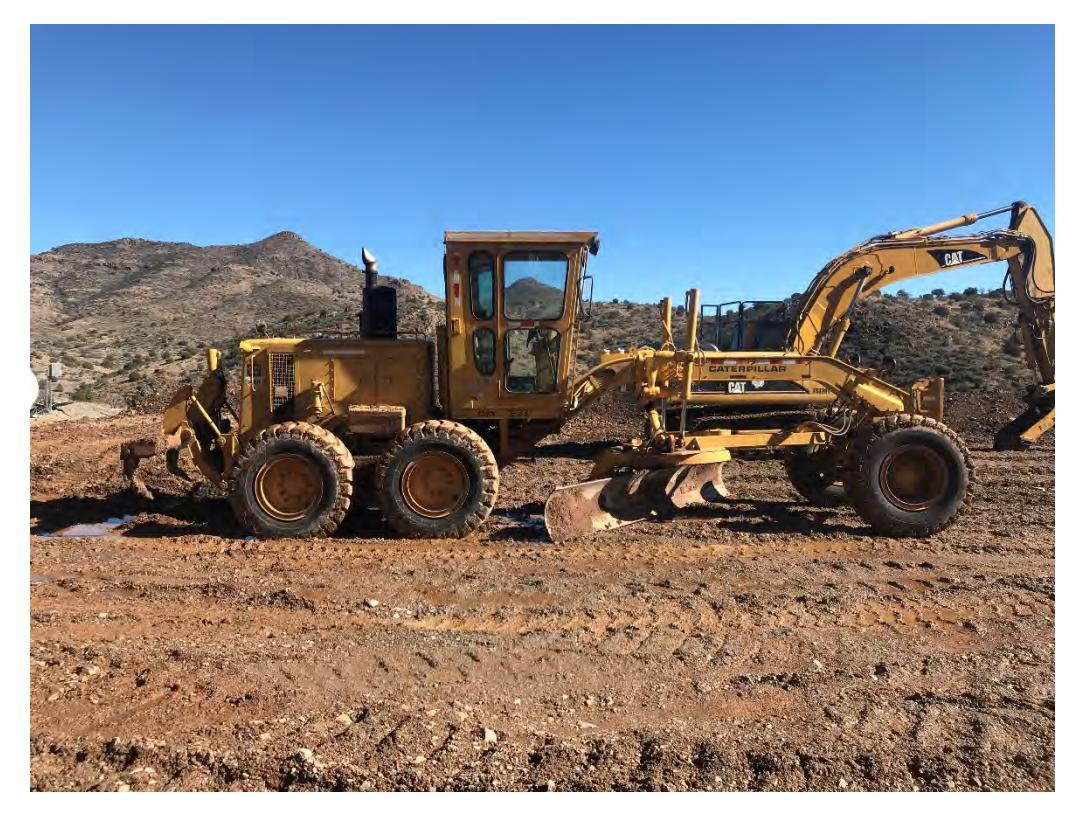
Mobilized Grader

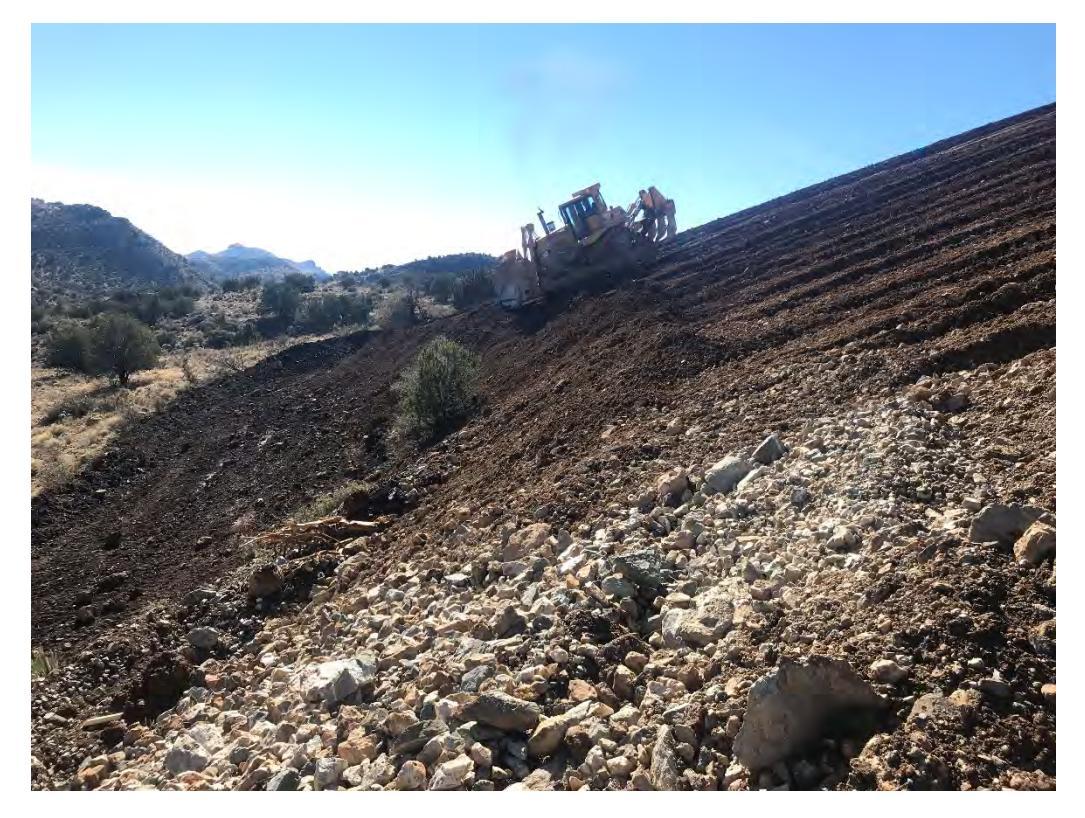
Current Toe of Southern Slope

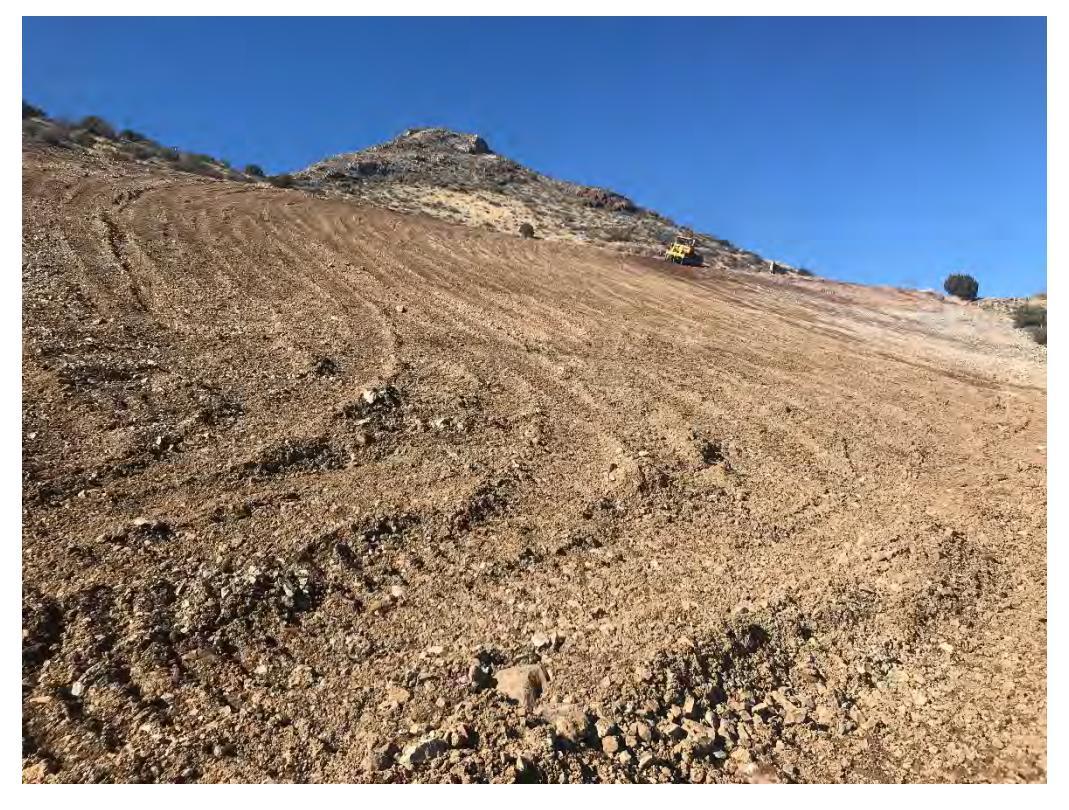
Finished Northern Slope

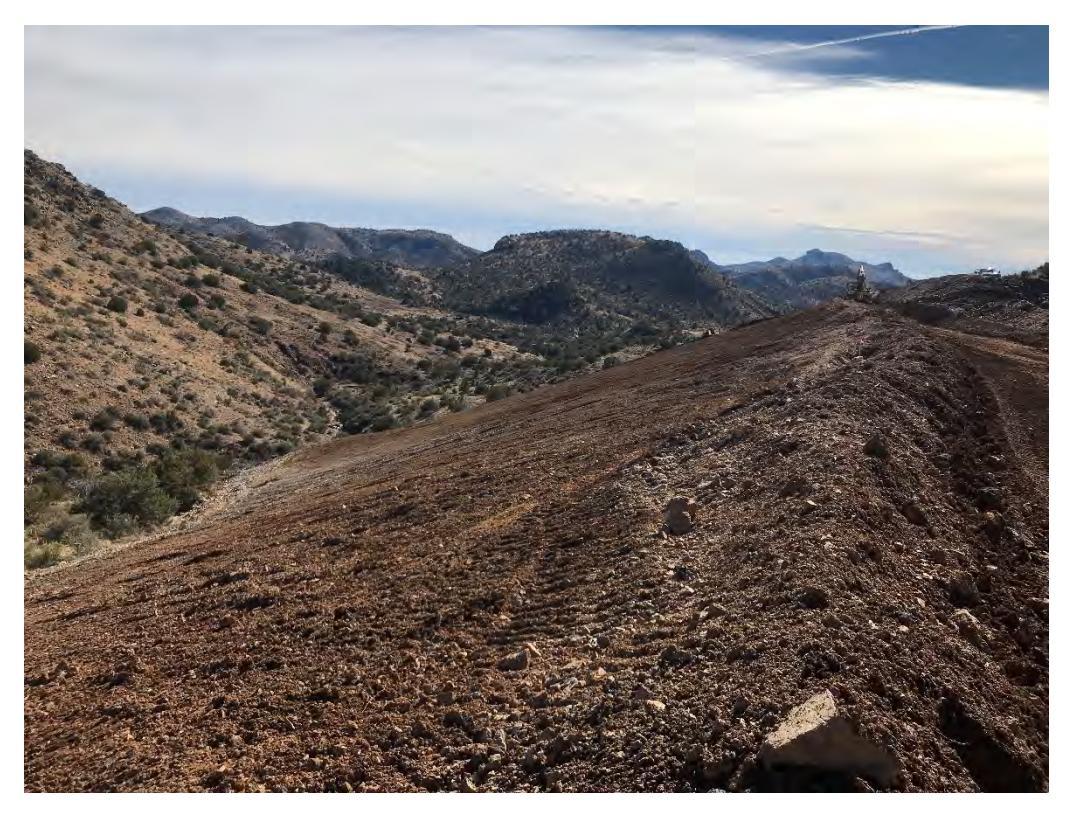
Finished Slope

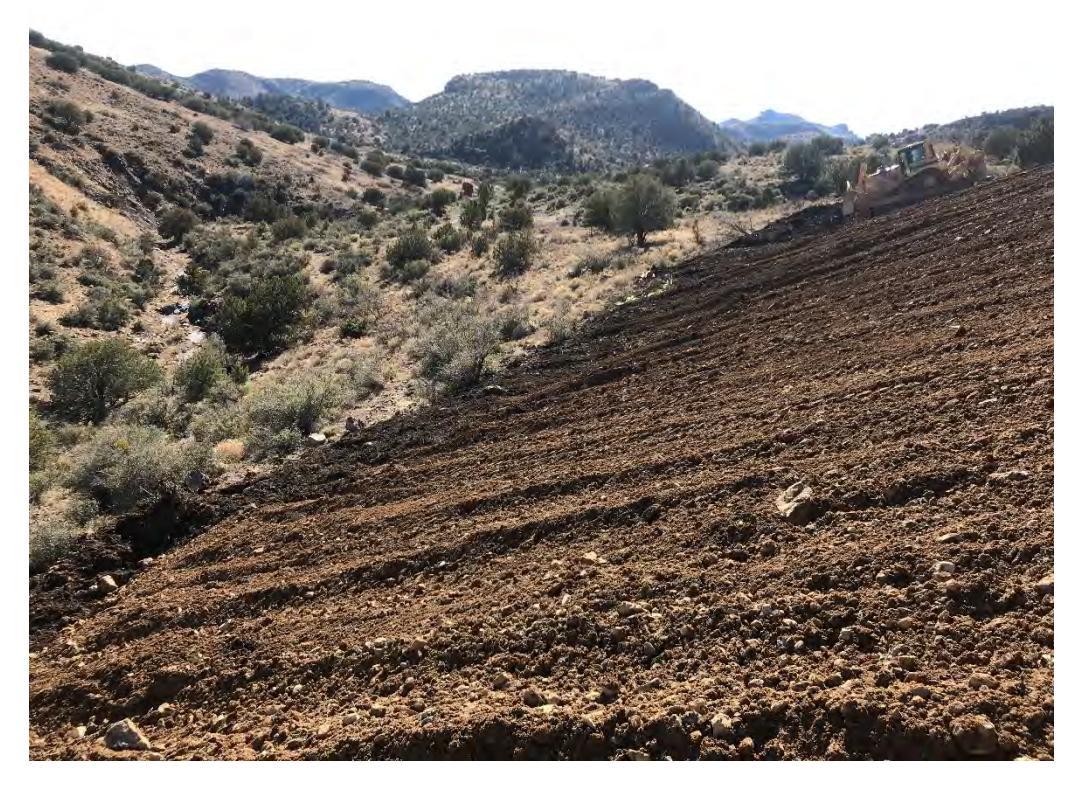
The southern slope of the project did not line up with the toe stakes properly. NewFields and McCauley discussed corrective action, which involved using the D8 to properly define a crest by cutting the slope.

South Completed Toe

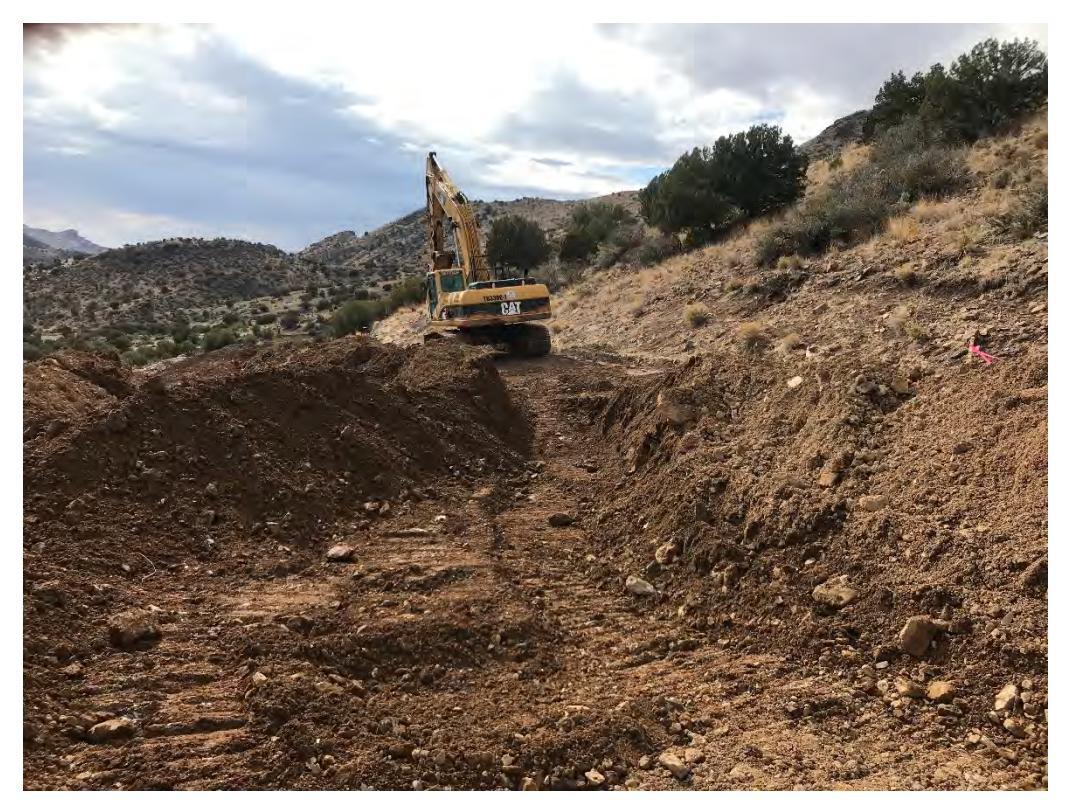
Cut ditch to County Road

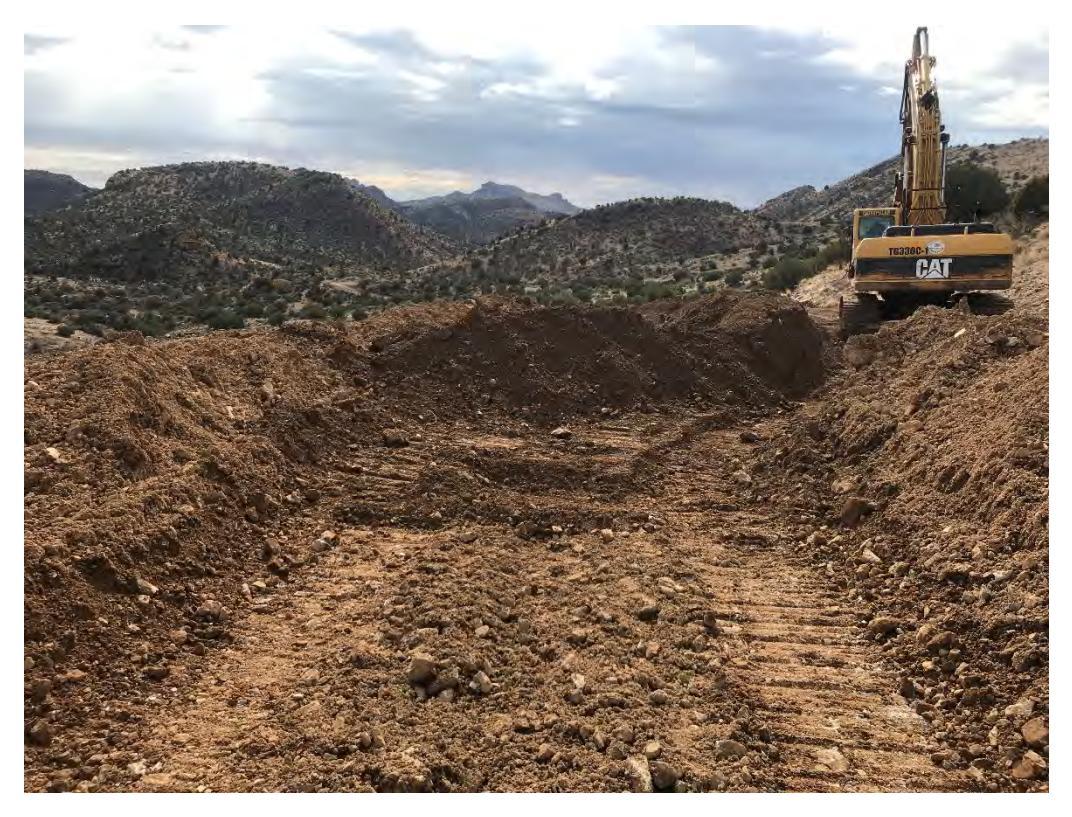
Diversion Berm
