**NEW MEXICO ABANDONED MINE LAND PROGRAM
COUNTY ROAD A-25 SUBSIDENCE
COLFAX COUNTY, NEW MEXICO
SITE CHARACTERIZATION AND MITIGATION RECOMMENDATIONS REPORT**

January 10, 2023

Project #: 01A-003-002

SUBMITTED BY: Trihydro Corporation

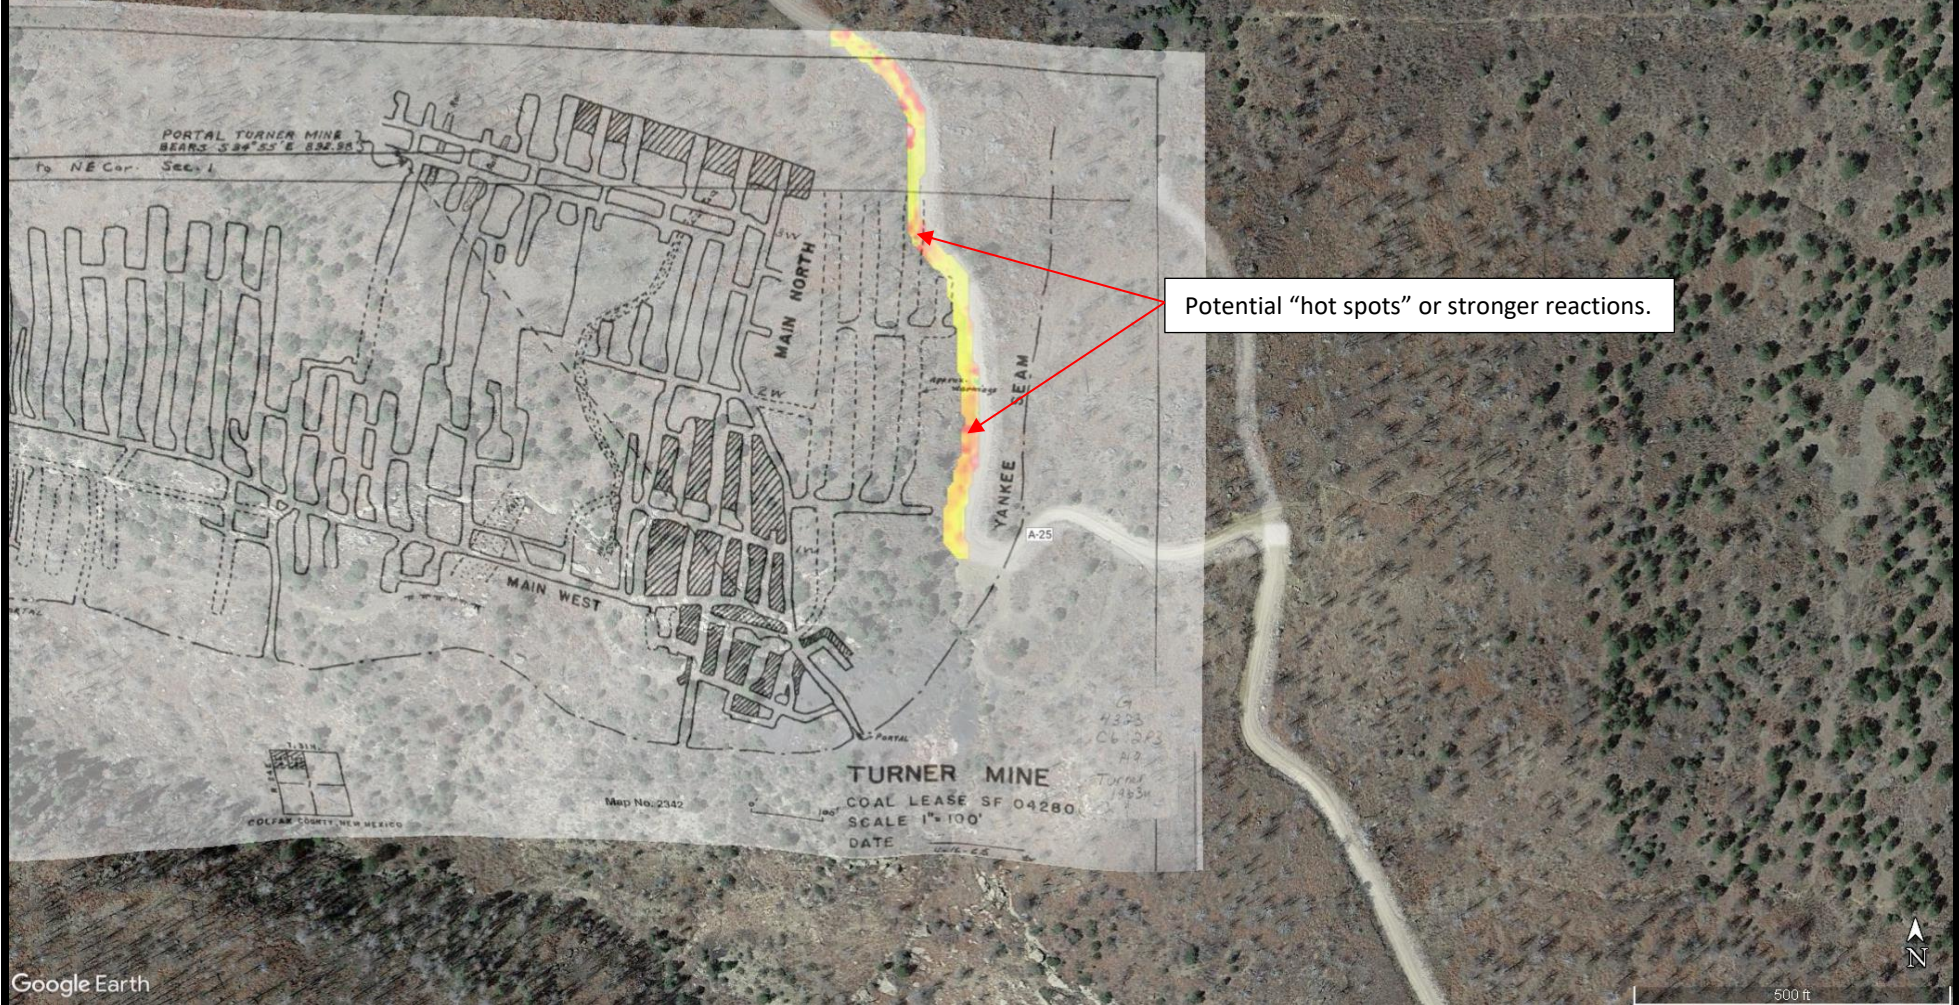
Potential "hot spots" or stronger reactions.

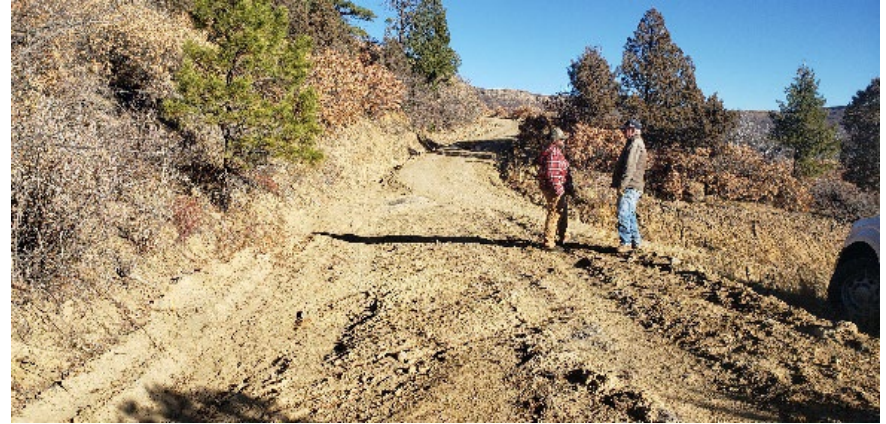
Photo 1. Subsidence feature found by Colfax County Road Department
