Construction Quality Assurance Report Lake One Reclamation Chino Mines Company – Hurley, New Mexico

September 19, 2014

**CONSTRUCTION QUALITY ASSURANCE REPORT
LAKE ONE RECLAMATION
CHINO MINES COMPANY – HURLEY, NEW MEXICO**

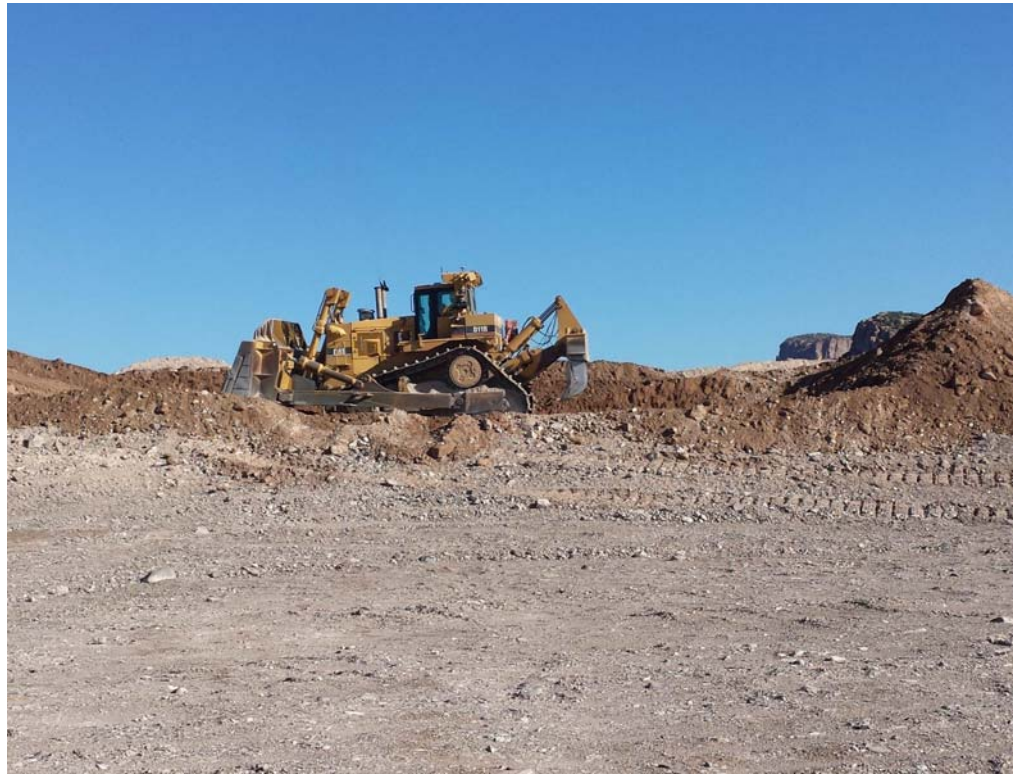
PHOTO 1

August 16, 2013
FMRS excavating material
from the
Razorback Ridge Borrow Area.

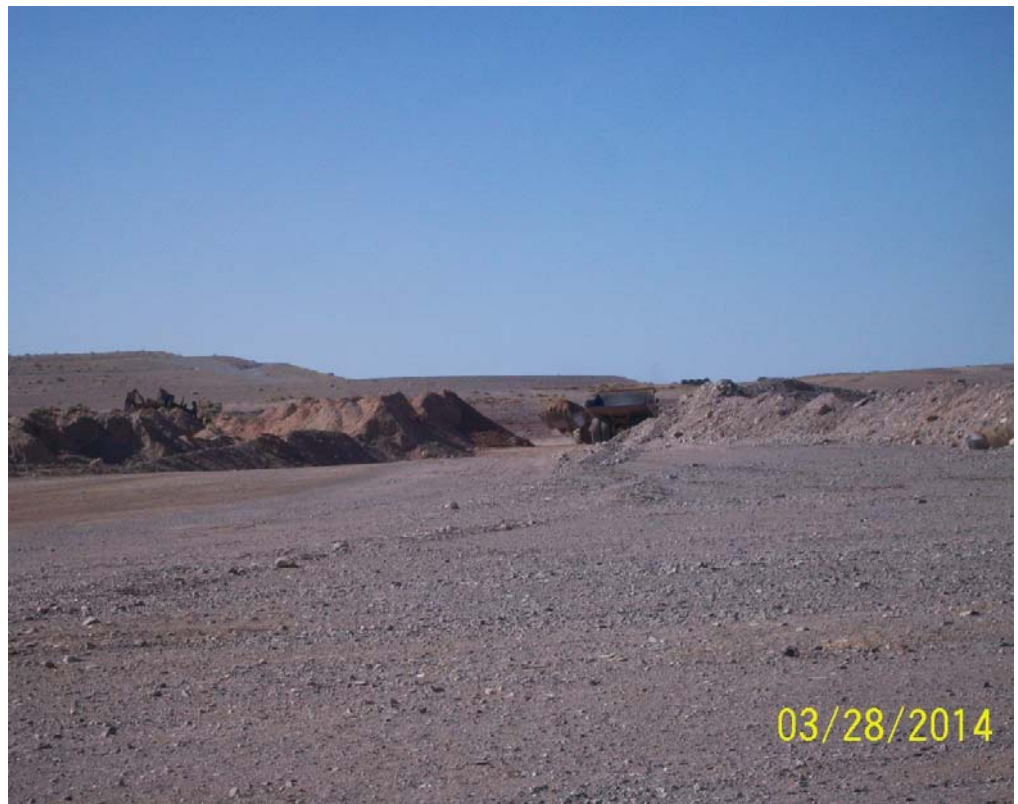
PHOTO 2

March 28, 2014
FMRS hauling cover
material from Borrow Area B.

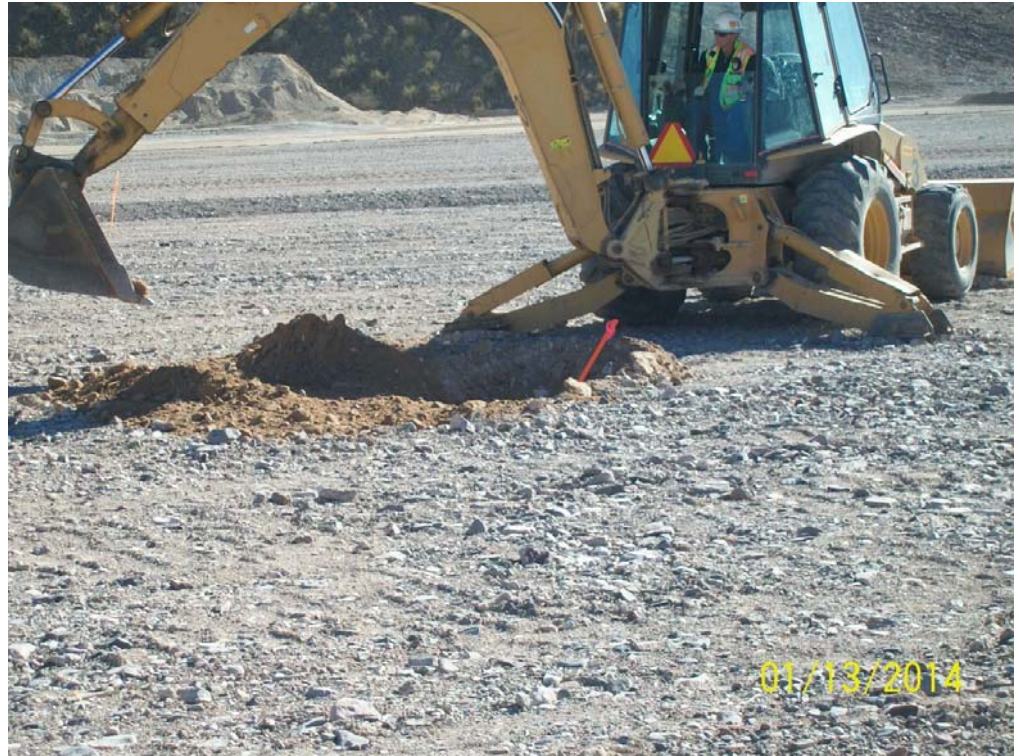
PHOTO 3

January 11 - January 17, 2014
FMRS excavating QA
test pits for EMC2 to
measure cover thicknesses
within IR-018.

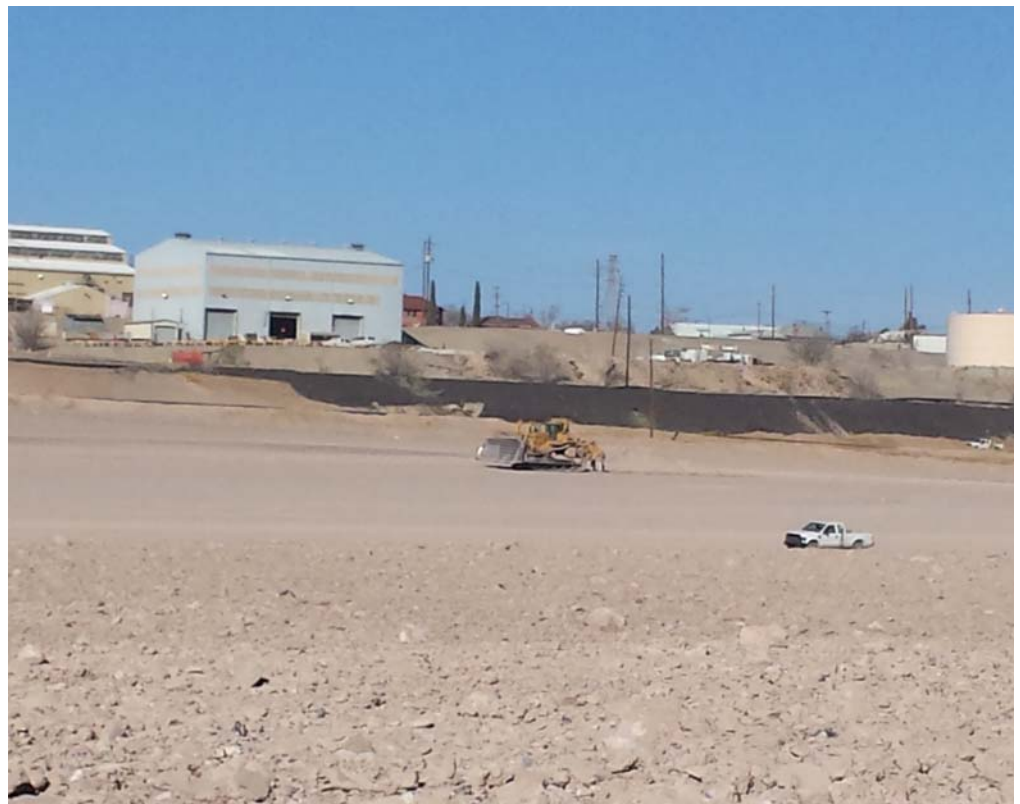
PHOTO 4

February 15 -
February 21, 2014
FMRS scarifying the
final approved cover
surface in IR-018.

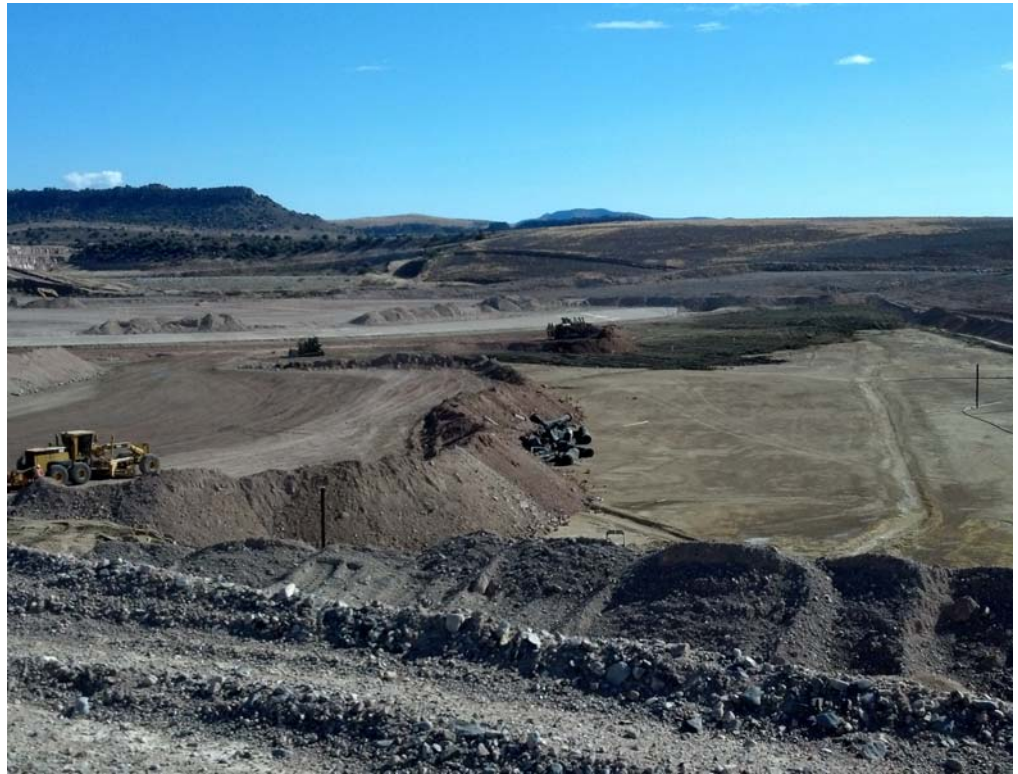
PHOTO 5

February 8 - February 14, 2014
Placement of cover
material in IR 027.

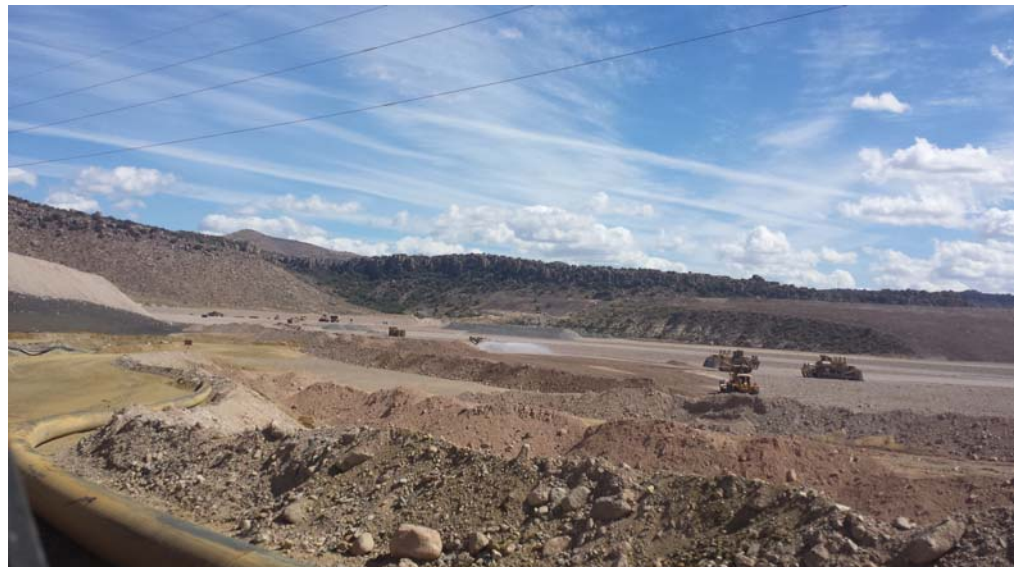
PHOTO 6

March 8 - March 14, 2014
FMRS crews placing cover
material in IR 032.

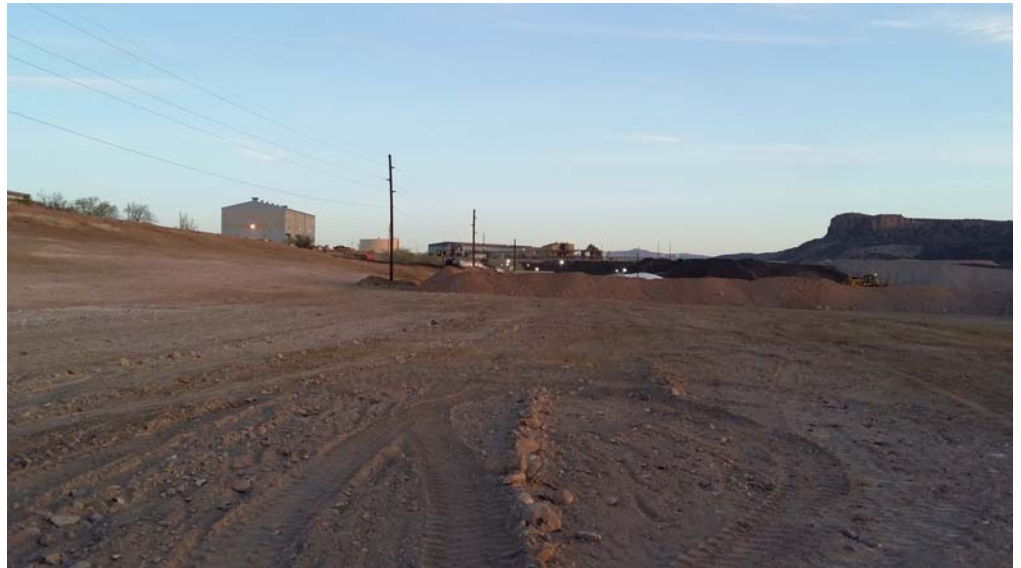
PHOTO 7

March 15 - March 21, 2014
FMRS crews placing
cover material in IR 033.

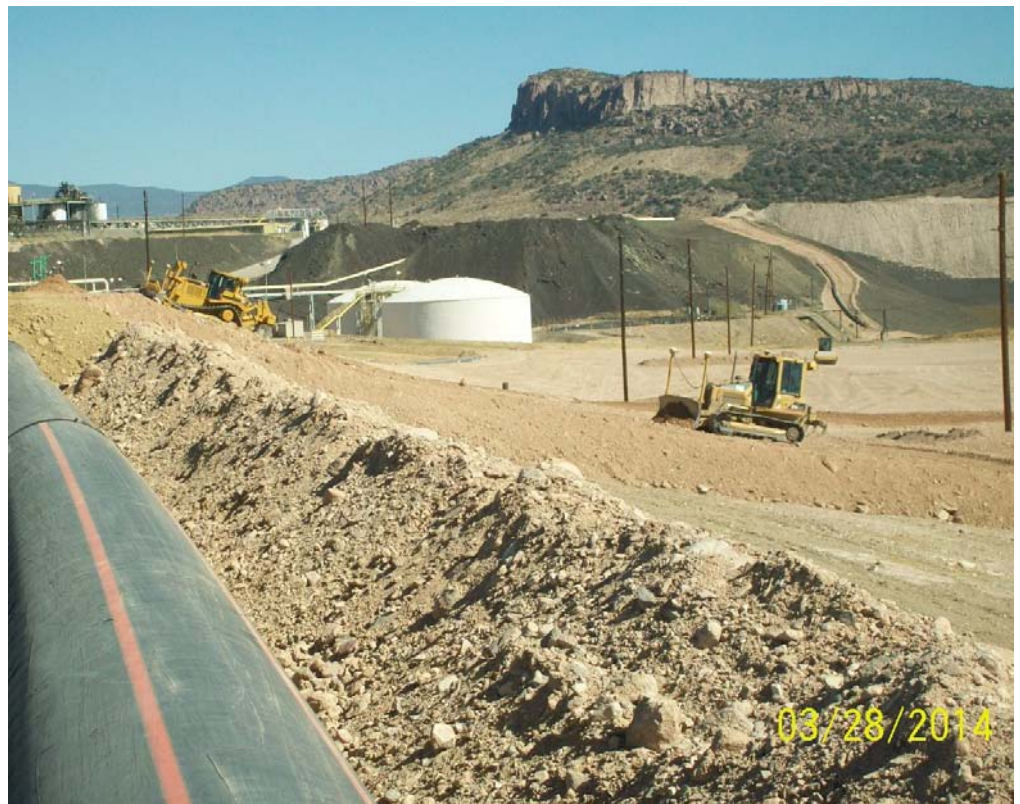
PHOTO 8

March 22 - March 28, 2014
FMRS crews placing
cover material in IR 033.

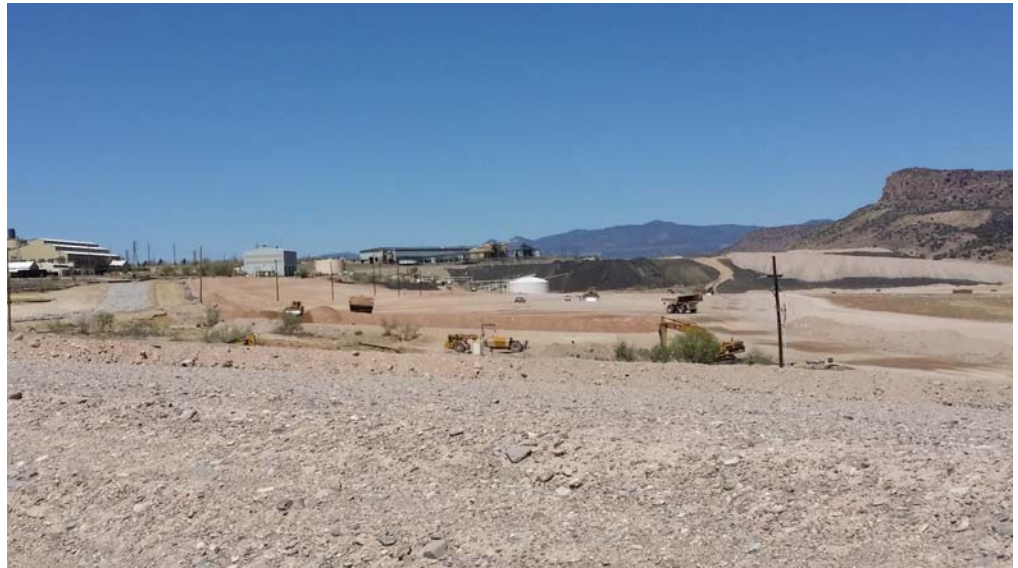
PHOTO 9

March 29 - April 4, 2014
FMRS crews placing cover
material in IR-033.

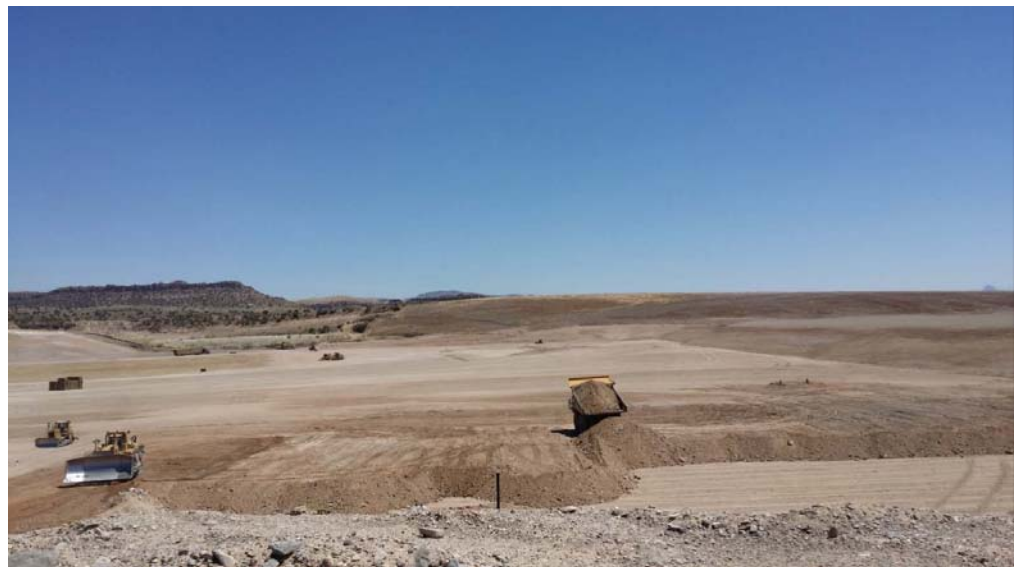
PHOTO 10

April 12 - April 18, 2014
FMRS crews placing
cover material in IR 033.

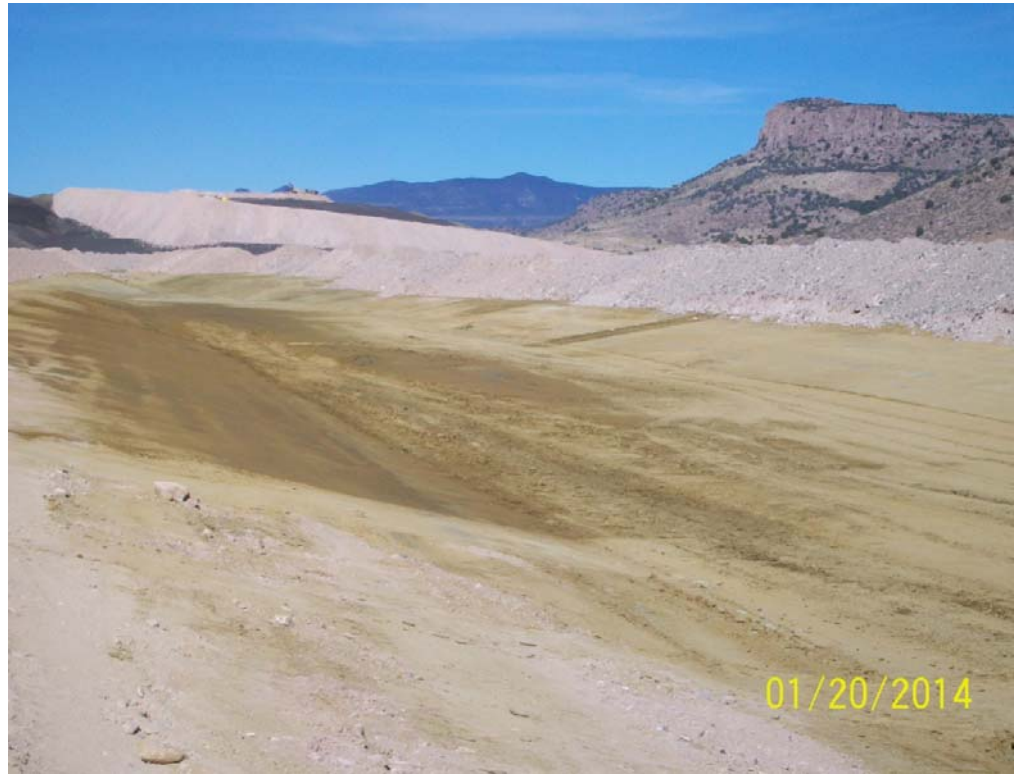
PHOTO 11

January 18 - January 24, 2014
Placing Gila Bedding from
the south end of the
Razorback Ridge Borrow Area
in plug-dumps above
Channel P1, Reach 3
in approved IR-020.

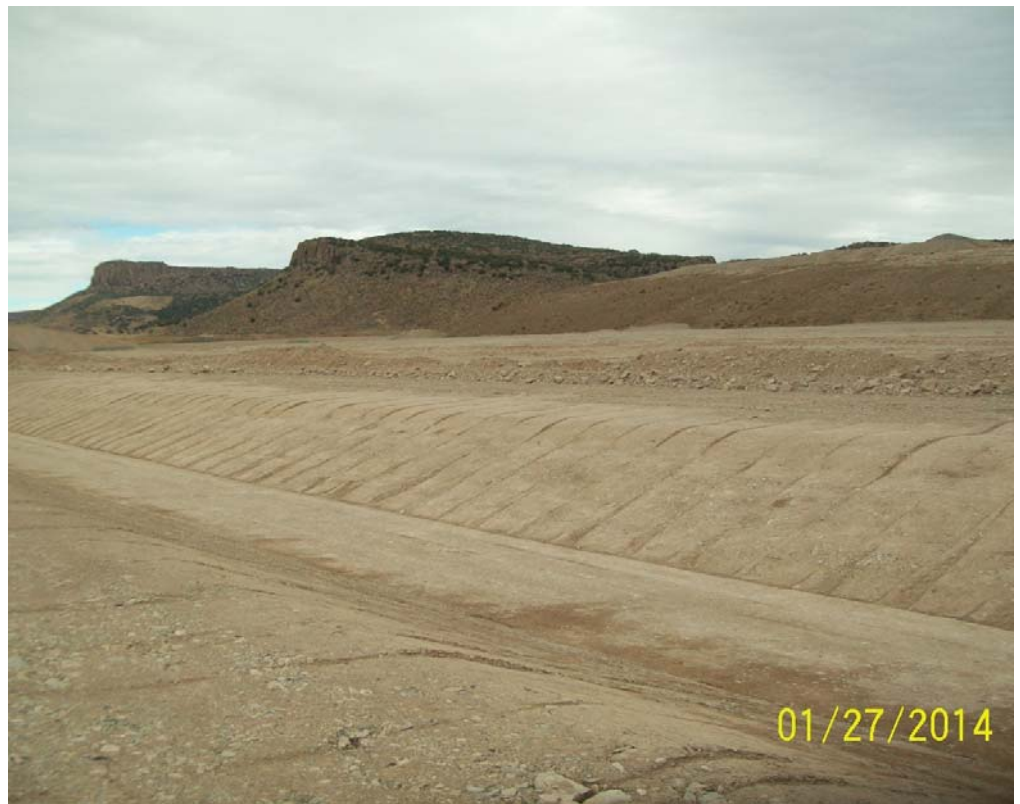
PHOTO 12

January 25 - January 31, 2014
Compaction of Gila Bedding
in Channel P1, Reach 3.

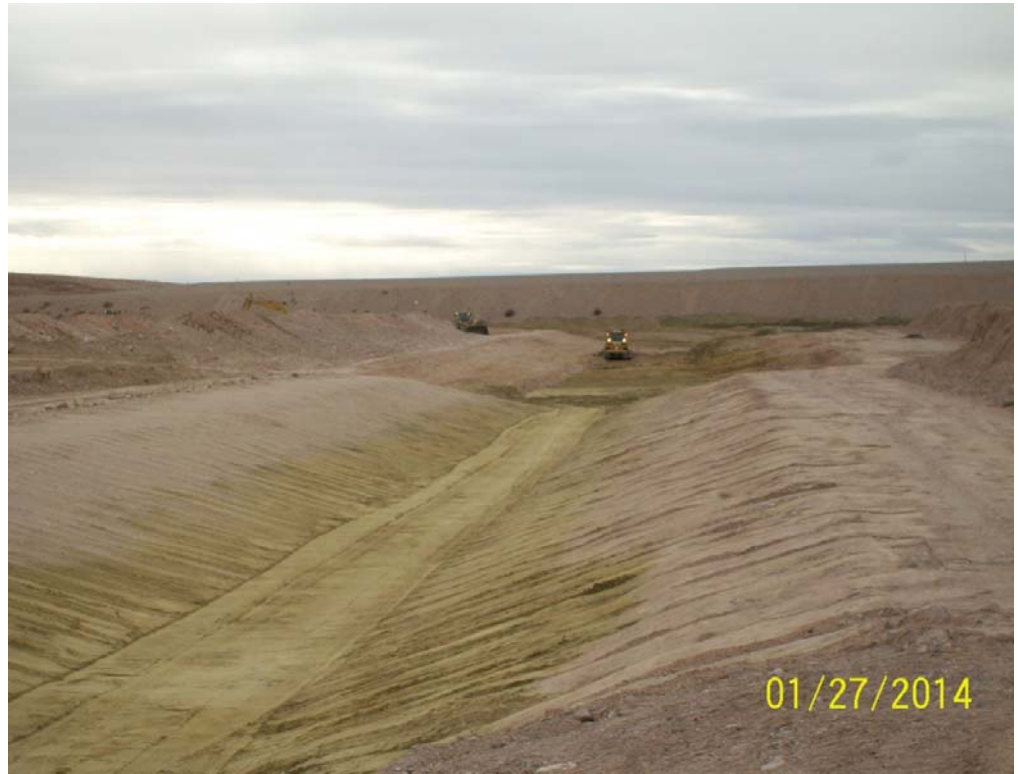
PHOTO 13

January 25 - January 31, 2014
Subgrade surface preparation
in Channel P1, Reach 3.

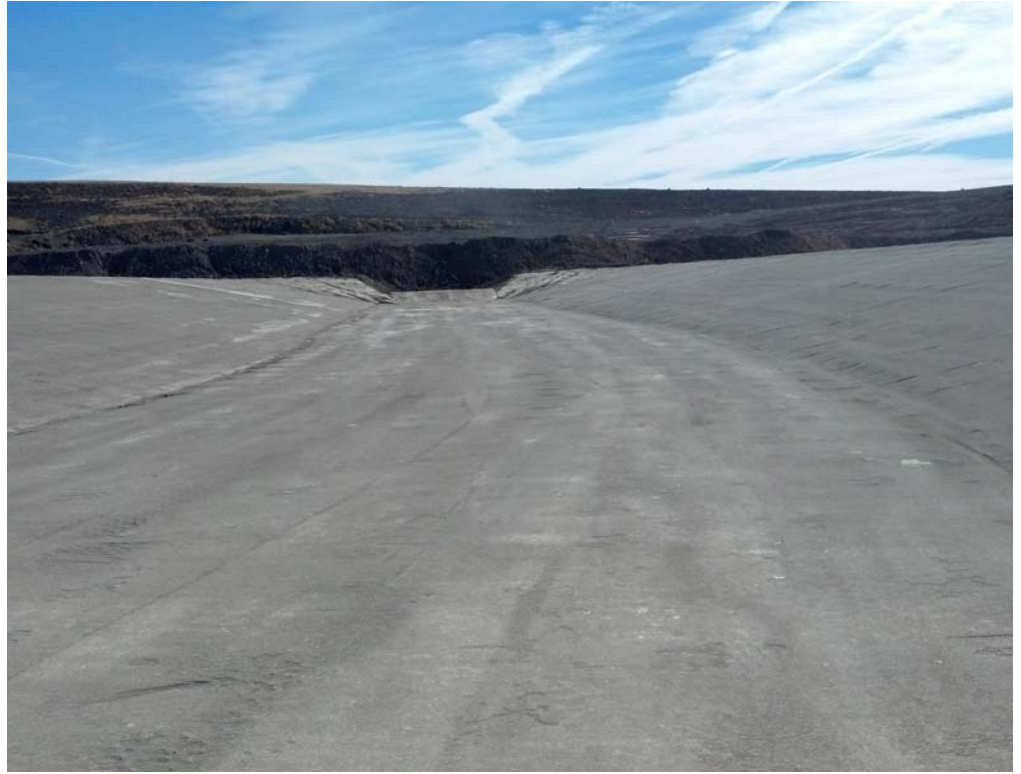
PHOTO 15

February 8 - February 14, 2014
Compaction of liner bedding
surface in Channel P1, Reach 2
(Lined Channel).

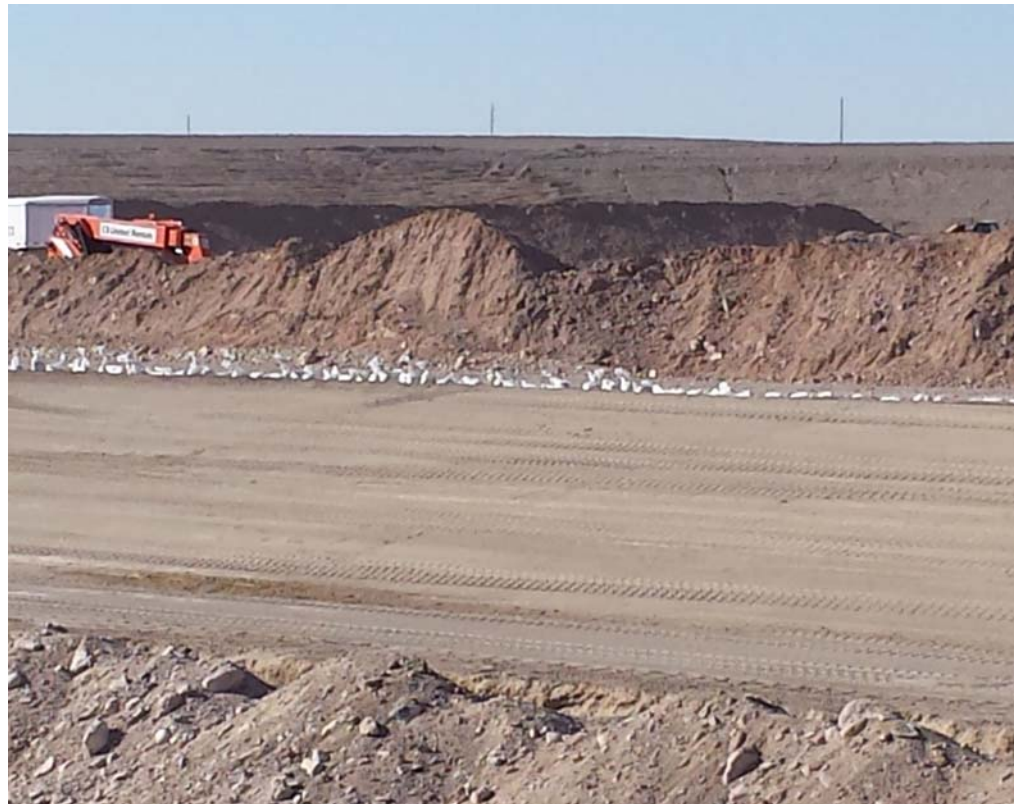
PHOTO 16

February 15 -
February 21, 2014
FMRS completed preparing
the HDPE liner
bedding surface and
anchor trench construction
in Channel P1, Reach 2.

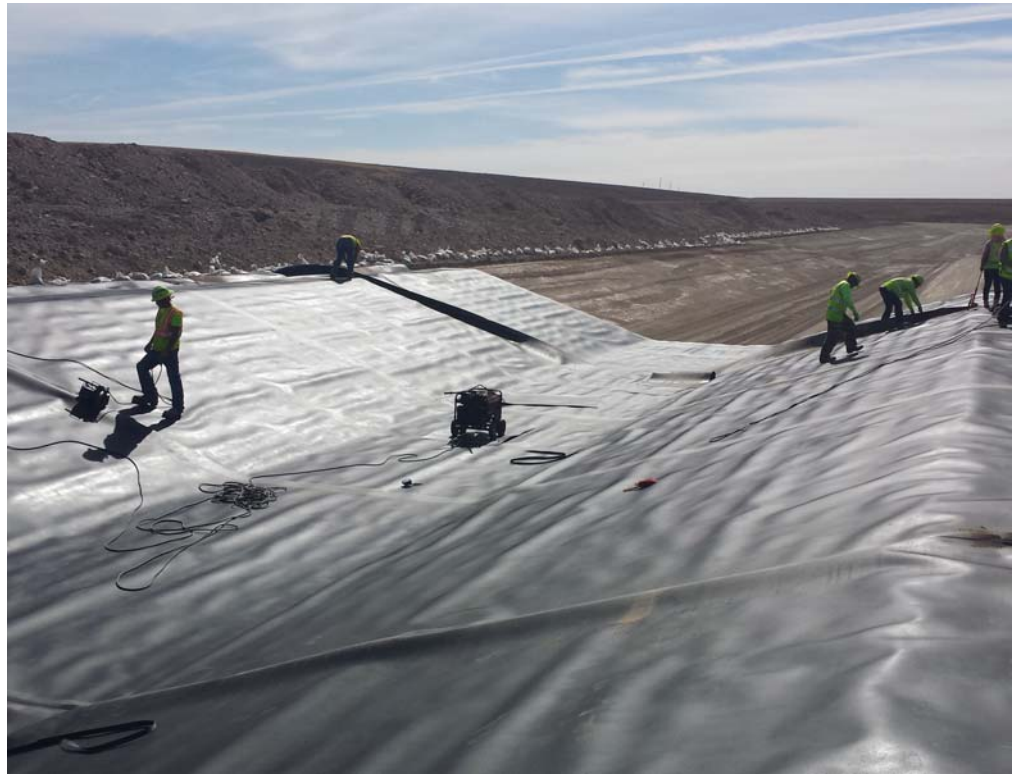
PHOTO 17

February 15 -
February 21, 2014
AEG installing 60-mil
textured HDPE Liner
in Channel P1, Reach 2.

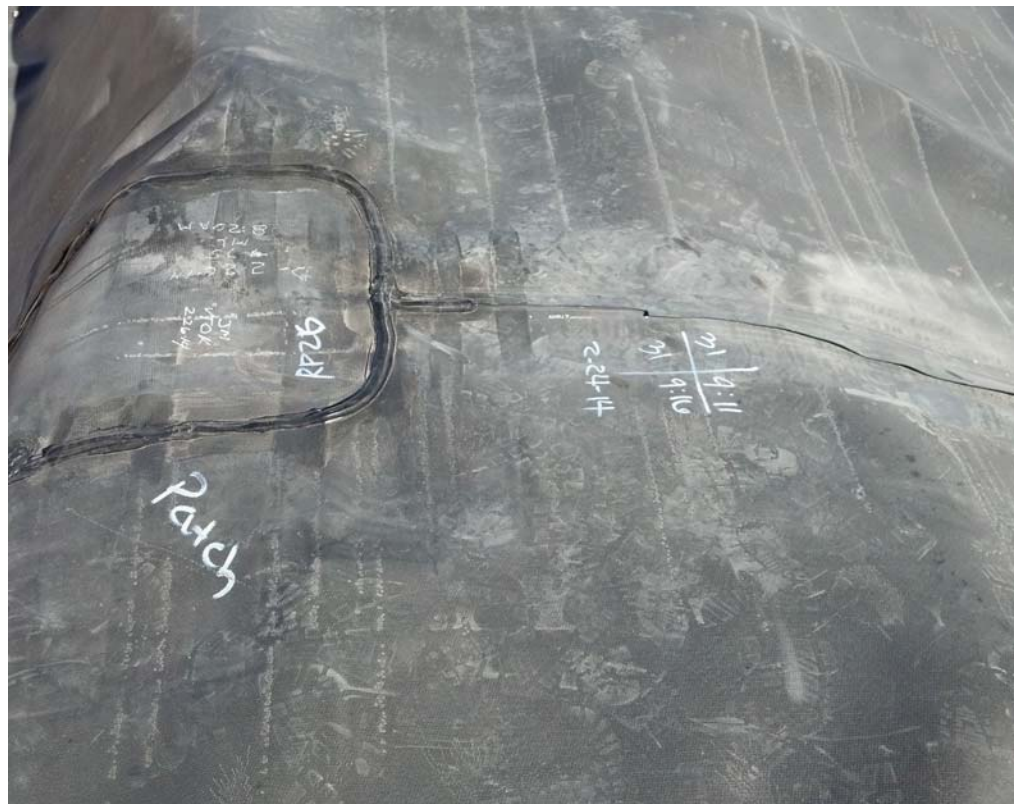
PHOTO 18

February 22 -
February 28, 2014
Destructive testing of the
liner installation in
Channel P1, Reach 2

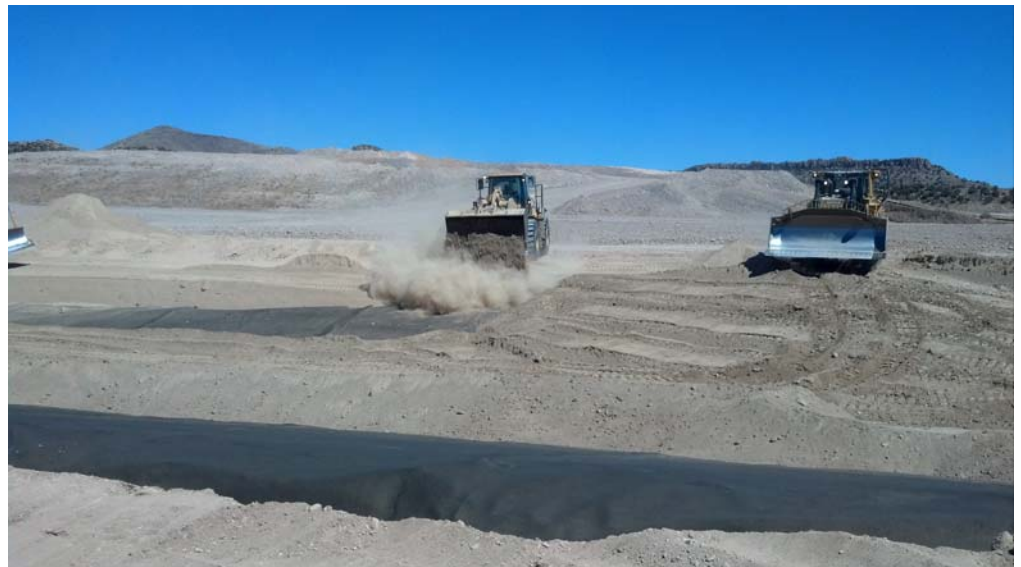
PHOTO 20

March 8 - March 14, 2014
FMRS crews placing
fine sand bedding material
in Channel P1, Reach 2.

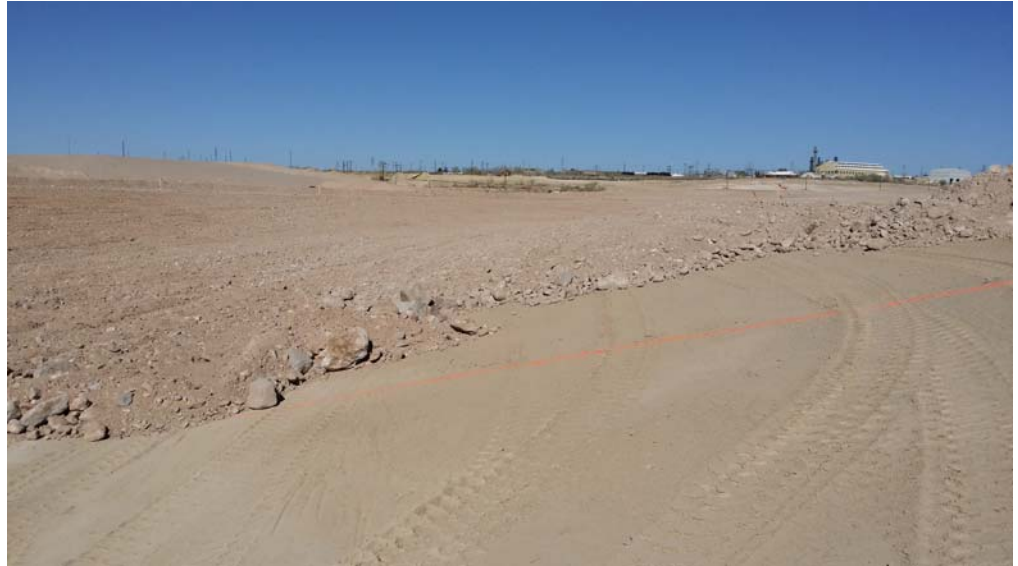
PHOTO 21

March 15 - March 21, 2014
FMRS crews placing
Gila bedding material in
Channel P1 Reach 2.

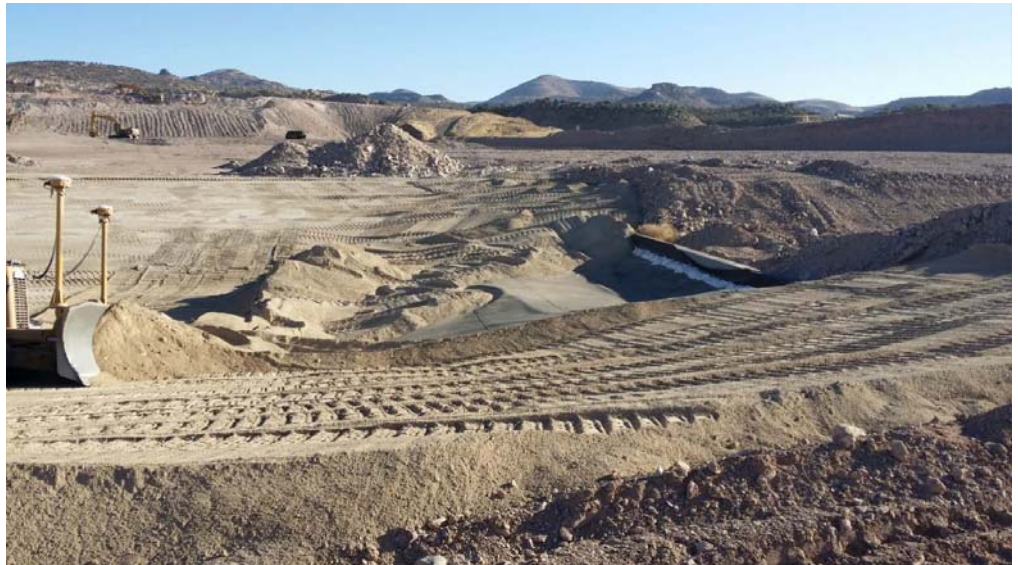
PHOTO 22

March 15 - March 21, 2014
FMRS placing fine sand
bedding material
in Channel P1.

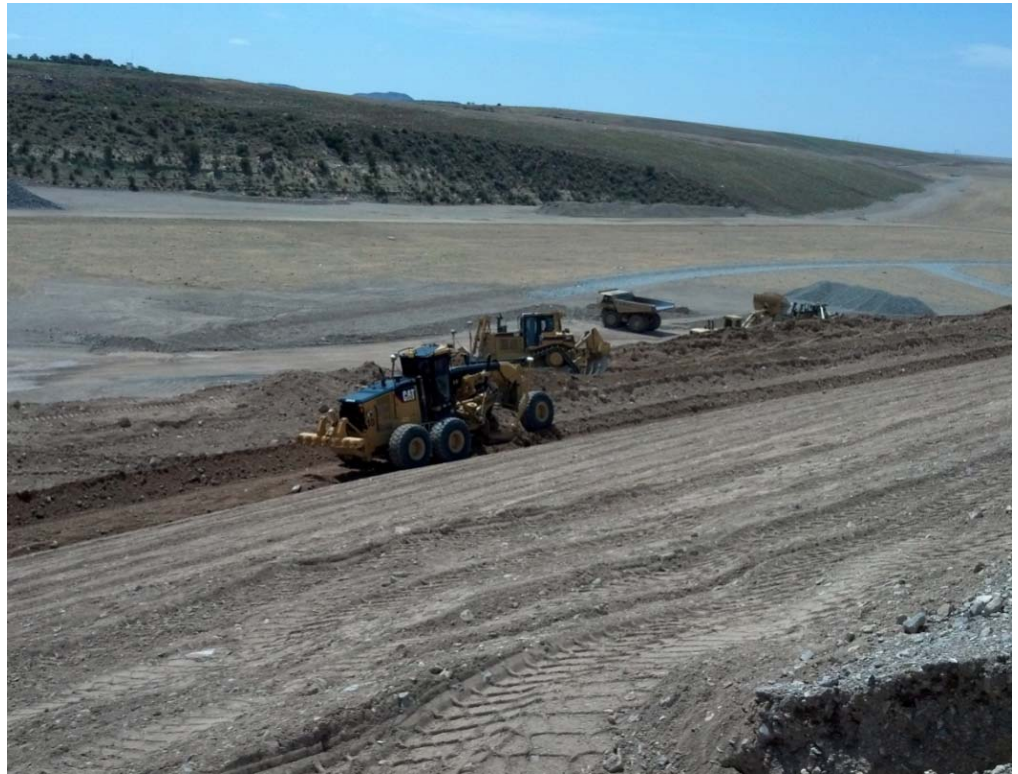
PHOTO 23

July 12 - July 18, 2014
FMRS constructing
Outslope Channels 08 and 09.

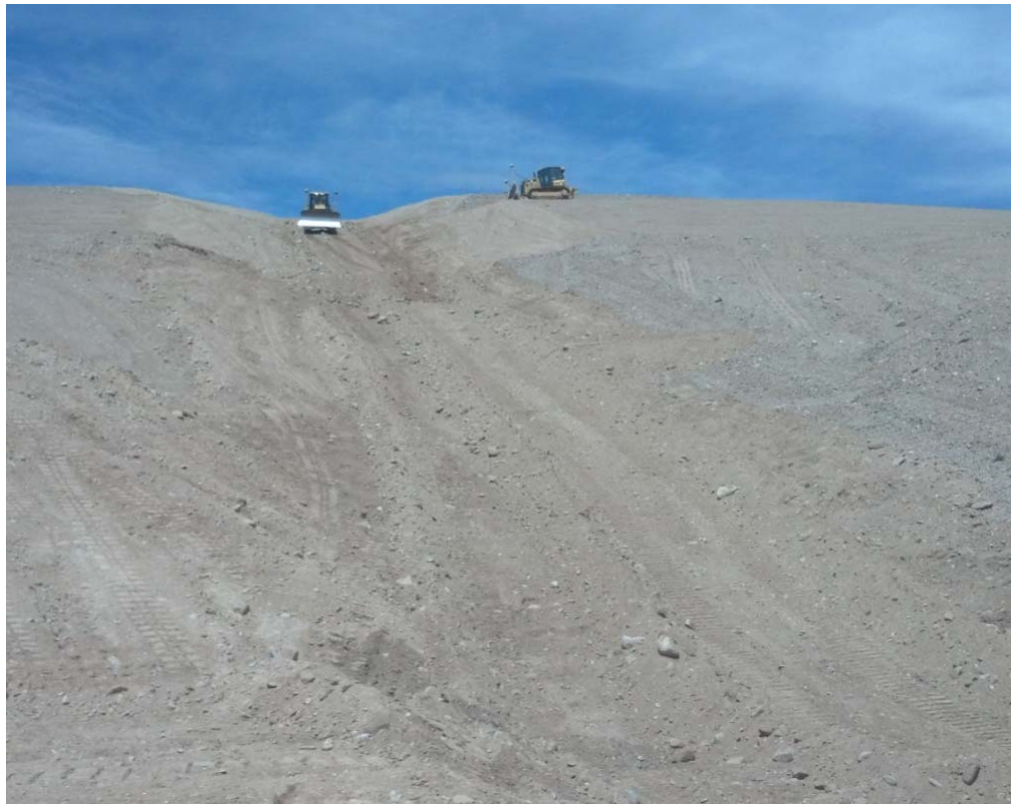
PHOTO 24

July 26 - August 1, 2014
FMRS constructing Down
Drain 2.

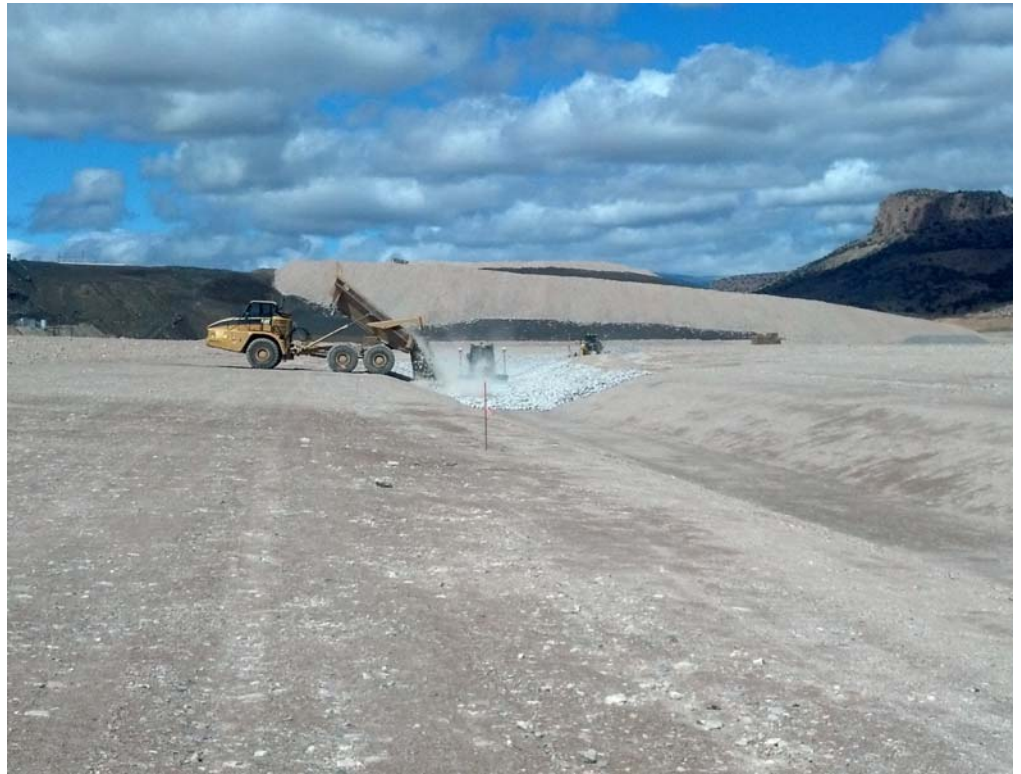
PHOTO 25

March 1 - March 7, 2014
FMRS placing 3" D50
riprap in Channel P1, Reach 3.

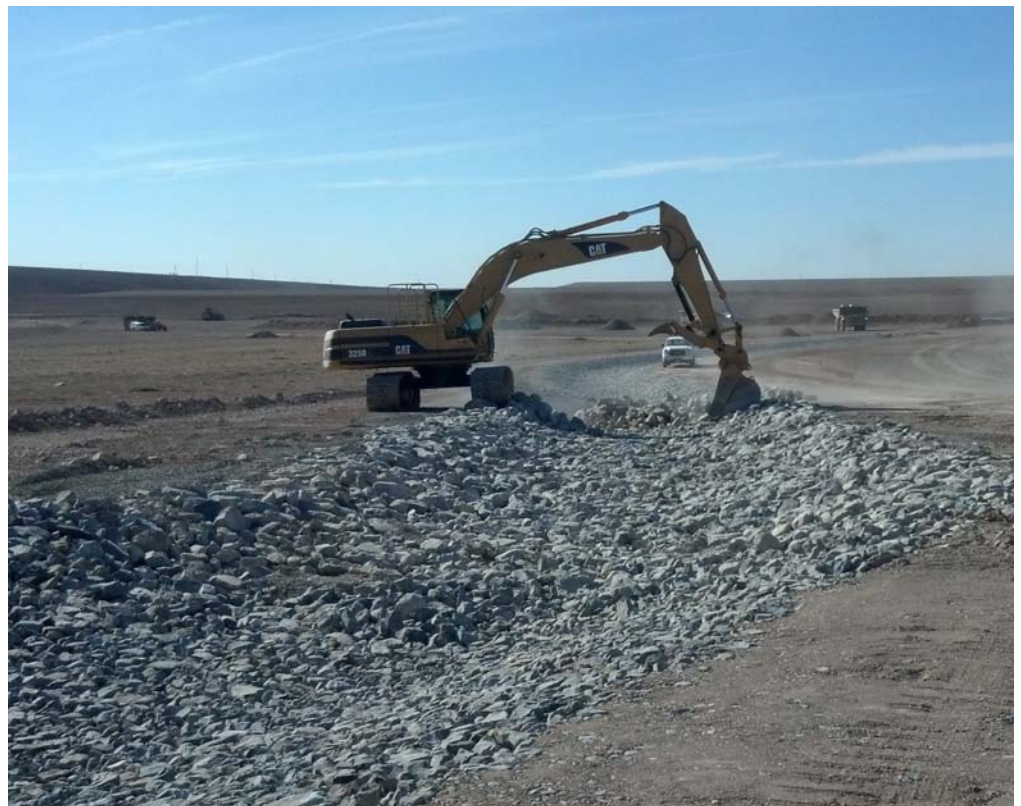
PHOTO 26

April 5 - April 11, 2014
FMRS placing 3" D50
riprap in Channel S1, Reach 2.

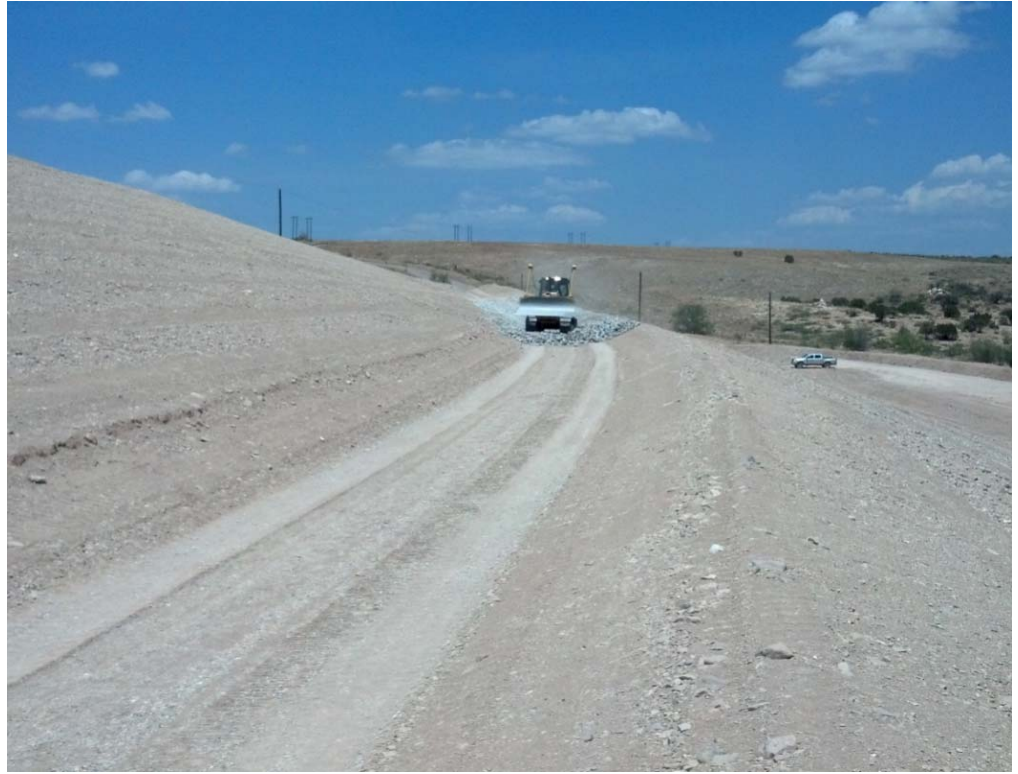
PHOTO 27

July 19 - July 25, 2014
FMRS placing 3" D50
riprap in Outslope Channel 08.

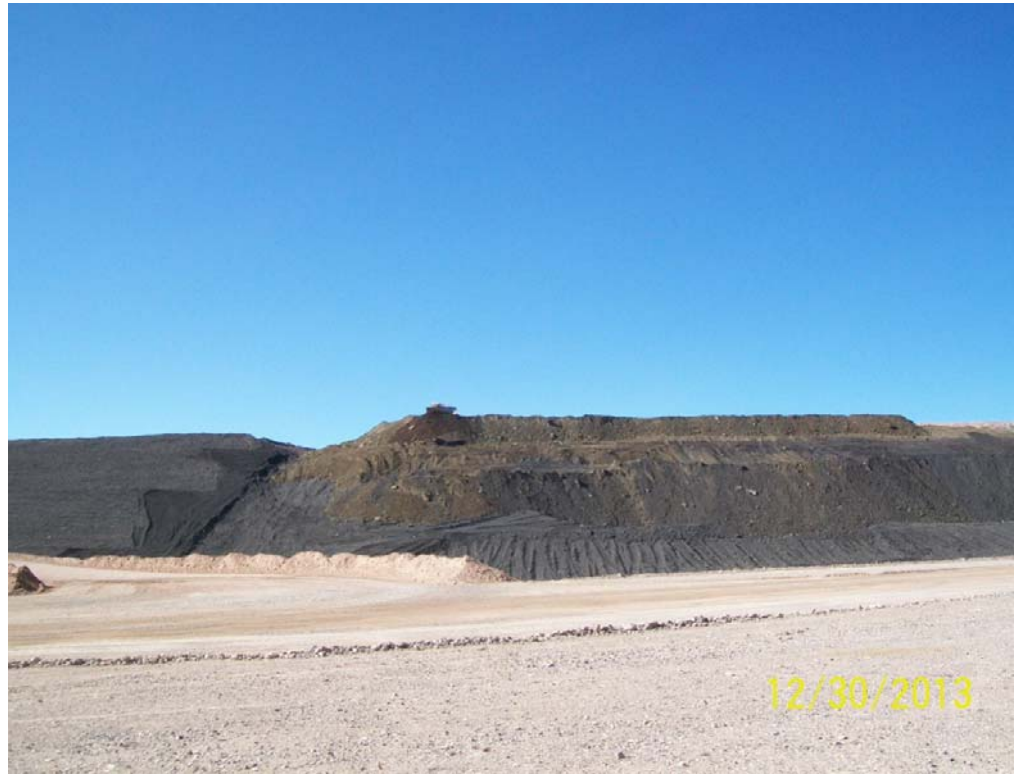
PHOTO 28

December 27, 2013 -
January 3, 2014
Slag material from the
north end of the Slag Pile
being placed as fill on
the east crest.

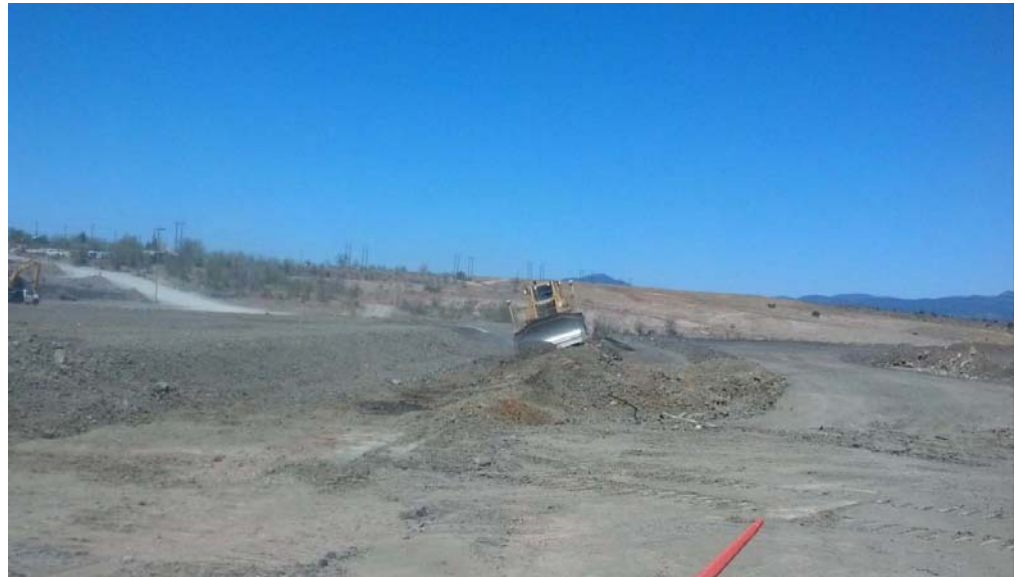
PHOTO 29

April 5 - April 11, 2014
FMRS continuing
subgrade regrading operations
on the top of the Slag Pile.

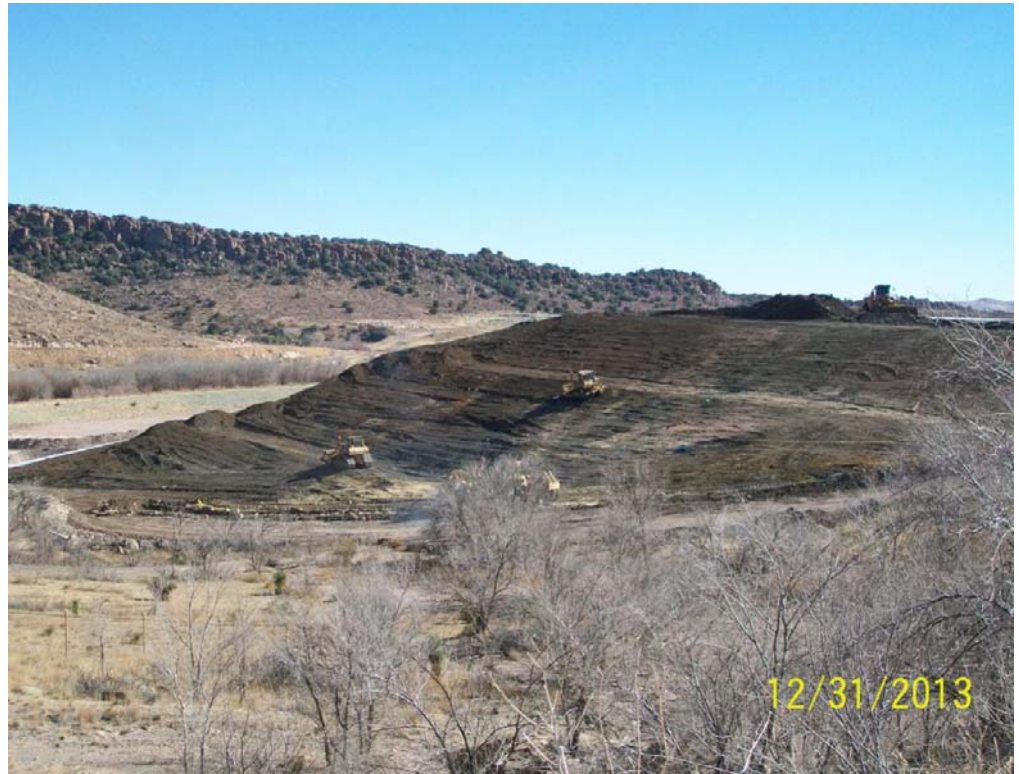
PHOTO 30

December 27, 2013 -
January 3, 2014
Regrading of outslopes and
channel benches on the
northern slope of the Slag Pile.

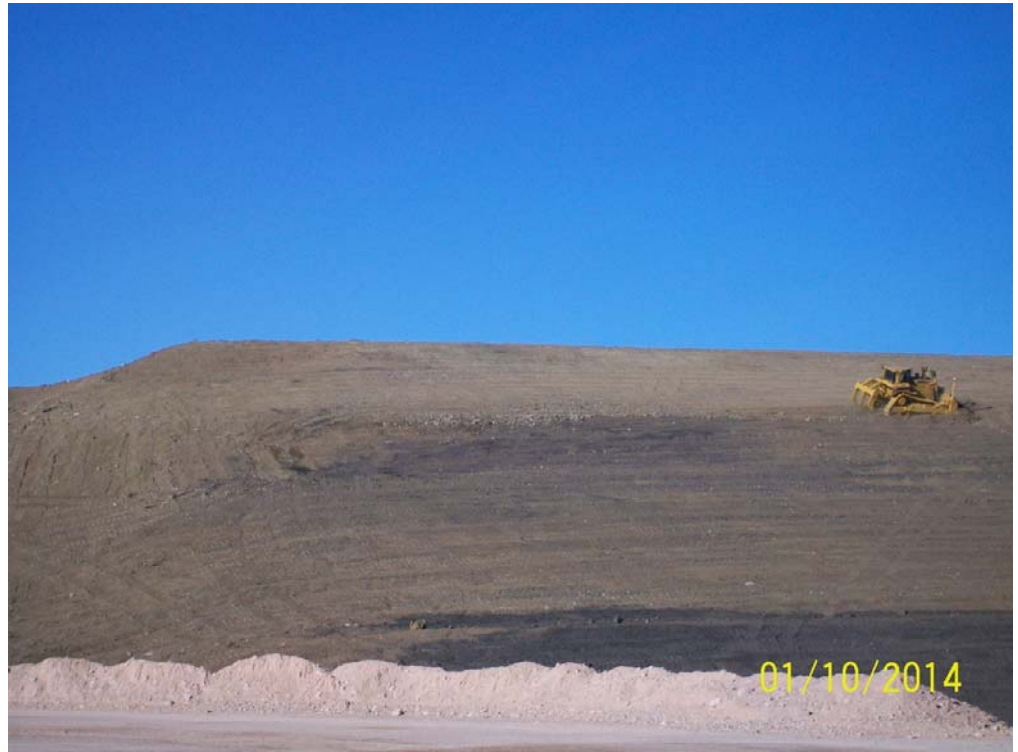
PHOTO 31

January 4 - January 10, 2014
Grading the east crest and the
upper channel benches and
outslopes on the Slag Pile.

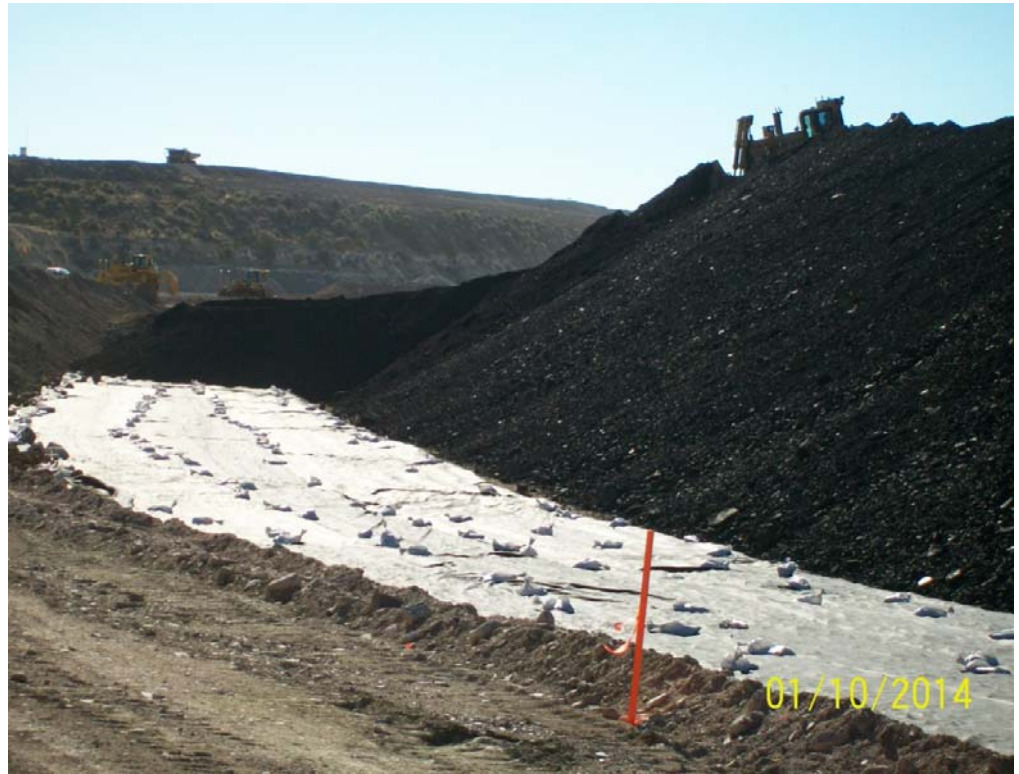
PHOTO 32

January 4 - January 10, 2014
Excavating slag material
from the base of the
Slag Pile and placing it
over the Slag Pile
toe seep collection system.
