Construction Quality Assurance Report Lake One Reclamation Chino Mines Company – Hurley, New Mexico

September 19, 2014

**CONSTRUCTION QUALITY ASSURANCE REPORT
LAKE ONE RECLAMATION
CHINO MINES COMPANY – HURLEY, NEW MEXICO**

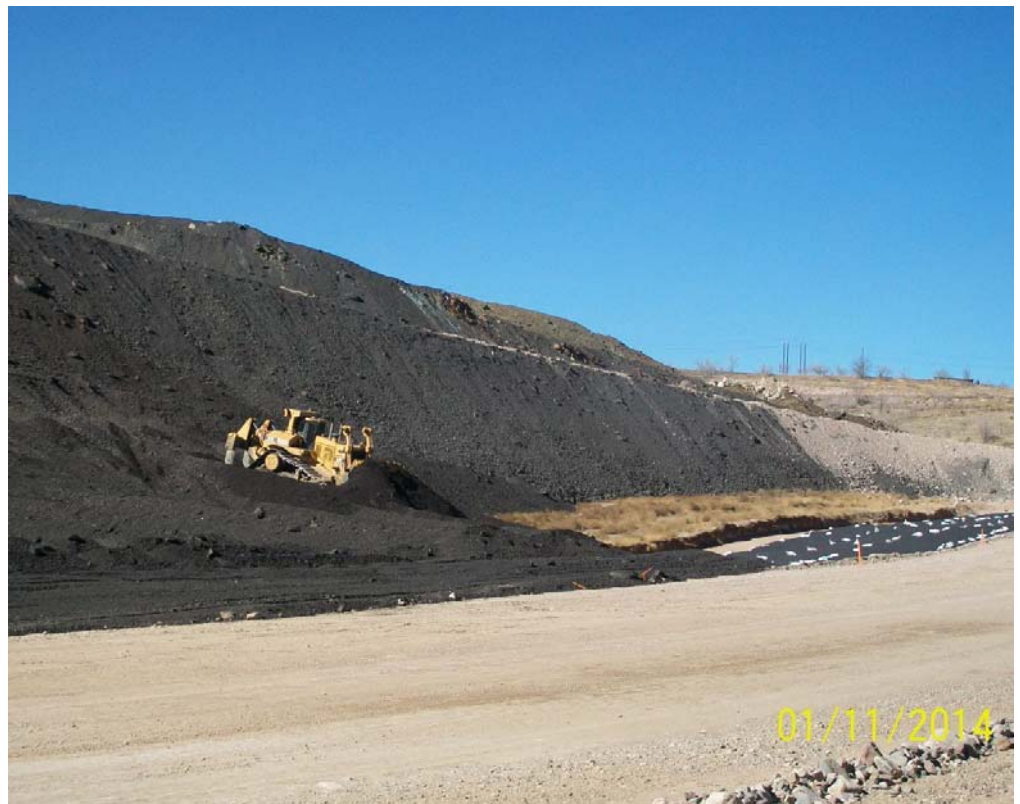
PHOTO 33

January 11 - January 17, 2014
FMRS dozer-pushing
slag material from the
base of the Slag Pile
to cover over the
seep collection system.

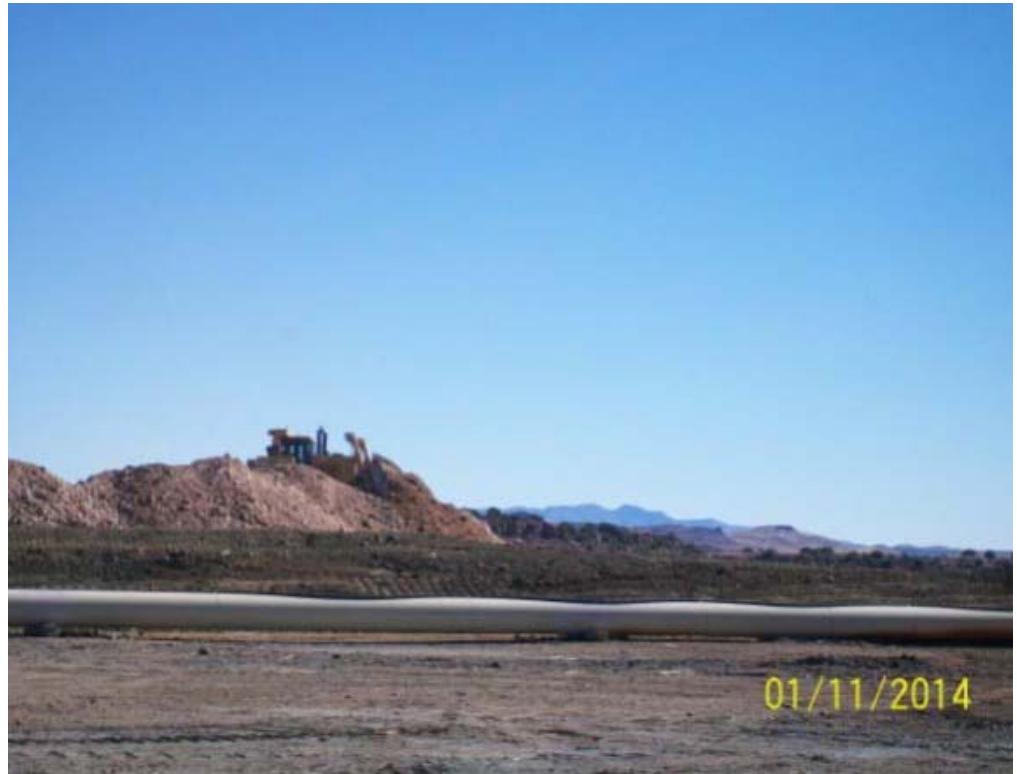
PHOTO 34

January 11 - January 17, 2014
FMRS placing cover
material in approved
IR-019 on top of the Slag Pile.

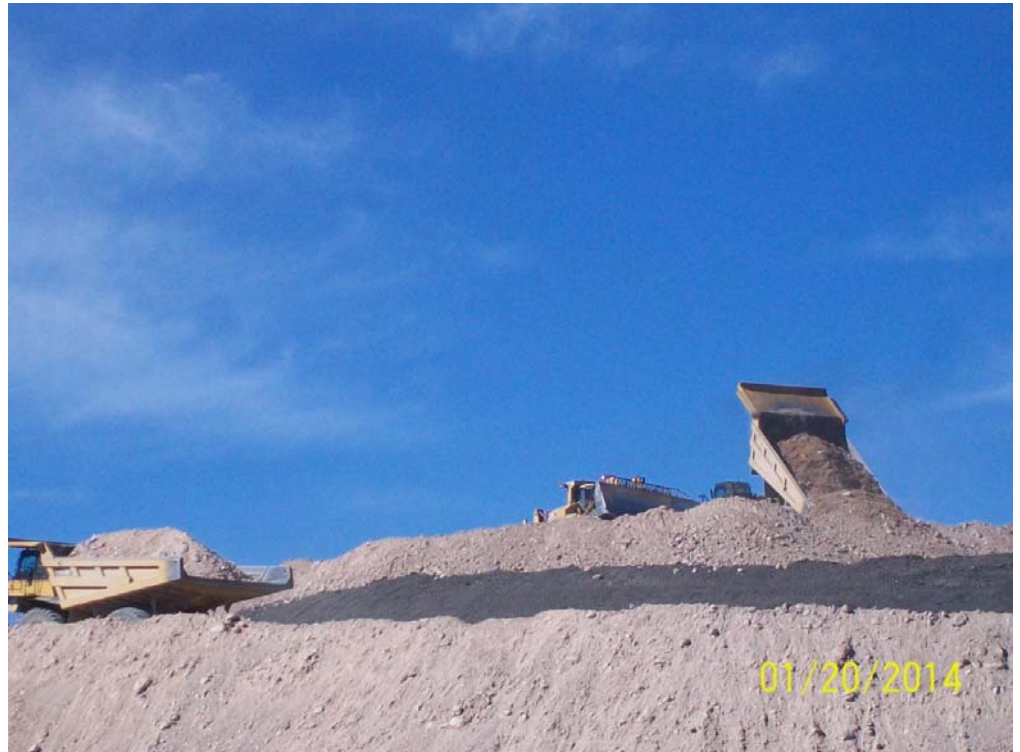
PHOTO 35

January 18 - January 24, 2014
Placing cover material
in approved IR-019 on
top of the Slag Pile.

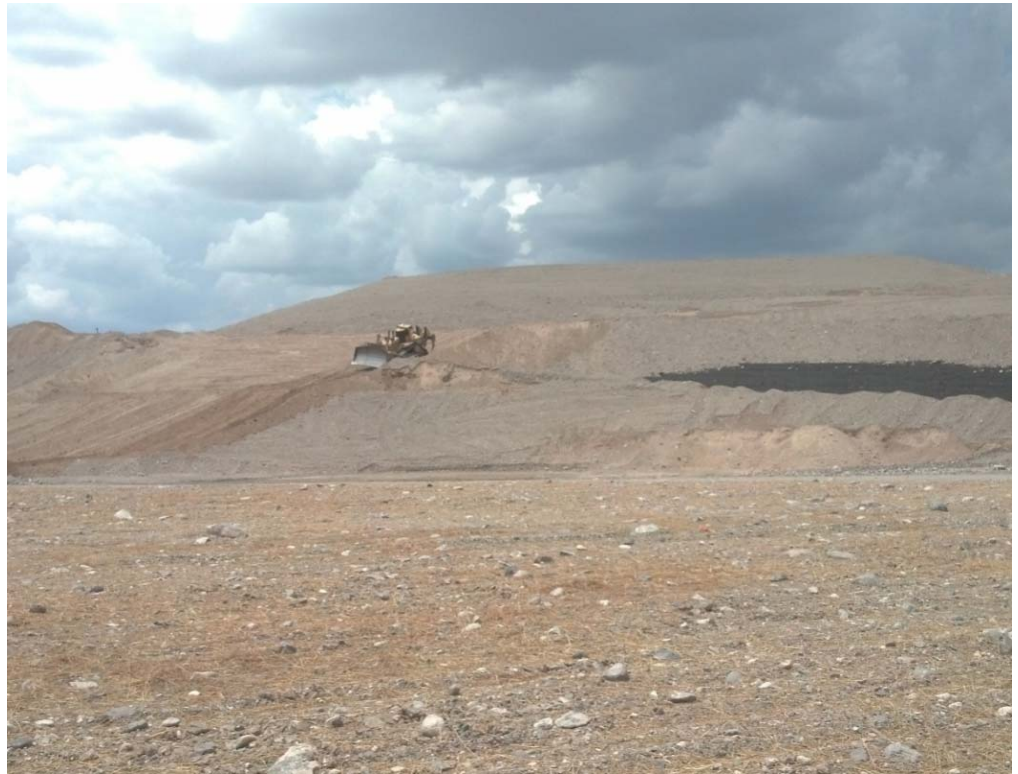
PHOTO 36

July 12 - July 18, 2014
FMRS placing cover in
approved IR-69 on the
northeast outslope
of the Slag Pile.

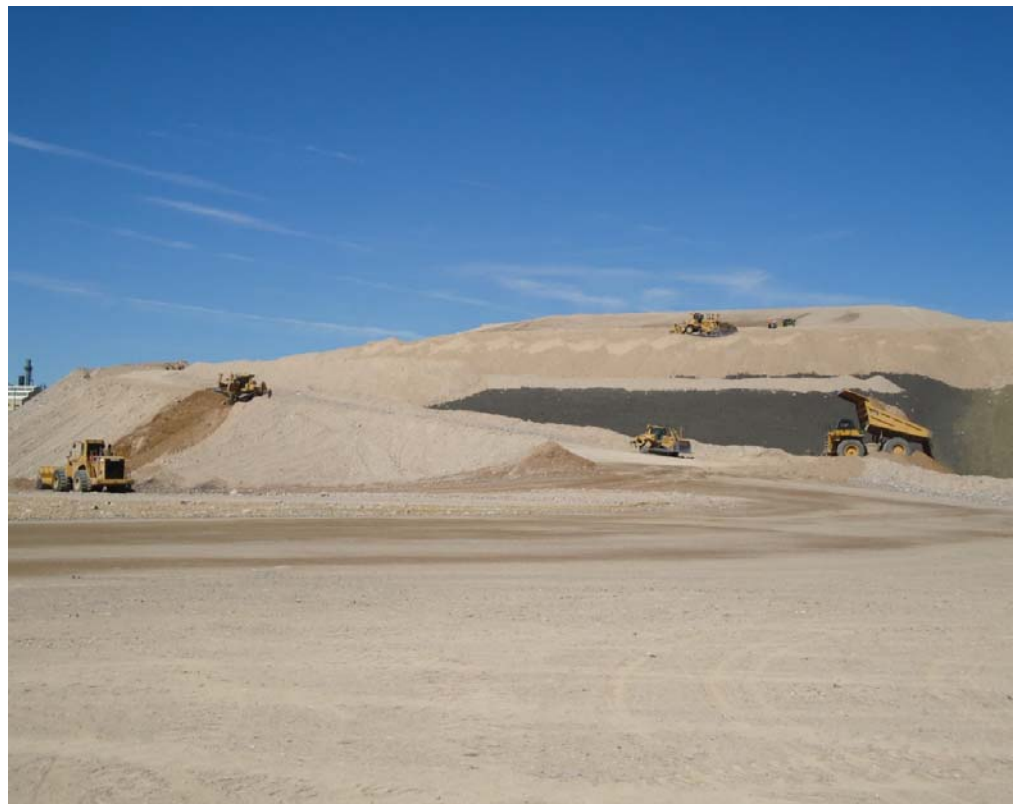
PHOTO 37

July 5 - July 11, 2014
FMRS placing cover on the
east outslope of the Slag Pile.

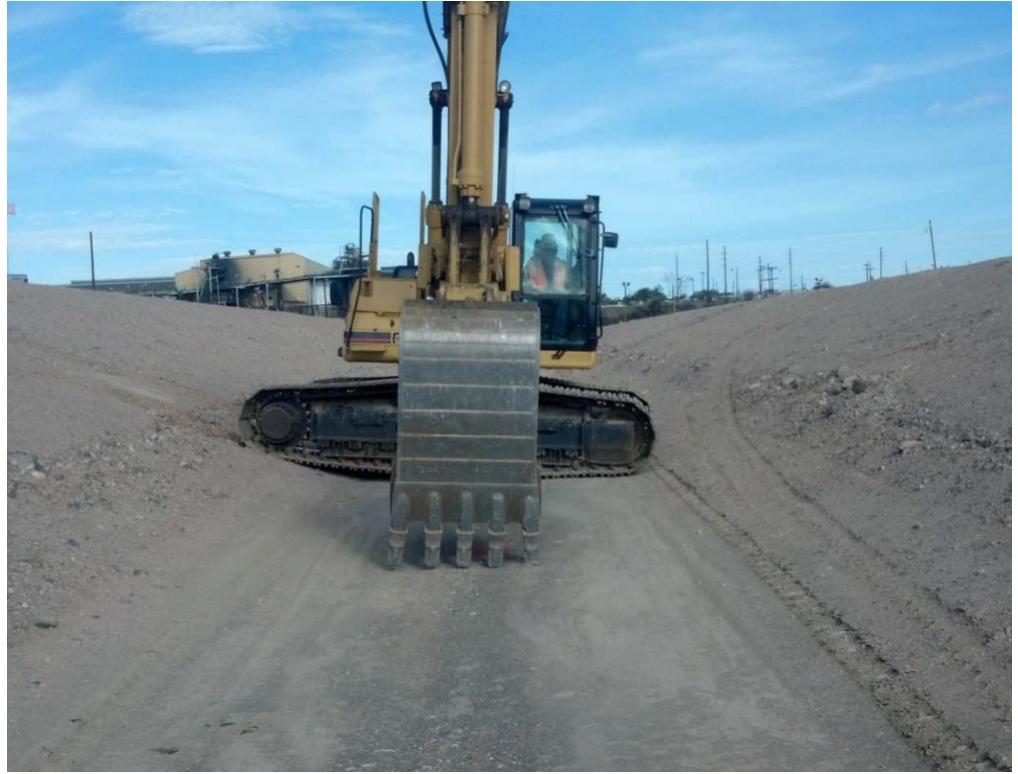
PHOTO 38

July 12 - July 18, 2014
FMRS excavating QA
test pits for cover thickness
measurement within IR-63.

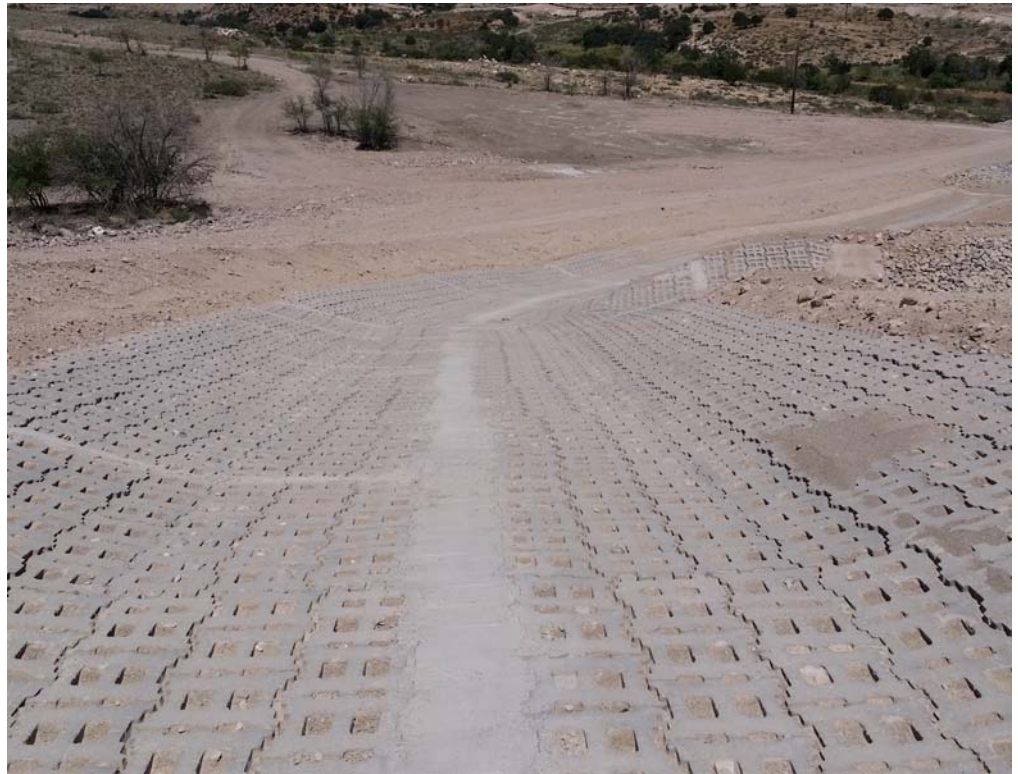
PHOTO 39

September 2, 2014
Completed Down Drain 1.

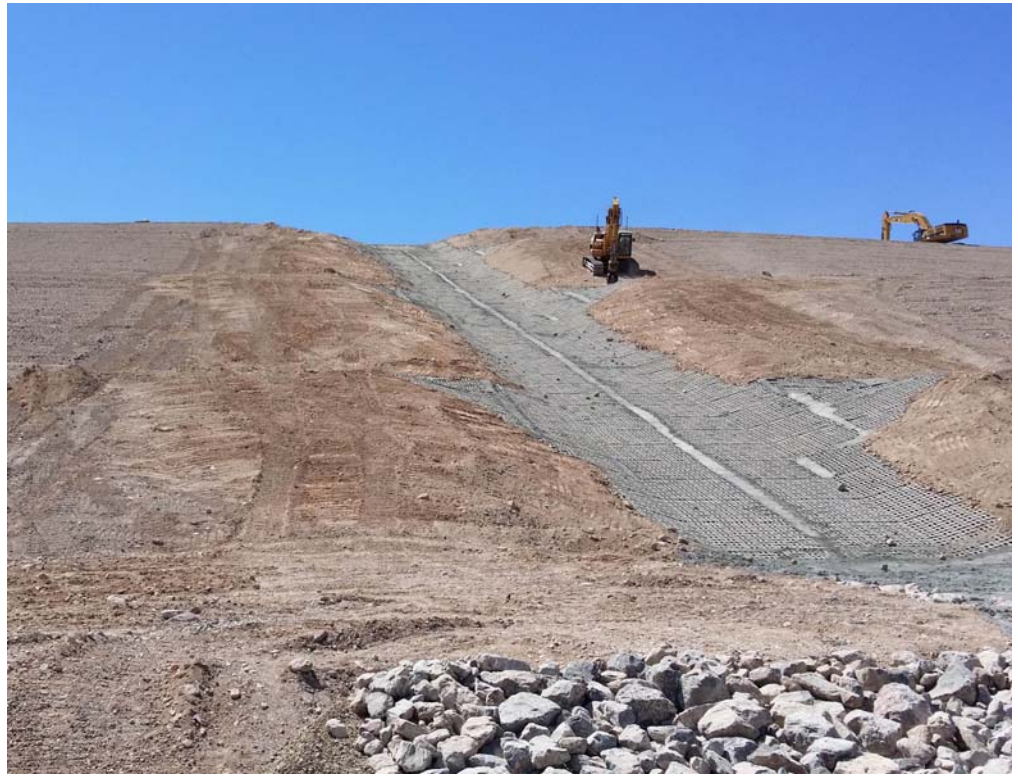
PHOTO 41

September 2, 2014
FMRS crews working on
Down Drain 2.

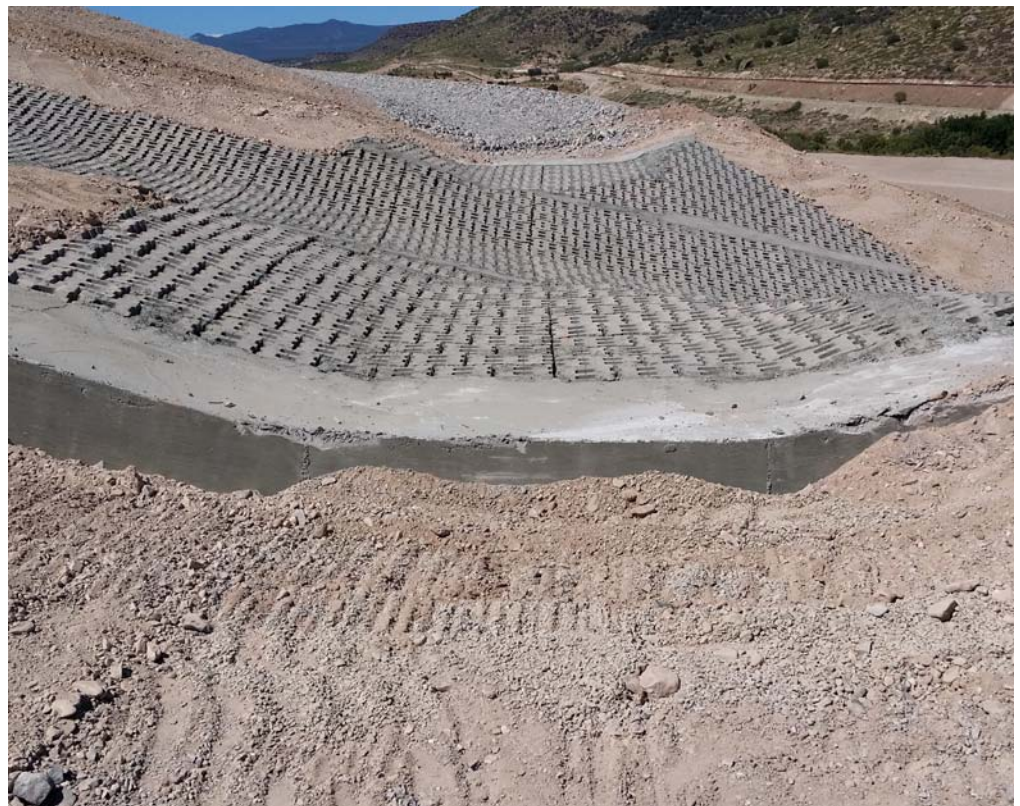
PHOTO 42

September 2, 2014
Outslope Channel to
Down Drain 2 transition
under construction.

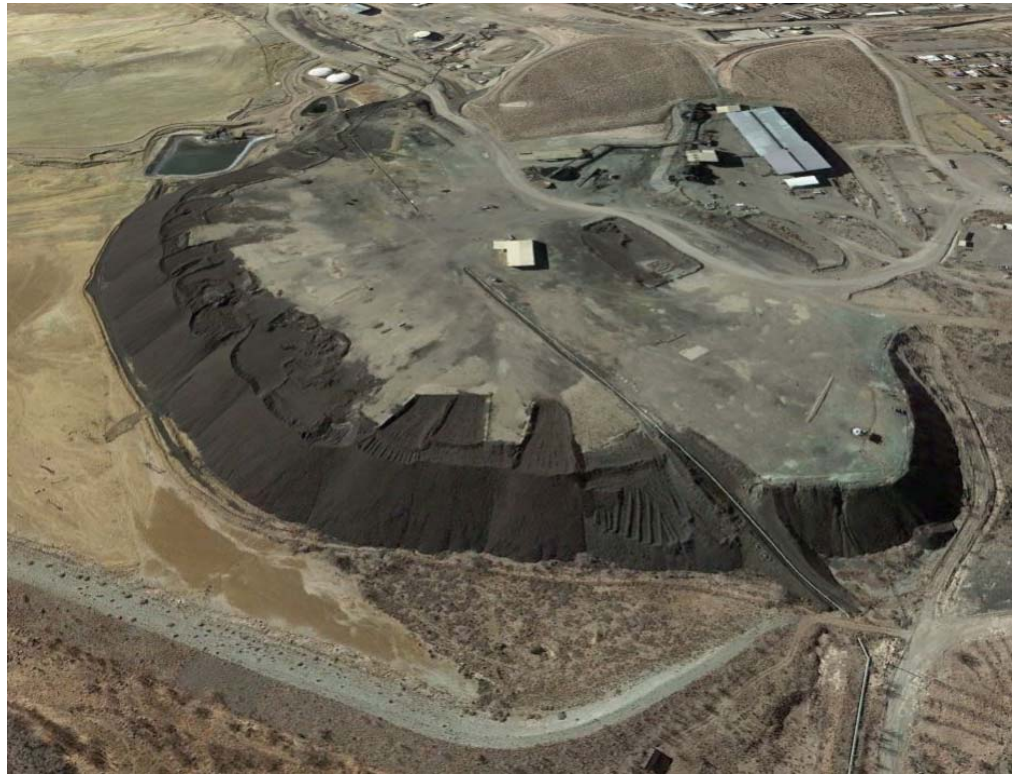
PHOTO 43

January 21, 2013
(Google Image)
Slag Pile prior to reclamation,
looking southwest.

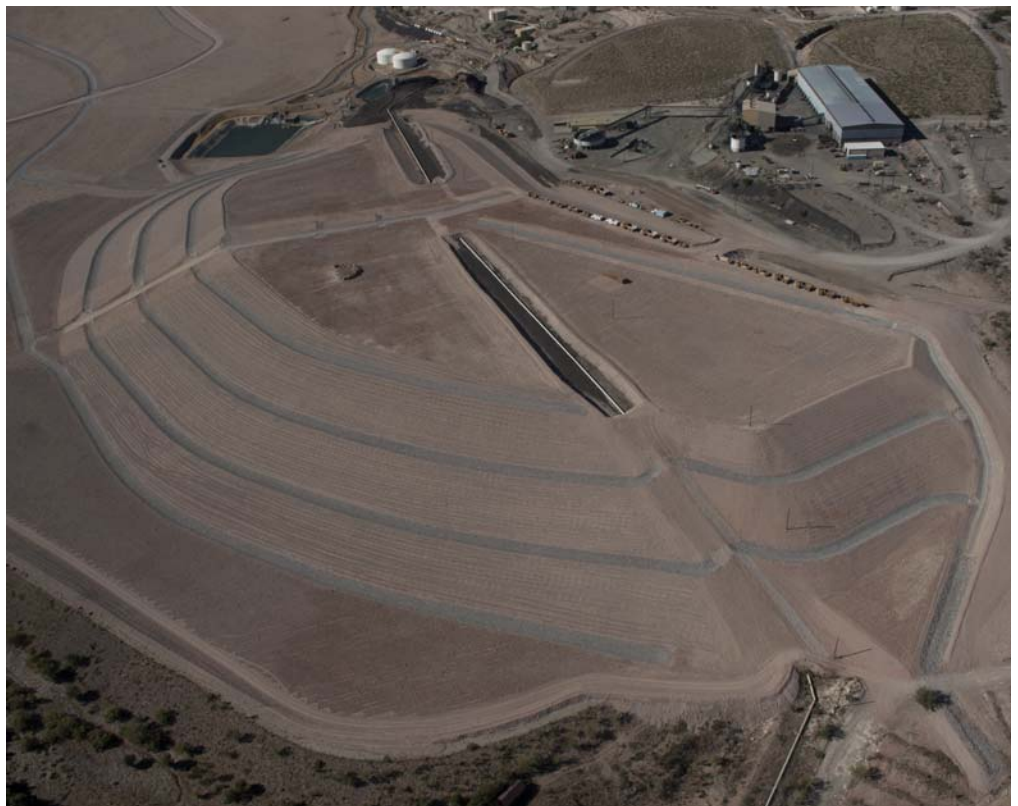
PHOTO 44

September 10, 2014
Completed Slag Pile,
looking southwest.

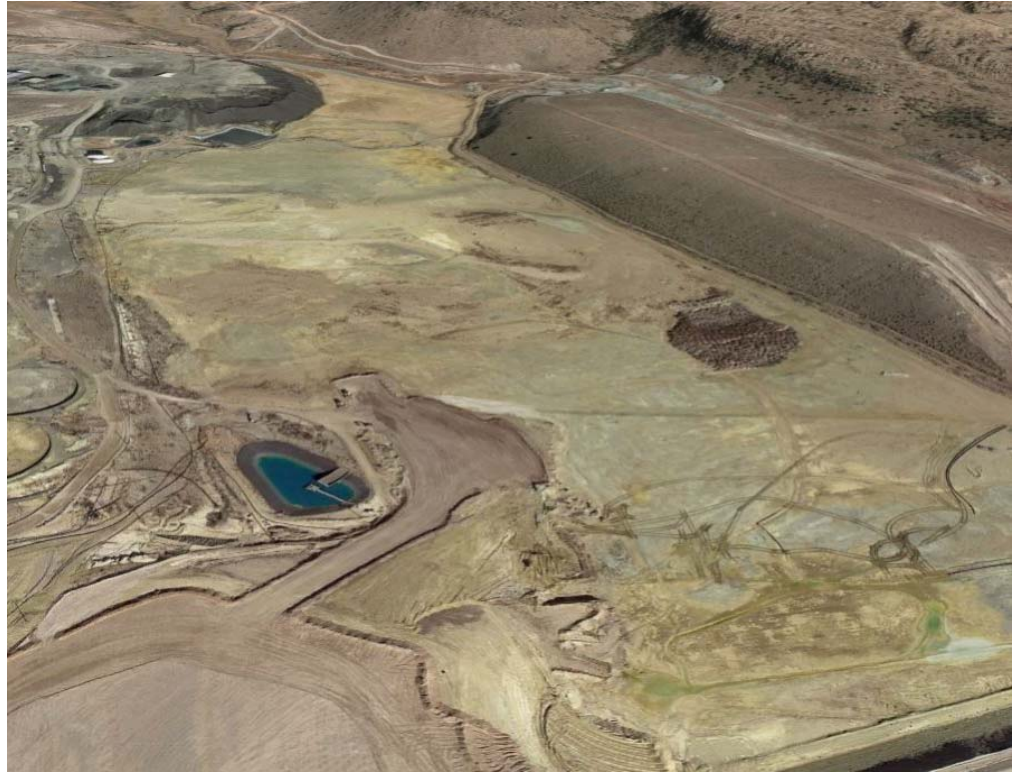
PHOTO 45

January 21, 2013
(Google Image)
Lake One prior to reclamation,
looking north.

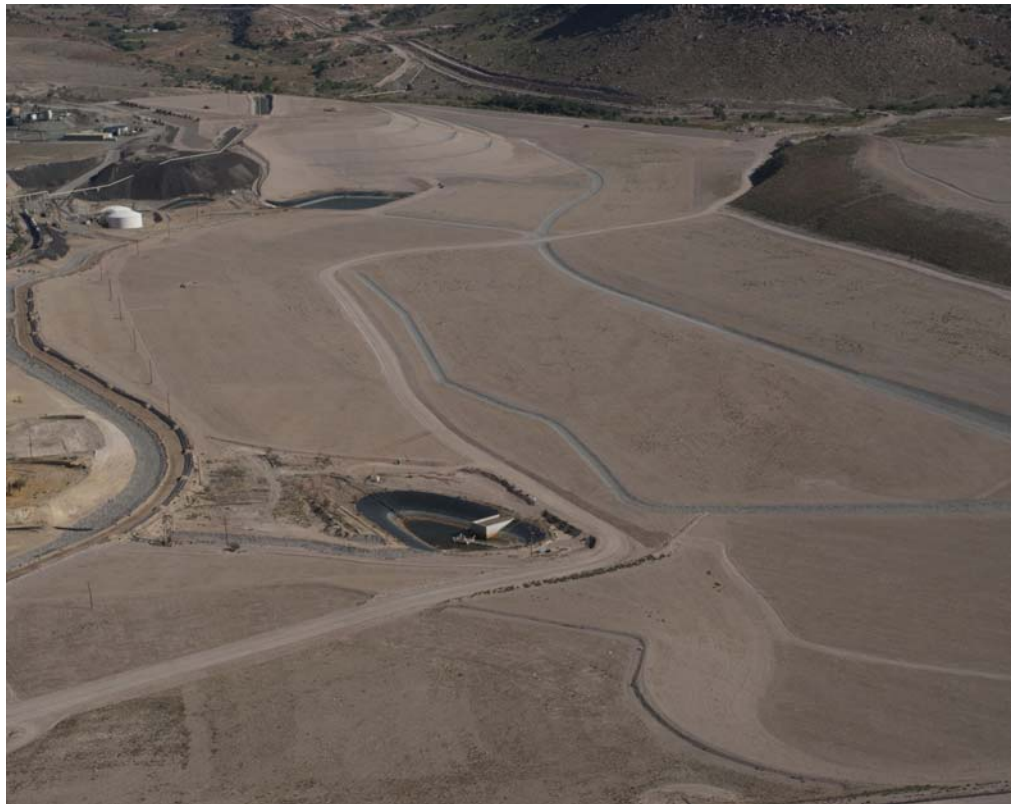
PHOTO 46

September 10, 2014
Completed Lake One
Reclamation area,
looking north.

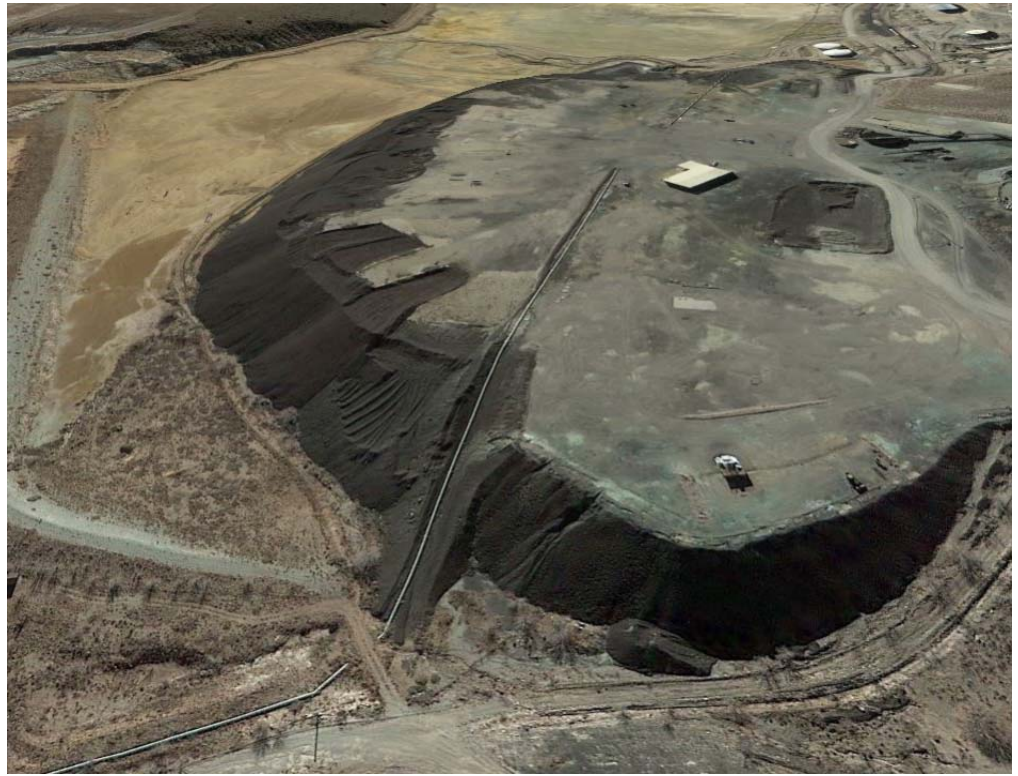
PHOTO 47

January 21, 2013
North side of Slag Pile
prior to reclamation,
looking southeast.

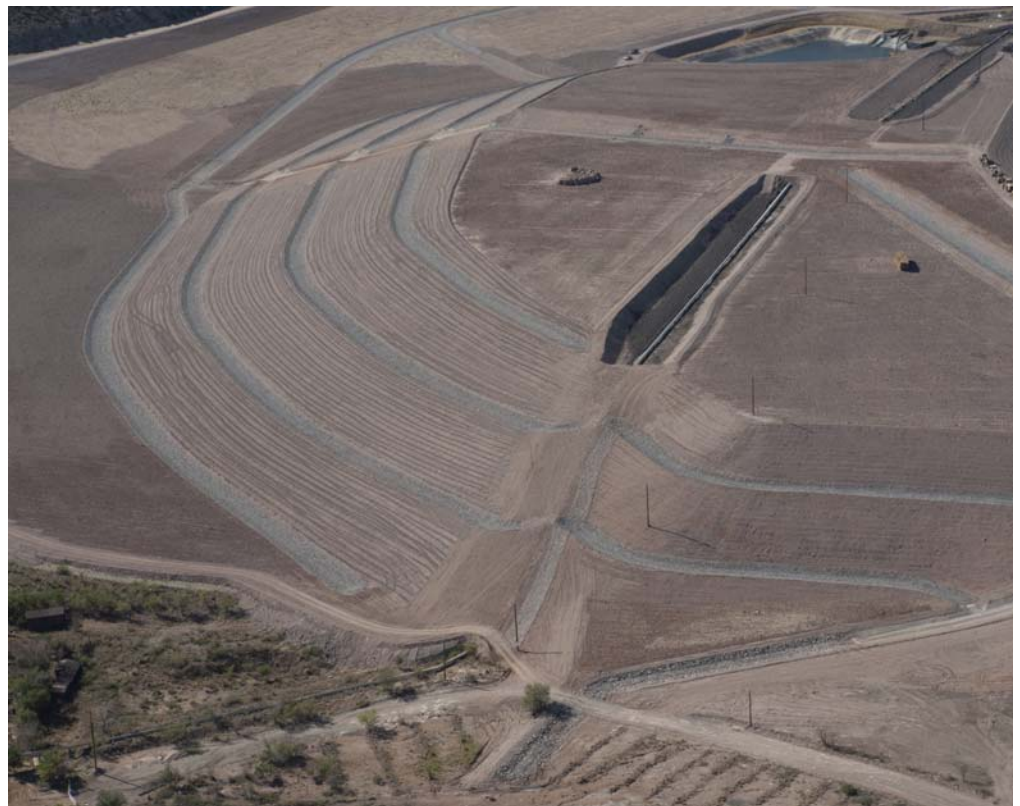
PHOTO 48

September 10, 2014
North side of
completed Slag Pile,
looking southeast.

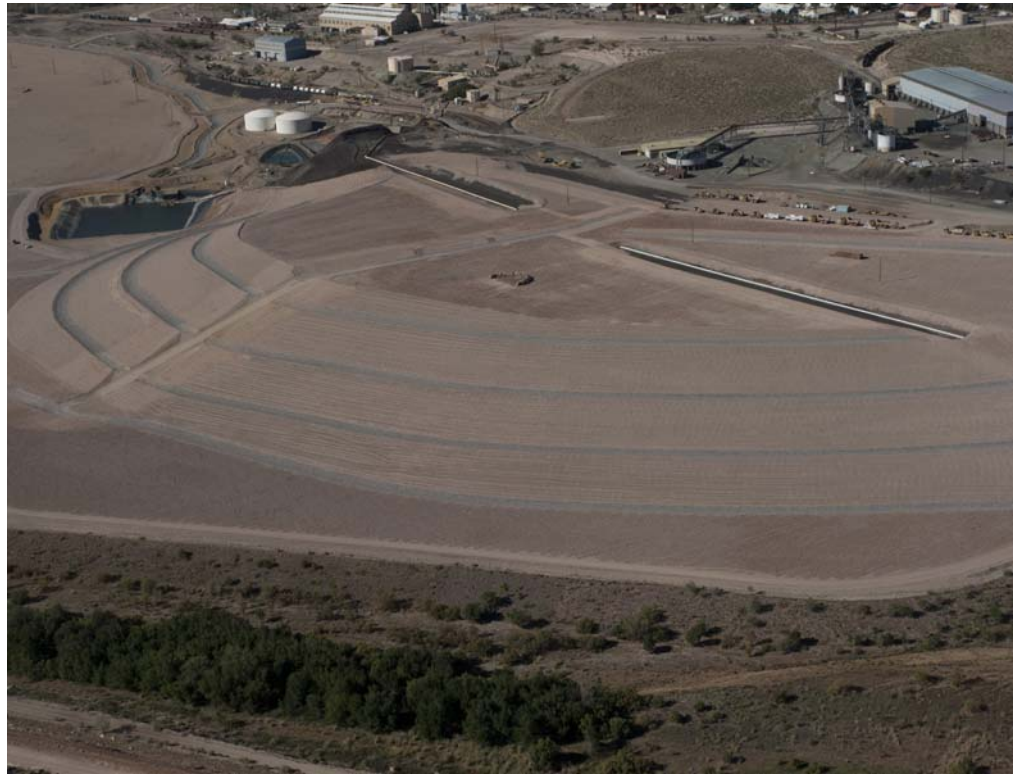
PHOTO 49

September 10, 2014
East side of
completed Slag Pile,
looking southwest.

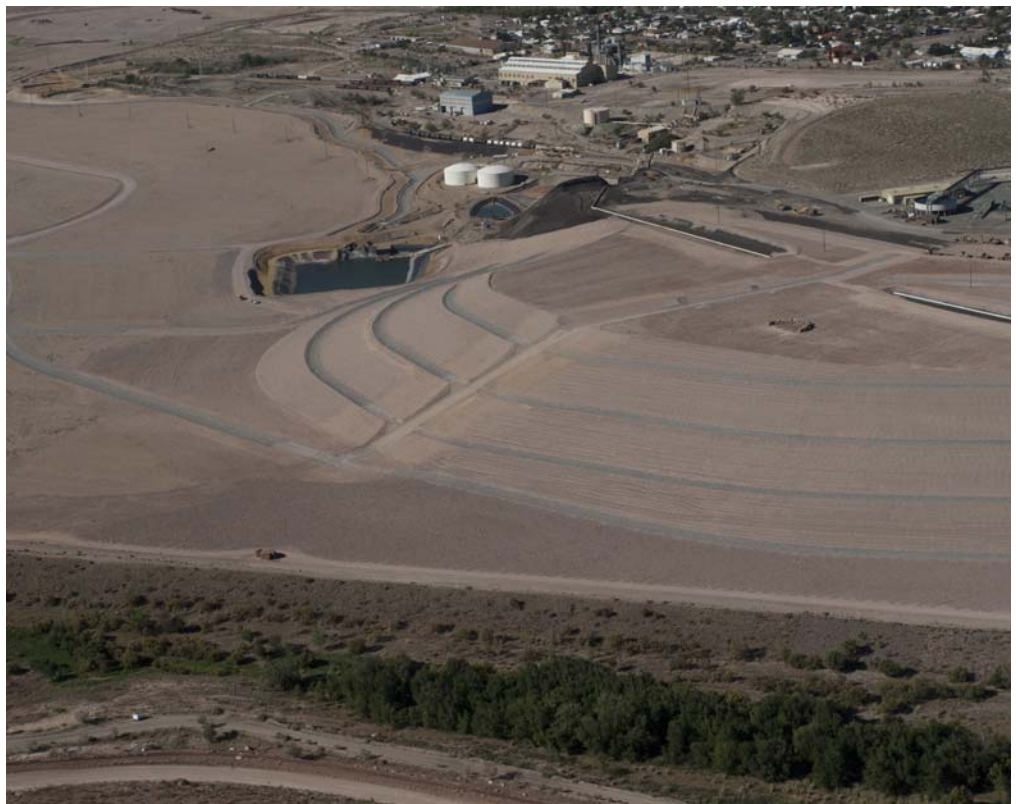
PHOTO 50

September 10, 2014
Completed Slag Pile and
Lake One Reclamation area,
looking southwest.

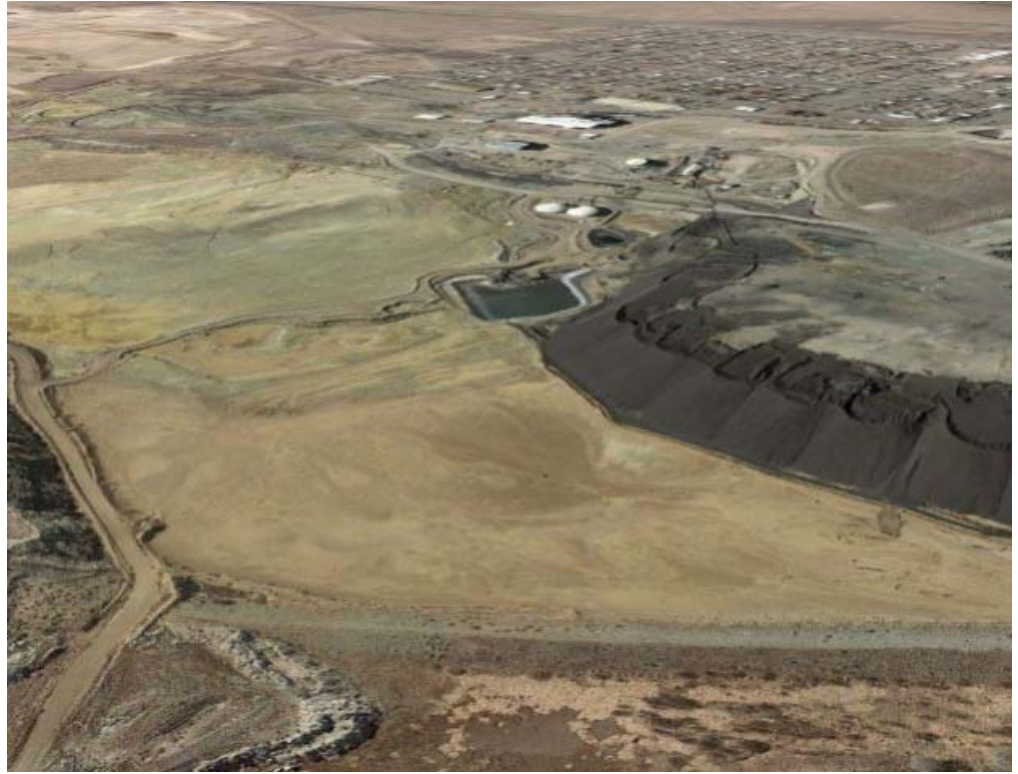
PHOTO 51

January 21, 2013
(Google Image)
Slag Pile and Lake One
prior to reclamation,
looking southwest.

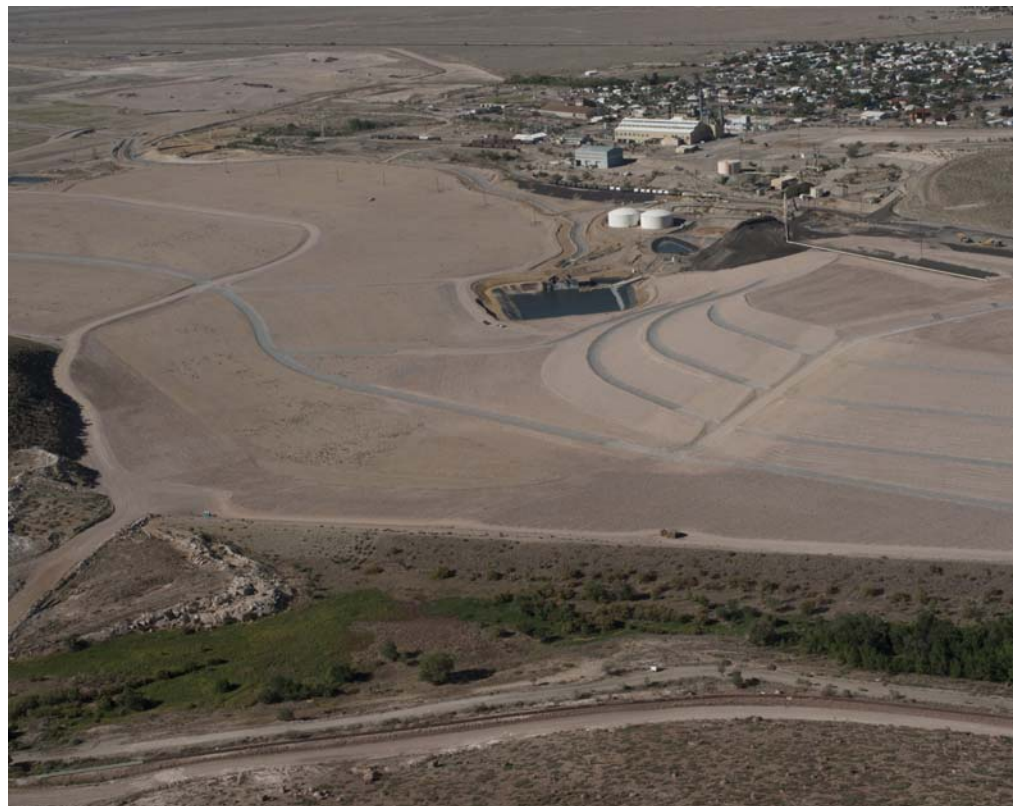
PHOTO 52

September 10, 2014
Completed Slag Pile and
Lake One Reclamation area,
looking southwest.
